Subject: Response to DMS Comments for DRAFT Monitoring Year 2 Report
Thomas Creek Restoration Project, Wake County
DMS Project # 96074, DEQ Contract #5549, RFP# 16-005020

FINAL

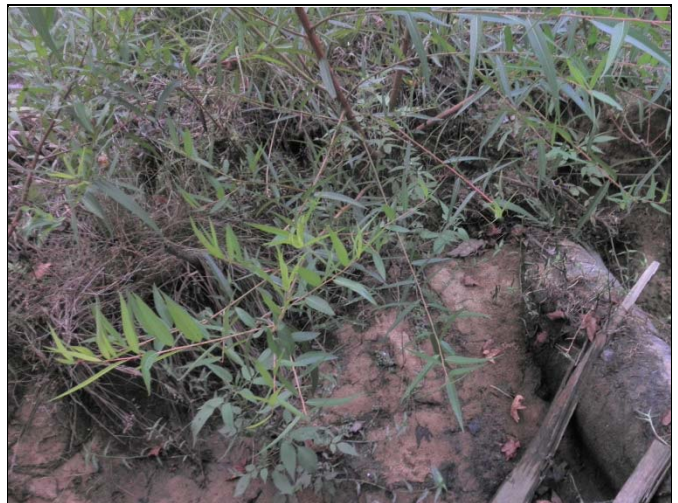
Reach 2: Crest Gauge, 0.21 ft on 5/2/17 (from 3.2" rain on 4/25/17, see associated spikes in flow gauge graphs)

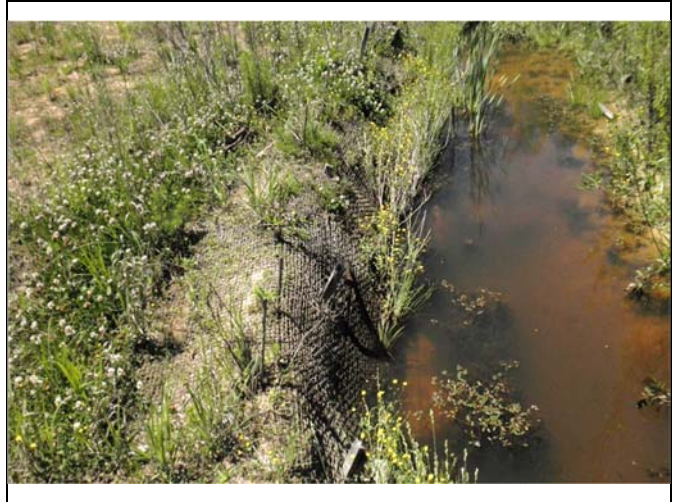
Stream Problem Area 1 (lack of woody vegetation establishment along left bank), R2 Station 32+25

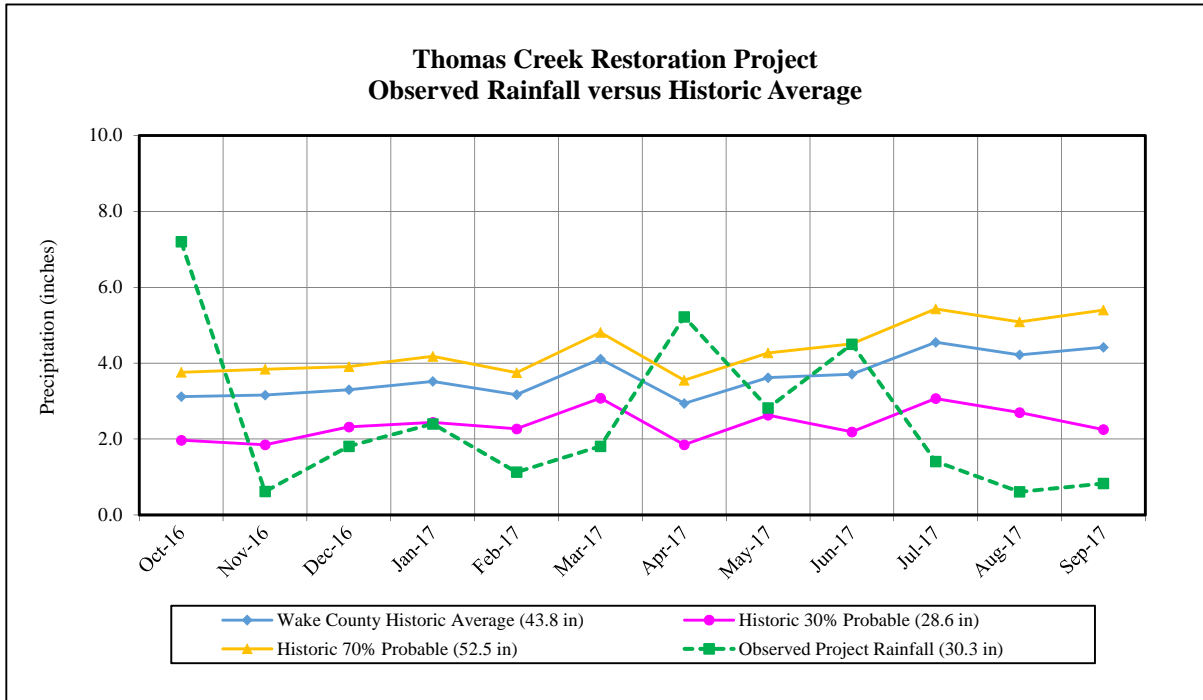
Figure 9.

As the observed monthly rainfall data for the project presented in Figure 9 demonstrates, the past 12 months have been quite dry as compared to historic averages. A total of just 30.3" of rainfall was observed for the project (using the nearest NC-CRONOS station KTTA), while Wake County averages 43.8" of annual rainfall, a deficit of over 13". The NCDWR drought monitoring history for Wake

Note: Historic average annual rainfall for Wake County is 43.8", while the observed project rainfall recorded just a total of 30.3" over the previous 12 months (from 10/1/2016 to 9/30/2017). Project rainfall data was collected from the nearest NC-CRONOS station KTTA.

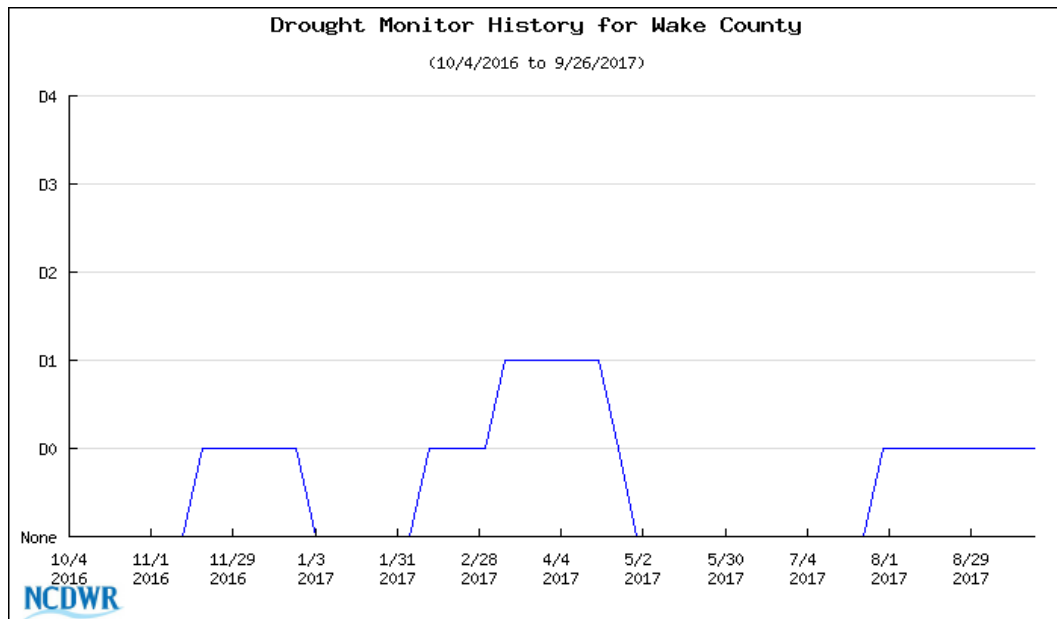
County also indicates that for significant periods of time over the past 12 months the County has been in Abnormally Dry (D0) or Moderate Drought (D1) conditions. Appendix E contains more details on the observed and historic rainfall data for the Site.

NCDEQ's Division of Water Resources Drought Monitor History also recorded significant periods of Abnormally Dry (D0) and Moderate Drought (D1) conditions for Wake County during the previous 12 months as shown below:
