Subject: Response to DMS Comments for DRAFT Monitoring Year 3 Report
Thomas Creek Restoration Project, Wake County
DMS Project # 96074, DEQ Contract #5549, RFP# 16-005020

Figure 5 Index Map
Current Condition Plan View
Thomas Creek Site - MY3

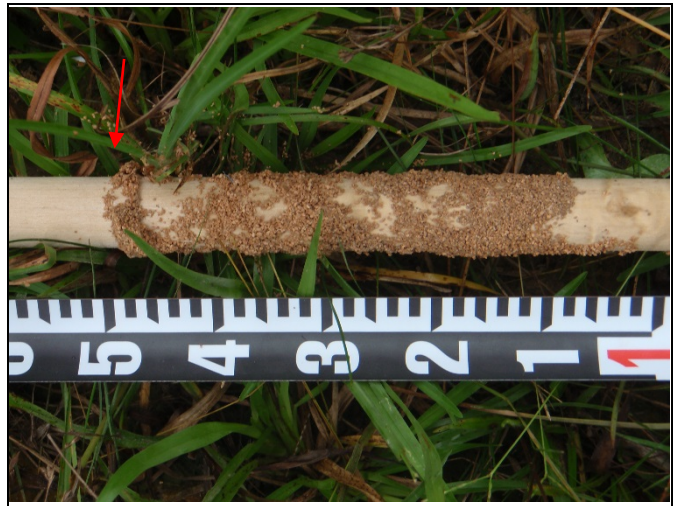
To monitor on-site bankfull events, one crest gauge (crest gauge #1) was installed along the downstream portion of Reach R2 at bankfull elevation along the left top of bank at approximately Station 38+90. During Year 3 monitoring, two above-bankfull events were documented; one in April 2018 and another in September 2018 (from Hurricane Florence). Further details of the crest gauge readings are presented in Table 12 in Appendix E, and photographs can be found in Appendix B.

Overbank event of 1.49 ft from Hurricane Florence (photo: 10/10/18)

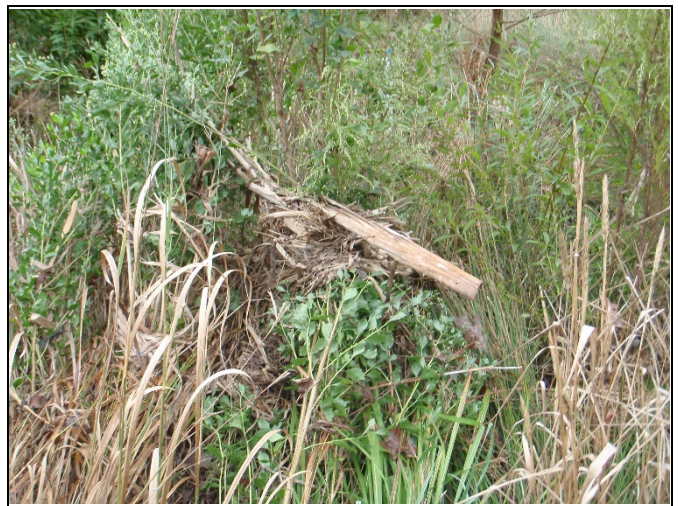
Evidence of overbank flow, Reach R3: Debris jam in the limbs of floodplain vegetation

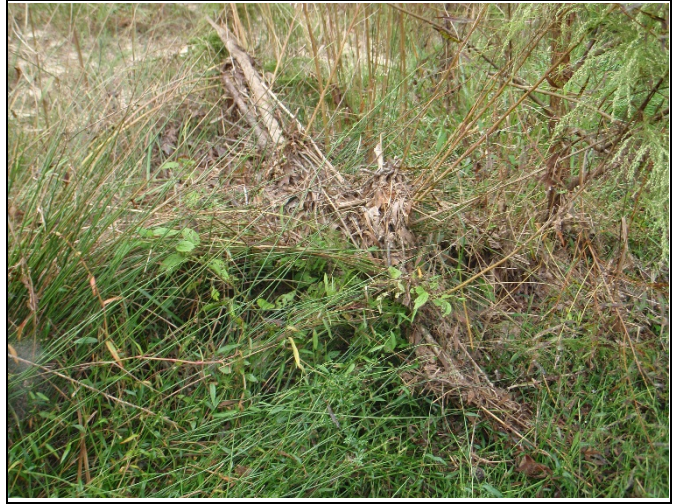
Evidence of overbank flow, Reach R5: Debris pile / wrack line in floodplain

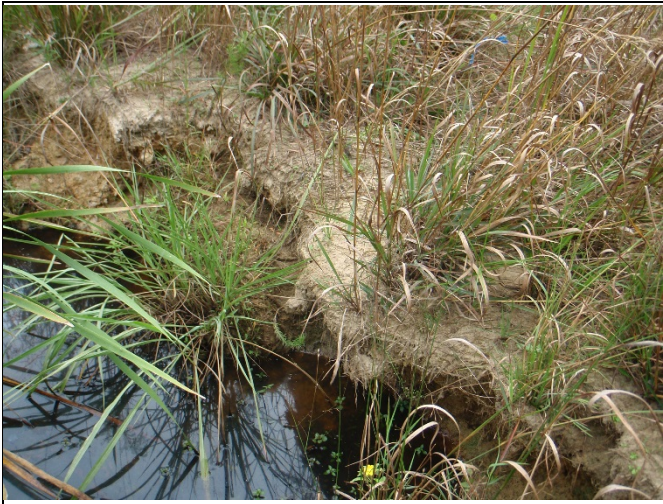
During Year 3 monitoring, there were two SPAs observed on site. Both are short sections (~15 ft each) of minor bank scour that occurred during Hurricane Florence along the downstream sections of pool bends on Reach R2. These two sections are shorter sub-sections of stream areas previously identified in the Monitoring Year 2 (MY2) report as SPAs for lacking good bank vegetation. In March 2018 these areas had been replanted with livestakes, which were growing and stabilizing the banks when Hurricane Florence hit in mid-September. The vast majority of the banks with the newly establishing livestakes held firm through the storm, but the two SPA areas experienced minor scour from the high flows and had their livestakes seriously damaged or washed out altogether. These areas will be graded back by hand and replanted with additional livestakes in the winter of 2018/2019. These SPAs are further described in Table 5 and shown in both the CCPV and in photographs, all of which can be found in Appendix B.

SPA-1: Bank scour and damaged livestock establishment from Hurricane Florence, left bank of R2, Station 34+75

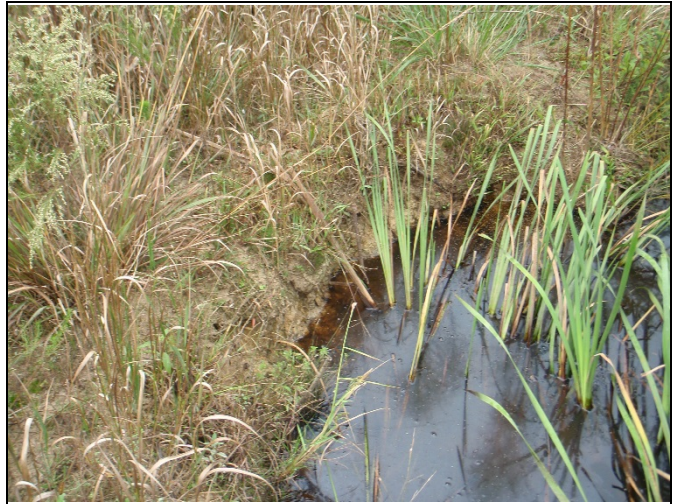
SPA-2: Bank scour and damaged livestock establishment from Hurricane Florence, left bank of R2, Station 35+75

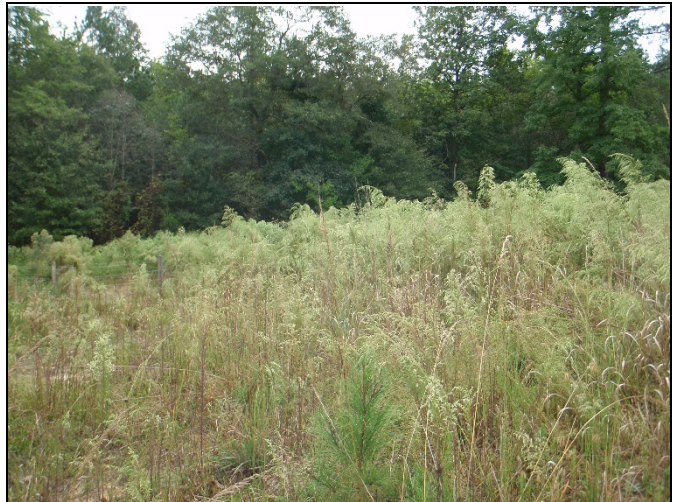
There were however, two Vegetation Problem Areas (VPAs) identified during the Year 3 monitoring. The first VPA is an area of low stem density totaling 0.20 acres observed along both banks of a section of Reach T1. This area is somewhat steeper and drier than the surrounding, more vegetatively successful areas. It is believed that previously harsh growing seasons that were particularly hot and dry ultimately led to a high plant mortality. It will be supplementally planted with bare-root and/or 1-gallon plants of appropriate species during the winter of 2018/2019. The second VPA is an area of low vigor/short stem heights totaling approximately 0.38 acres noted along the left buffer of Reach R3. Upon close observation, there are a sufficient number of living stems in this area, they simply are not growing at the expected rate. As noted above, previous growing seasons have been particularly harsh and that no doubt hurt plant growth. However, a subsequent soil test revealed that this buffer area could also benefit from a small application of soil amendments. So, over the winter of 2018/2019, this area will receive an application of lime, and then some additional fertilizer in the spring and/or fall of 2019. These VPAs are further described in Table 6 and shown in the CCPV, both of which can be found in Appendix B.

VPA-1: Thin stem density observed within the riparian buffers of both banks of Reach T1

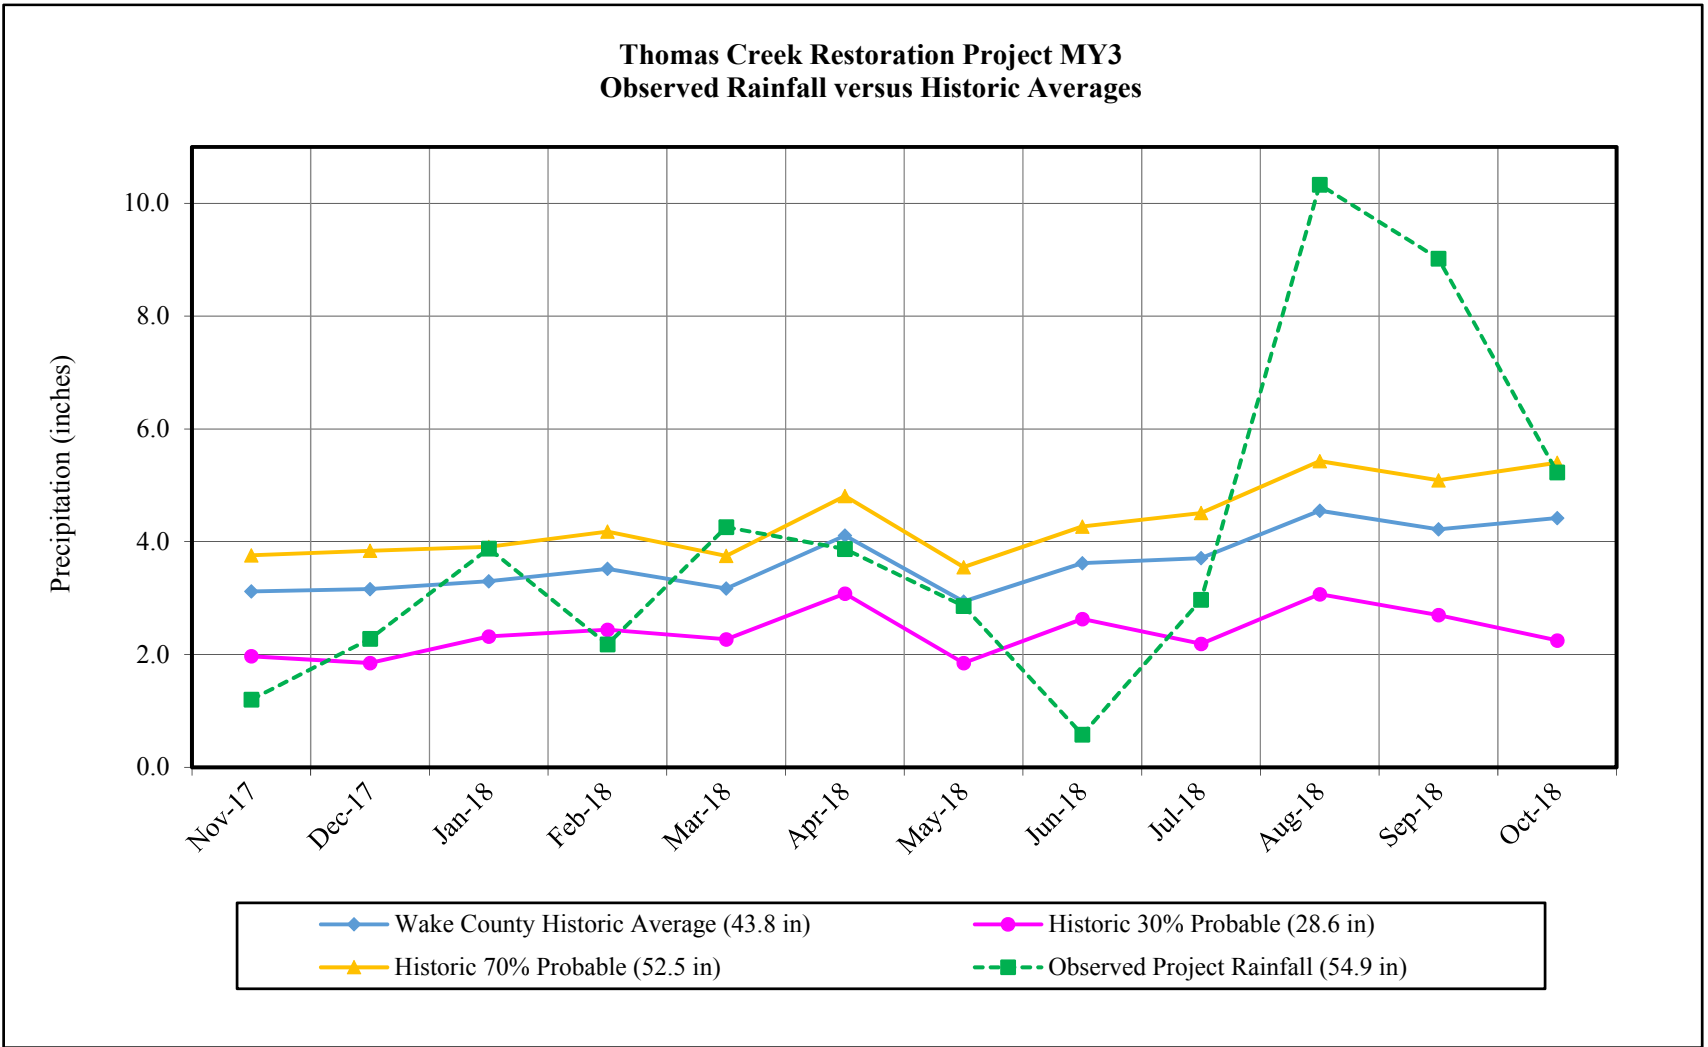
As the observed monthly rainfall data for the project presented in Figure 9 in Appendix E demonstrates, the past 12 months have been much wetter as compared to historic averages. A total of 54.9 in. of rainfall was observed for the project (using the nearest NC-CRONOS station KTTA), while Wake County averages 43.8 in. of annual rainfall, an excess of over 11 in.

Note: Historic average annual rainfall for Wake County is 43.8", while the observed project rainfall recorded a total of 54.9" over the previous 12 months (from 11/1/2017 to 10/31/2018). Project rainfall data was collected from the nearest NC-CRONOS station KTTA.
