# **Final Thomas Creek Restoration Project Year 4 Monitoring Report**

Wake County, North Carolina

DMS Project ID Number – 96074, DEQ Contract No. 5549

Report Prepared and Submitted by Michael Baker Engineering, Inc.

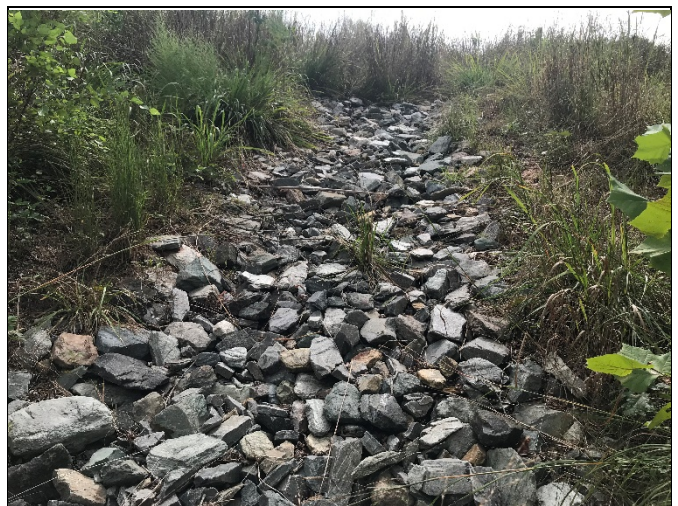
PP-18: Reach 2, view of stabilized drainage on left bank at Station 20+80

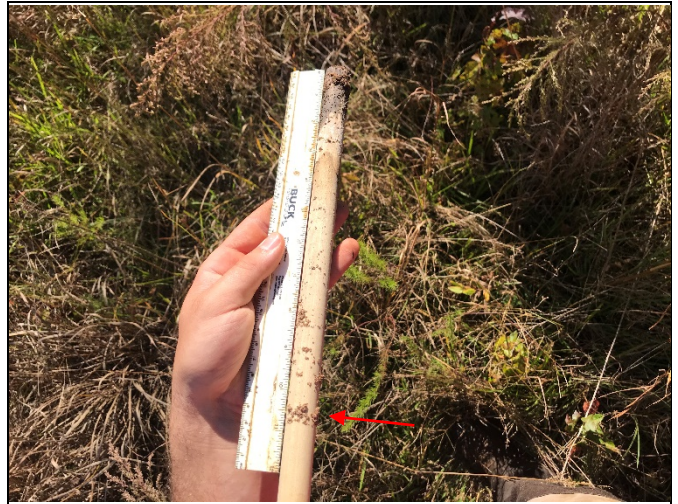
To monitor on-site bankfull events, one crest gauge (crest gauge #1) was installed along the downstream portion of Reach R2 at bankfull elevation along the left top of bank at approximately Station 38+90. During Year 4 monitoring, one above-bankfull event was documented in April 2019. Further details of the crest gauge readings are presented in Table 12 in Appendix E, and photographs can be found in Appendix B.

Overbank event of 0.89 ft on 4/19/19

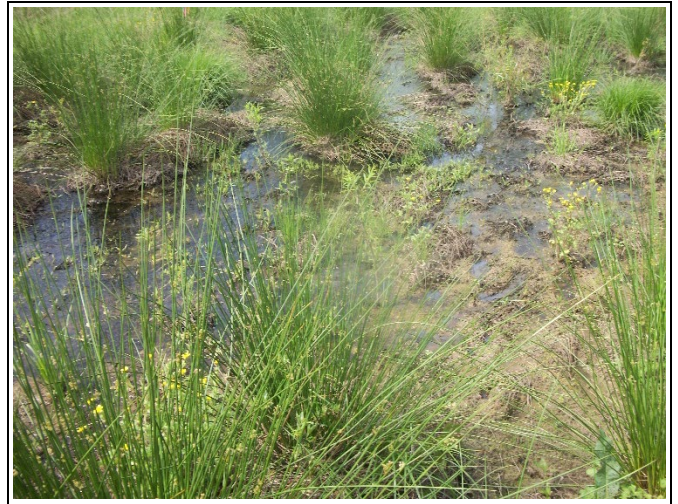
Flow/scour paths and standing water in floodplain near crest gauge on Reach R2.

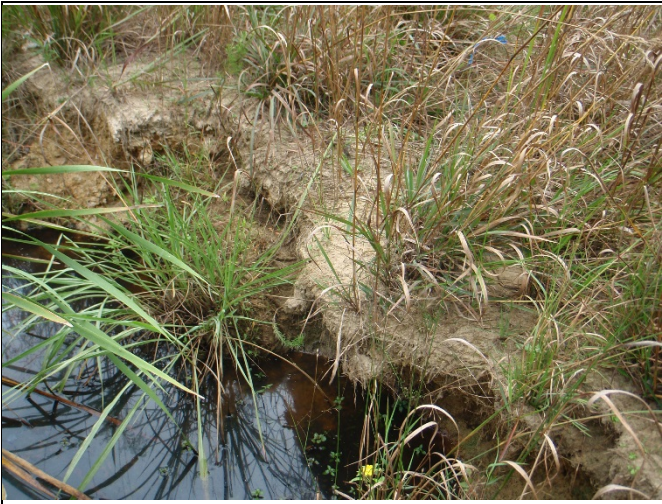
As discussed in the Year 3 monitoring report, Baker had previously noted two short sections of minor bank scour along Reach R2 resulting from Hurricane Florence. These areas were graded back by hand and were seeded and replanted with additional livestakes in January 2019 (the exact repair locations are shown in the CCPV). Subsequent inspection of these area revealed that they have remained stable and are vegetating well as shown in the Maintenance and Repair Photographs, which can be found in Appendix B.

Previous bank scour from Hurricane Florence, left bank of R2, Station 34+75 (BEFORE)

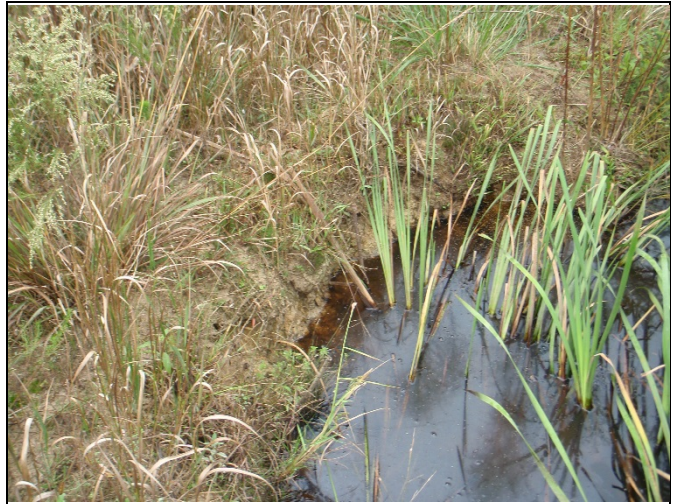
Previous bank scour from Hurricane Florence, left bank of R2, Station 35+75 (BEFORE)

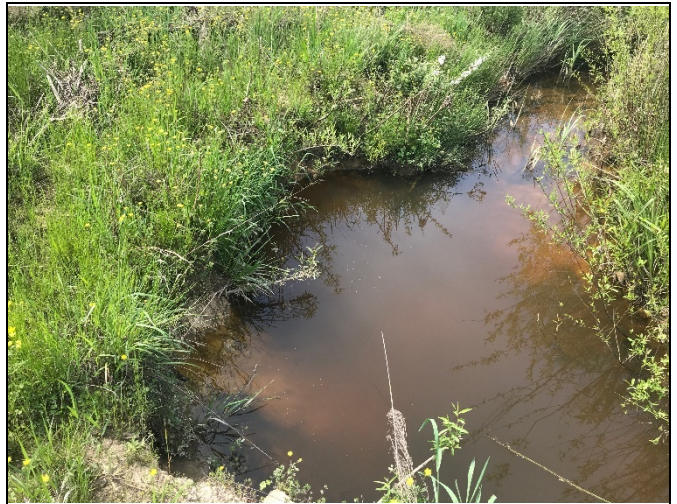
R2 Station 35+75: Bank stabilizing in April 2019

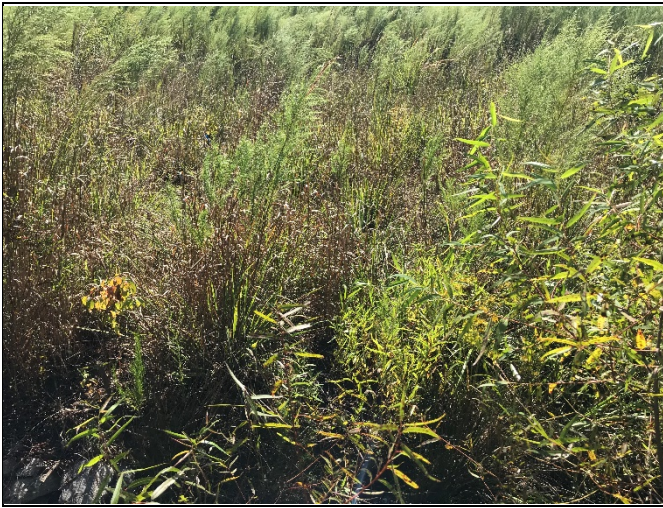
R2 Station 34+75: Bank stabilizing in September 2019

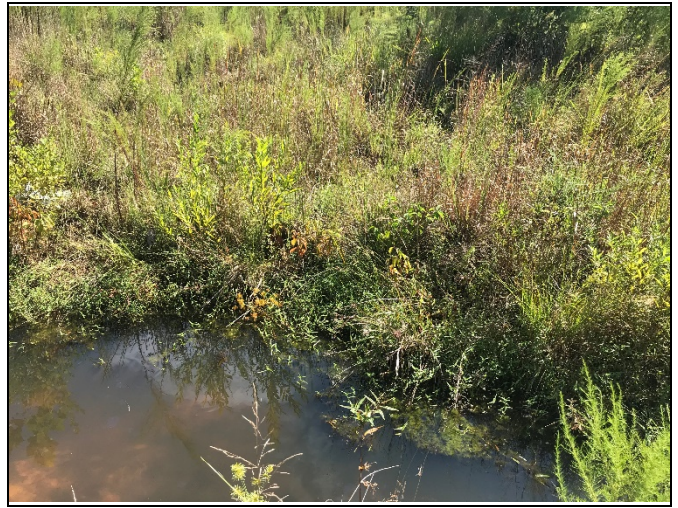
R2 Station 35+75: Bank stabilizing in September 2019

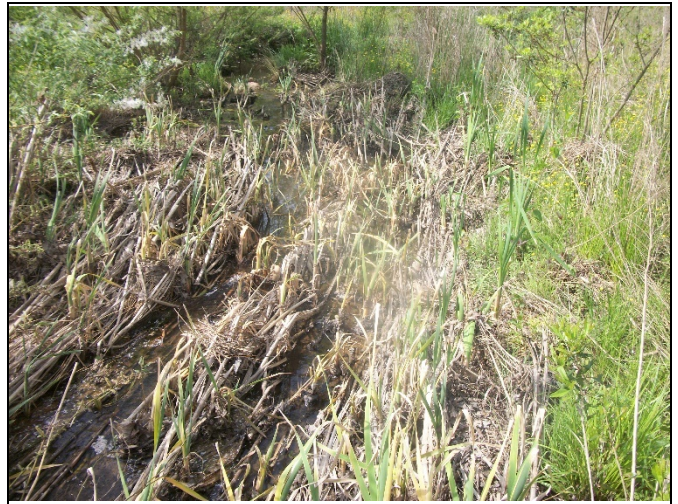
Additionally, there were no areas of non-native invasive species vegetation observed during the Year 4 monitoring. However, several sections of stream along the upper and middle portions of Reach R2 and the lower portion of Reach R4 were observed to have scattered pockets of native cattail (*Typha latifolia*) growing in the channel. These sections were treated in March and April of 2019 to control their growth as shown in the Maintenance and Repair Photographs in Appendix B. These areas will be monitored in the future and treated again if necessary.

Cattail (*Typha latifolia*) treated in upper Reach R2 in March and April 2019

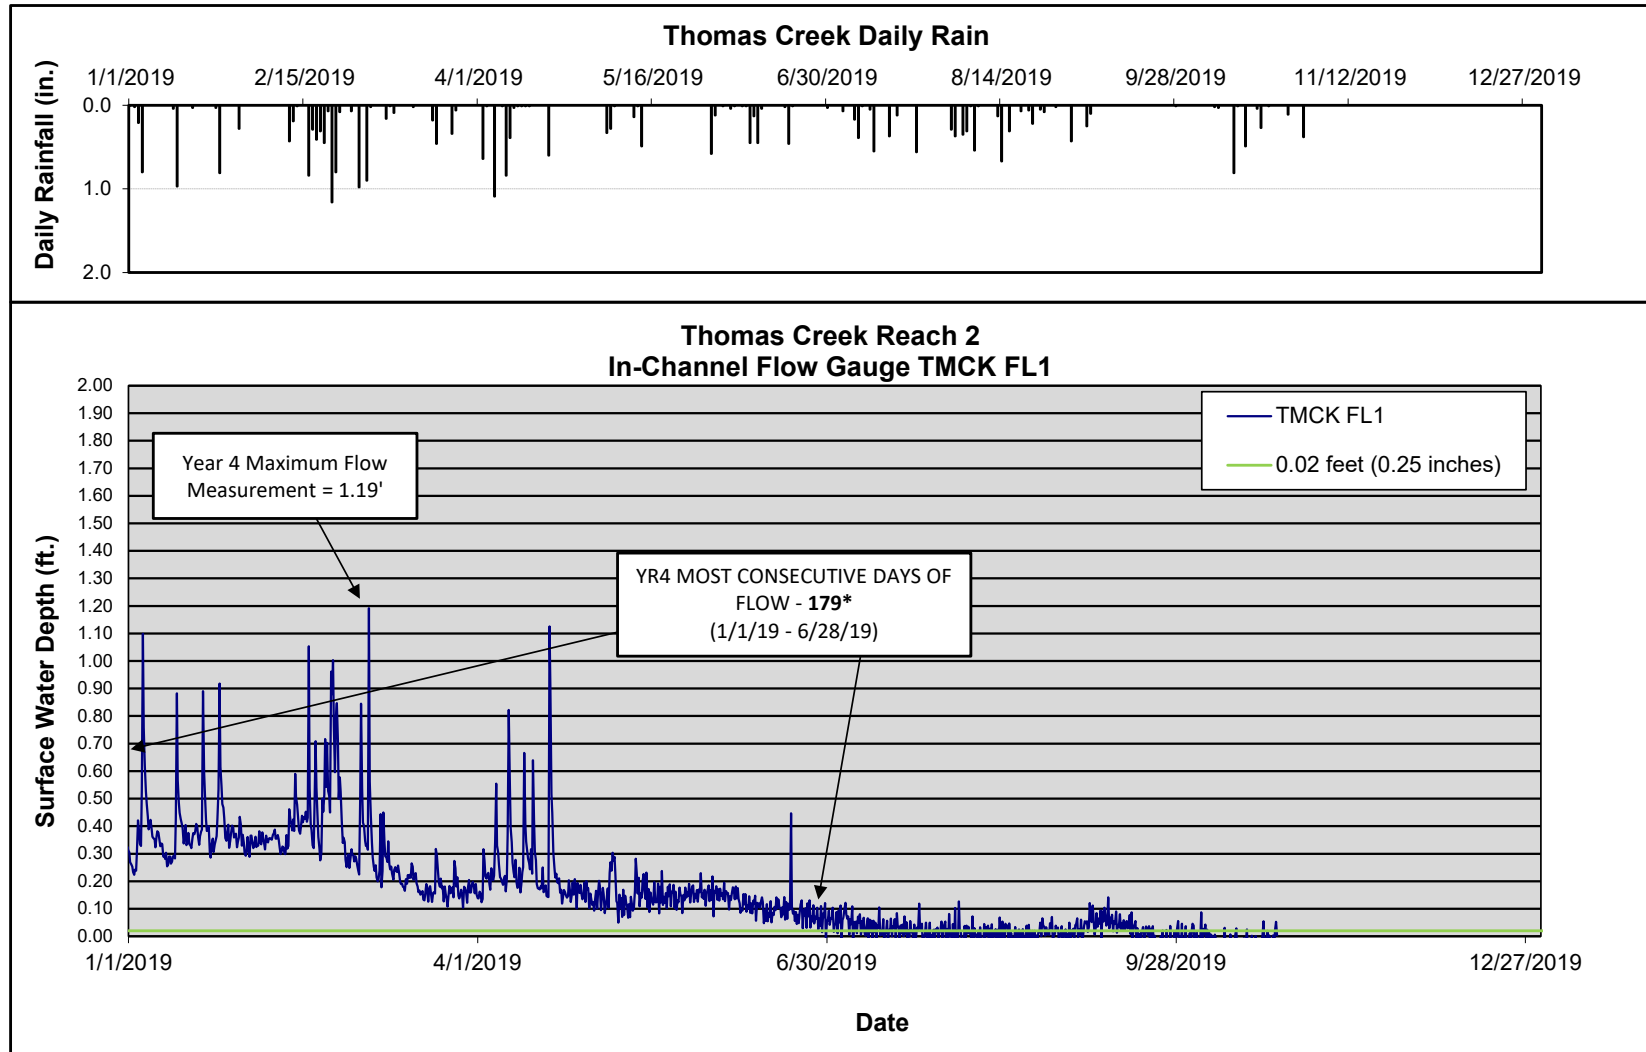
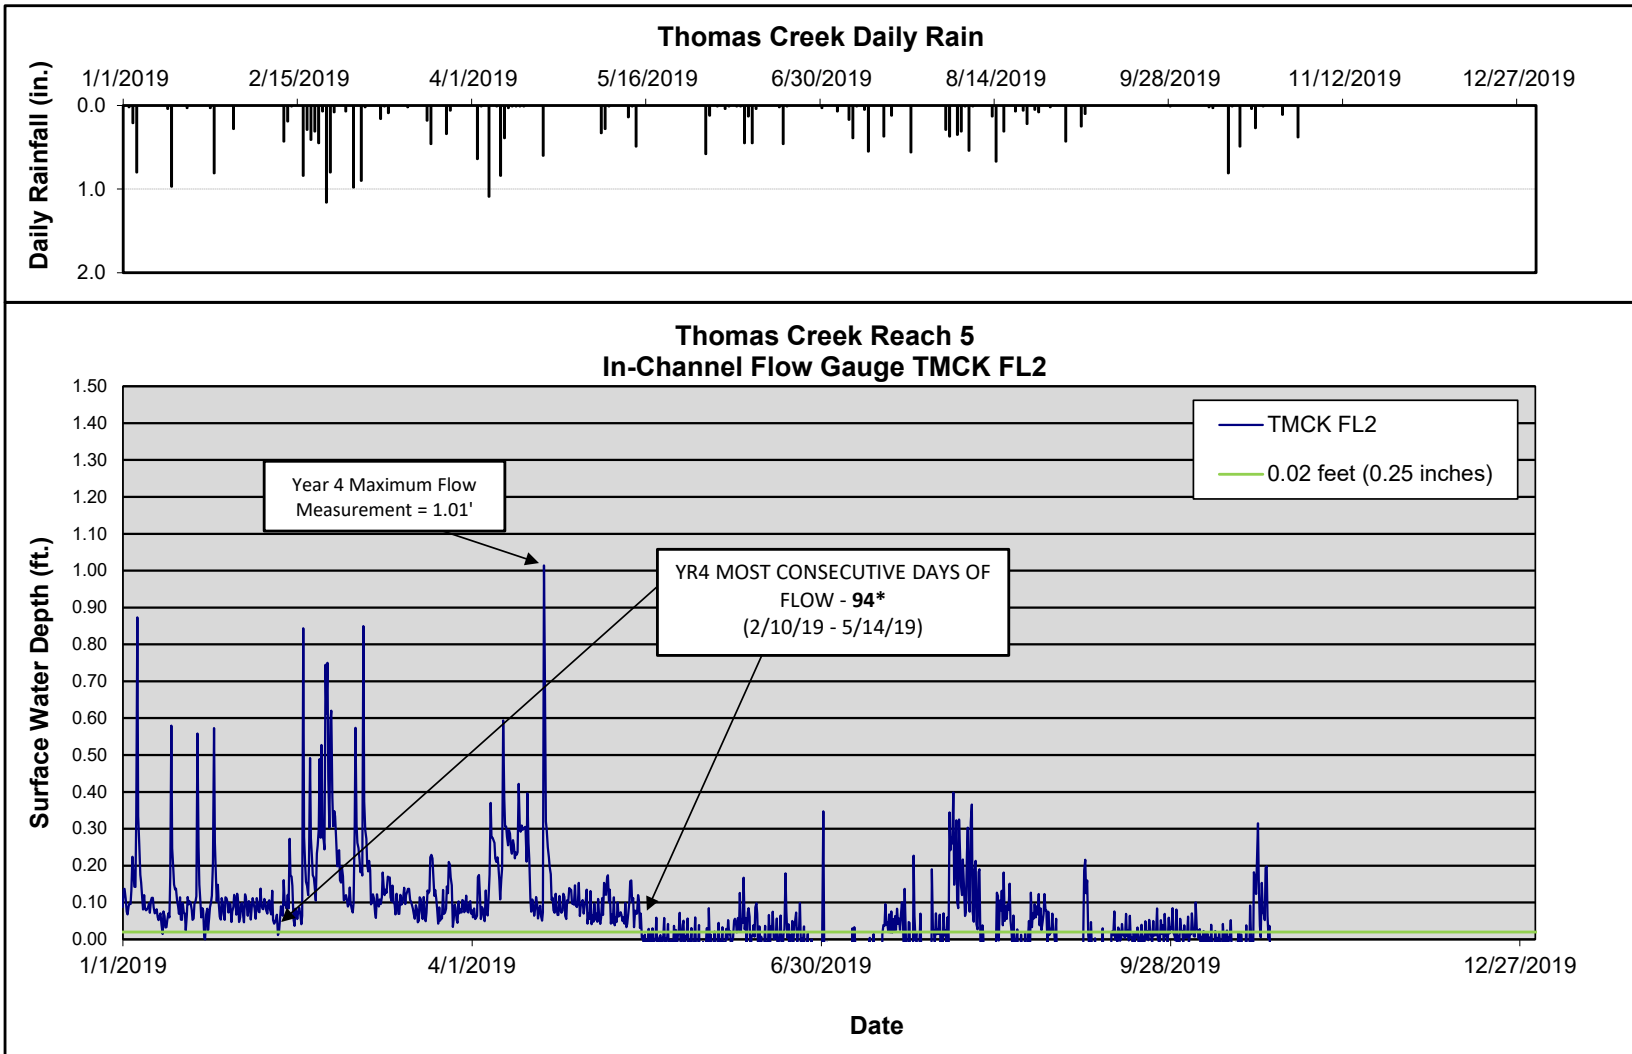
**Figure 8. Flow Gauge Graphs**

To monitor flow on restored reaches, two flow gauges were installed on site; TMCK-FL1 on Reach 2 (Station 20+75), and TMCK-FL2 on Reach 5 (Station 33+90). The Year 4 flow monitoring data demonstrated that both flow gauges met the stated success criteria of 30 days or more of consecutive flow. The gauges also demonstrated similar patterns relative to rainfall events and can corroborate reported overbank flow events from the crest gauge, as shown in the flow gauge graphs found in Appendix E.

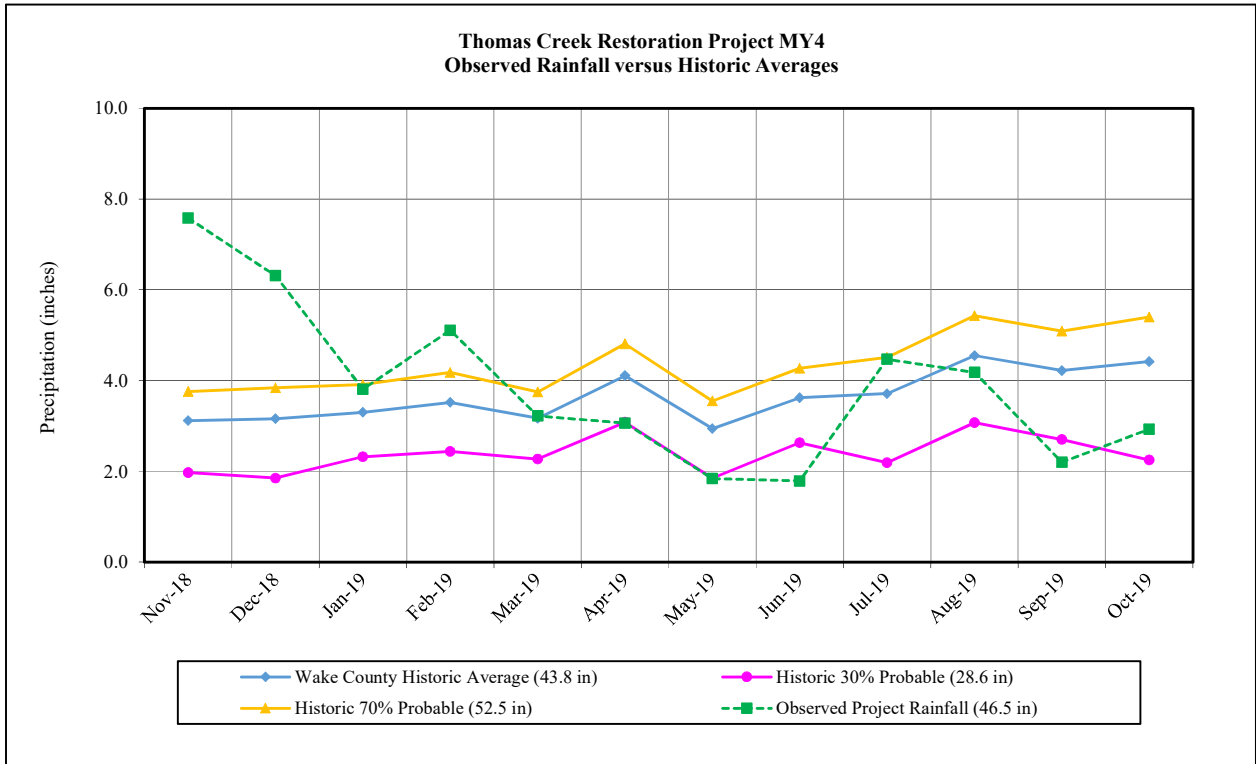
Figure 9. Observed Rainfall Versus Historic Averages

As the observed monthly rainfall data for the project presented in Figure 9 in Appendix E demonstrates, the past 12 months have varied dramatically as compared to historic average precipitation. A total of 46.5 inches of rainfall was observed for the project (using the nearest NC-CRONOS station KTTA), while Wake County averages 43.8 inches of annual rainfall, an excess of just 2.7 inches. However, the winter of 2018-2019 saw much greater than average rainfall totals, while several months in the summer and fall saw much less than average rainfall totals. In fact, the Site was under stage D1 – Moderate Drought conditions as of 10/15/19 as per the NC Drought Management Advisory Council.

Note: Historic average annual rainfall for Wake County is 43.8", while the observed project rainfall recorded a total of 46.5" over the previous 12 months (from 11/1/2018 to 10/31/2019). Project rainfall data was collected from the nearest NC-CRONOS station KTTA.
