# **Thomas Creek Restoration Project Year 5 Monitoring Report - FINAL**

Wake County, North Carolina

DMS Project ID Number – 96074, DEQ Contract No. 5549

Report Prepared and Submitted by Michael Baker Engineering, Inc.

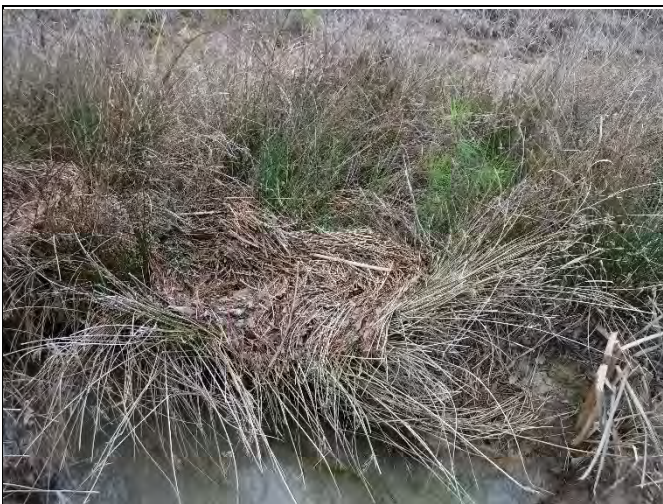
Debris piles along bank on Reach R2  
(photo from 2/20/20)

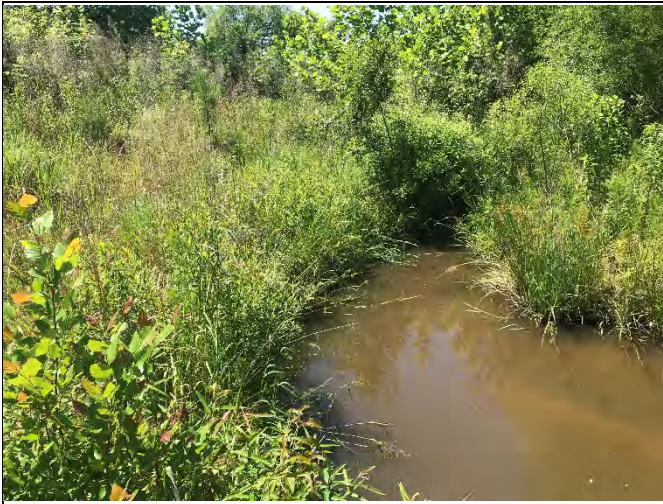
R2 Station 34+75: Previous bank repair on left bank from Hurricane Florence scour (photo: June 2020)

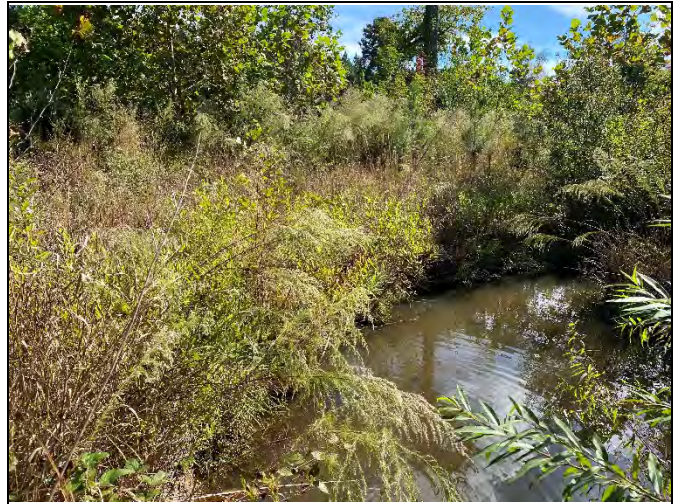
R2 Station 34+75: Previous bank repair on left bank from Hurricane Florence scour (photo: October 2020)

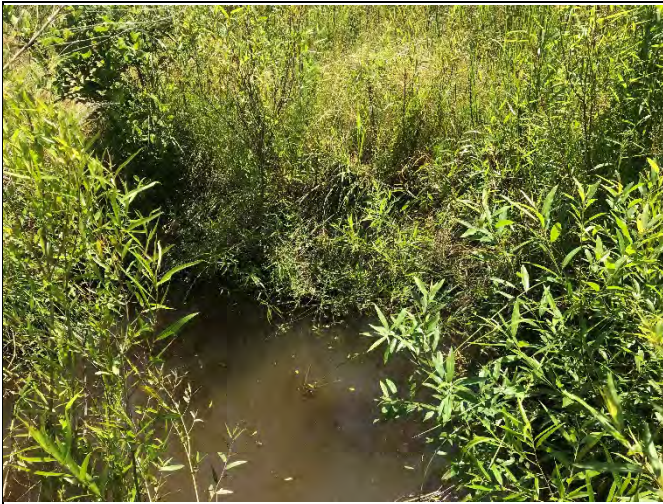
R2 Station 35+75: Previous bank repair on left bank from Hurricane Florence scour (photo: June 2020)

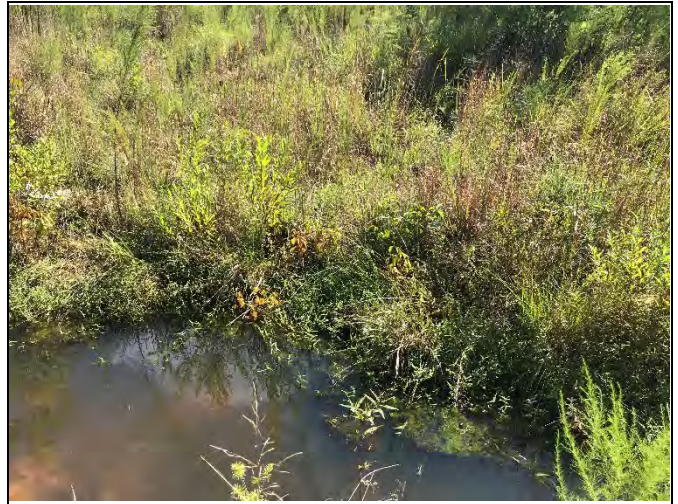
R2 Station 35+75: Previous bank repair on left bank from Hurricane Florence scour (photo: October 2020)

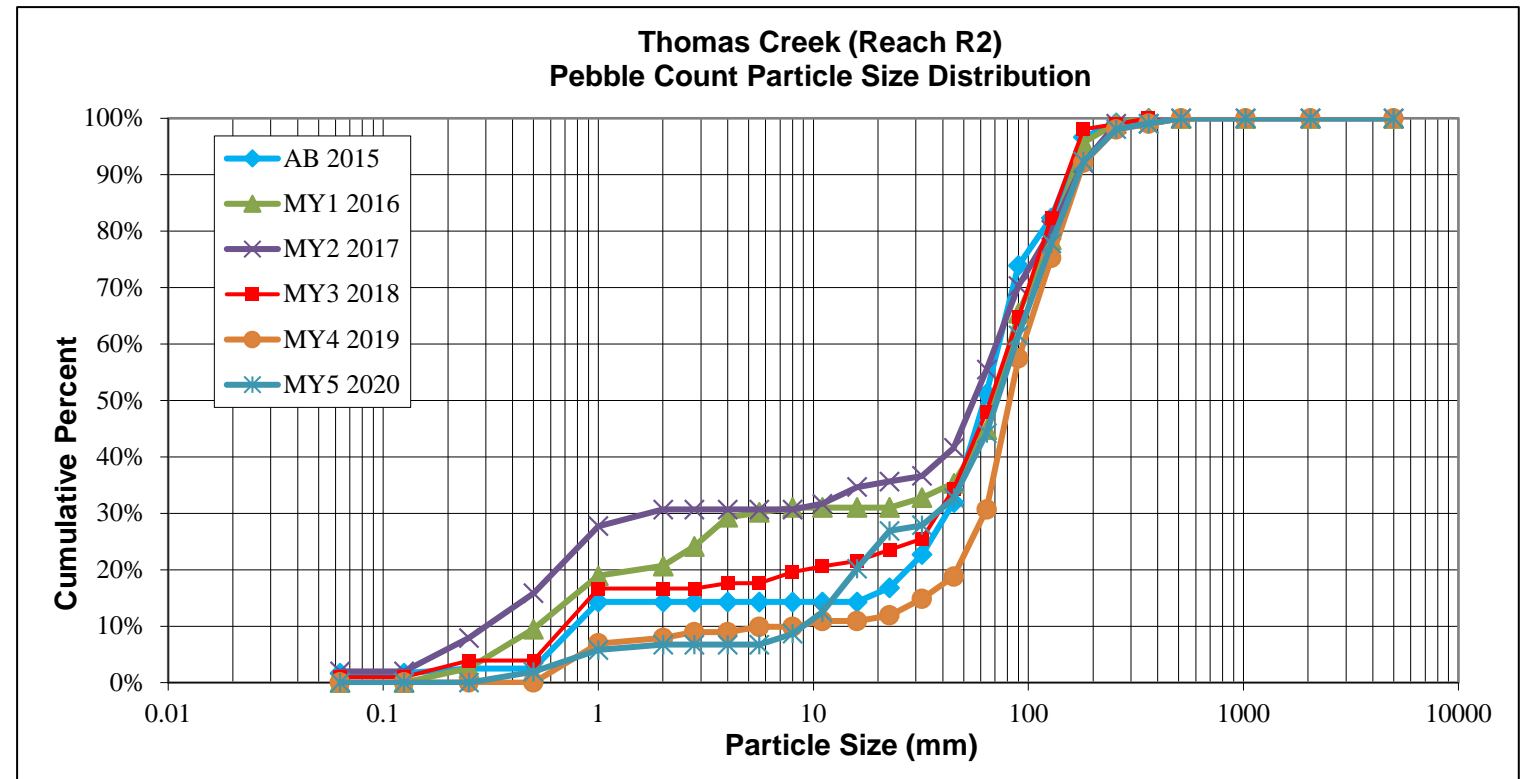
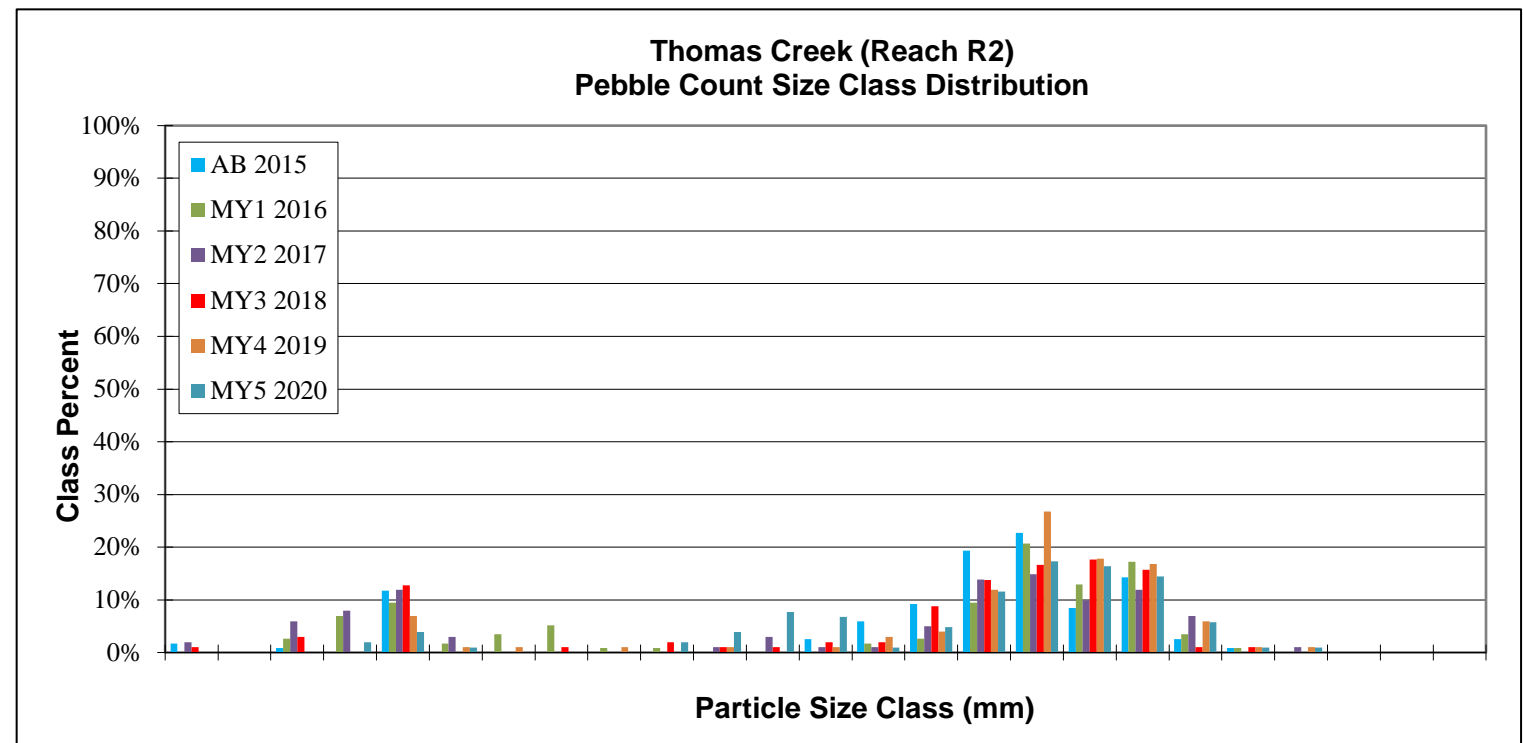
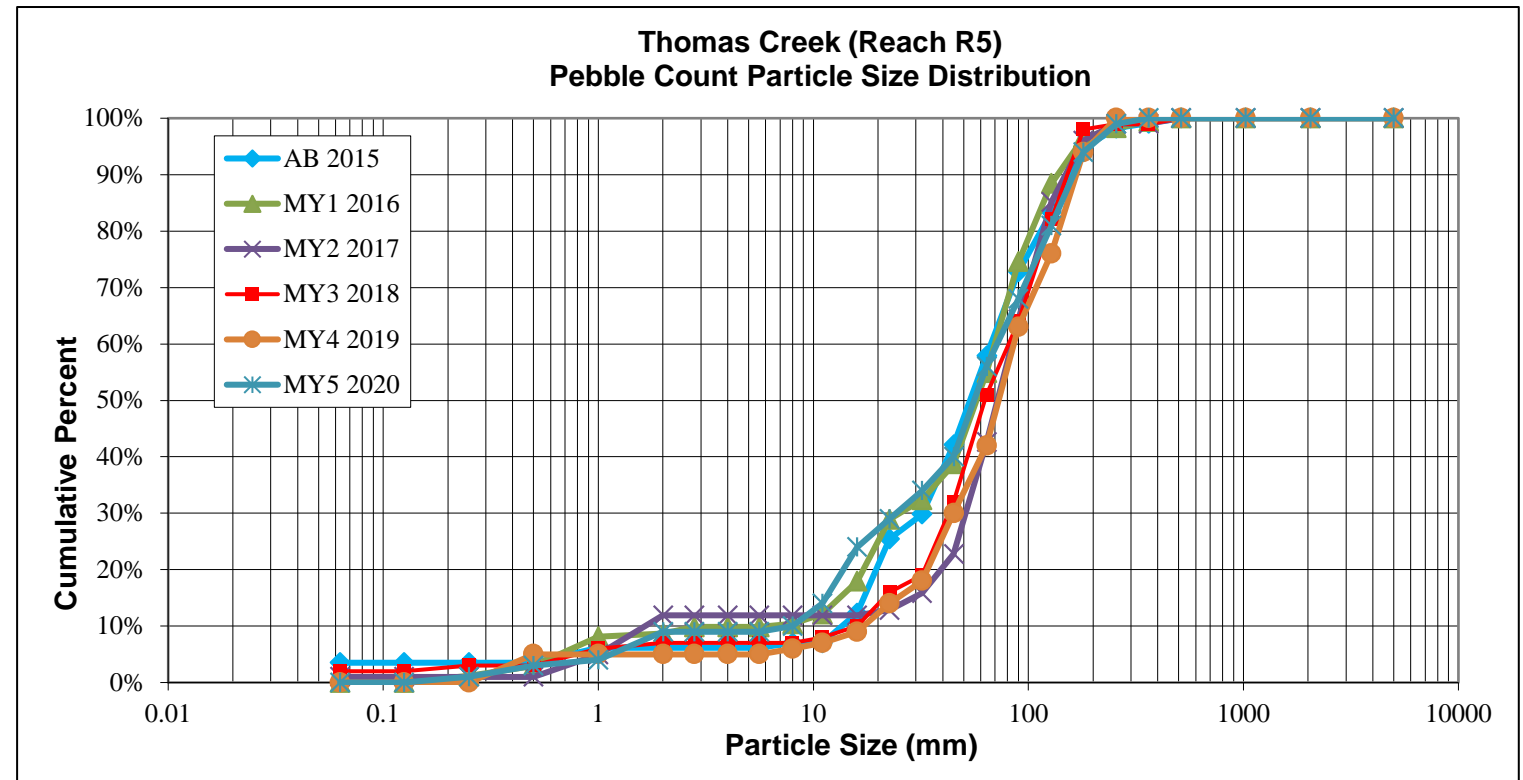
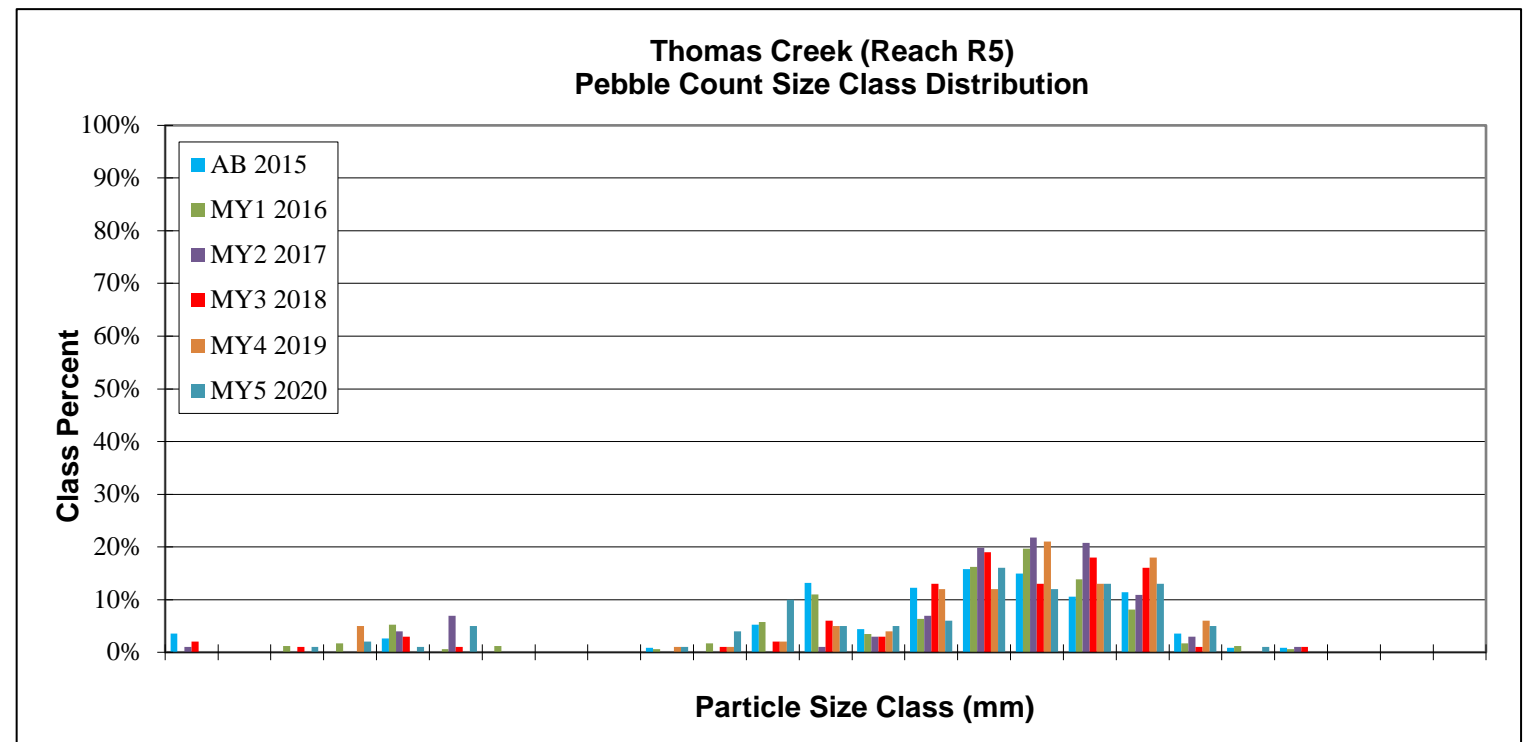
**Figure 7. Pebble Count - Monitoring Year 5**  
**Thomas Creek Mitigation Project, DMS# 96074**

Two pebble counts were conducted during Year 5 monitoring, one each in riffles located along Reach R2 and Reach R5. The results indicate that the riffle in R2 appears stable and is quite similar to the previous year's condition, having apparently fully flushed out the finer sediment previously observed to have been deposited there. The riffle in R5 also appears quite stable as the distribution is fairly consistent with all previous results,

despite the significant flow events of the past few years. Pebble count data and graphs can be found in Appendix D, while photographs of the two riffles at the time of sampling can be found in Appendix B.

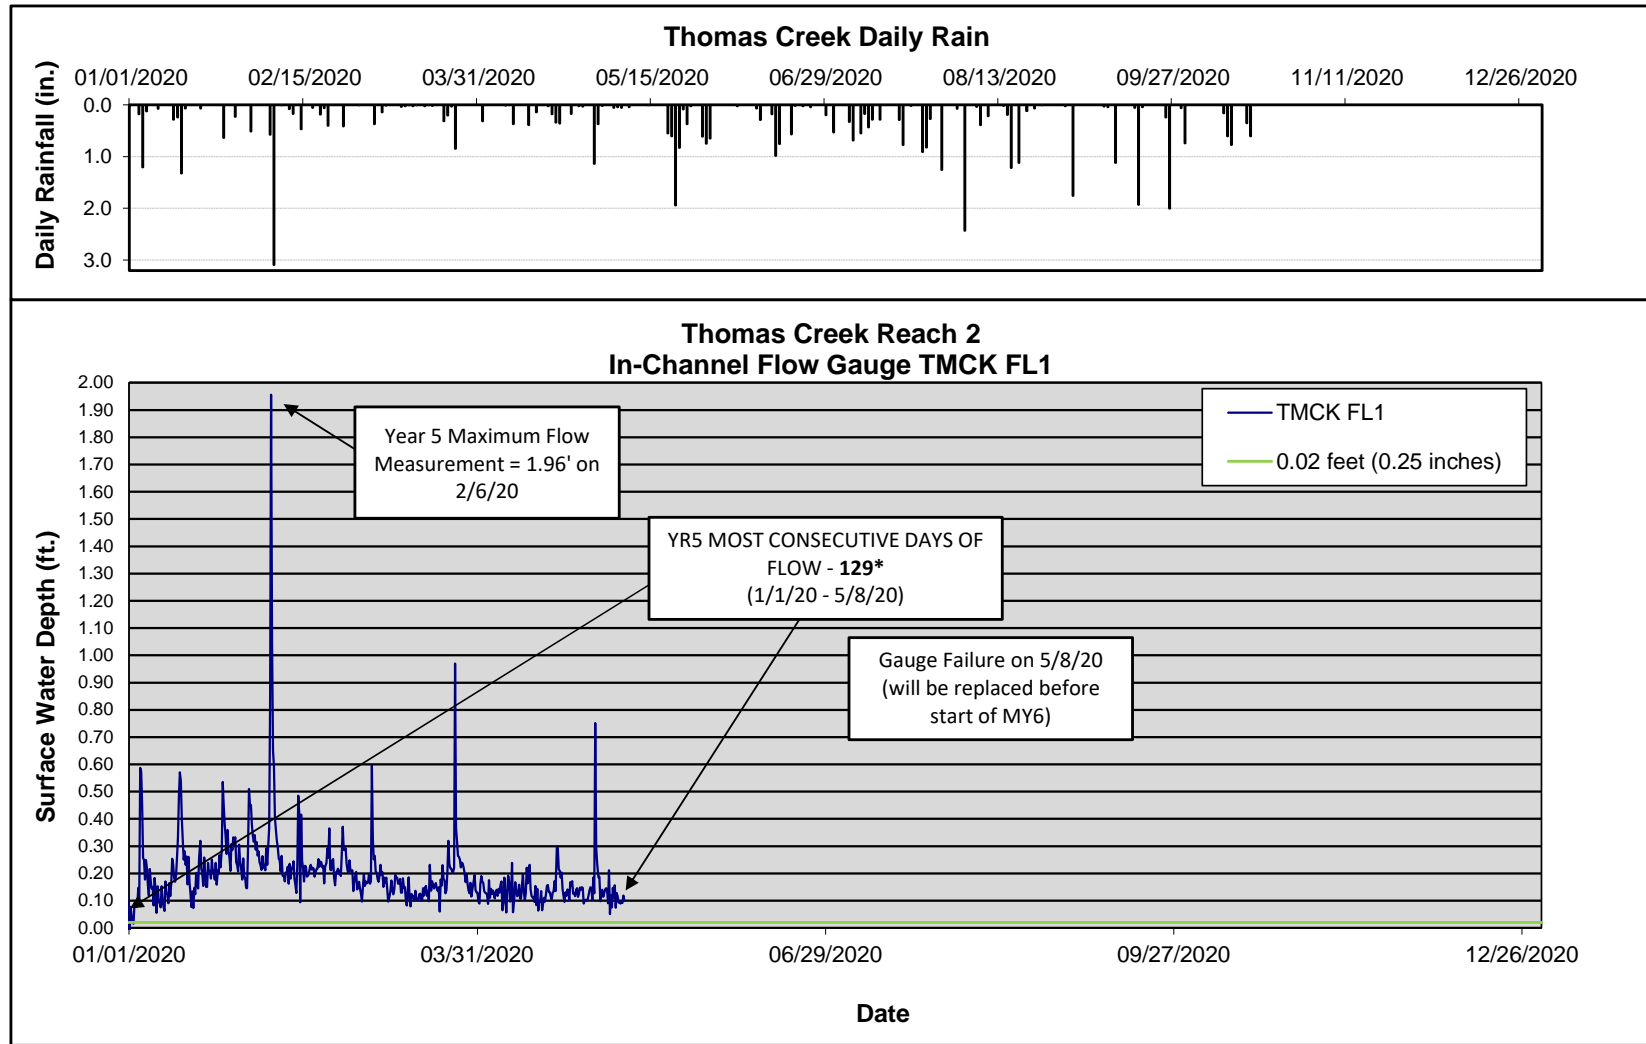
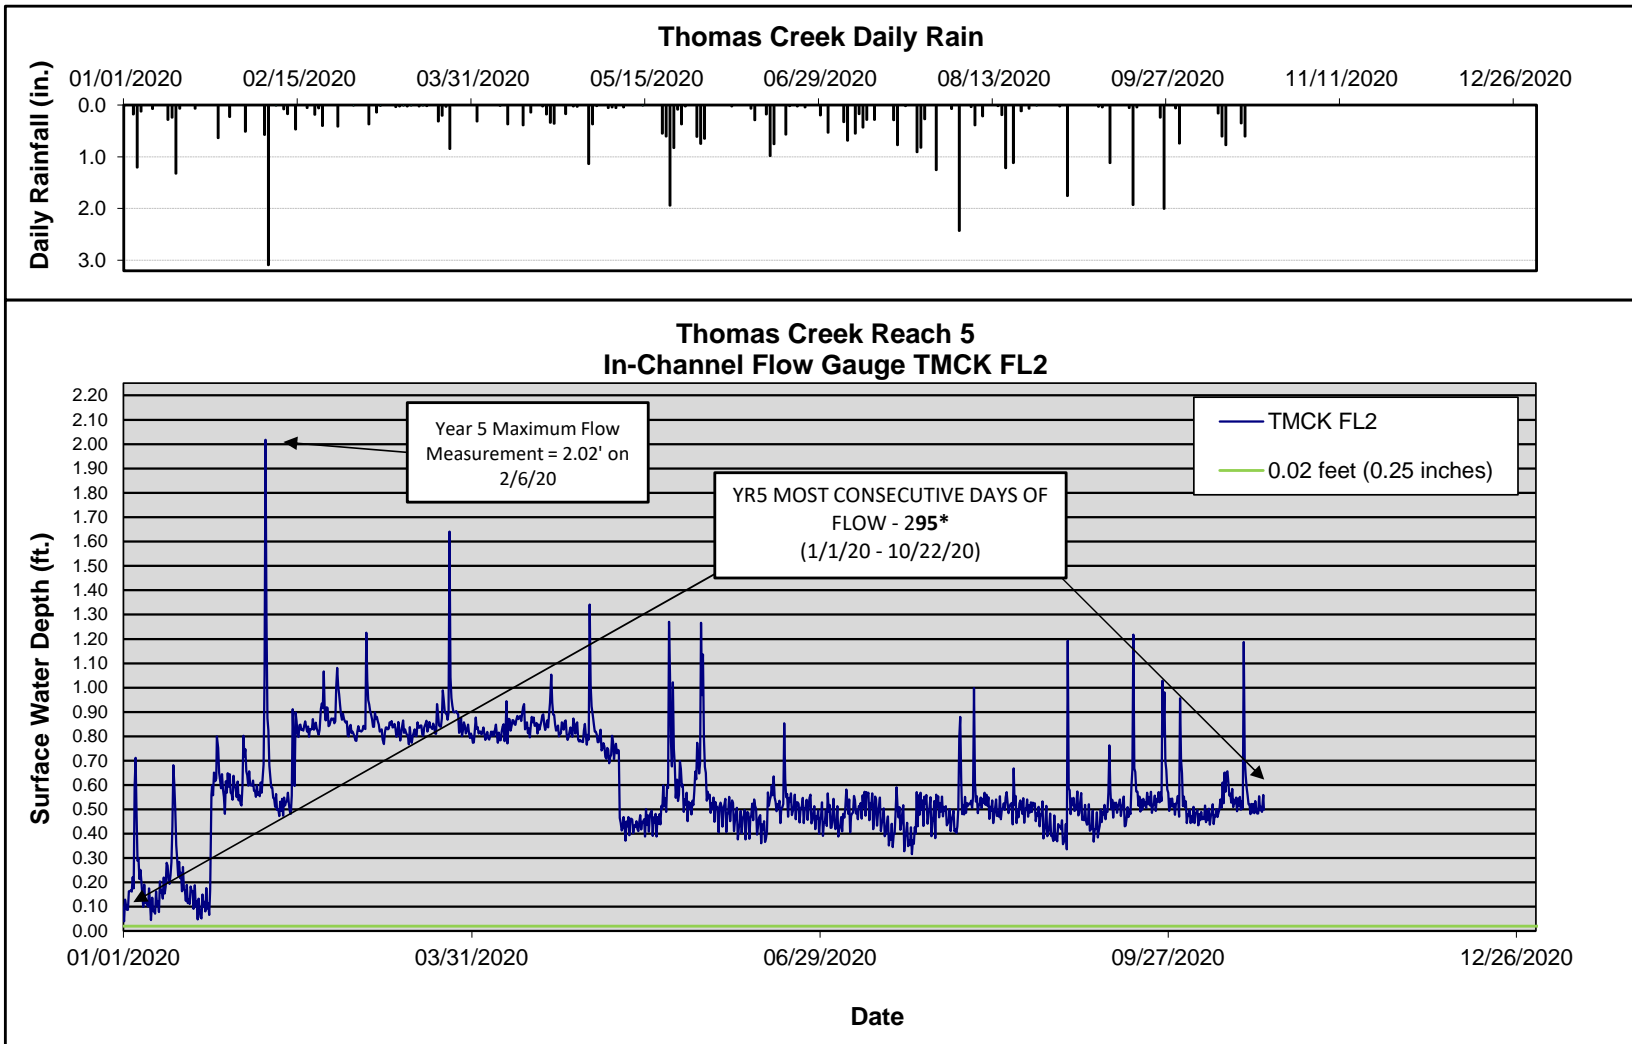
**Figure 8. Flow Gauge Graphs**

Year 5 flow monitoring demonstrated that both flow gauges (TMCK-FL1 and TMCK-FL2) met the stated success criteria of 30 days or more of consecutive flow through Reaches 2 and 5 respectively. Flow gauge TMCK-FL1 documented 129 days of consecutive flow in Reach 2, while flow gauge TMCK-FL2 documented 295 days of consecutive flow in Reach 5. The flow gauges demonstrated similar patterns relative to rainfall events as shown in the flow gauge graphs in Appendix E. Unfortunately, the pressure transducer device in Flow Gauge #1 failed in May 2020. It will be replaced before the start of Year 6 monitoring.

To monitor flow on restored reaches, two flow gauges were installed on site; TMCK-FL1 on Reach 2 (Station 20+75), and TMCK-FL2 on Reach 5 (Station 33+90). The Year 5 flow monitoring data demonstrated that both flow gauges met the stated success criteria of 30 days or more of consecutive flow. The gauges also demonstrated similar patterns relative to rainfall events and can corroborate reported overbank flow events from the crest gauge, as shown in the flow gauge graphs found in Appendix E.

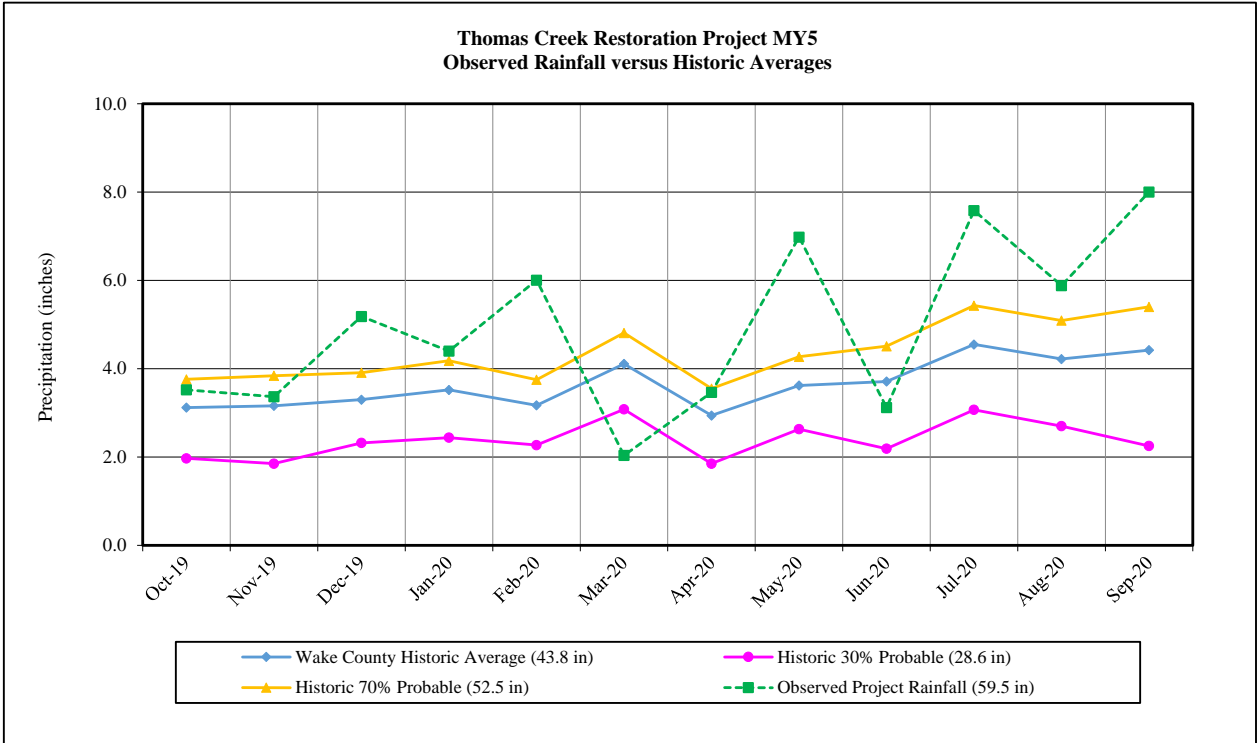
Figure 9. Observed Rainfall Versus Historic Averages

As the observed monthly rainfall data for the project presented in Figure 9 in Appendix E demonstrates, the past 12 months have been much wetter as compared to historic averages for Wake County. A total of 59.5 in. of rainfall was observed for the project using the nearest NC-CRONOS station, while Wake County averages 43.8 in. of annual rainfall.

Note: Historic average annual rainfall for Wake County is 43.8", while the observed project rainfall recorded a total of 59.5" over the previous 12 months (from 10/1/2019 to 9/31/2020). Project rainfall data was collected from the NC-CRONOS station LAKE.
