Thomas Creek Restoration Project Year 6 Monitoring Report - FINAL

Wake County, North Carolina

DMS Project ID Number – 96074, DEQ Contract No. 5549

Report Prepared and Submitted by Michael Baker Engineering, Inc.

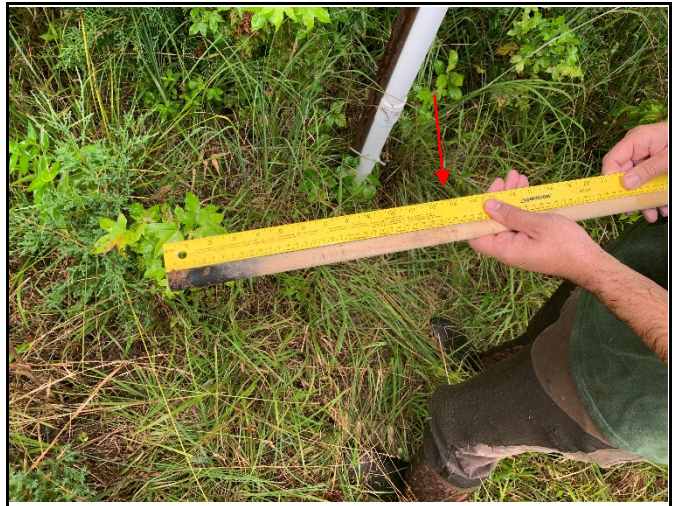
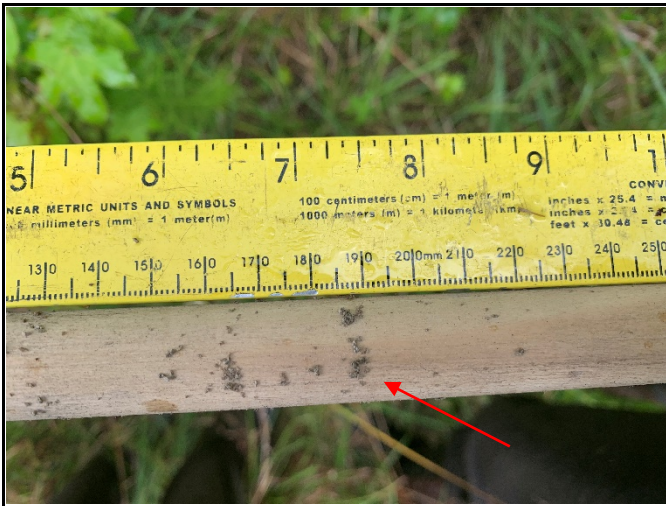
Overbank event of 0.62 ft on 7/8/21
(photo from 8/10/21)

Overbank event of 0.62 ft (7.4 in) on 7/8/21
(photo from 8/10/21)

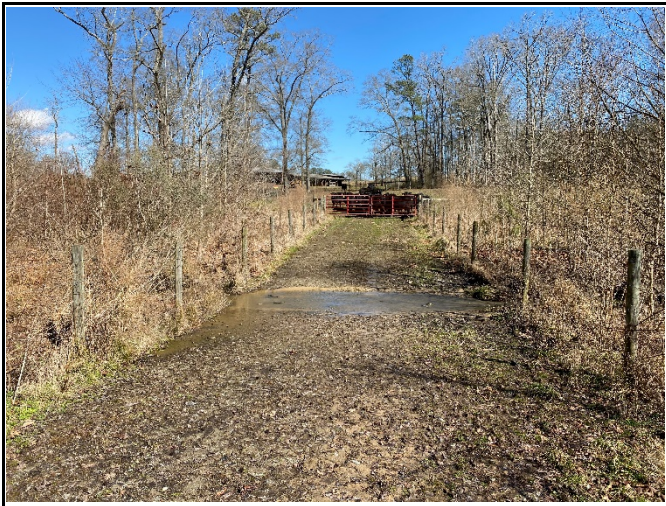
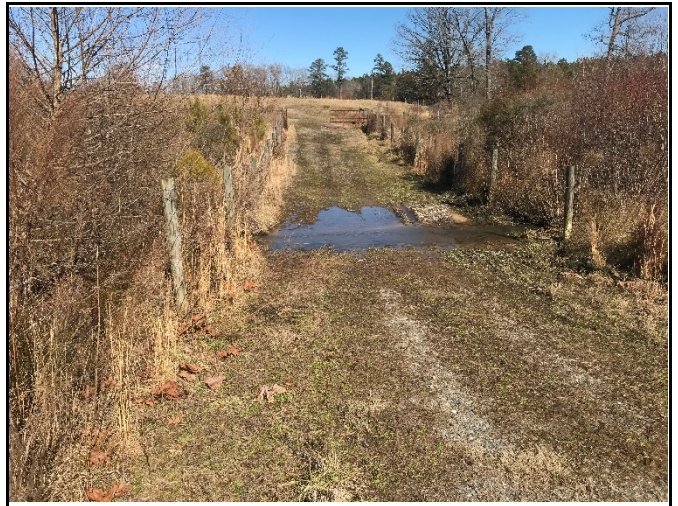
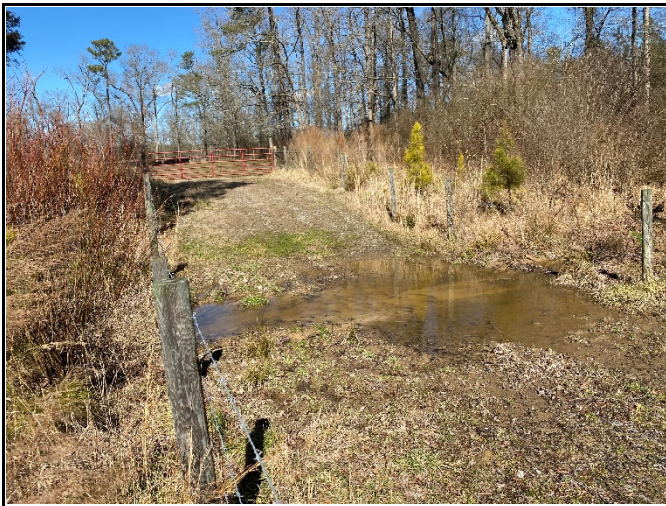
Stable Rock Ford Crossing on Reach R2 (photo: 2/16/21)

Stable Rock Ford Crossing on Reach R5 (photo: 2/16/21)

Stable Rock Ford Crossing on Reach T1 (photo: 2/16/21)

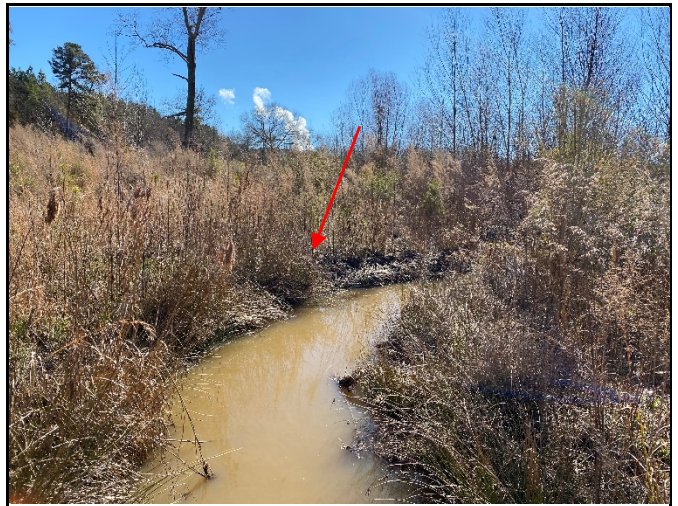
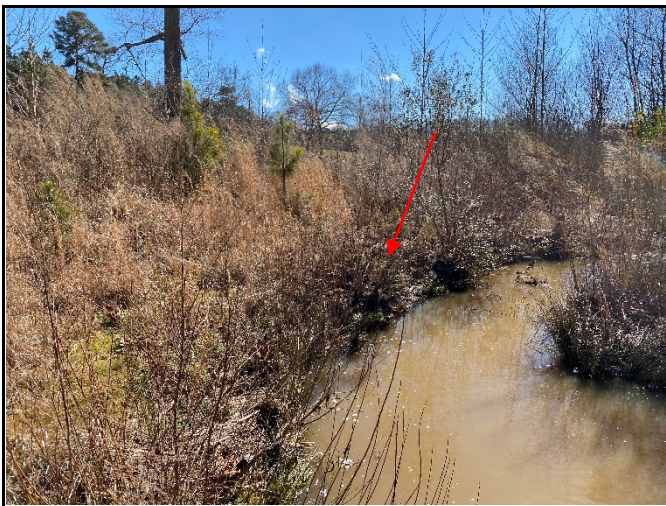
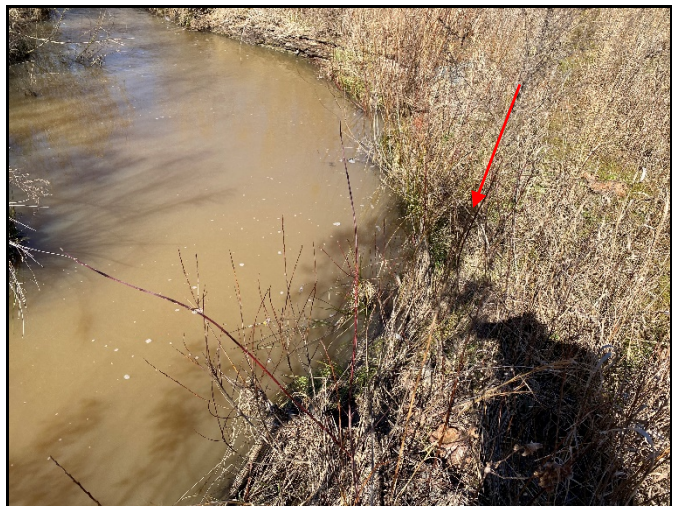
Previously repaired bend a long Reach R2 (photo: 2/16/21)

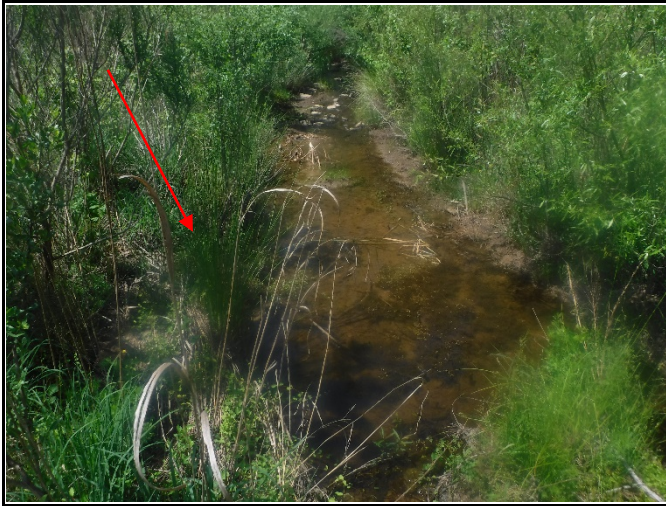
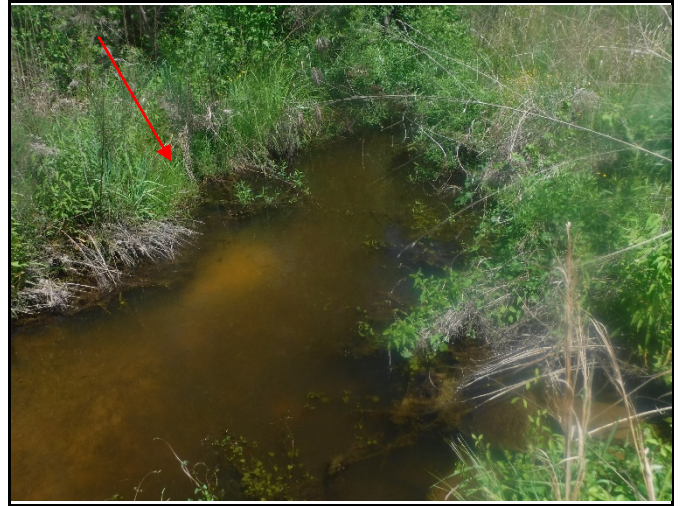
Previously repaired bend a long Reach R2 (photo: 5/5/21)

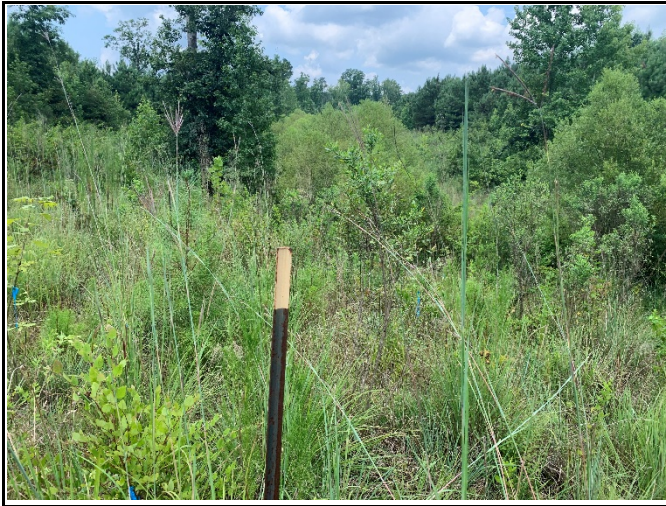
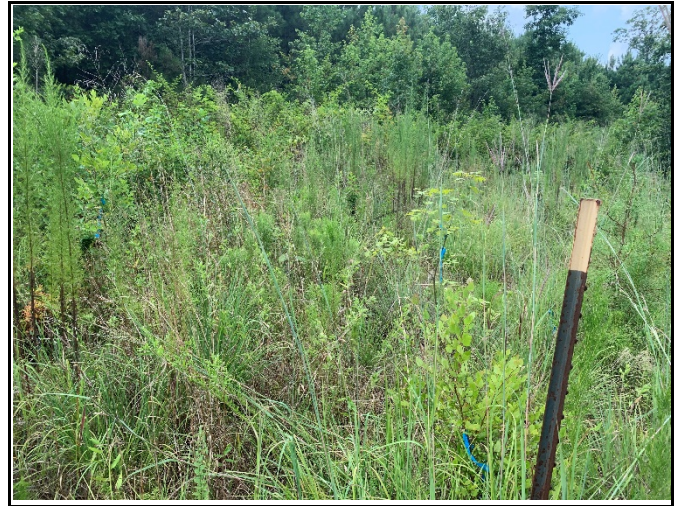
Also, as previously discussed in the Year 3 monitoring report in 2018, an area roughly 0.38 acres in size of low vigor/short stems had been noted within the left buffer of upper Reach R3, though stem density remains quite good. Based on soil test results, this area has periodically received small applications of soil amendments to help improve stem growth. In April of 2021, pelletized lime was applied to this area along with small amounts of fertilizer to the planted stems. The plant vigor and growth in this area certainly continues to improve but remains a little behind the growth observed on the rest of the site. As such, soil amendments will continue to be applied to this area. Please see the CCPV in Appendix B for the location of this amended area.

Vegetation growth within the left buffer of upper Reach R3, looking up-valley (photo: 8/10/21)

Vegetation growth within the left buffer of upper Reach R3, looking down-valley (photo: 8/10/21)

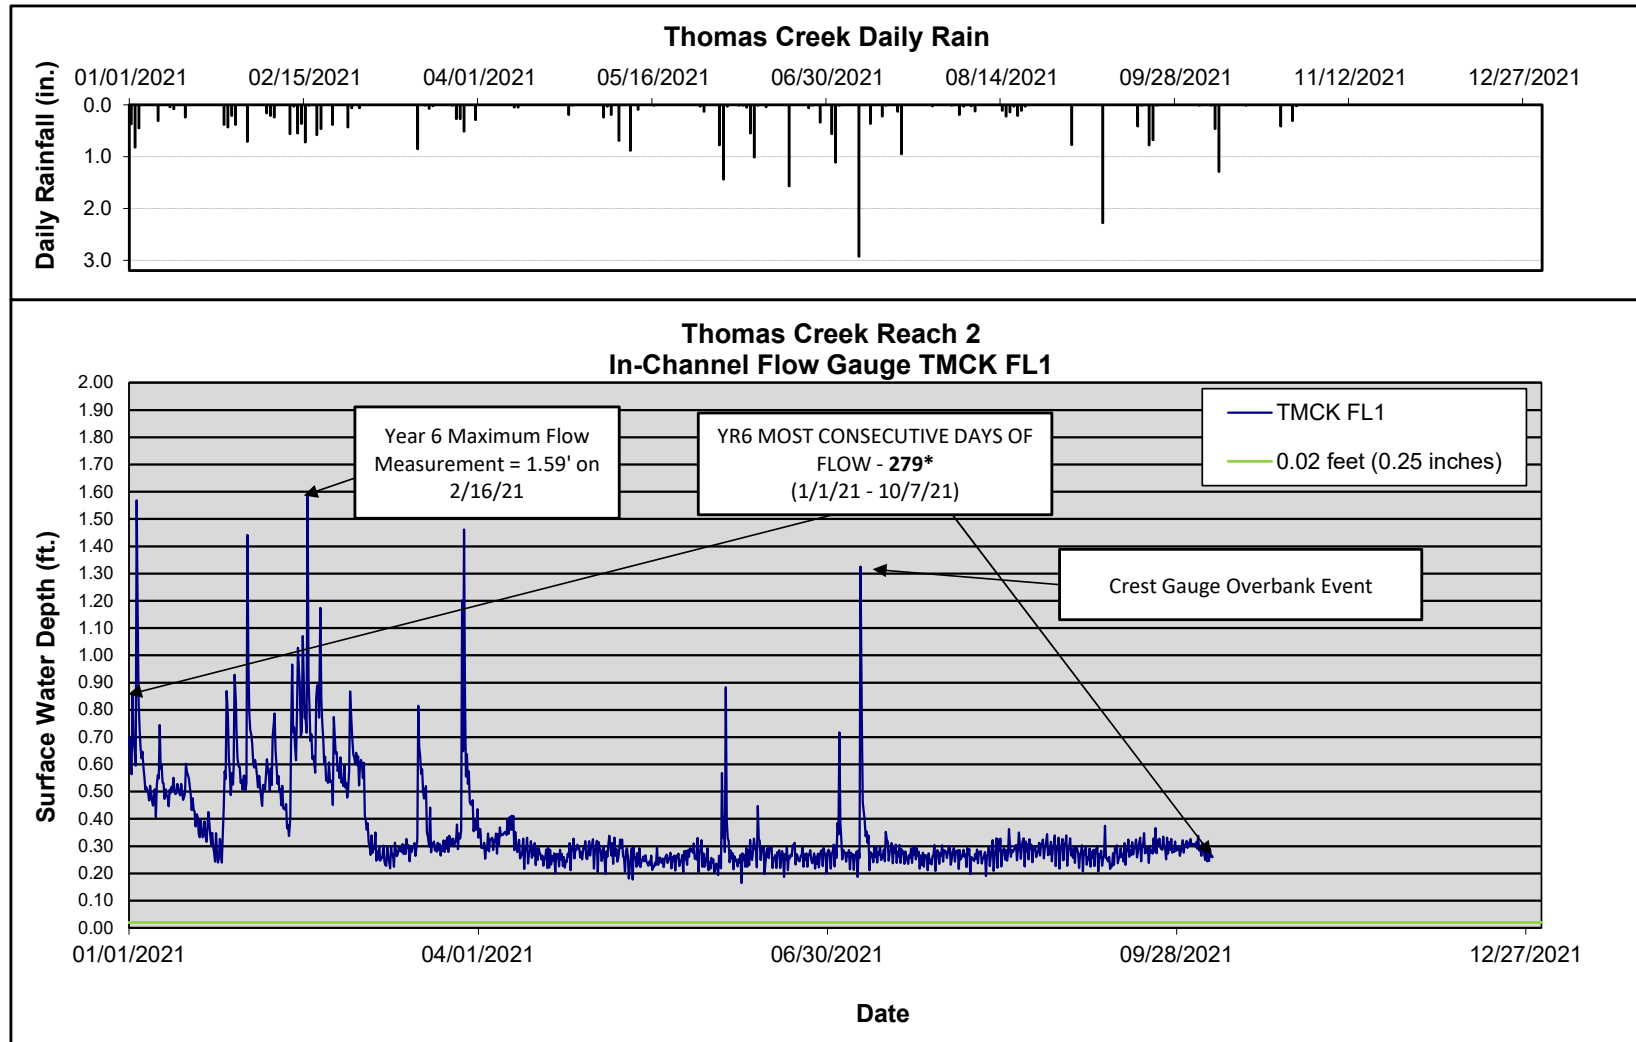
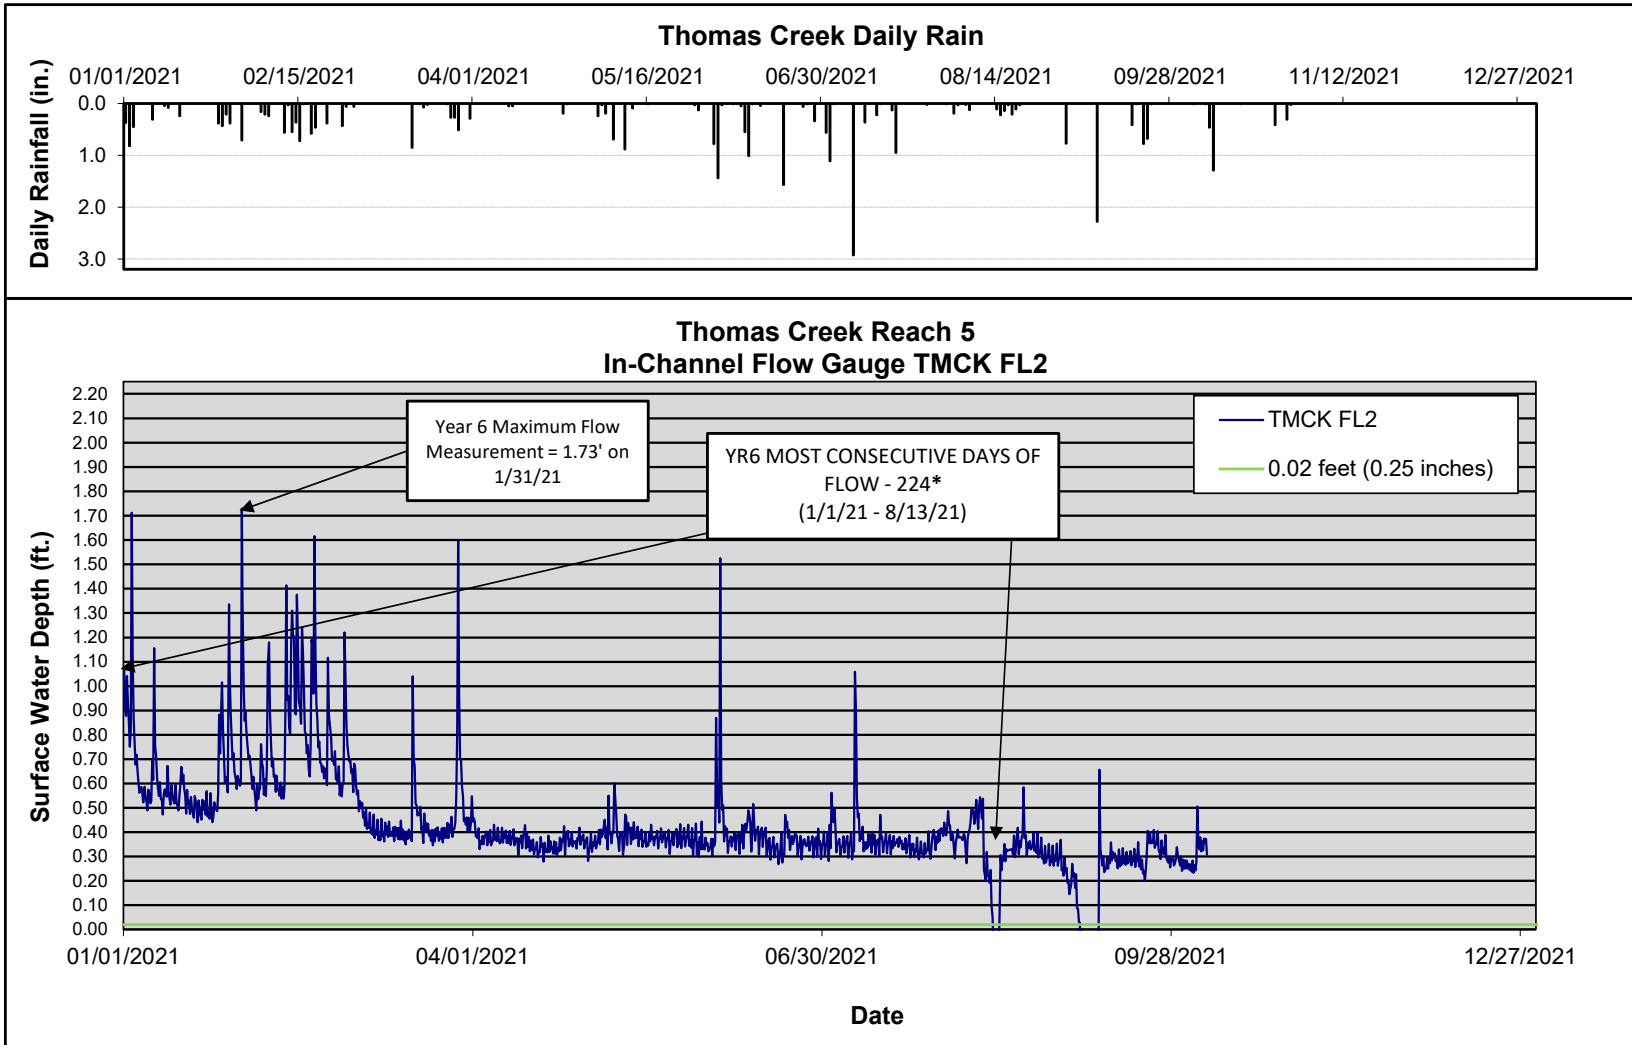
Figure 8. Flow Gauge Graphs

Year 6 flow monitoring demonstrated that both flow gauges (TMCK-FL1 and TMCK-FL2) met the stated success criteria of 30 days or more of consecutive flow through Reaches 2 and 5 respectively. Flow gauge TMCK-FL1 documented 279 days of consecutive flow in Reach 2, while flow gauge TMCK-FL2 documented 224 days of consecutive flow in Reach 5. The flow gauges demonstrated similar patterns relative to rainfall events and can corroborate reported bankfull events from the crest gauge, as shown in the flow gauge graphs in Appendix E.

* Surface water flow is estimated to have occurred when the pressure transducer reading is equal to or above 0.02 feet (0.25 inches) in depth.

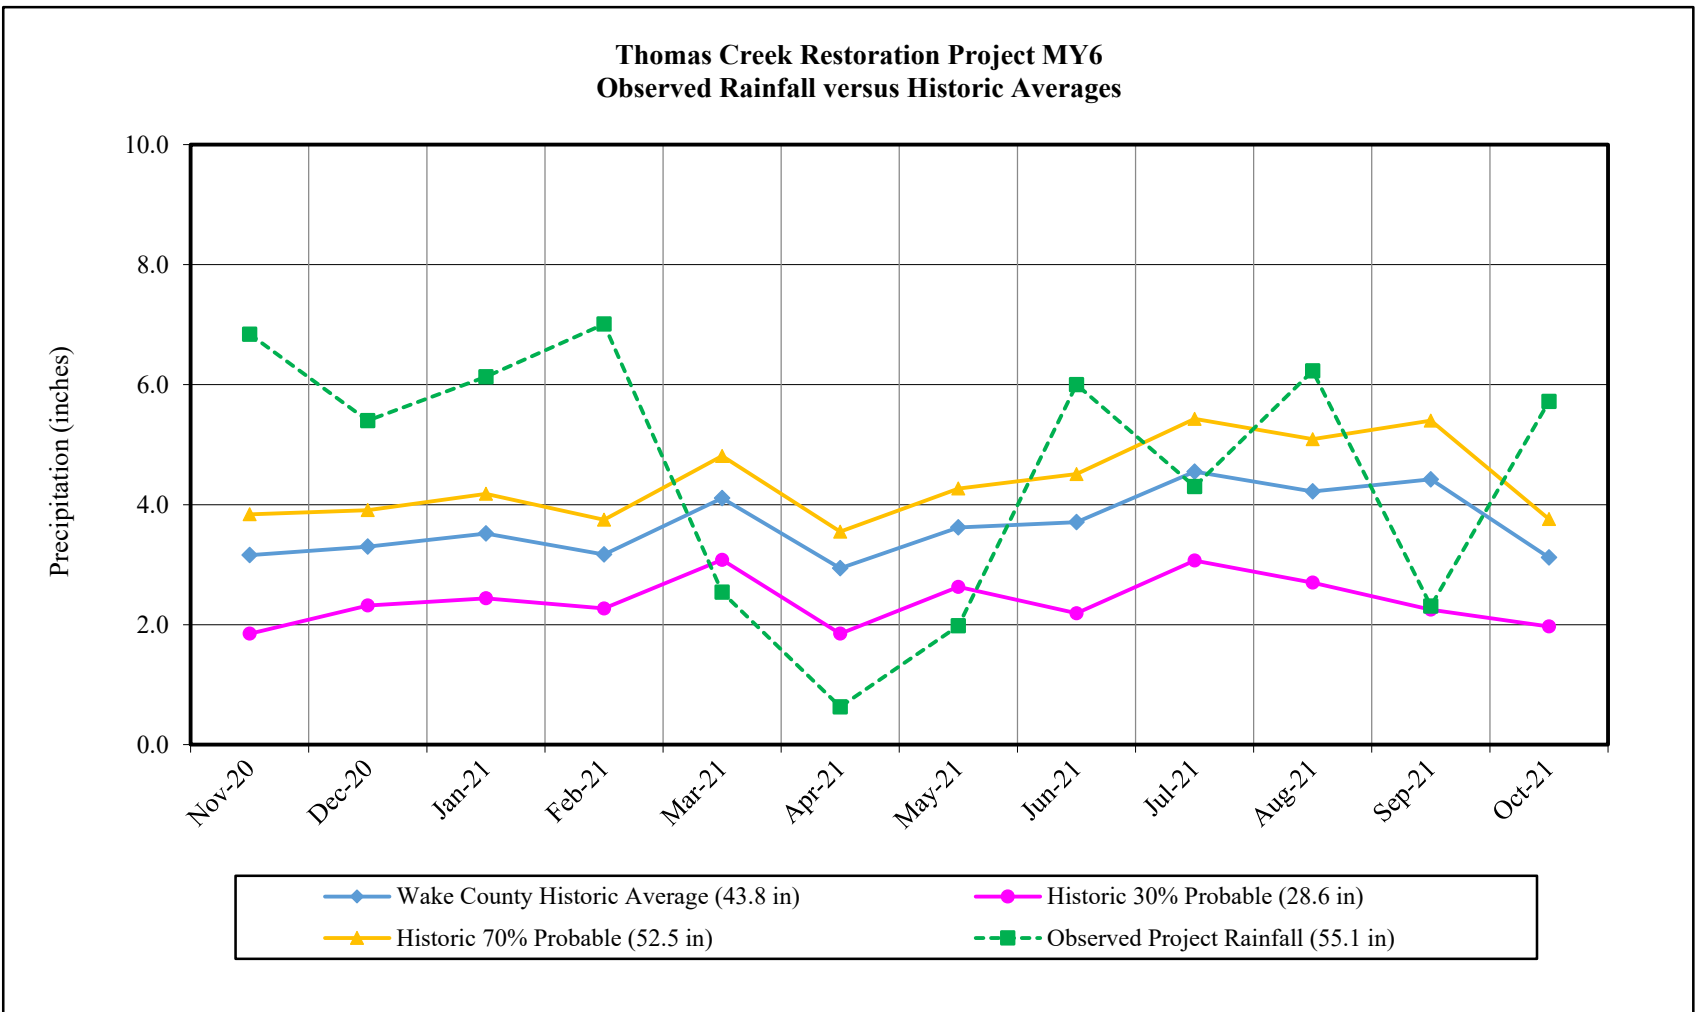
Figure 9. Observed Rainfall Versus Historic Averages

As the observed monthly rainfall data for the project presented in Figure 9 in Appendix E demonstrates, the past 12 months have been wetter as compared to historic averages for Wake County. A total of 55.1 in. of rainfall was observed for the project using the nearest NC-CRONOS station, while Wake County averages 43.8

in. of annual rainfall. However, it should be noted that bulk of this excess rainfall came over the winter of 2020-2021, while the spring of 2021 was well below average monthly rainfalls and the summer and fall of 2021 were much closer to their average ranges.

Note: Historic average annual rainfall for Wake County is 43.8", while the observed project rainfall recorded a total of 55.1" over the previous 12 months (from 11/1/2020 to 10/31/2021). Project rainfall data was collected from the NC-CRONOS station LAKE.
