# MONITORING YEAR 5 ANNUAL REPORT

## VILE CREEK MITIGATION SITE

Alleghany County, NC  
DEQ Contract No. 5999  
DMS Project No. 96582

Data Collection Period: April – October 2021  
Submission Date: January 19, 2022

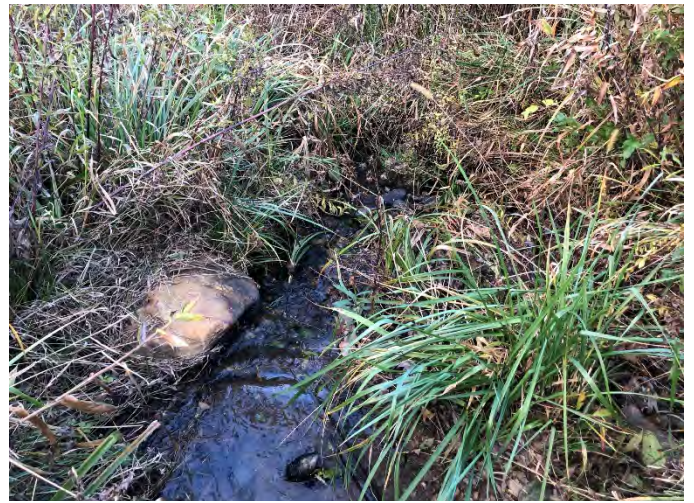
**Photo 4** – UT1 R1: Station 204+90 – Structure missing. 10-26-2021

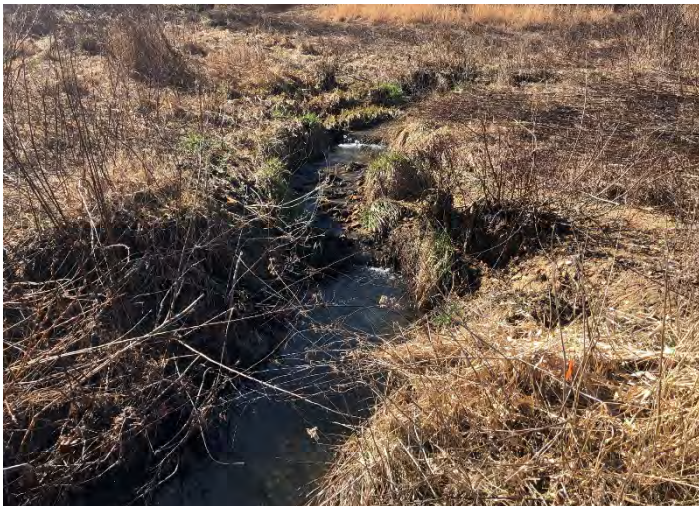
**Photo 5** – UT1 R1: Station 205+10-205+50- Stream realignment. 3-2021

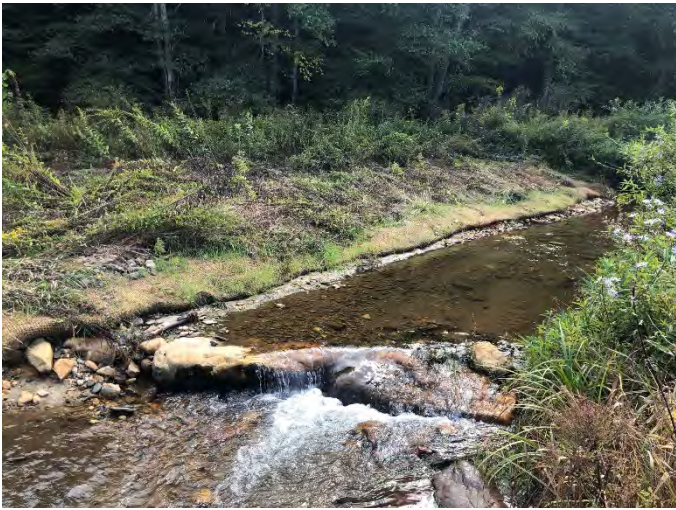
Vile Creek R2: STA 118+50 - 118+80 - Right Bank Repair 9-28-2021

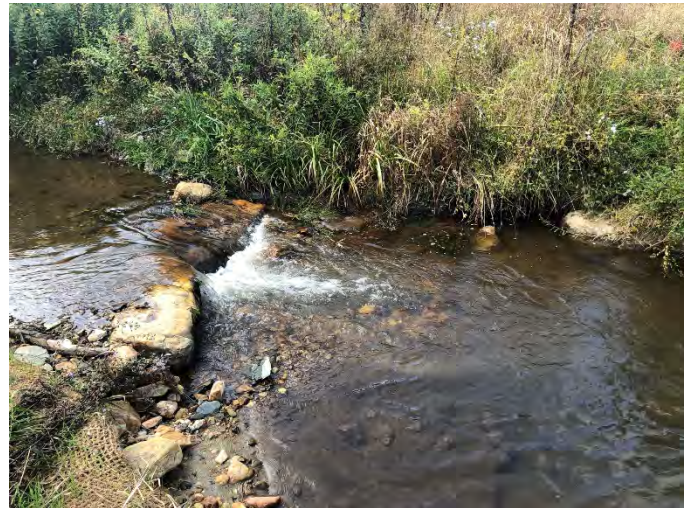
Vile Creek R2: STA 118+80 – J-Hook Repair 9-28-2021

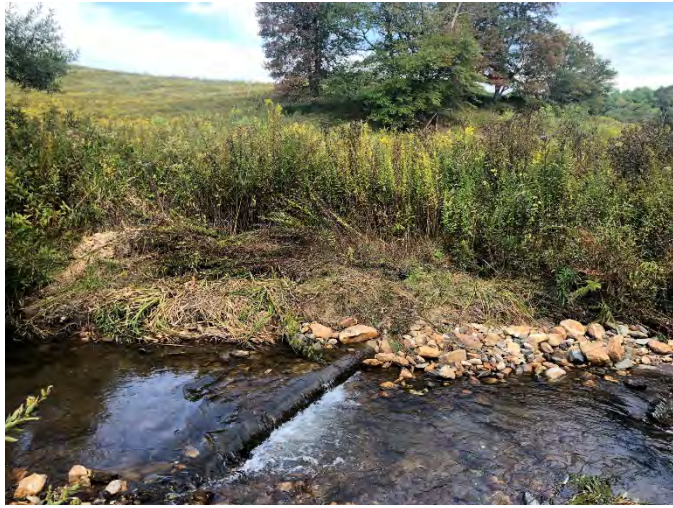
Vile Creek R2: STA 119+50 - 119+70 - Bank Repair 9-28-2021

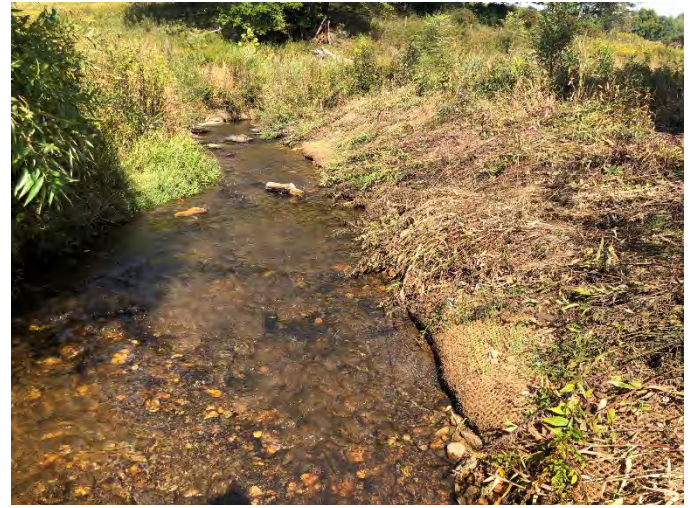
Vile Creek R2: STA 121+00 - 121+25 - Right Bank Repair 9-28-2021

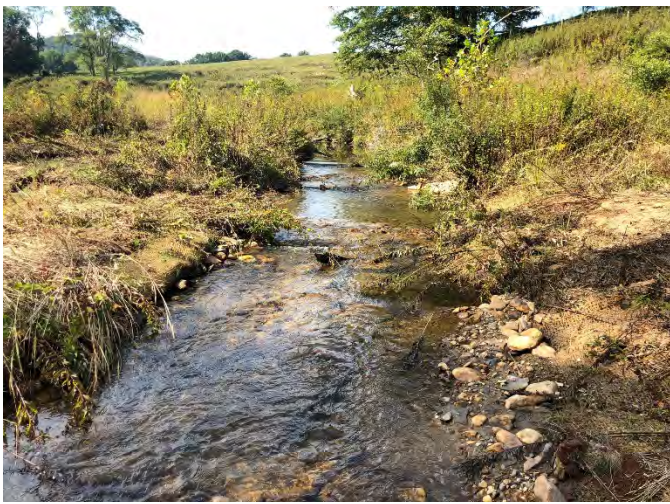
Vile Creek R2: STA 122+20 - 123+00 – Stream Repair  
9-28-2021

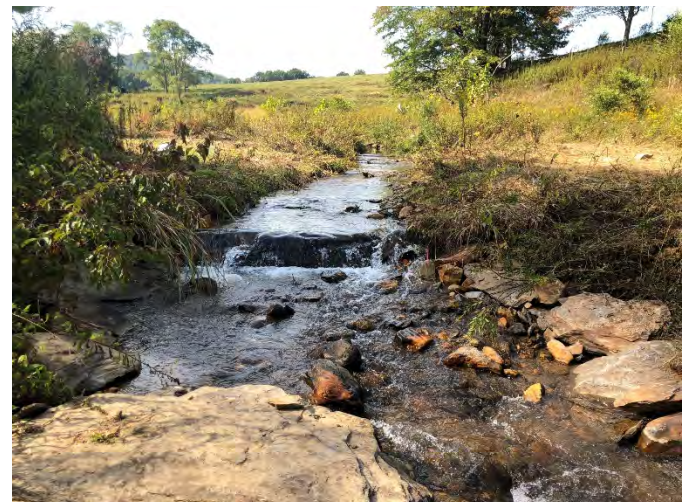
Vile Creek R2: STA 123+00 – Rock Sill Repair 9-28-2021

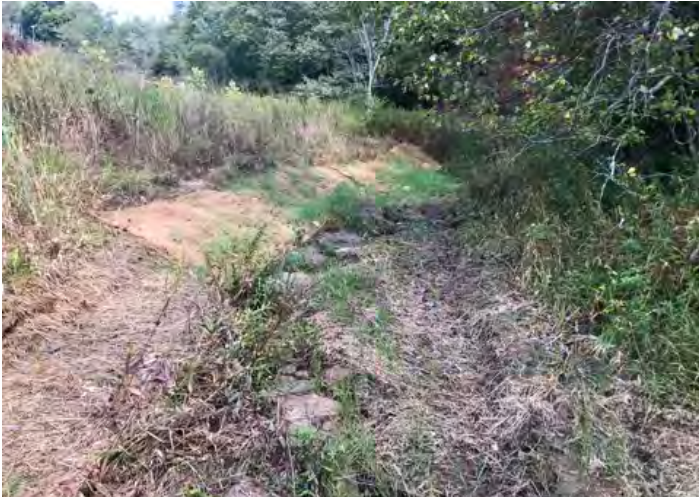
Vile Creek R3: STA 125+00 - 125+60 - Secondary Channel Repair  
9-28-2021

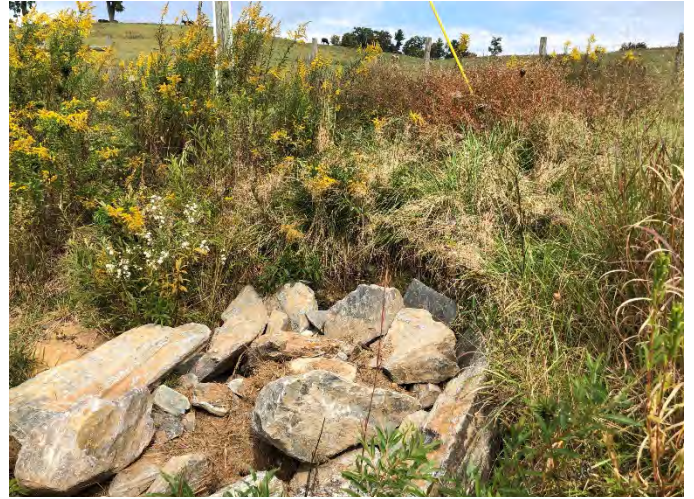
UT2 BMP – Headcut Repair 9-28-2021

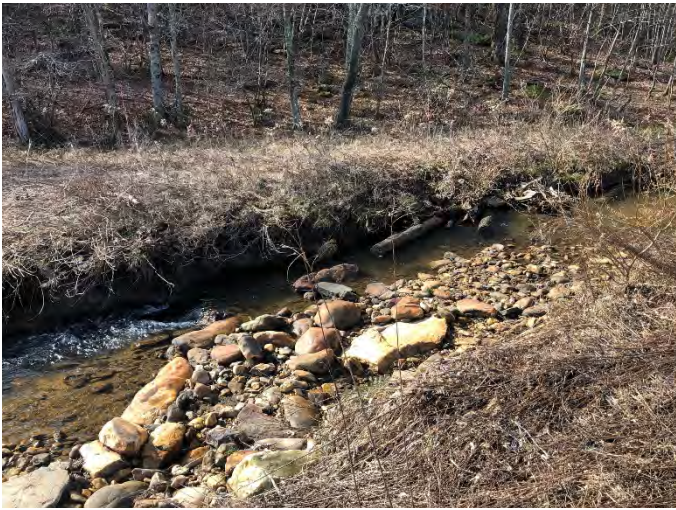
Vile Creek R2: STA 118+50 - 118+80 - Right Bank Erosion 3-17-2021

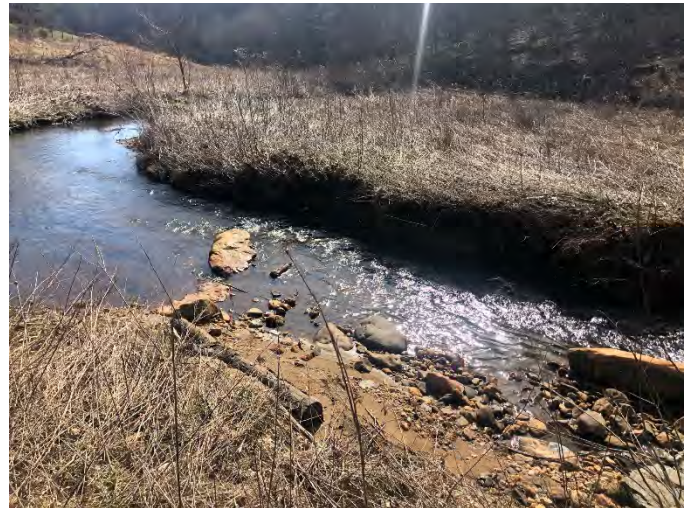
Vile Creek R2: STA 118+80 – J-Hook structure failure 3-17-2021

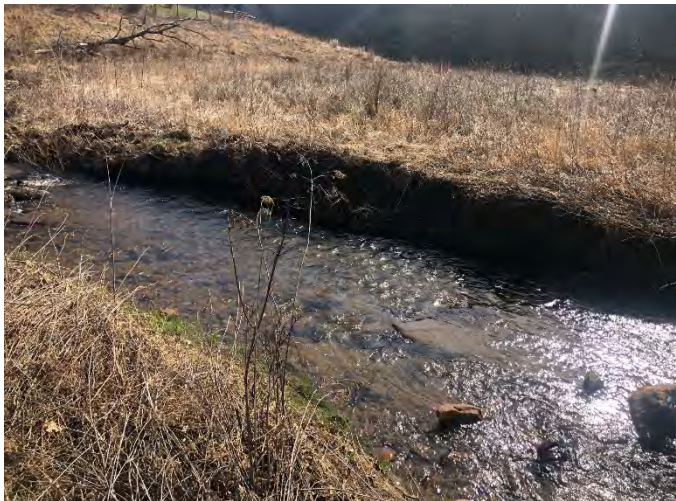
Vile Creek R2: STA 120+70 - 121+00 – Right Bank Erosion. 3-17-2021

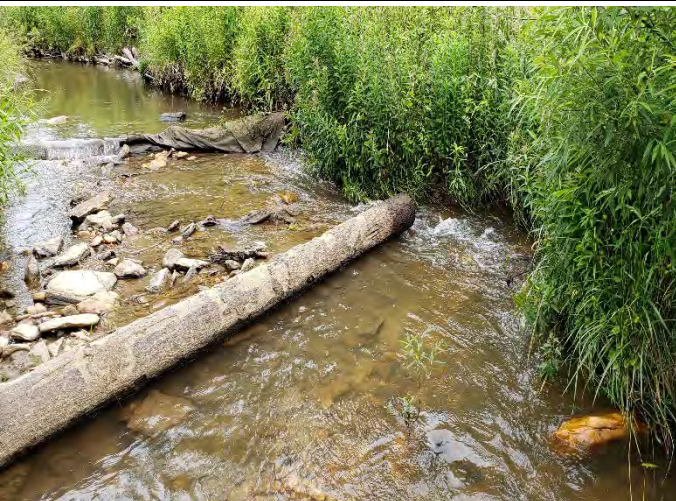
Vile Creek R2: STA 122+20 - 123+00 – Angled Log Riffle Failure. 7-01-2021

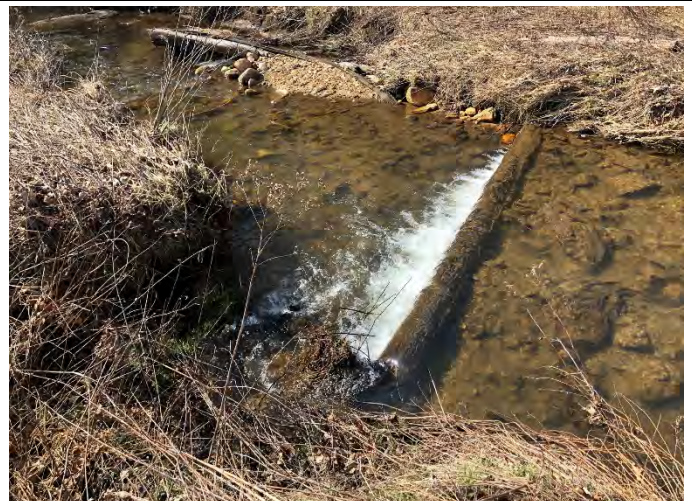
Vile Creek R2: STA 122+20-123+00 – Left Bank Erosion 3-17-2021

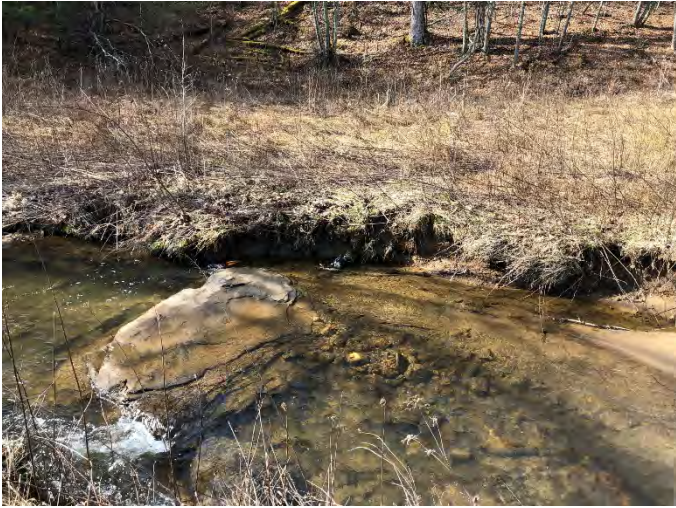
Vile Creek R2: STA 123+00 – Rock Sill Failure 3-17-2021

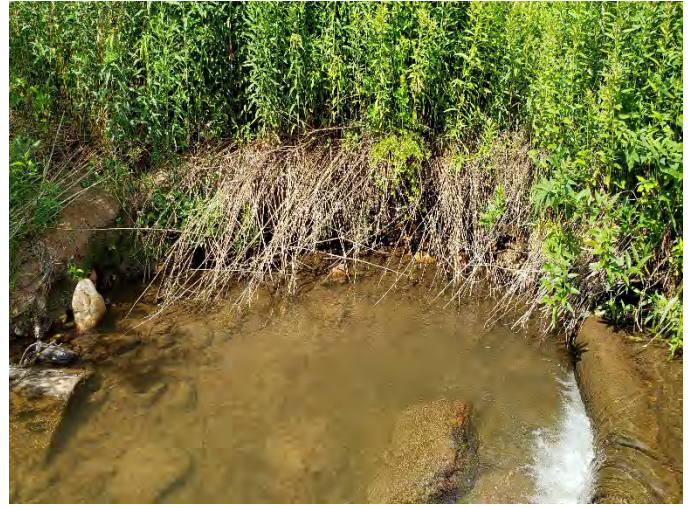
Vile Creek R2: STA 121+00 - 121+25 - Left Bank Erosion 5-23-2021
