MONITORING YEAR 2 ANNUAL REPORT

ALEXANDER FARM MITIGATION SITE

Alexander County, NC
DEQ Contract No. 7416
DMS Project No. 100048
USACE Action ID No. SAW-2018-00451
NCDEQ DWR Certification No. 18-0665
RFP #: 16-007277

Data Collection Period: January 2021 – November 2021
Final Submission Date: February 1, 2022

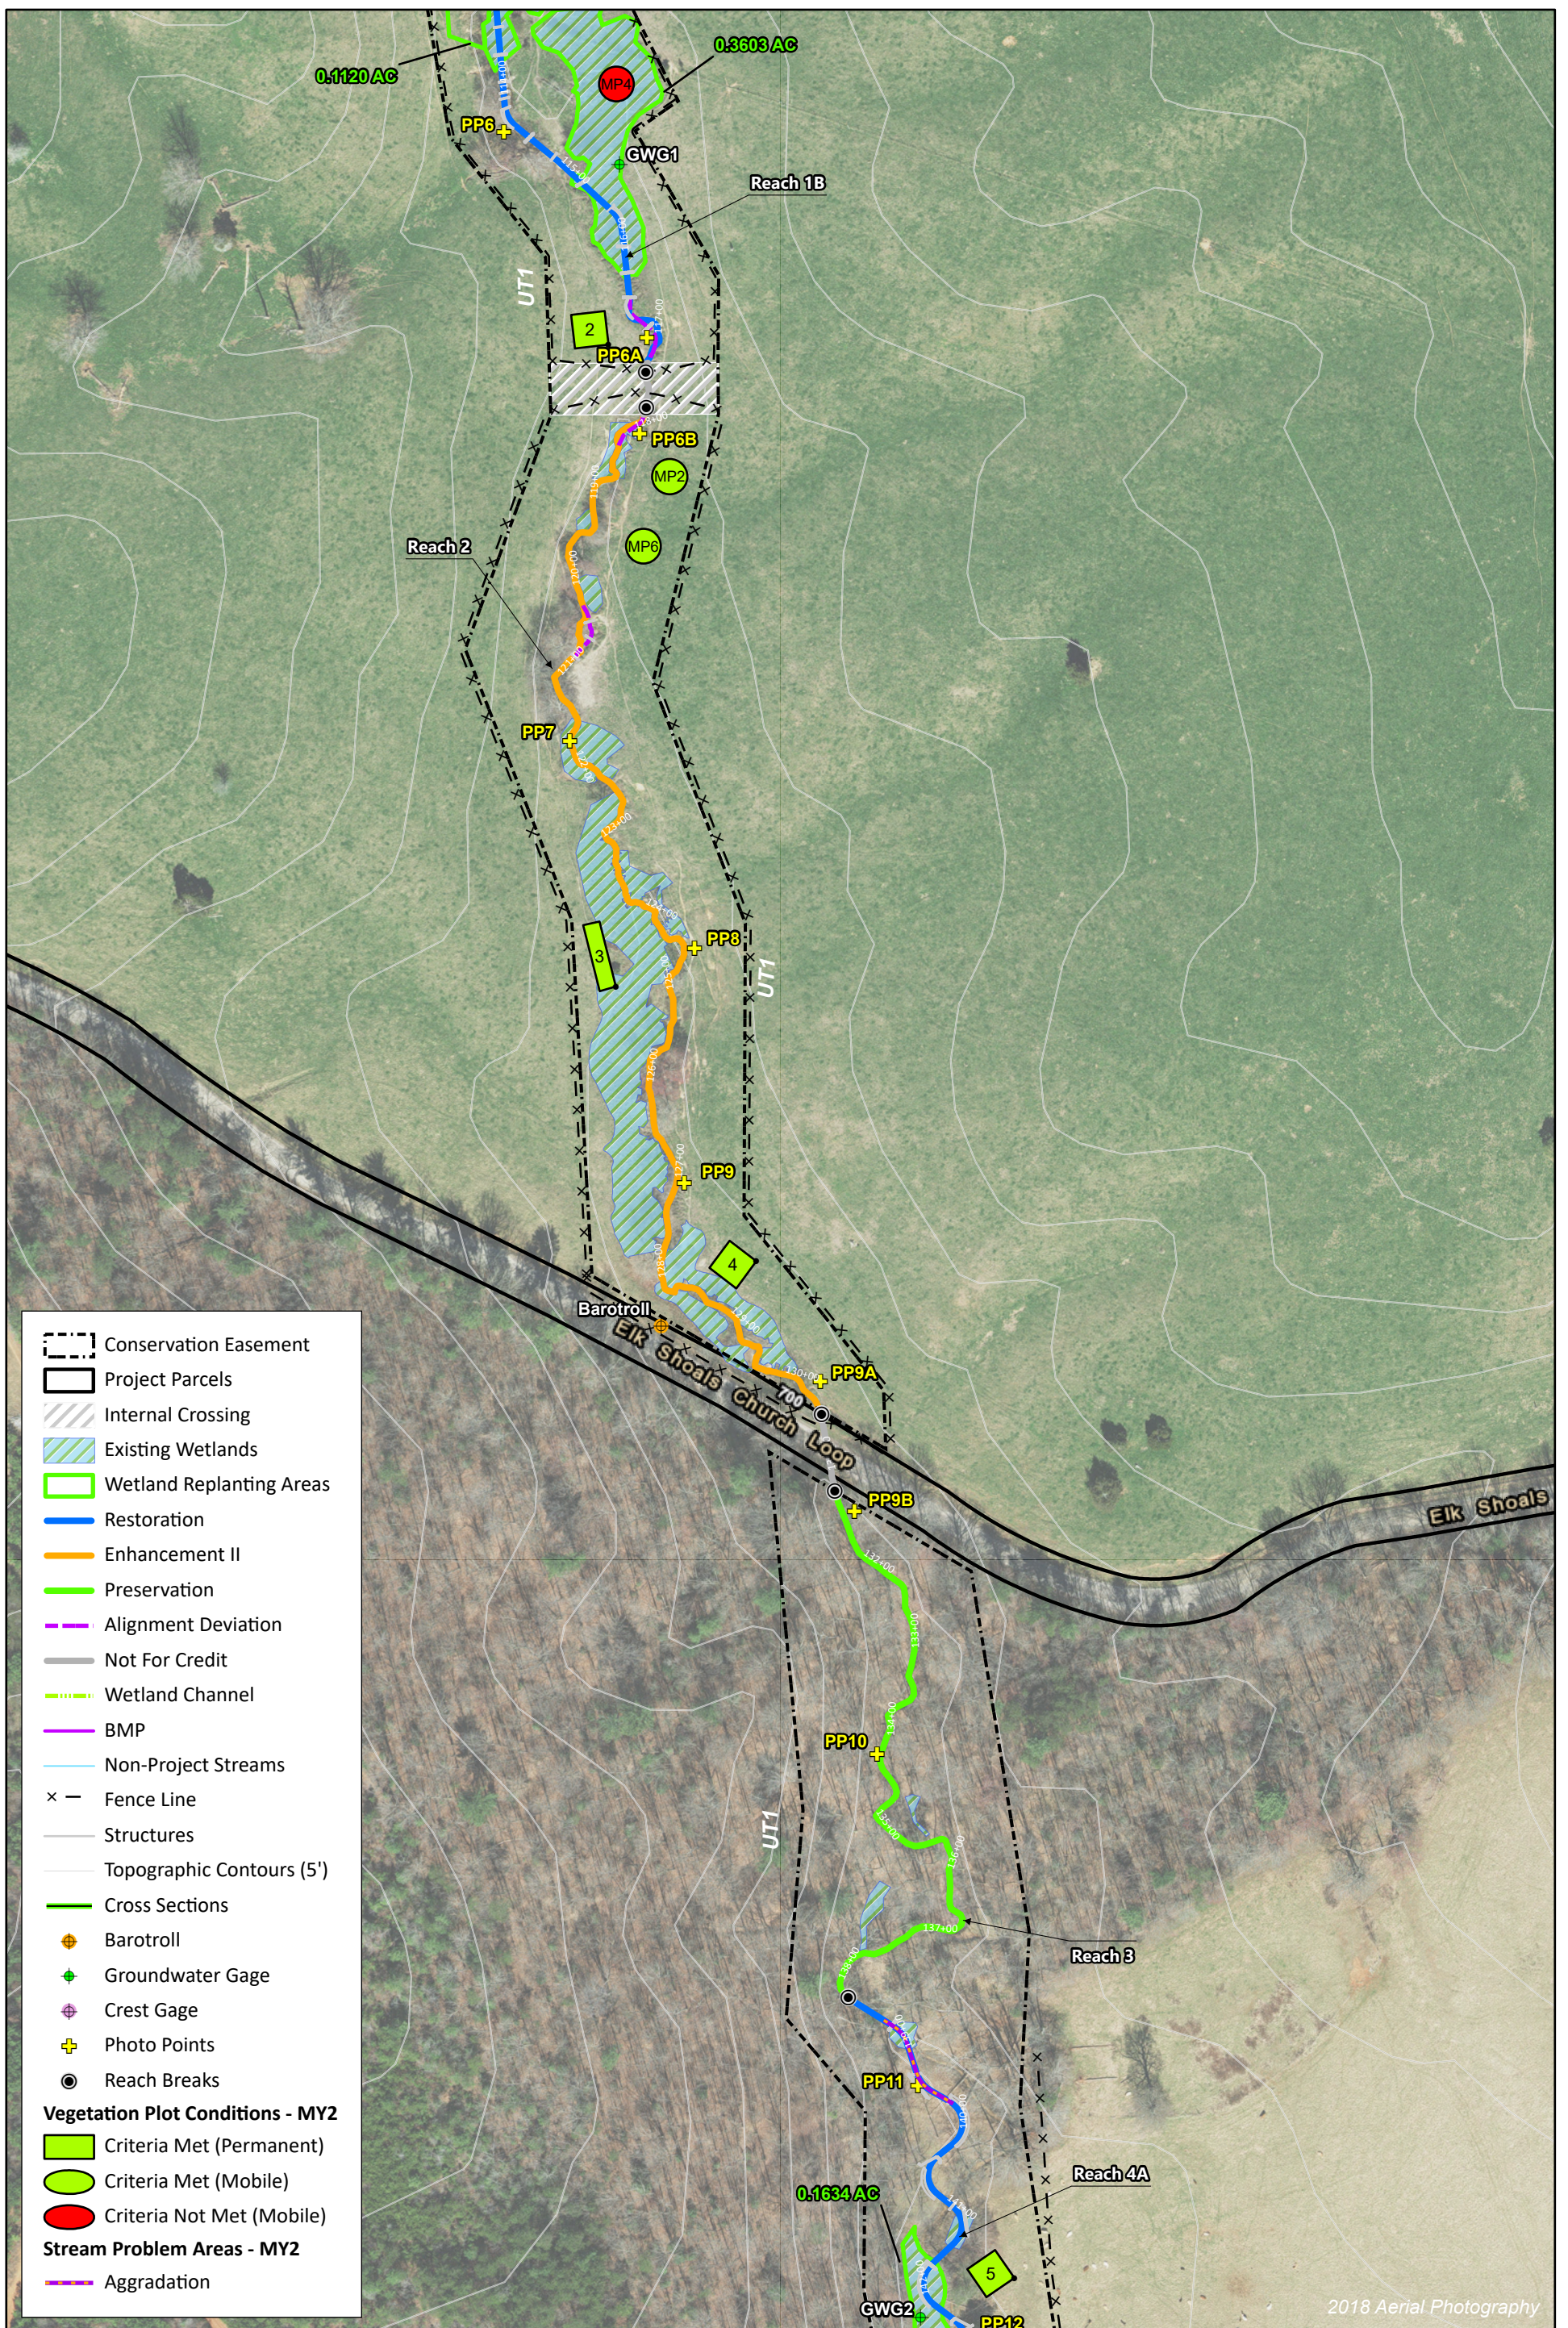
Figure 3.2 Current Condition Plan View
 Alexander Farm Mitigation Site
 DMS Project No. 100048
 Monitoring Year 2 - 2021
 Alexander County, NC

Two of these areas of concern, located along the left floodplain of UT4B from Station 152+00 - 157+10 and 163+75 - 166+66, continue to struggle and are trending much wetter than anticipated, relative to existing conditions. The other area of concern is located within some of the existing wetlands. Though these wetlands' planted stem densities are less than optimal their overall densities are generally sufficient when volunteers are included. Therefore, the supplementally planted wetlands are not included in Table 7 and are represented as wetland planting areas on Figures 3.1 and 3.2 rather than low stem density.

In order to improve planted stem densities within these areas described, wetland species will be planted, as needed, during the winter of 2022. Out of ten of the proposed species, three were included in the approved Mitigation Plan. Wildlands is requesting the inclusion of the other seven species to increase diversity and tolerance of the wetter than expected conditions. See Appendix 7 for the proposed planting lists, NC IRT approval email, and for the proposed planting locations.

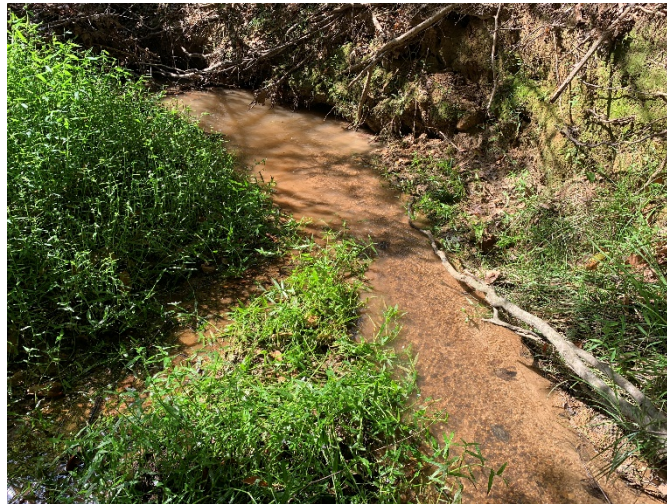
UT1 R1A Structure Piping (STA 104+00) – view Upstream
(09/15/2021)

UT1 R4A Aggradation (STA 139+00-139+75) – view downstream (09/15/2021)

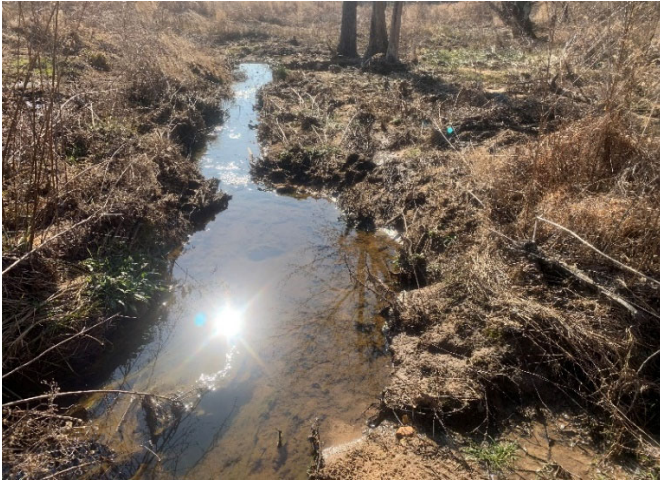
All streams on the Site are remaining stable. The three areas of concern that were recorded in MY1 have stabilized with streambank vegetation and are no longer an issue. During the MY2 visual stream assessment a couple minor areas of concern were noted along UT1 Reach 1A and UT1 Reach 4A. On UT1 Reach 1A, station 140+00, there are a couple small areas of piping under the angled log sills within the riffle. On UT1 Reach 4A there is approximately 110 LF of aggradation from station 138+75 to 139+85. It is anticipated that the channel will continue to move the sediment through the system, and it will no longer be an issue. Wildlands will continue to monitor these areas and remedial actions will be implemented if areas of concern begin to threaten the stability of the project. Please refer to Appendix 2 for stream stability tables, area of concern photos, and CCPV Figures 3.0 – 3.3.

UT1 R2 Right Bank Erosion (STA 120+00-120+20) – view downstream (2/9/2021)
