MONITORING YEAR 4 ANNUAL REPORT

BIG HARRIS CREEK MITIGATION SITE

Cleveland County, NC
DMS Project No. 739
DEQ Contract 006256
DWR 401 Project No. 10-0811
USACE Action ID No. SAW-2009-0475
Broad River Basin
HUC 03050105

Data Collection Period: May – November 2021

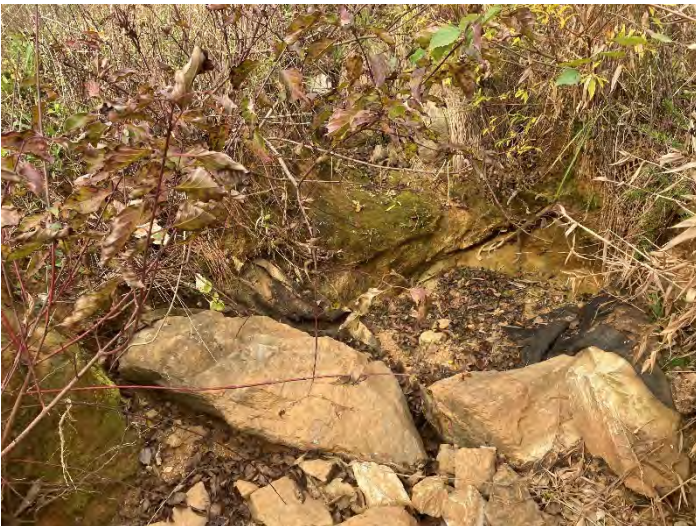
Scott Creek Channel Incision (STA 1211+25 – 1211+36) – view upstream
(10/27/2021)

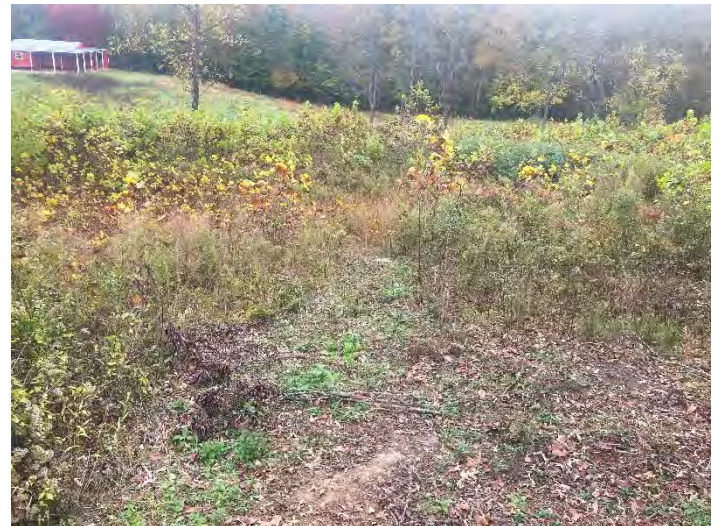
Royster Creek R1 Rock Sill Failed (STA 806+74) – view upstream
(11/3/2021)

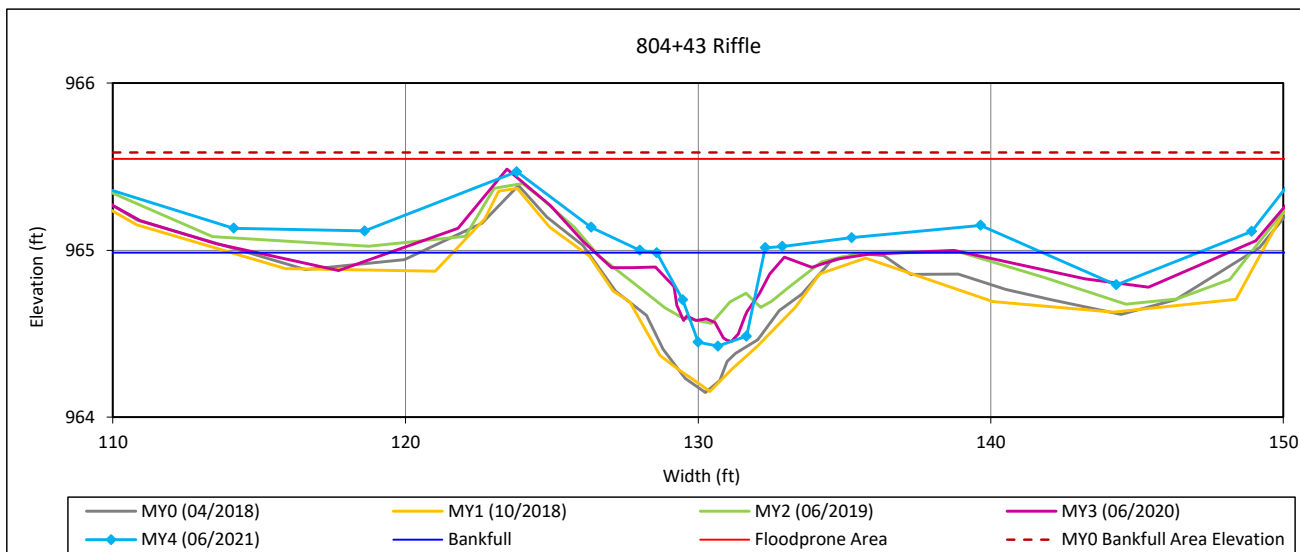
Royster Creek Reach 1: Cross-Section 9

A few cross-sections showed small fluctuations in channel dimension related to minor scour or deposition, which are normal and not indicative of instability. Riffle cross-sections 9, 13, 29, and 31 exhibited channel narrowing because of deposition coupled with the continued establishment of streambank vegetation which is a common adjustment and not suggestive of instability. During MY3, aggradation was documented at pool cross-section 32 and 33 on Upper Fletcher Creek Reach 2. The source of in-stream sediment may be offsite since no erosion was noted along Upper Fletcher Reaches 1 or 2. These cross-sections exhibit narrowing and deepening in MY4.

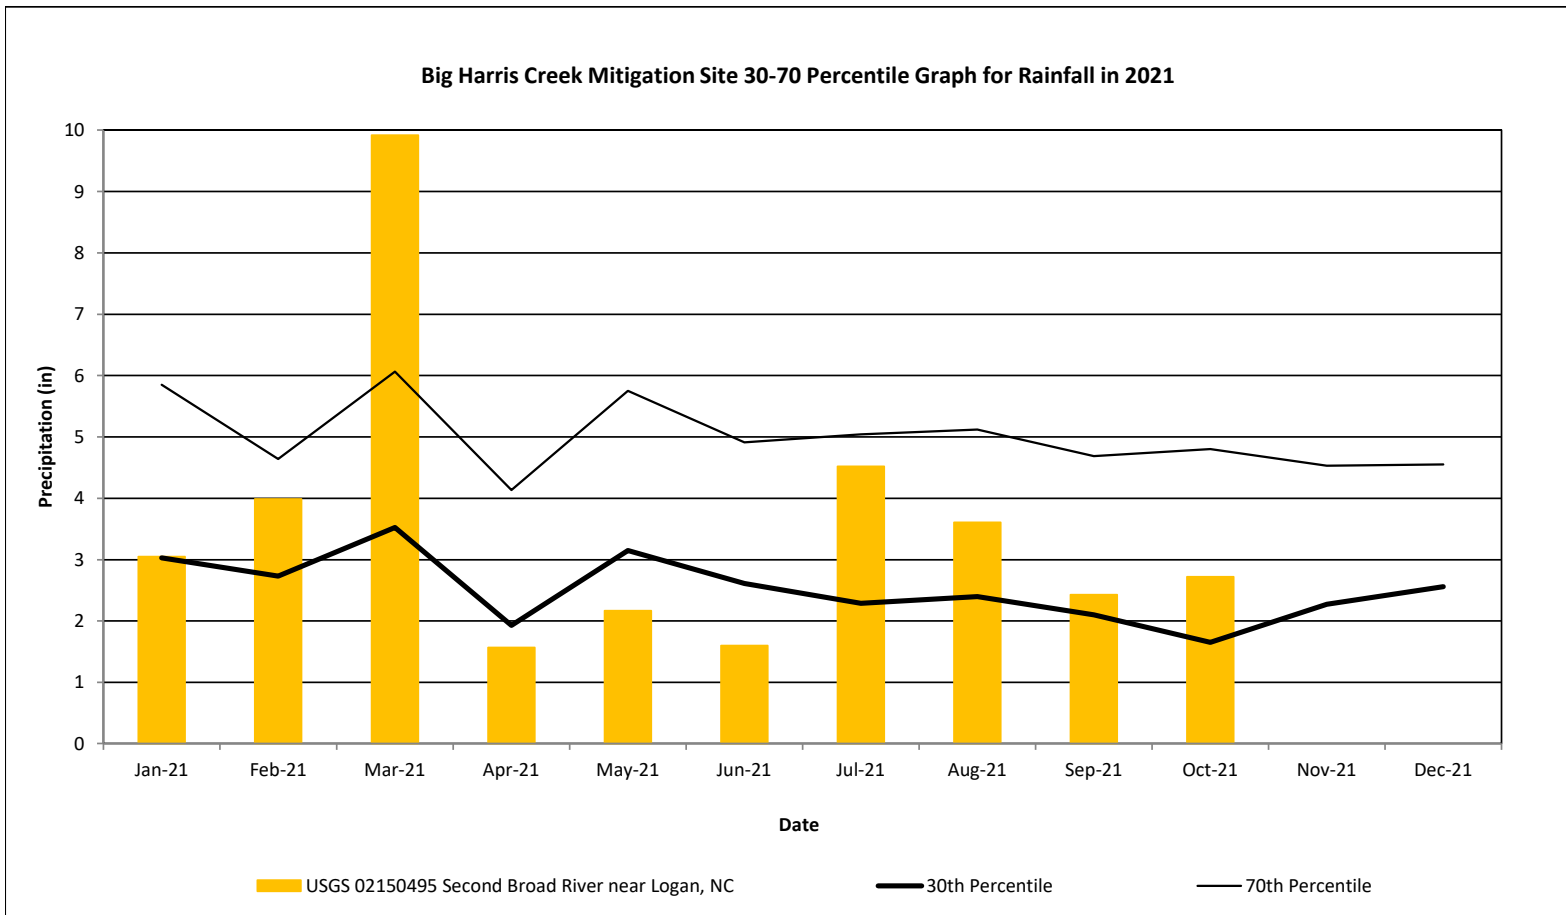
30th and 70th percentile rainfall data collected from WETS Station Shelby 2 NW in Shelby, NC (USDA, 2000).
