MY1 FINAL MONITORING REPORT

BRAHMA SITE

Alamance County, North Carolina

DMS Project No. 100092

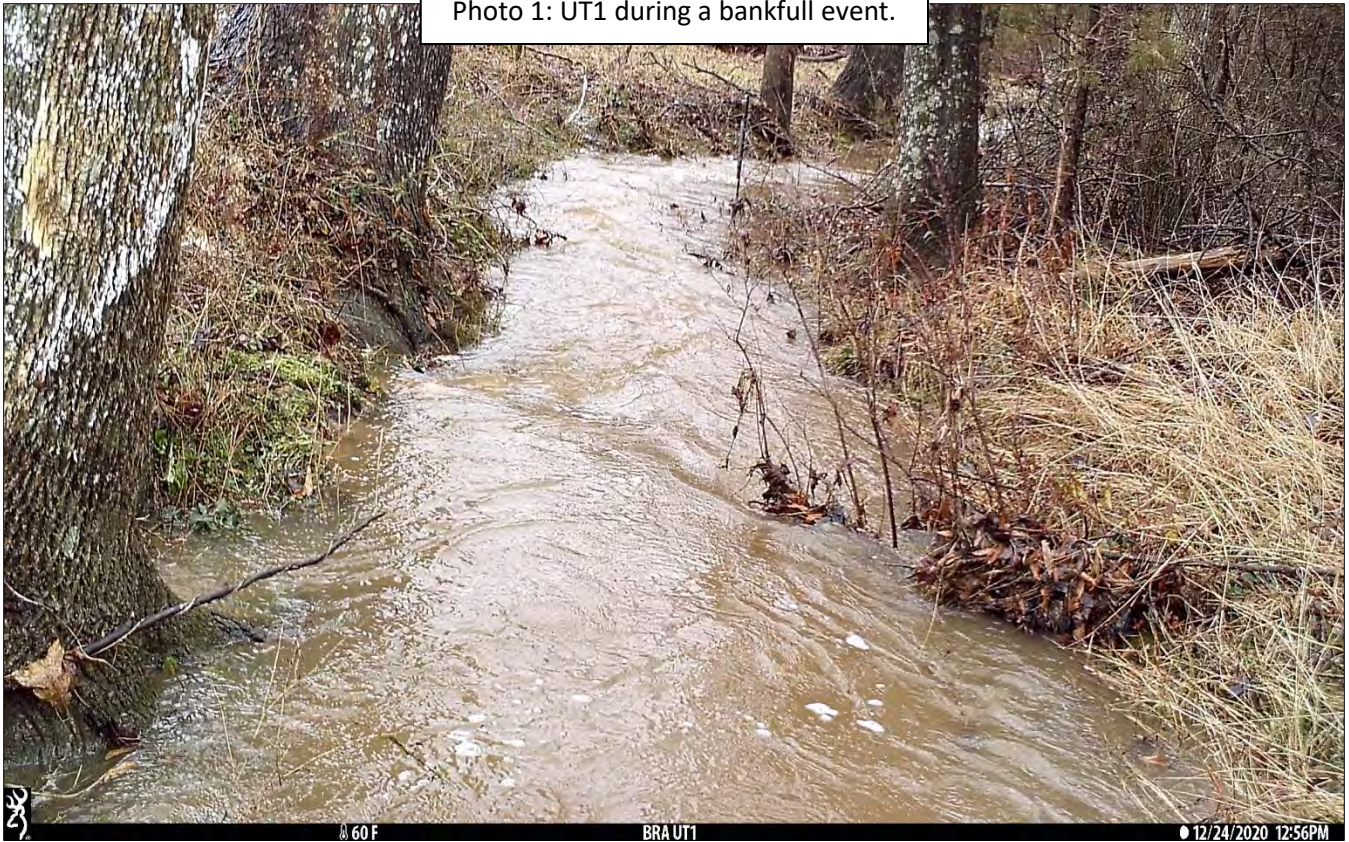
Photo 1: UT1 during a bankfull event.

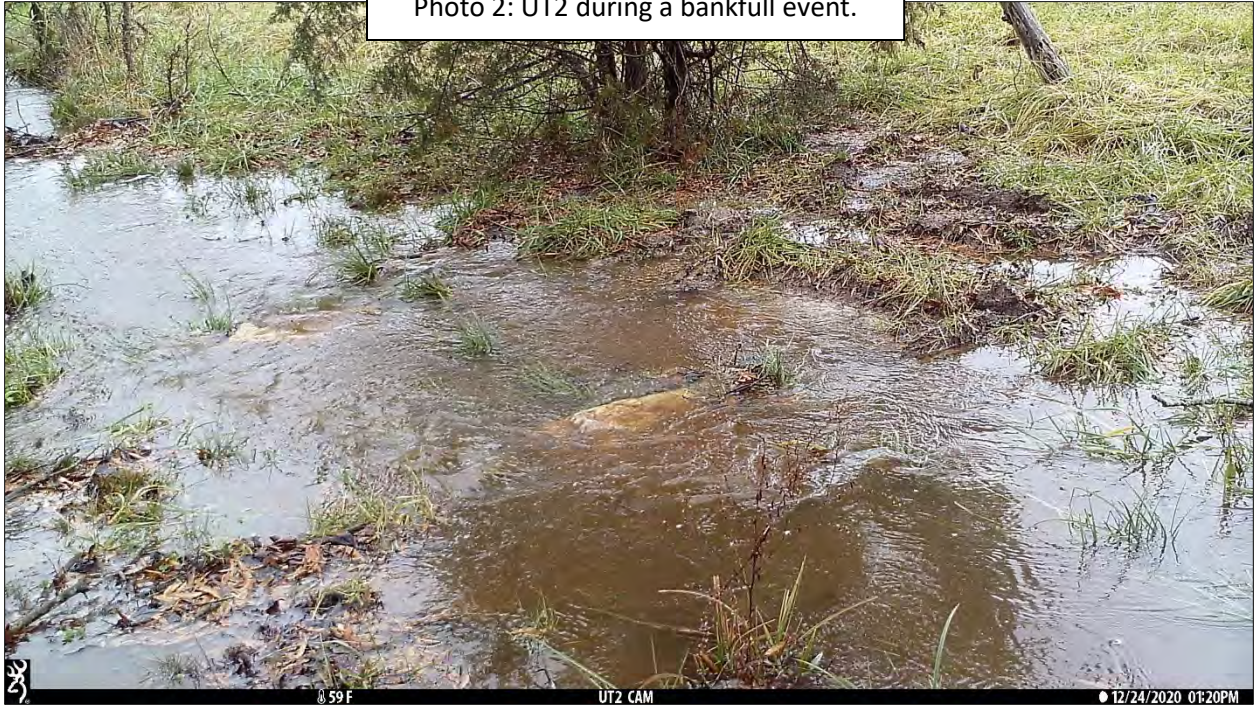
Photo 2: UT2 during a bankfull event.

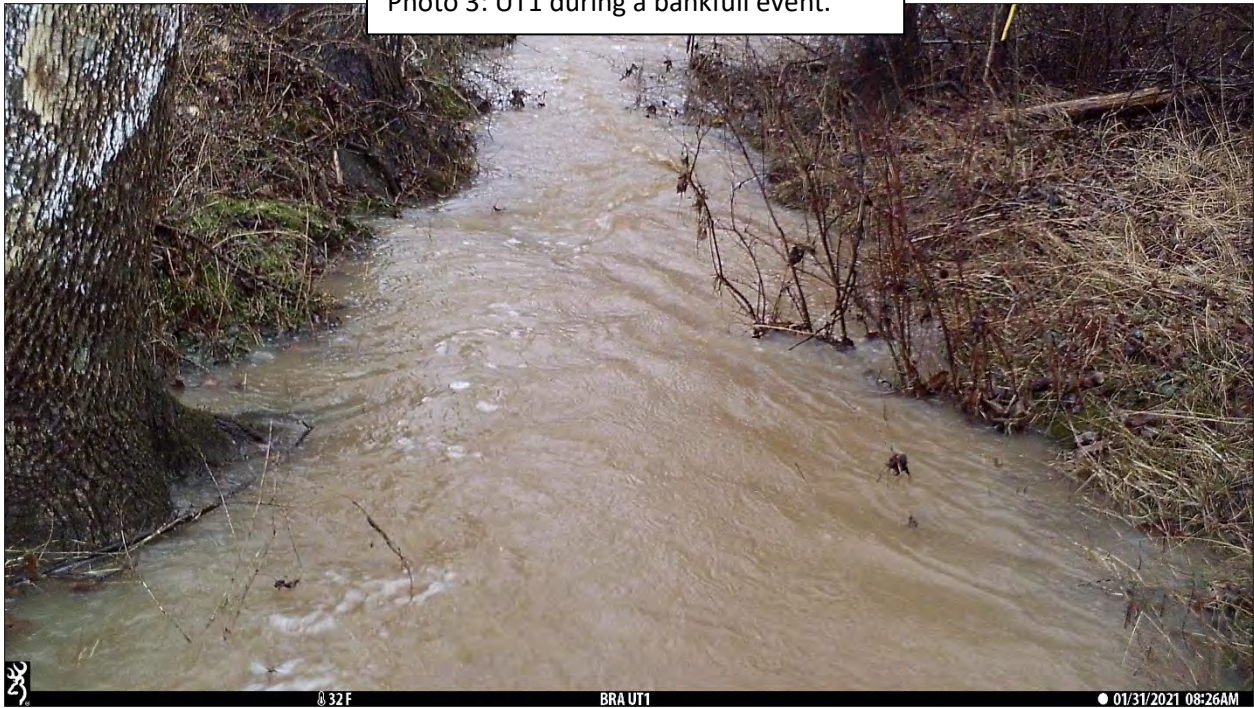
Photo 3: UT1 during a bankfull event.

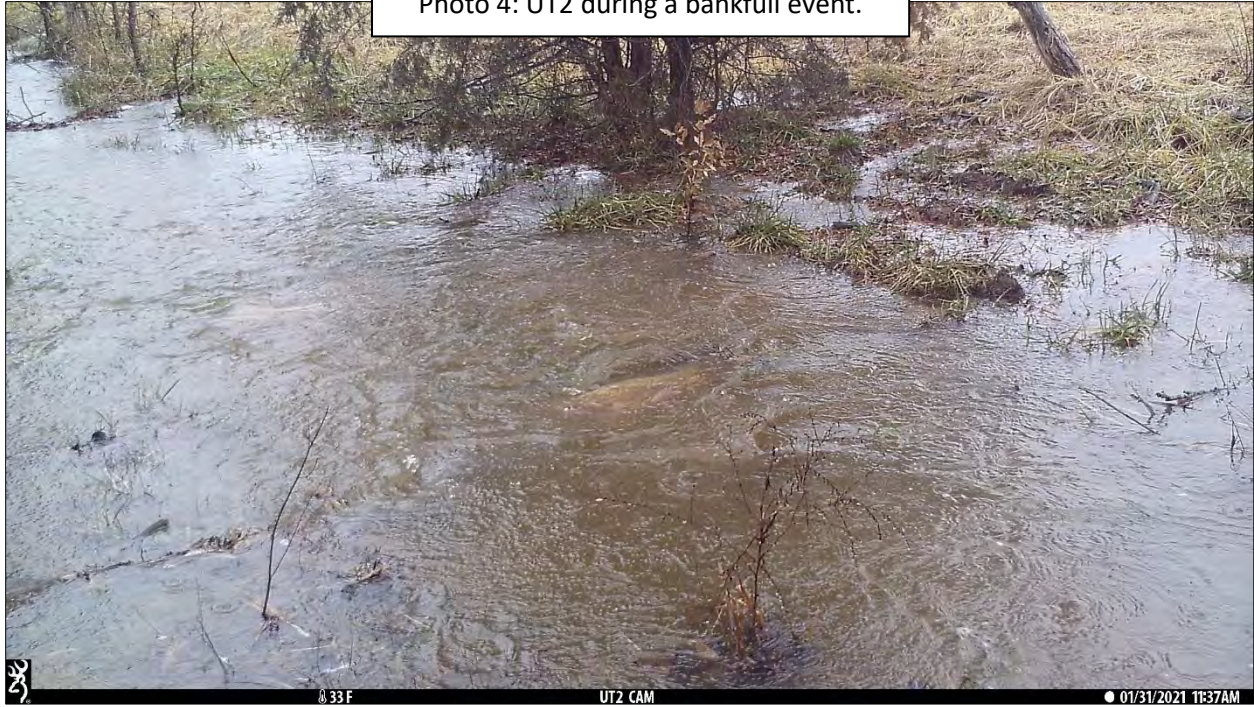
Photo 4: UT2 during a bankfull event.

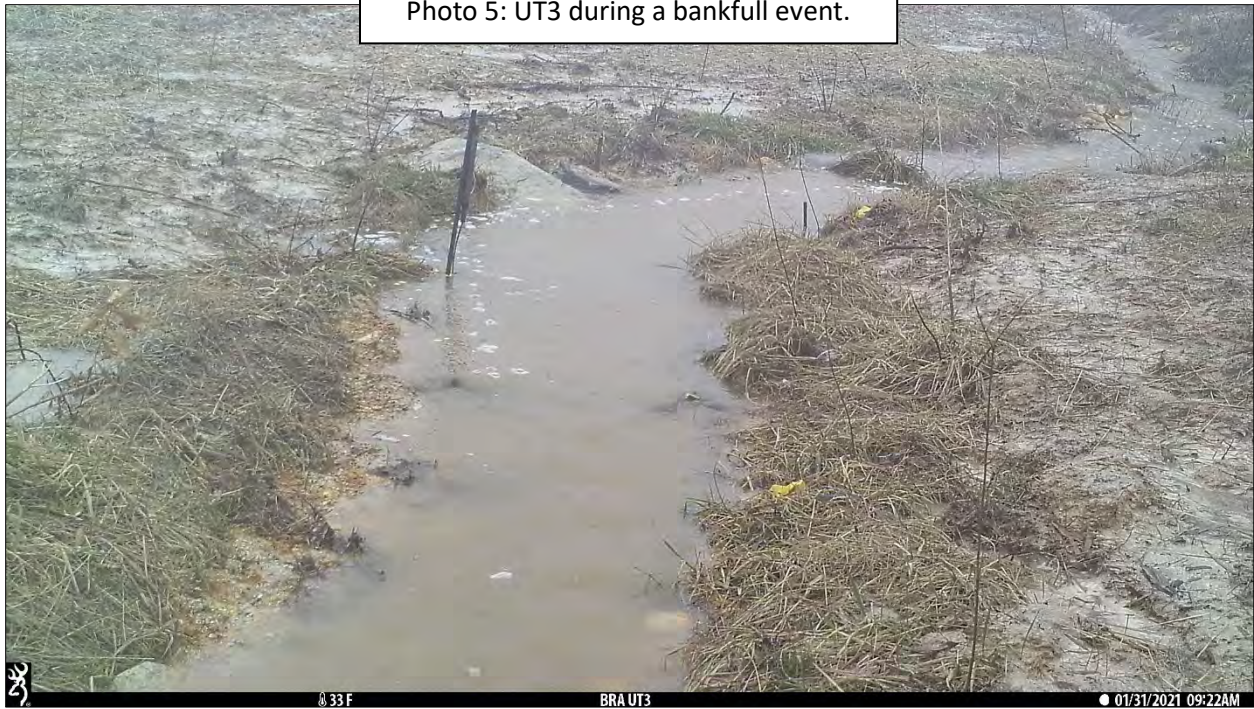
Photo 5: UT3 during a bankfull event.

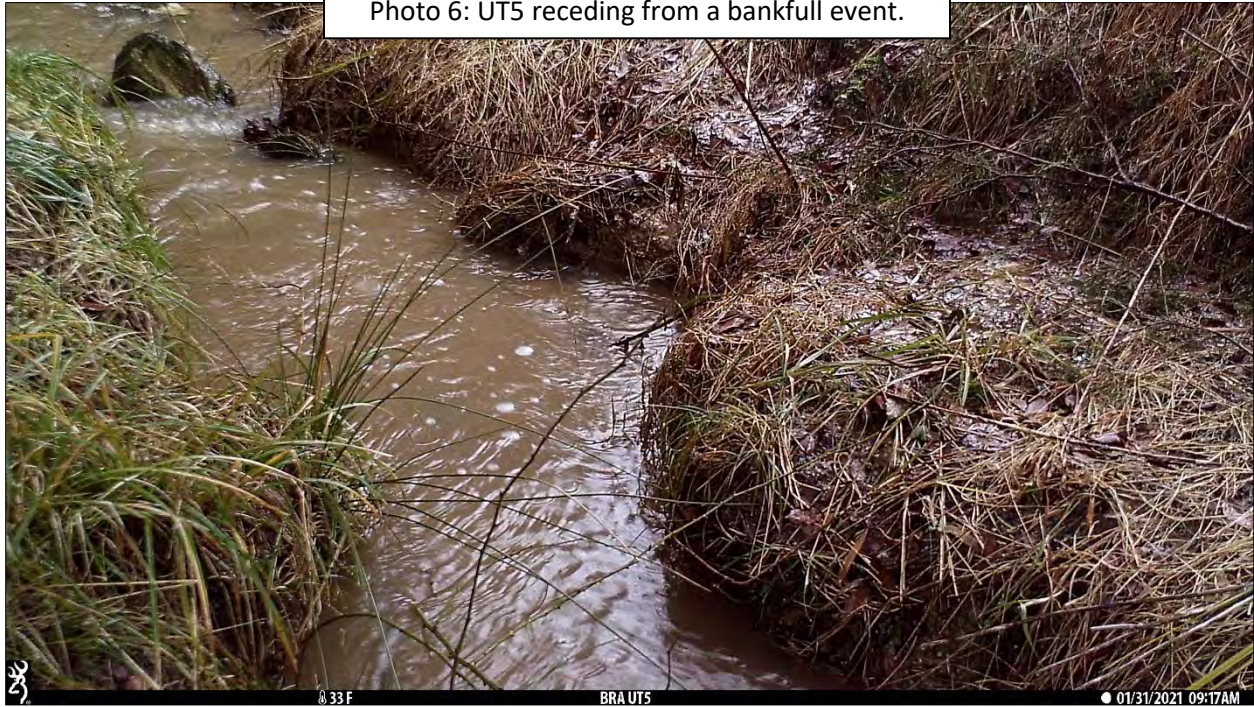
Photo 6: UT5 receding from a bankfull event.
