# **Brown Creek Tributaries Restoration Project FINAL Year 7 Monitoring Report/Closeout Report**

Anson County, North Carolina

DMS Project ID No. 95351  
DEQ Contract No. 004641  
USACE Action ID: SAW-2012-01108  
DWR Project #14-0345  
RFP #16-004108 (Issued 6/20/2011)  
Yadkin River Basin: 03040104-061030

Project Info:           Monitoring Year: 7 of 7  
                              Year of Data Collection: 2021  
                              Year of Completed Construction: 2015  
                              Submission Date: February 2022

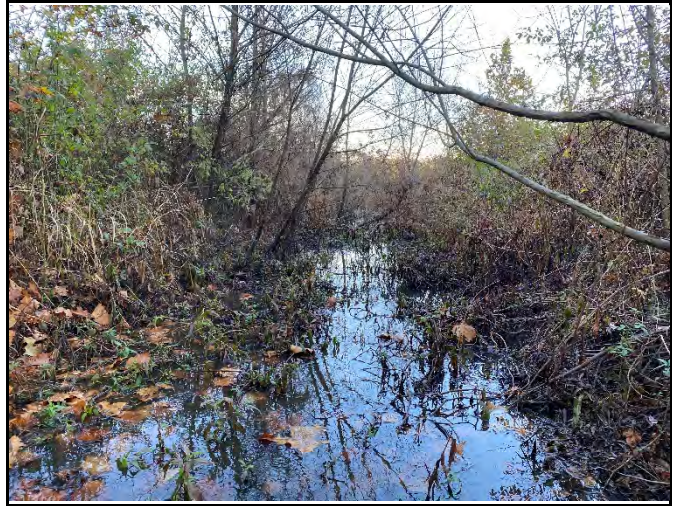
HC-R1: Photo showing normal flow restored and maintained after beaver dams removed in the spring.

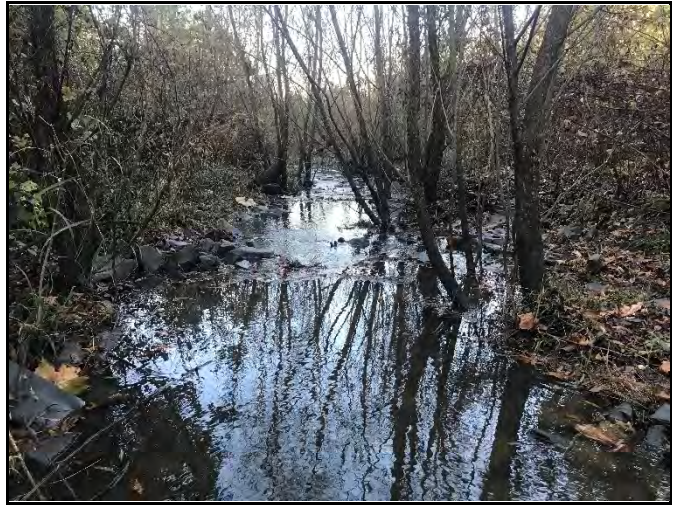
HC-R1: Photo showing normal flow restored and maintained after beaver dams removed in the spring.

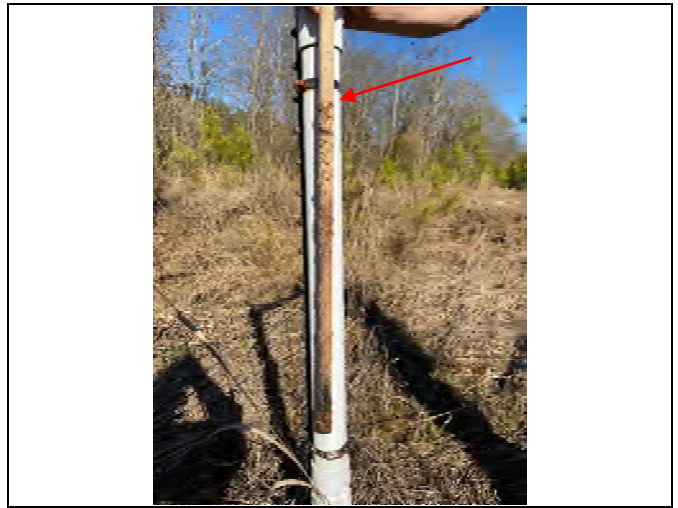
Crest Gauge Reach UT4-R2: Overbank event of 1.75'  
(photo from 3/8/21)

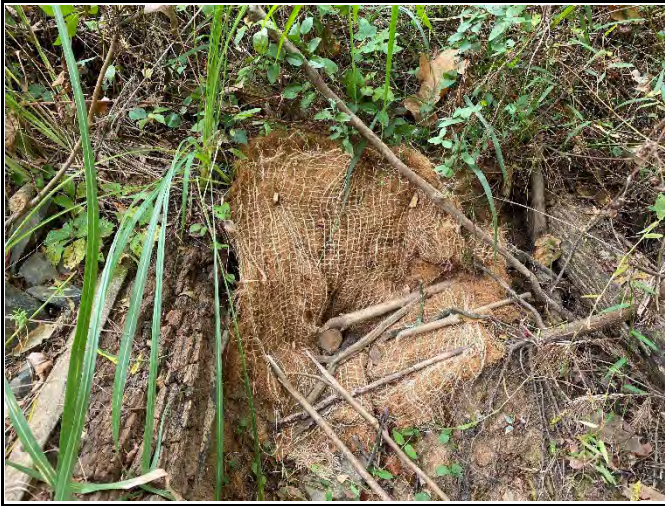
UT4-R2, SPA #1 Bank Repair (Left bank stabilized with matting, Sept.2021)

Additionally, there were three small areas of bank erosion/scour on the UT4 portion of the project noted in the previous MY6 report that were repaired in the fall of 2021 and done in accordance with the May 2021 Credit Release meeting discussion of the areas. Two were short sections of bank (~4-ft long) on lower UT4-R2 below

log vane structures where it appeared storms had impacted the established herbaceous vegetation growing along the bank leaving exposed bare soil. These two sections had erosion control matting installed over the bare areas and livestock placed within them. The third area was a section of bank (~3-ft long) beside a log weir on lower UT4-R1b where bank scour had resulted in bypass flow around the structure. The scoured area was backfilled with soil, filter fabric was installed over the soil, and larger rocks were placed on top to secure the repair. To be clear, these were small repair efforts that were all entirely completed by hand so no machinery had to be brought onto the site. Subsequent inspections in January 2022 revealed that these areas appeared to be stable and functioning well.

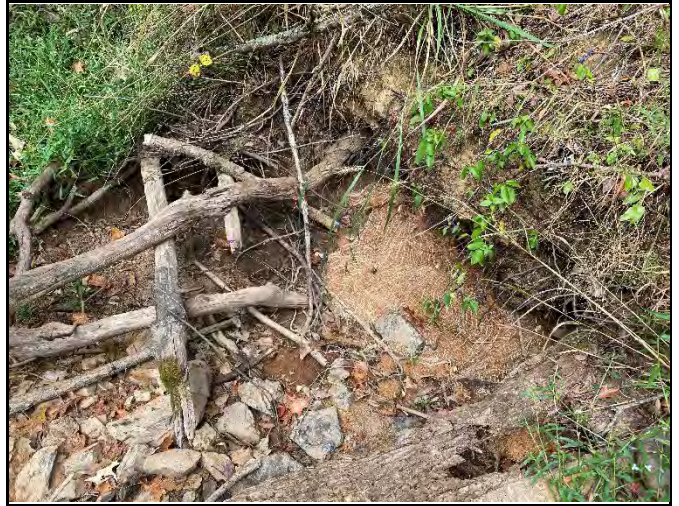
UT4-R2, SPA #1 Bank Repair (Right bank stabilized with matting, Sept.2021)

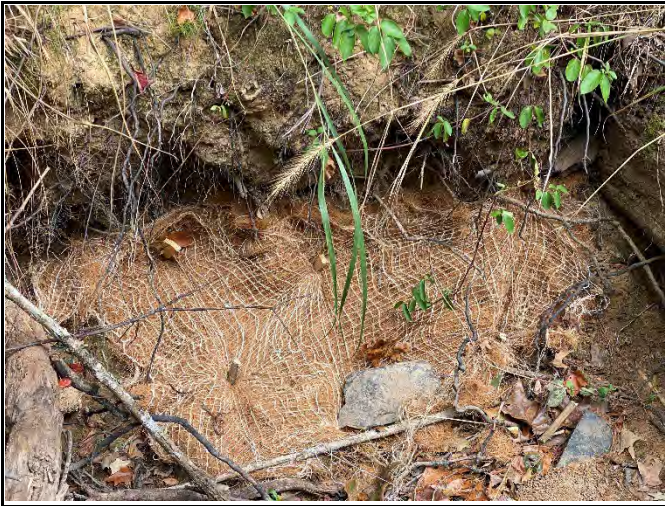
UT4-R2, SPA #1 Bank Repair (Right bank stabilized with matting, Close-up, Sept.2021)

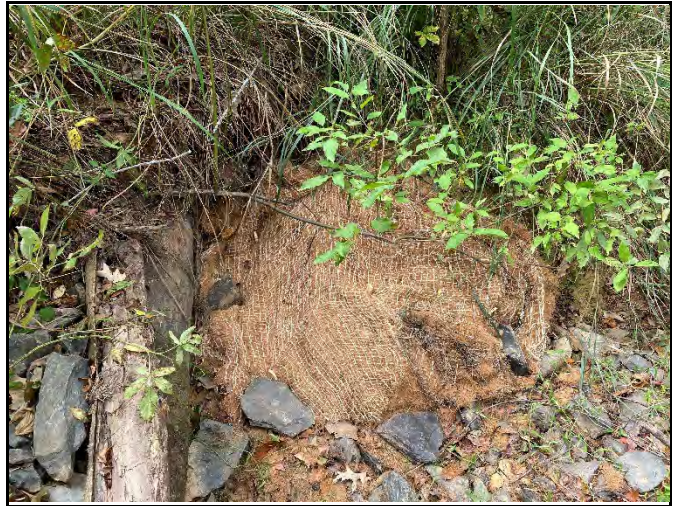
UT4-R2, Additional Bank Repair near SPA #1 (Stabilized with matting, Sept.2021)

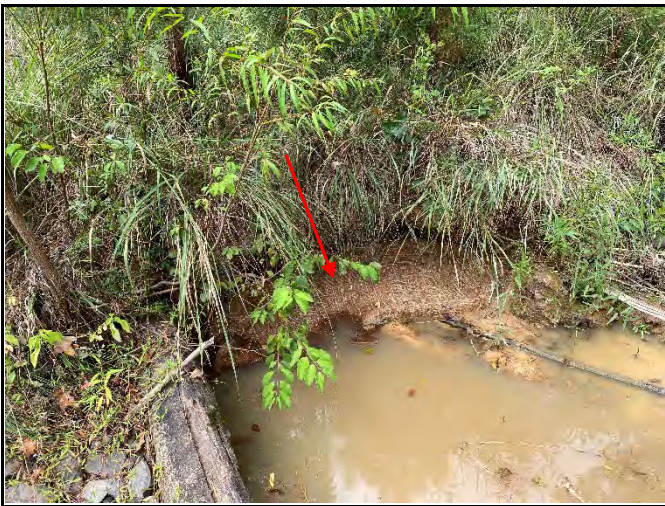
UT4-R2, SPA #2 Bank Repair (Stabilized with matting, Sept.2021)

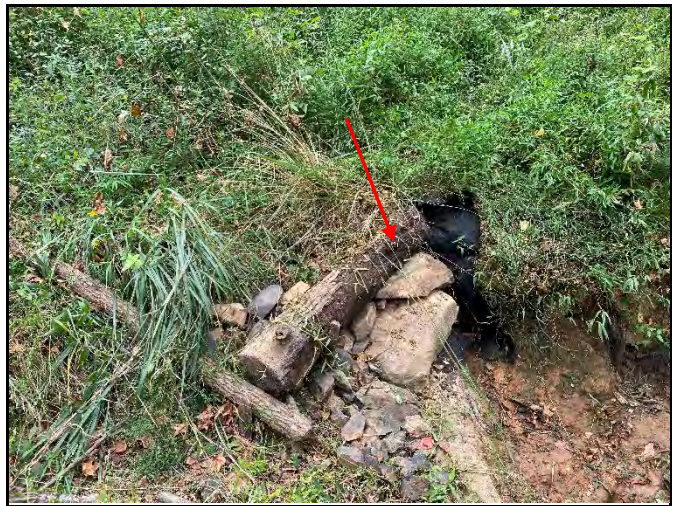
UT4-R1b, SPA #3 Bank Repair (Scour filled-in with soil, matting and rock/logs installed on top, Sept. 2021)

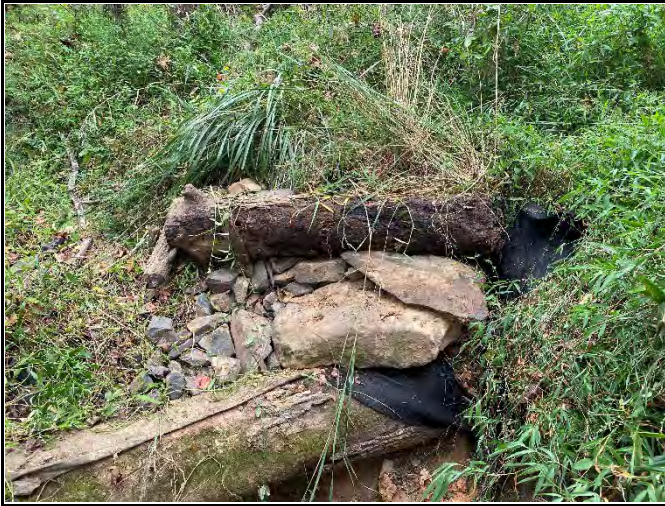
UT4-R1b, SPA #3 Bank Repair (scour filled-in with soil, matting and rock/logs installed on top, Sept. 2021)

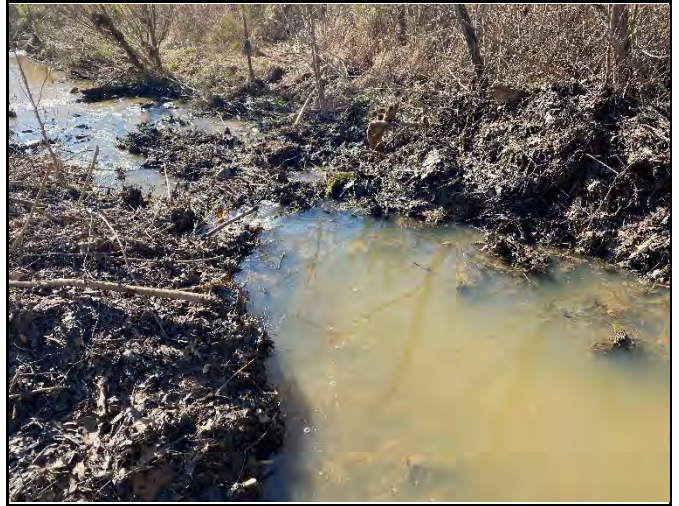
UT4-R2: Beaver dam removed (Mar. 2021)

Previously during MY6 site inspections in November 2020, several beaver dams were discovered on both portions of the project. A professional beaver wildlife specialist was employed to trap the beaver prior to his demolition of each of the dams with explosives and hand raking to remove the debris in March 2021 (see photographs in Appendix B). Fortunately, the vast majority of the vegetation used for the dams was the adjacent black willow, which is present in abundance and naturally regrows well. Subsequent field inspections revealed that no further beaver activity has been noted since that time.

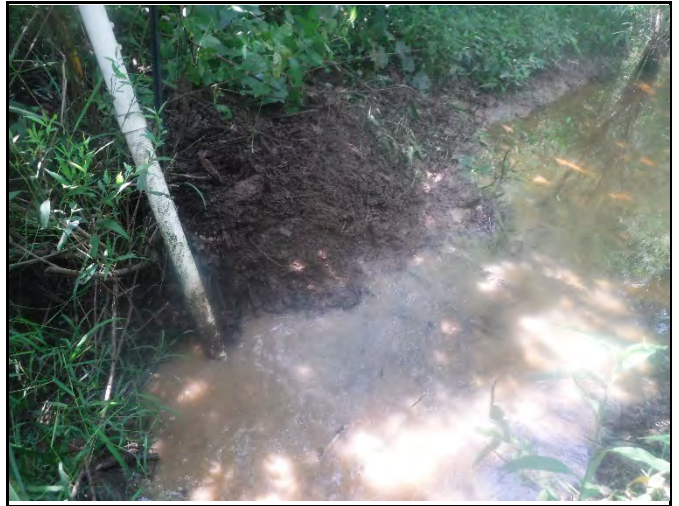
HC-R1: Beaver dam removed in Mar. 2021  
(photo from July 2021)
