Browns Summit Creek Restoration Project Year 5 Monitoring Report

Guilford County, North Carolina

DMS Project ID No. 96313, DEQ Contract No. 5792

Project Info: Monitoring Year: 5 of 7
 Year of Data Collection: 2021
 Year of Completed Construction (including planting): 2017
 Submission Date: December 2021

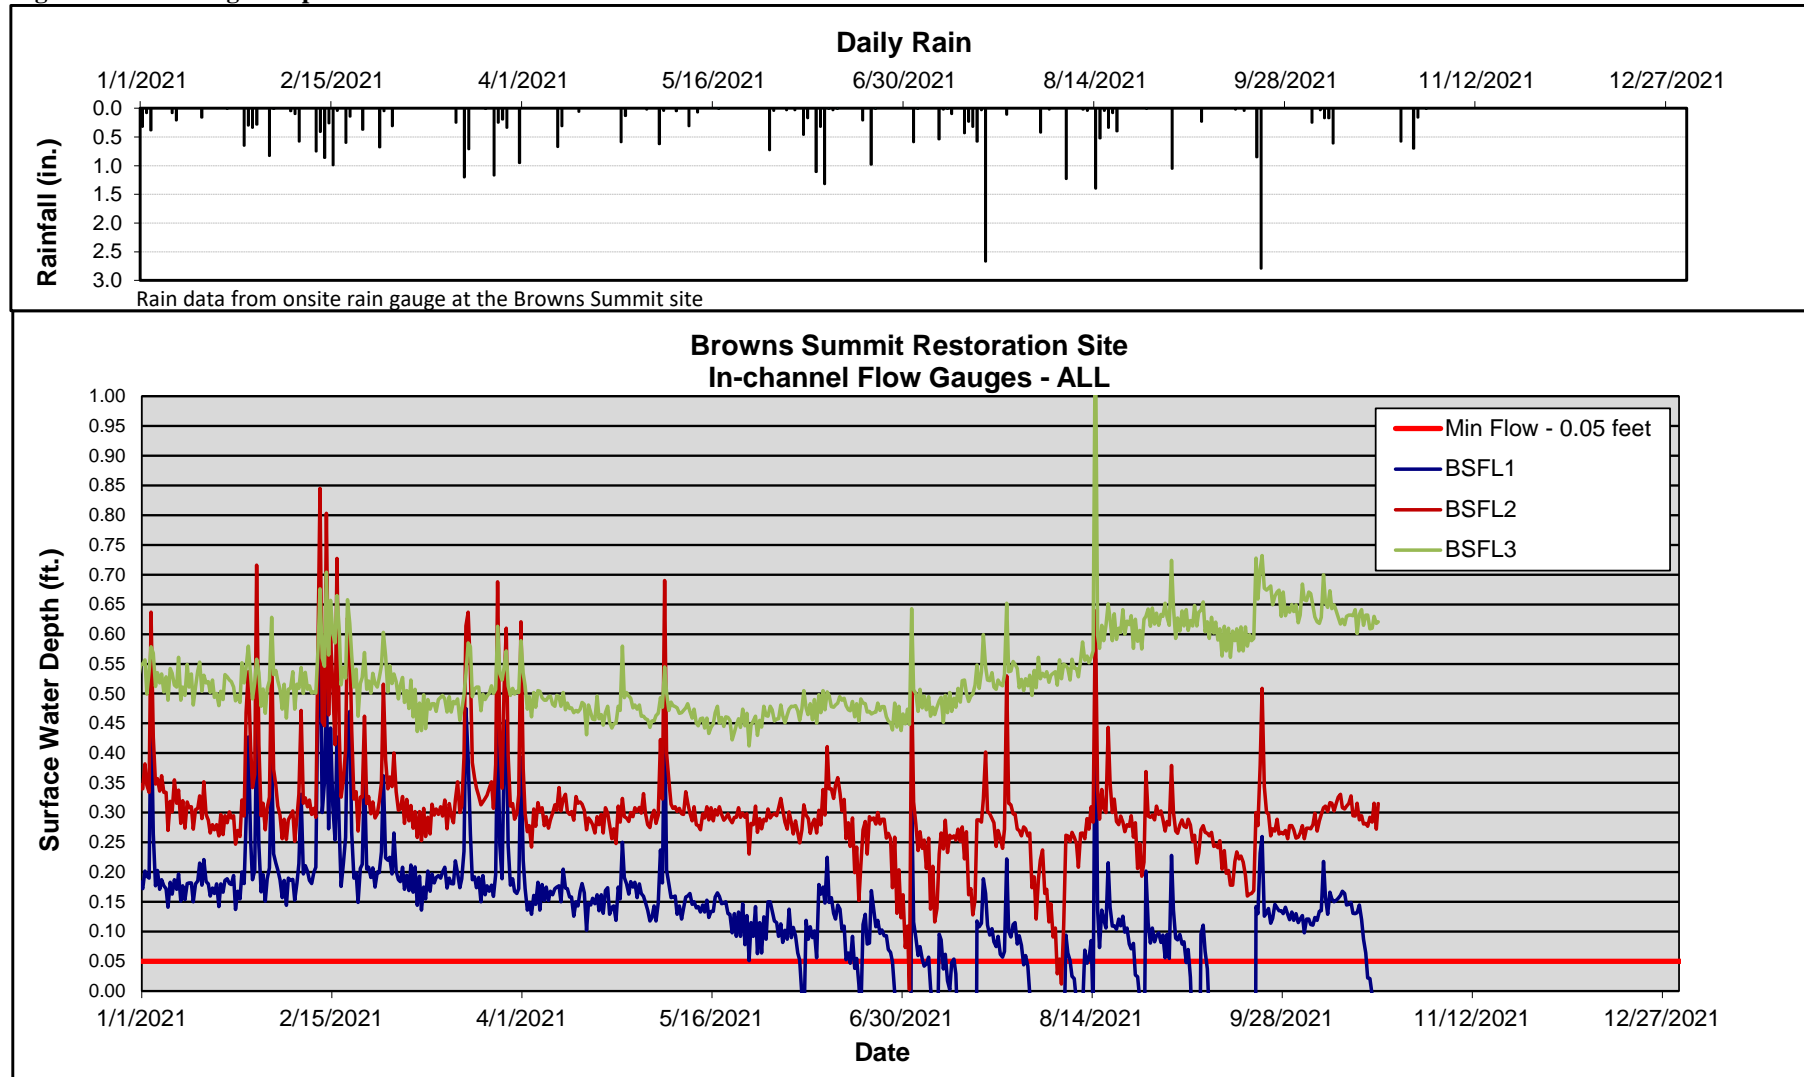
Figure 6. Flow Gauge Graphs

Year 5 flow monitoring demonstrated that all flow gauges (BSFL1, BSFL2 and BSFL3) met the stated success criteria of 30 days or more of consecutive flow through R4, T3 and T1 respectively. The gauges demonstrated similar patterns relative to rainfall events observed in the vicinity of the Site as shown in the flow gauge graphs in Appendix E.

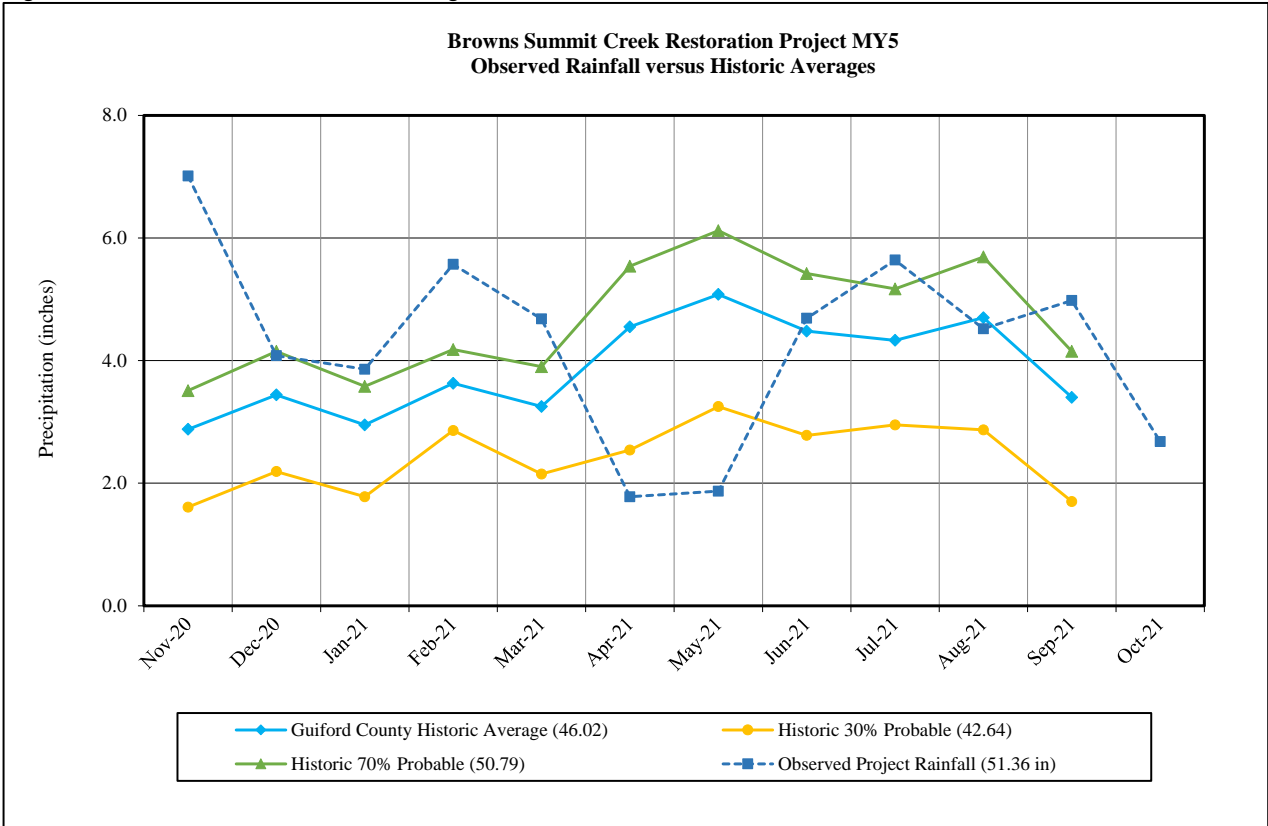
Response: Figure 8. Observed Rainfall Versus Historic Averages has been included in Appendix E of the report along with the supported files located in the e-submission folder.

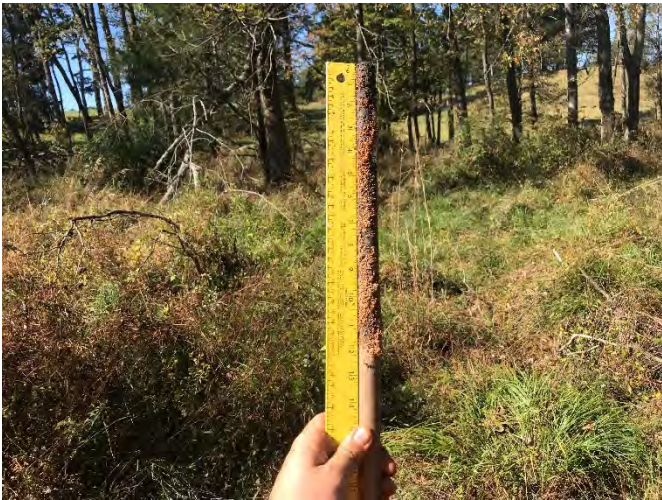
Manual Crest Gauge – Reading 10/21/2021 (1.01')

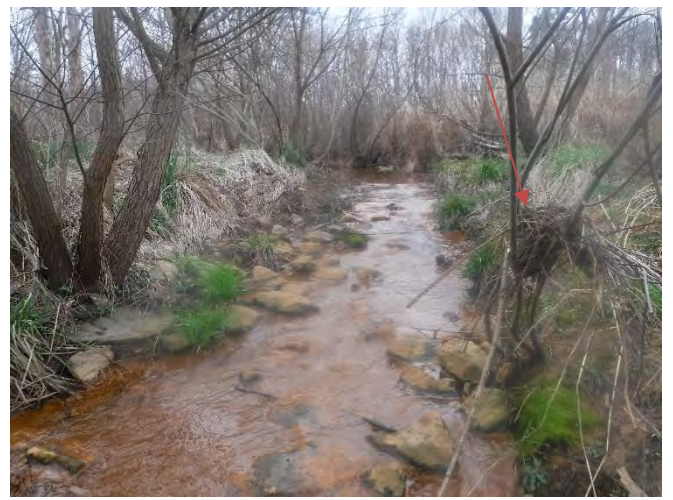
Wrack Line Showing High Flow (3/23/2021)

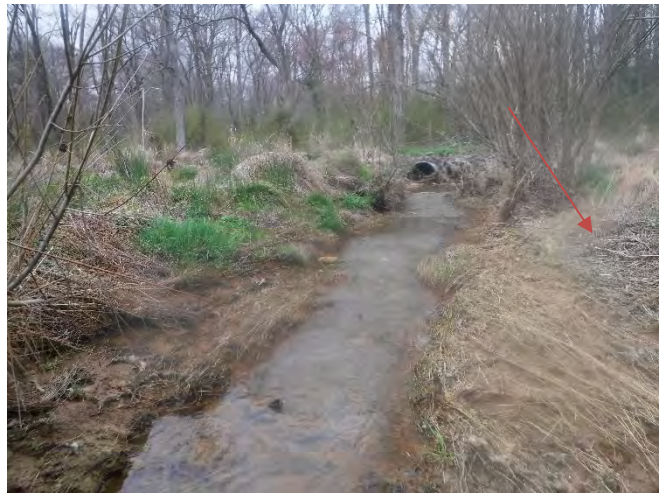
Wrack Line Showing High Flow (3/23/2021)
