# MONITORING YEAR 5 ANNUAL REPORT

## CANDY CREEK MITIGATION SITE

Guilford County, NC

NCDMS Project Number 96315

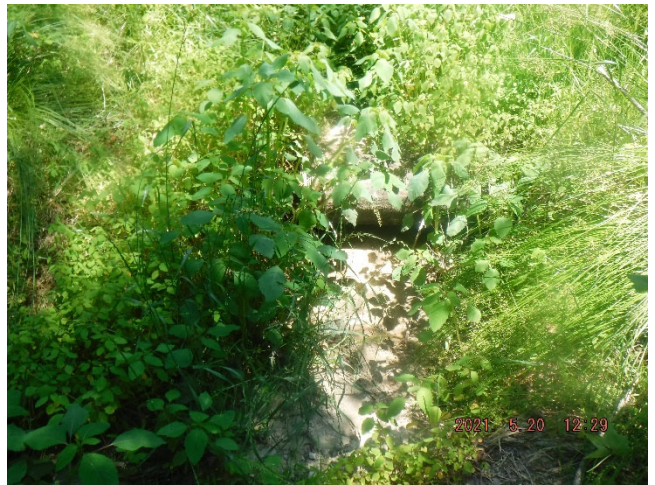
Candy Creek Reach 3 - Bank erosion, RB (Sta. 151+70-152+00) (05/20/2021)

As was discussed during the IRT site walk in July, machine repairs are scheduled for Candy Creek Reach 3 and UT1D for early in 2022. The right bank of Candy Creek Reach 3 will be reshaped to stop the outward erosion of the pool; the step-pool structures along UT1D will be reinstalled to stop the stream from piping underneath and preventing additional structure failure. Once these repairs are completed, the work will be described in a written summary that will be sent to DMS for inclusion in the report before it is submitted to the IRT for the Credit Release Meeting. The MY6 report will also describe the repairs that were completed and will include a photolog, as discussed in the July 7, 2021 IRT Credit Release Site Walk. Photos of the two areas are currently shown in the Areas of Concern Photographs (Appendix 2).

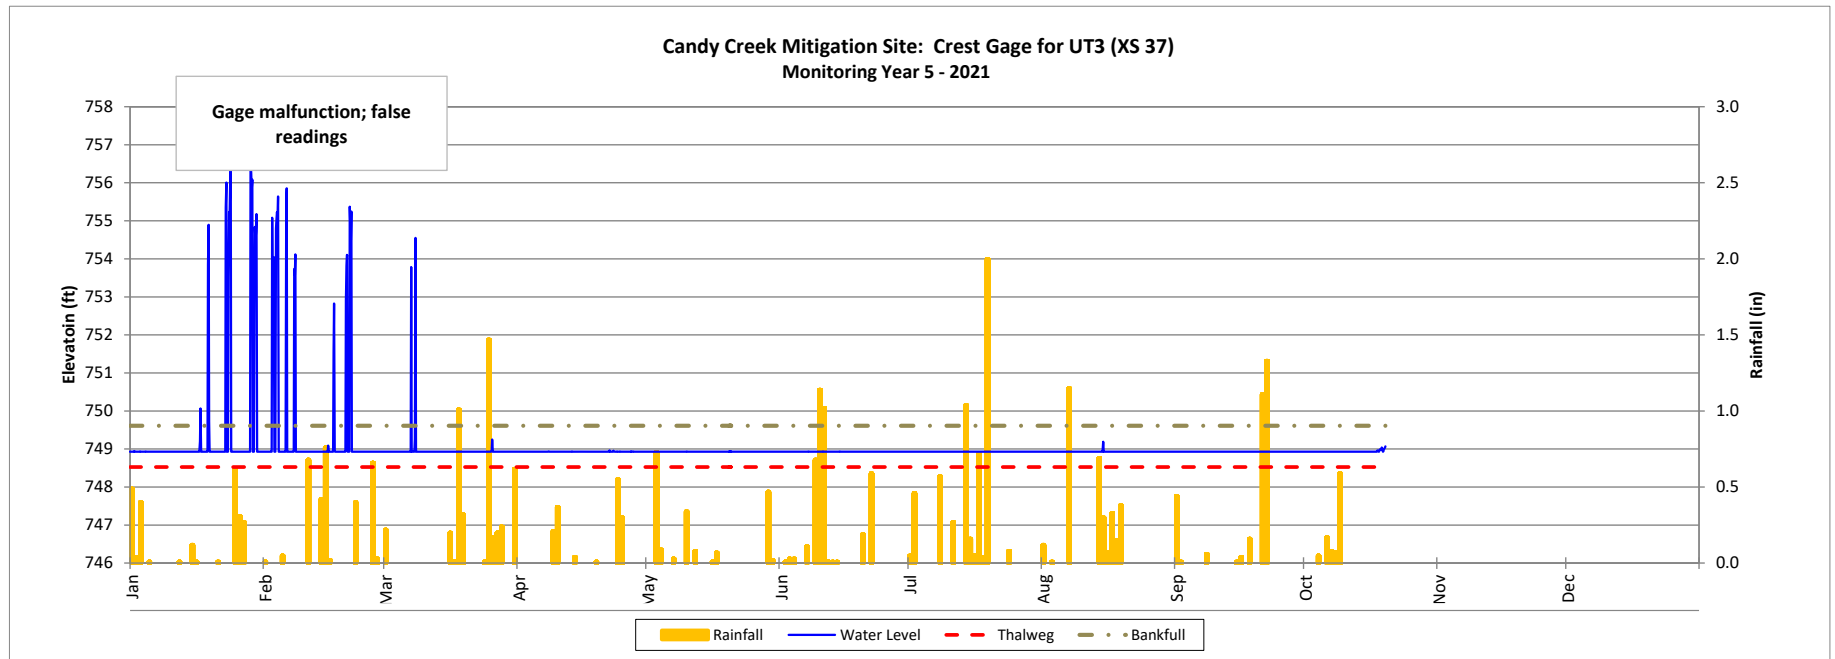
\*Due to the large spikes that do not seem to correlate with rainfall amounts, but occurred only during the winter months, Wildlands pulled air temperature data for the surrounding area and noticed a correlation between the spikes and when the air temperatures dropped below freezing. Therefore, Wildlands contacted In-situ on 11.18.21 to gain some technical insight on these findings. A Technical Support Specialist, Kaylie Haynes, at In-situ confirmed that these spikes are likely false readings due to freezing water around the pressure diaphragm in the gage. She referred us to specification sheet for the pressure transducers, Rugged TROLL(R) 100 Data Loggers, that Wildlands commonly uses in the field (2021). Therefore, Wildlands ignored the bankfull event spikes recorded from 01.01.21 - 04.01.21, when air temperature is more likely to fall below freezing, and only included bankfull events recorded between 04.01.21 - 10.31.21 when air temperature is more likely to remain above freezing and that positively correlated with rainfall amounts from the nearest rainfall gage. Moving forward, Wildlands will check the calibration on the gages using a known depths of water. If the gage is recording correctly, it will be reinstalled for use in 2022. If the gage is not recording correctly, Wildlands will refrain from using the gage unless it can be refurbished by In-situ, upon which Wildlands will check the calibration before reinstalling it for use during 2022.
