Year 6 Monitoring Report

Hudson Property

DMS Project ID #: 95361
DMS Contract #: 004638
DWR Project #: 20140422v1
USACE Action ID# SAW-2012-01394
Beaufort County, North Carolina

Submitted: February 2022

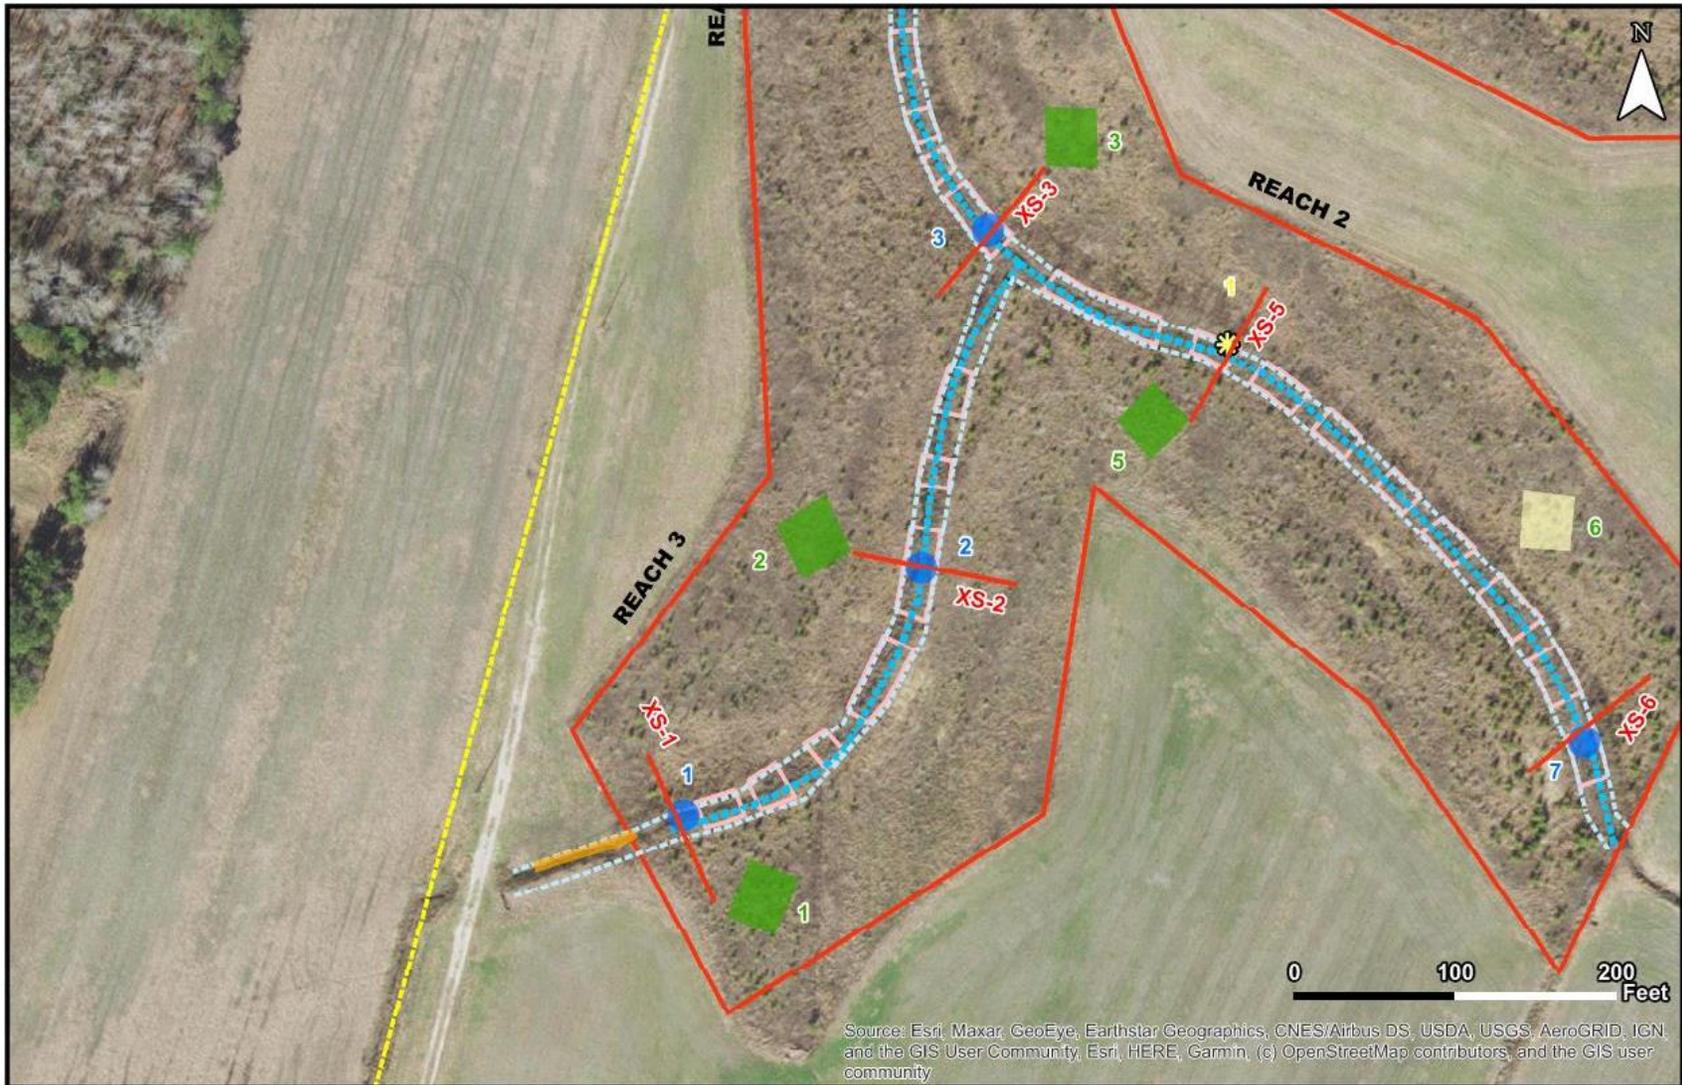
- 3. Please submit a feature characterizing the 20 ft. of erosion located along Reach 3.*
Ecotone Response: Erosion is now marked on CCPV of Reach 3 on page 14 of the report.

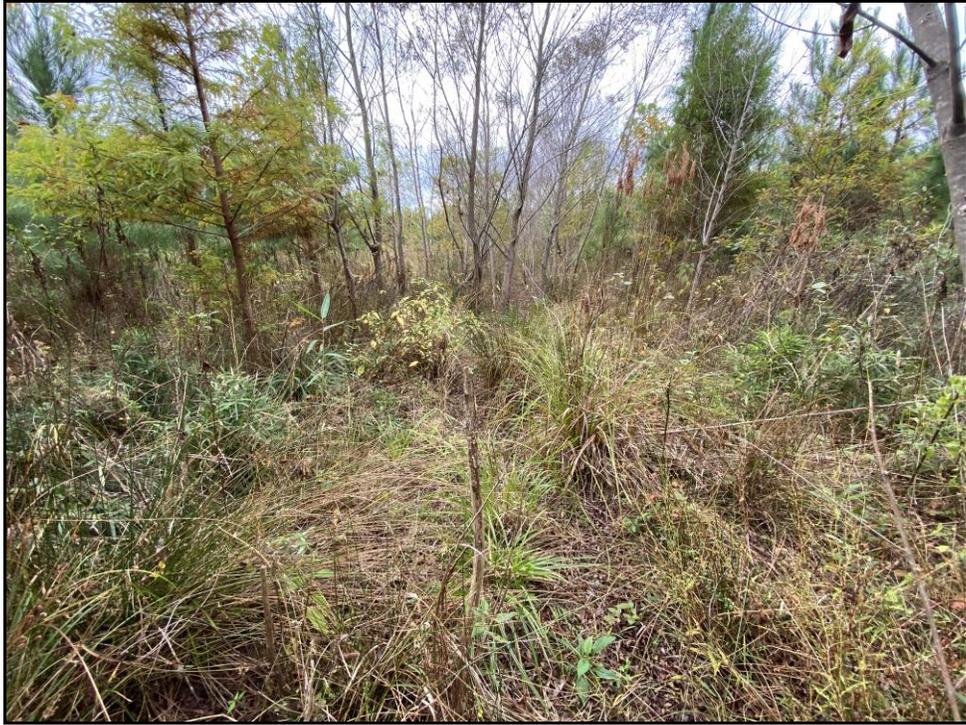
Photo 1: Highly vegetated stream area with wetland along Reach 1 - View Northwest.

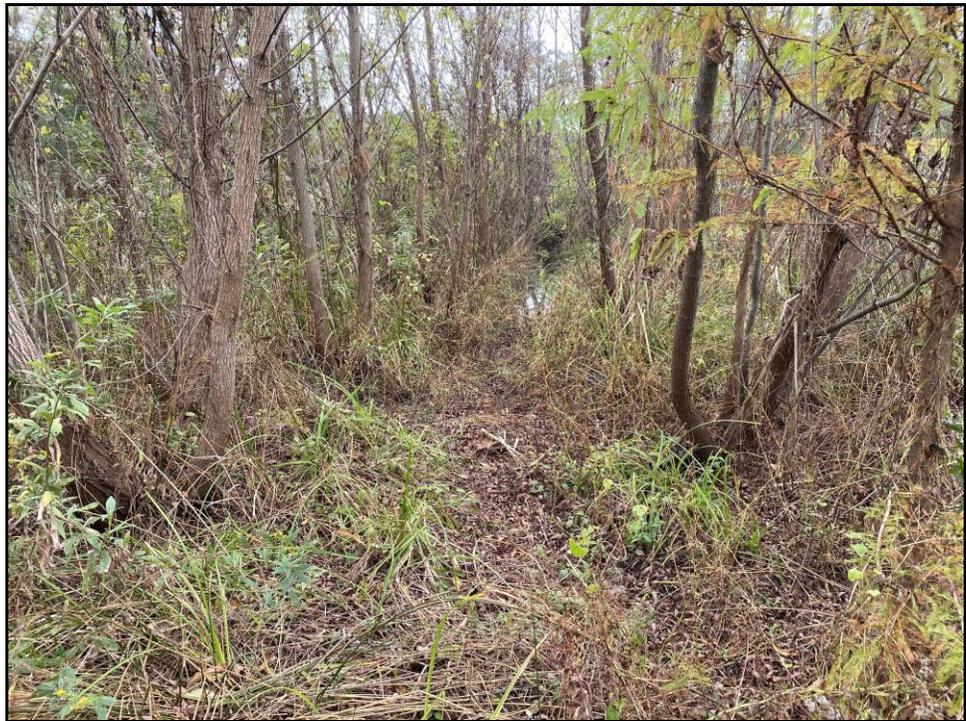
Photo 2: Near Cross Section 6 on Reach 2 – View Northwest.

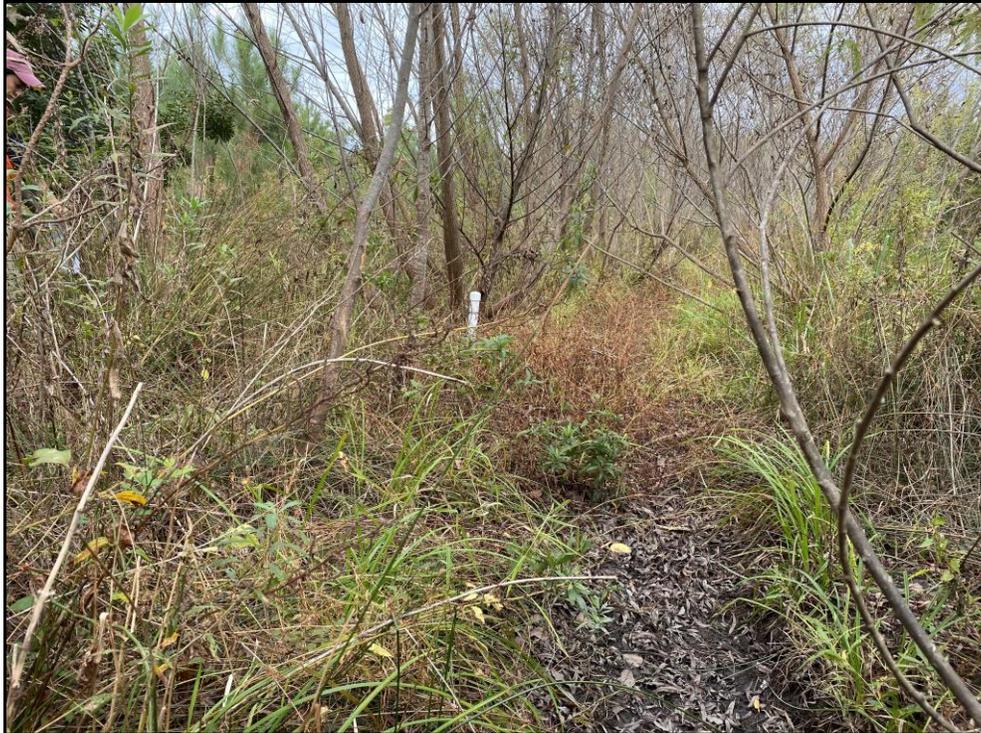
Photo 3: View of Cross Section 1 on Reach 3 – View Northeast.

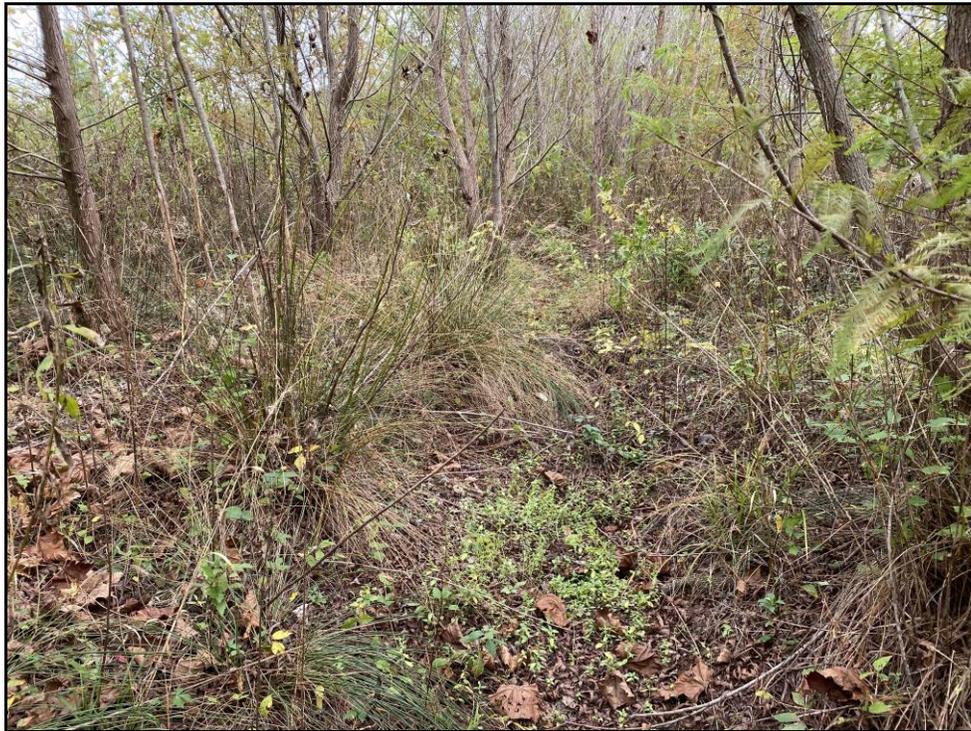
Photo 5: View near Cross Section 4 on Reach 4 –View Southeast

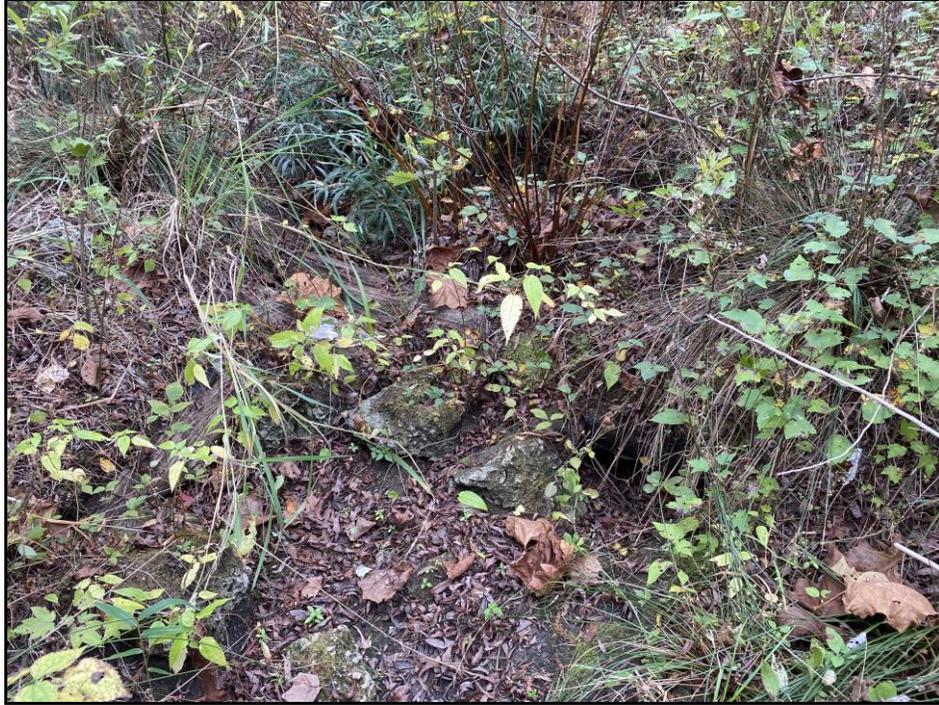
Photo 5: View near Cross Section 4 on Reach 4 –View Southeast (Piping).

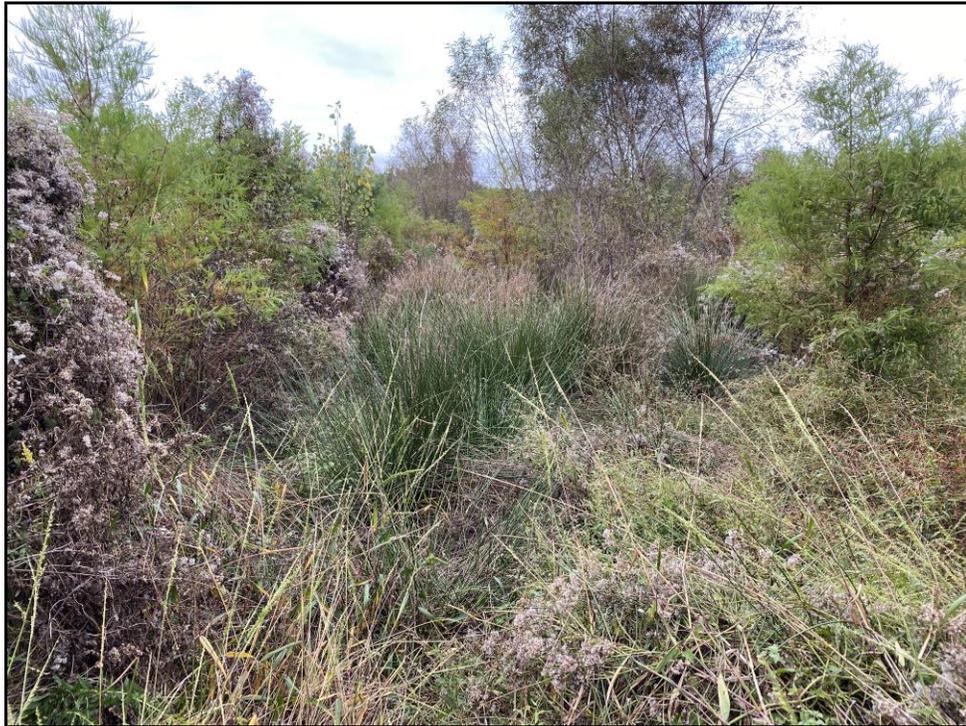
Photo 6: View downstream of Reach 5 Swamp Run.

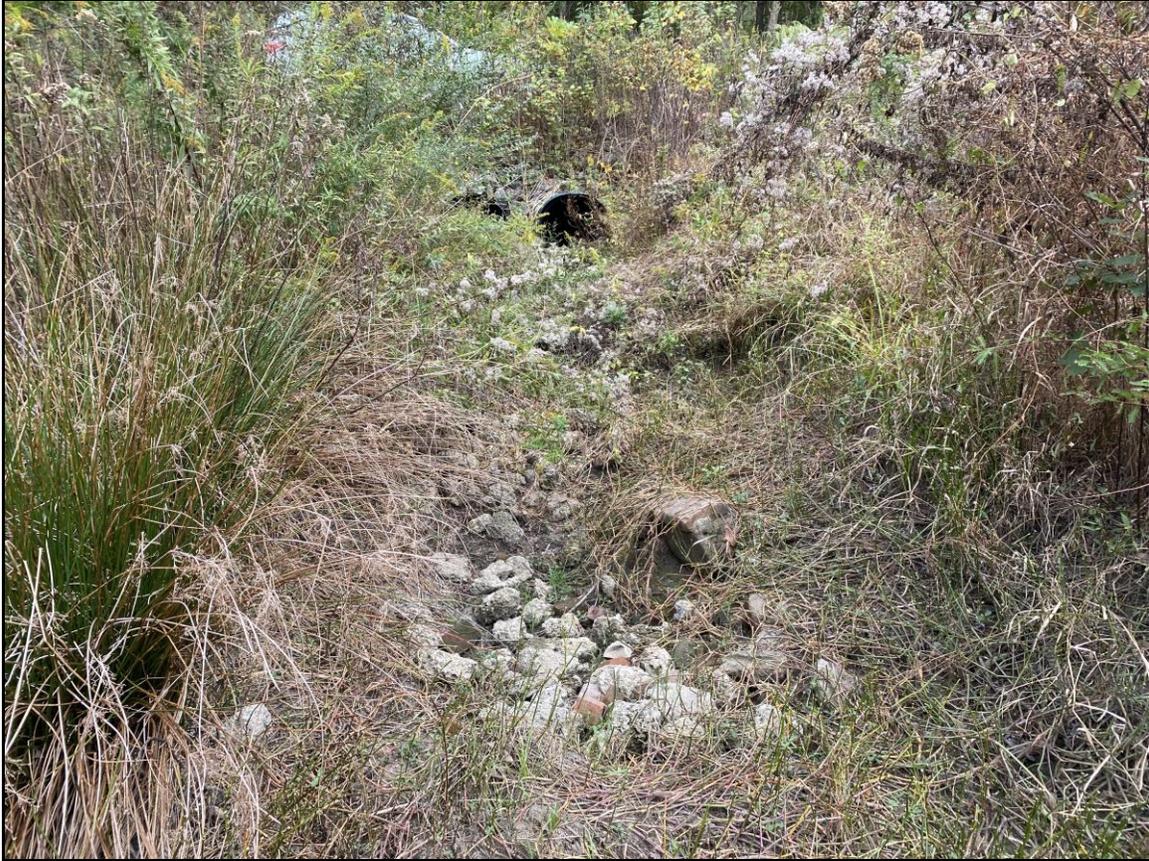
Photo 7: View upstream on Reach 5 Swamp Run.

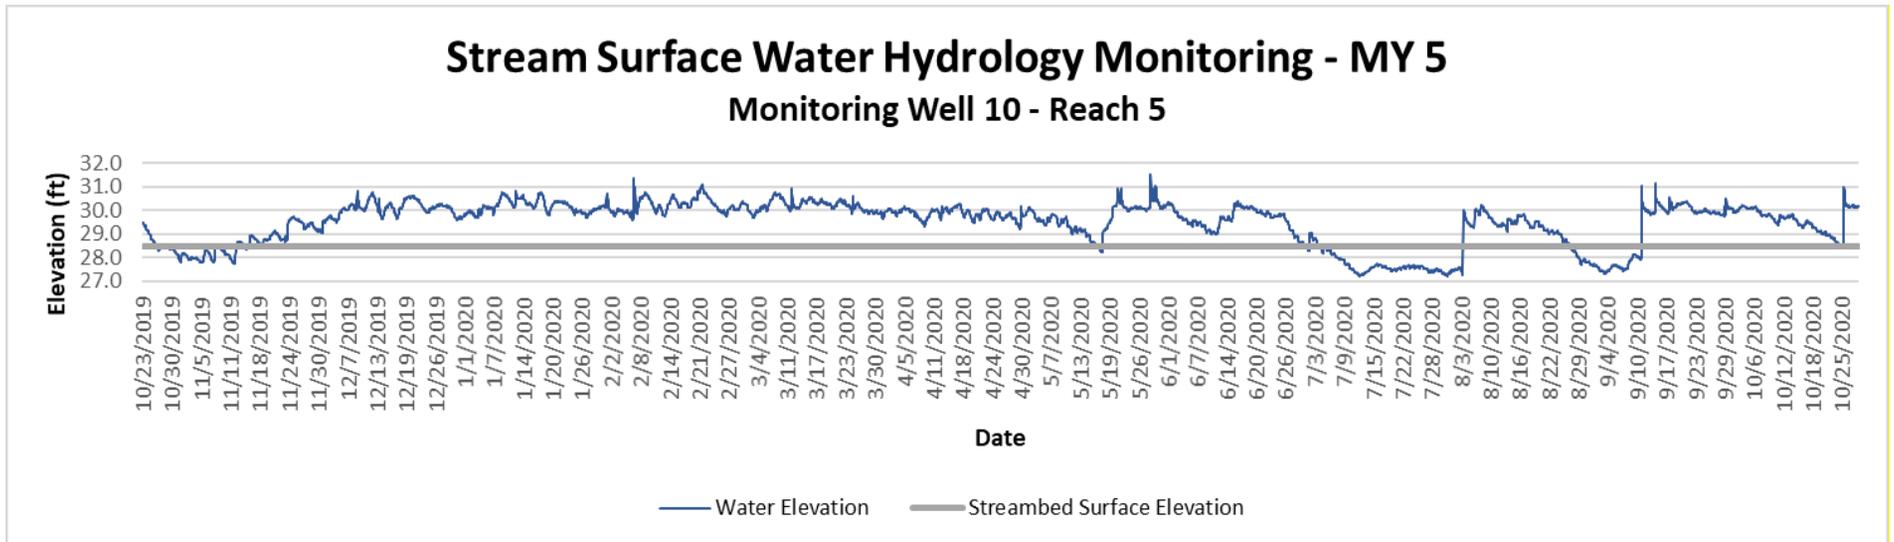
Figure 12
Monitoring Well 10 – Reach 5
Logger Malfunction; unable to download MY 6 data.
