**MONITORING YEAR 1
ANNUAL REPORT**
Final

LYON HILLS MITIGATION SITE

Wilkes County, NC
Yadkin River Basin
HUC 03040101

DMS Project No. 100085
NCDEQ Contract No. 7620
USACE Action ID No. SAW-2018-01784
DWR Project No. 2018-1274 v1
Data Collection Dates: April-November 2021

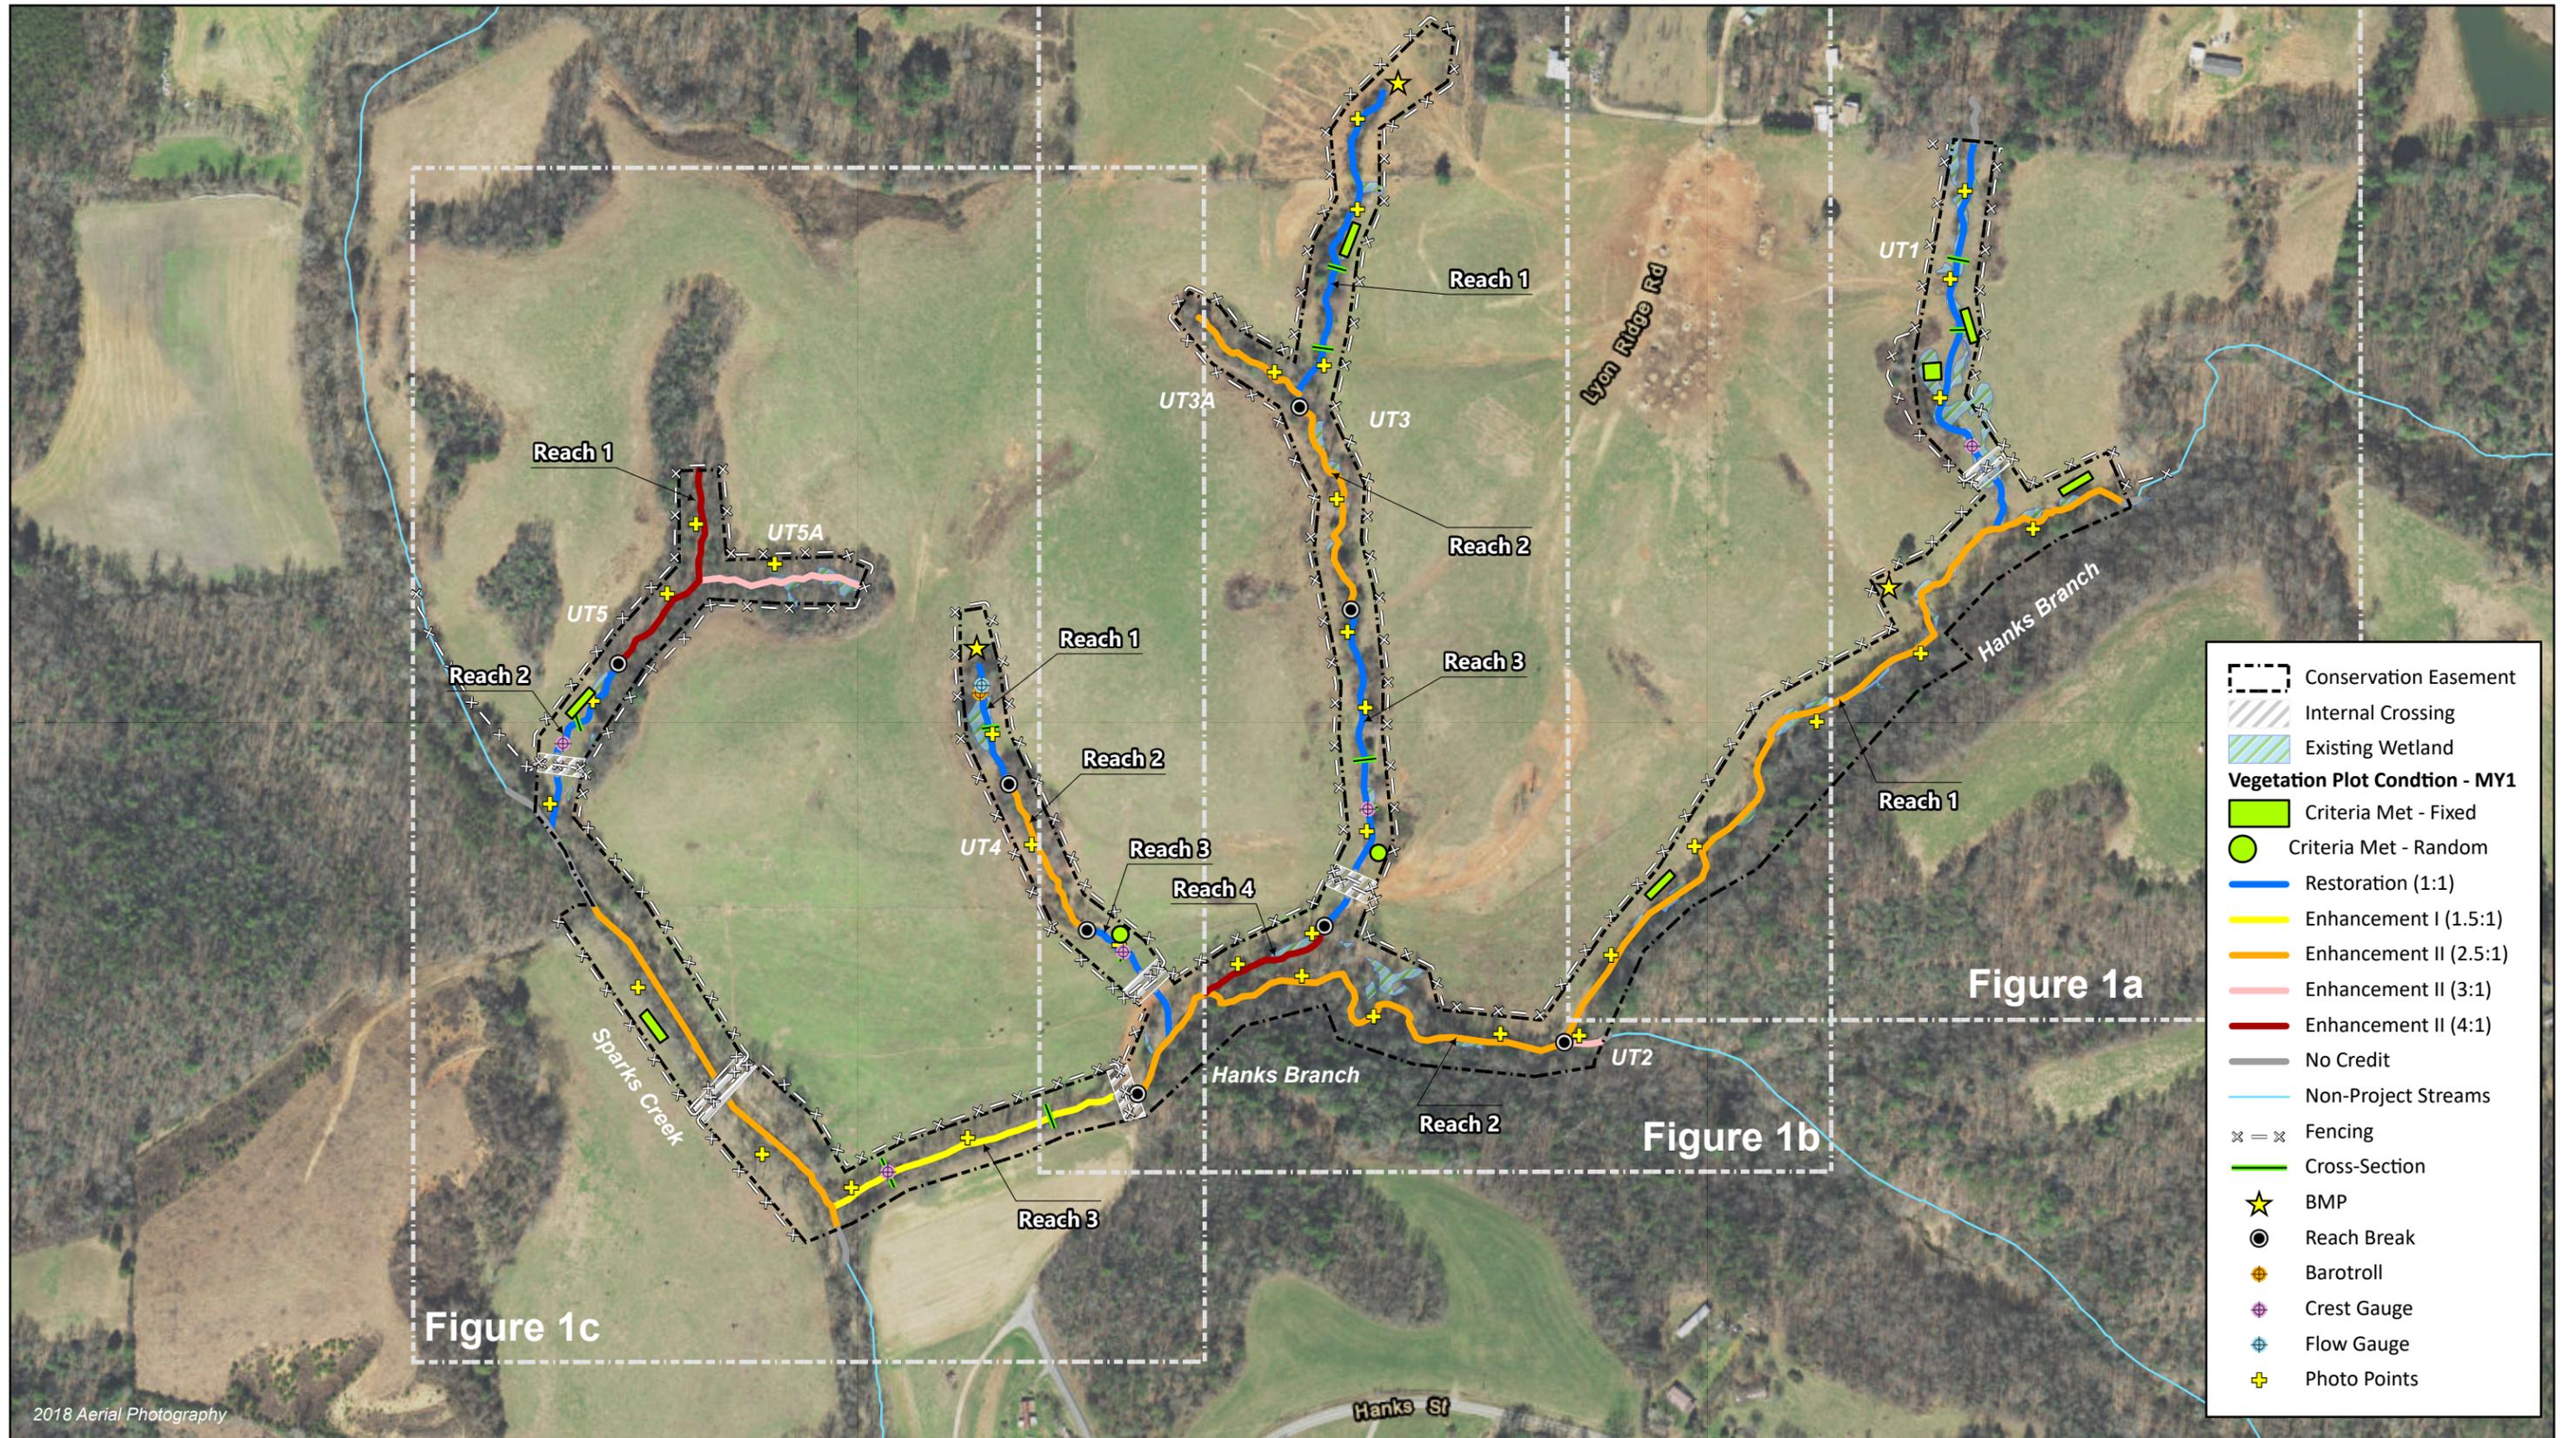
Figure 1. Current Condition Plan View Key
 Lyon Hills Mitigation Site
 DMS Project No. 100085
 Monitoring Year 1 -2021

Dense in-stream vegetation was observed along UT5 Reach 2 and sporadically found along UT4 Reach 1 and 3 (Figure 1c). Before vegetation was established on the banks, excess sediment washed into the channel from the surrounding areas after the pond was removed, causing aggradation along UT5 Reach 2. The in-stream vegetation continued to trap the sediment, preventing sediment from naturally moving through the system. Once the in-stream vegetation is treated in 2022, it is expected the sediment will flush through UT5. Dense vegetation has become established on the floodplain where the pond was removed, preventing further sediment from entering the stream. See Section 2.6 for further information on treating the in-stream vegetation.

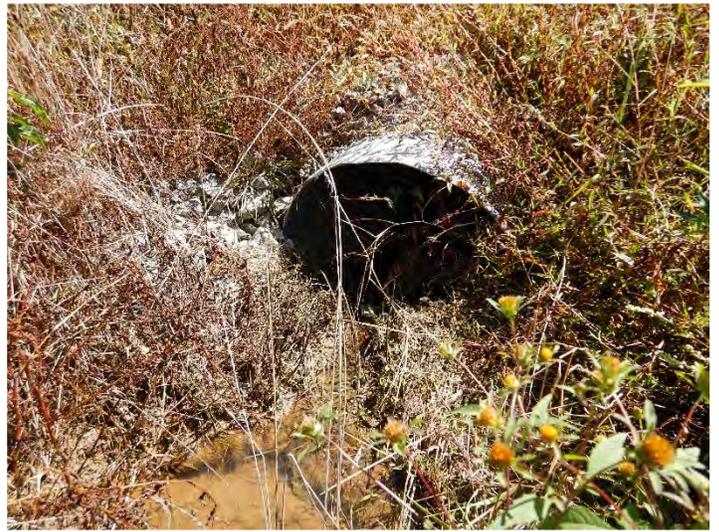
UT4 R3 - Looking Upstream (09/27/2021)
