**CEDAR CREEK STREAM AND WETLAND RESTORATION  
PROJECT  
MONITORING REPORT  
MONITORING YEAR 6  
FINAL**

SAMPSON COUNTY, NORTH CAROLINA  
CONTRACT No. 005011 - PROJECT No. 95718  
USACE ACTION ID No. 2012-00389 – NCDWR PROJECT No. 2013-0186

January 2021

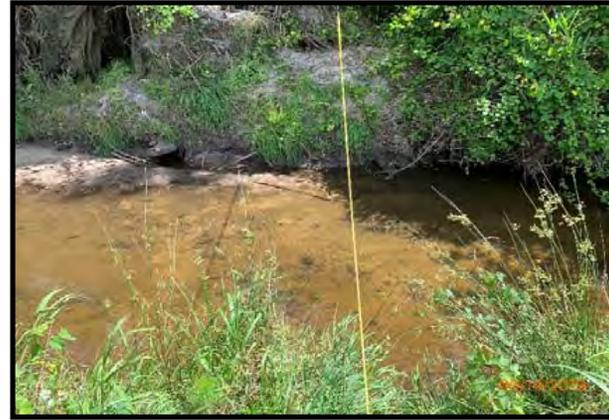
Left Bank \*Note Downed Tree
