MONITORING YEAR 6 ANNUAL/CLOSEOUT REPORT

GLADE CREEK II RESTORATION PROJECT

Alleghany County, NC
DWR No. 20090049 v.2
DMS Project Number 92343
USACE Action ID 2009-00589

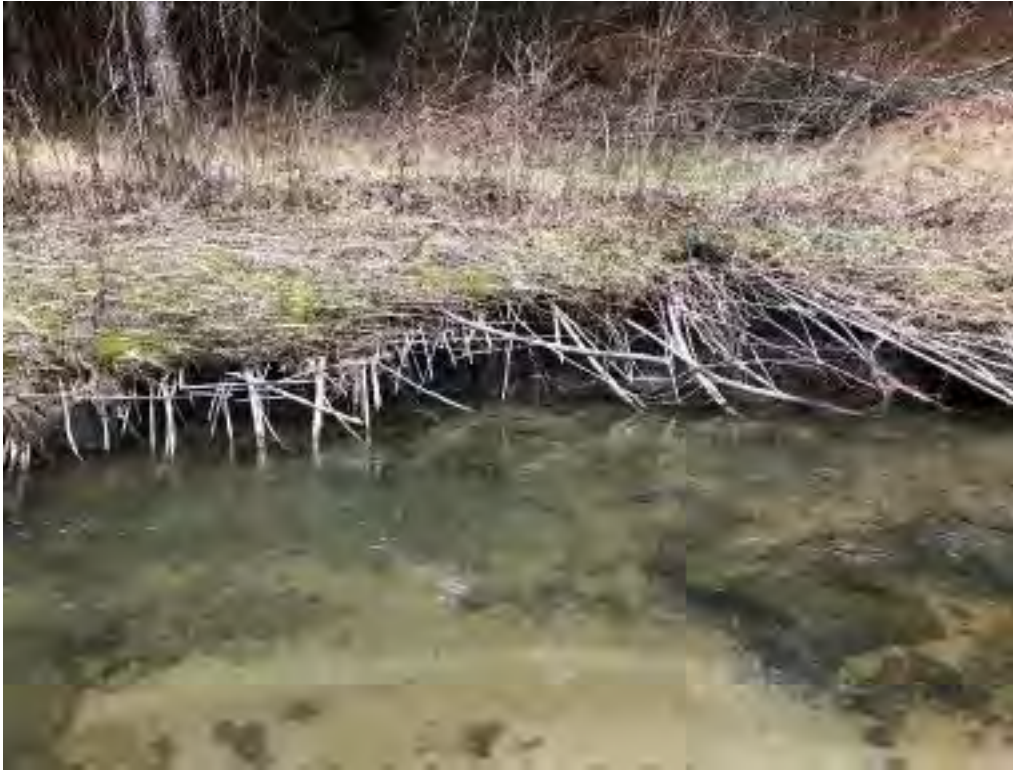
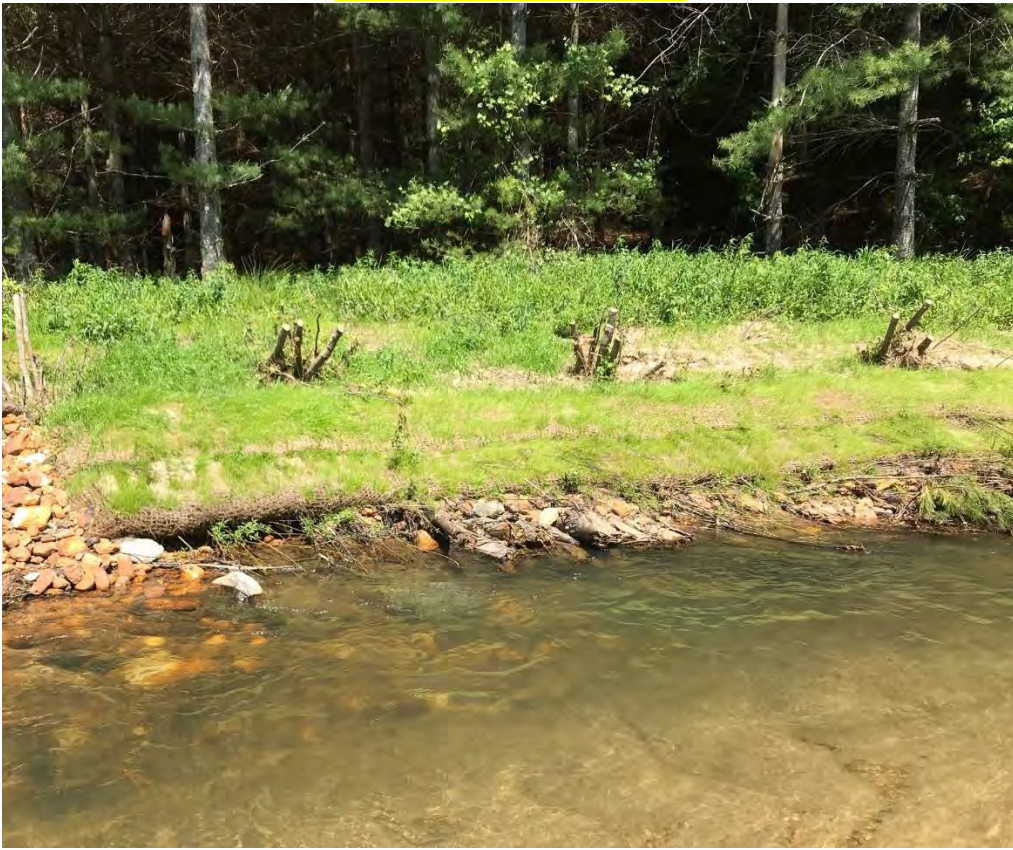
LEFT BANK UNDERCUT BRUSH MATTRESS (STA 22+25)

Pre-construction - November 2019

Post construction - June 2020

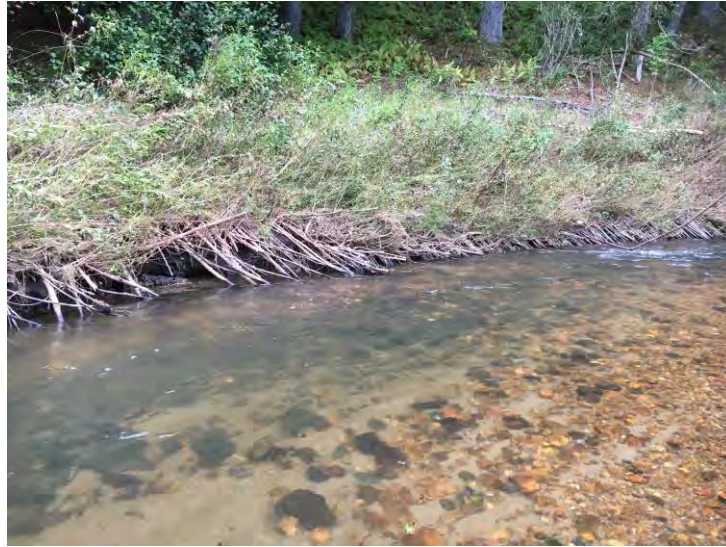
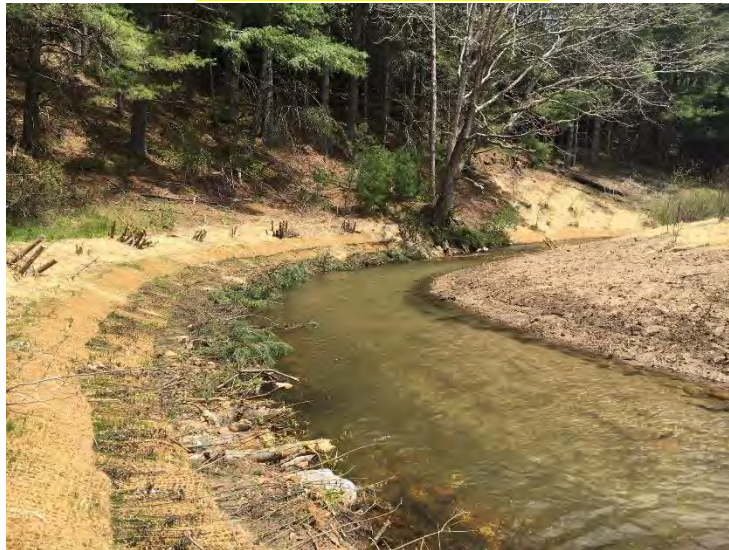
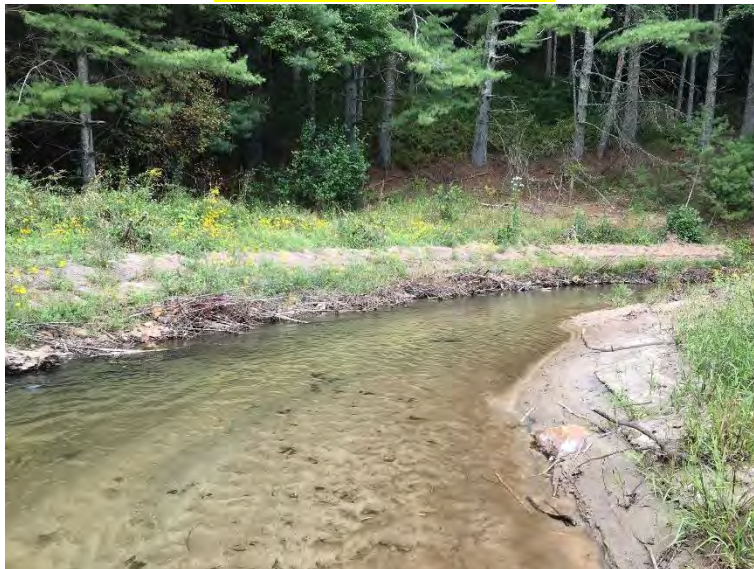
OUTER BEND EROSION AREA (STA 22+25 to STA 23+25)

Pre-construction - November 2019

Post construction - April 2020

Post construction - Sep 2020

DMS contracted with a provider to completed repairs along Glade Creek in April 2020. These repairs included installing a brush toe geolift and point bar regrading between stations 22+95 and 23+50, and stabilization of the hillslope between stations 24+25 and 24+75. Visual assessments in MY6 revealed that repairs appear to be stable and functioning as designed with livestakes and transplants becoming well established. ***A memo with as-built repair plans can be found in Appendix 6.*** Other small areas of scour that were not addressed by the repair remain along Glade Creek. However, woody vegetation is present along the banks in these areas causing them to be of relatively minor concern to the ecological integrity of the project. DMS also contracted with a provider to remove a beaver dam located on Glade Creek (near station 18+70) in October 2021.

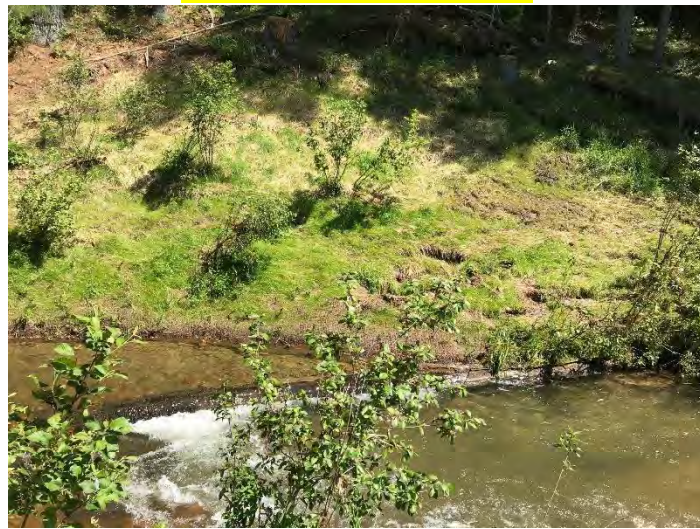
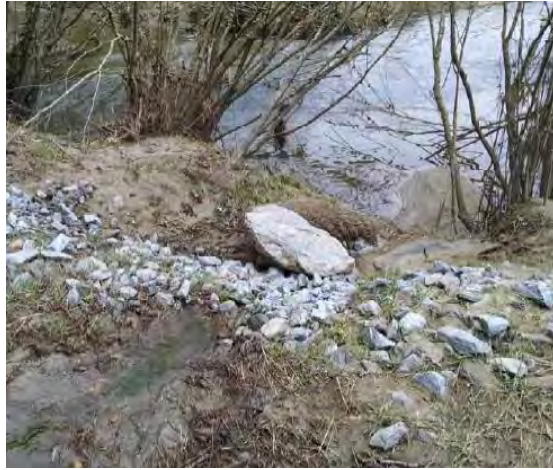
Wetland B Outlet Repair (STA 22+00)

Pre-construction - November 2019

Post construction - June 2020

In April 2020, DMS contracted with a provider to repair a headcut that had formed at the outflow of Wetland B where it meets Glade Creek Reach 2 (near station 22+75). The repairs included the installation of log sills for grade control at the wetland outflow. MY6 visual assessments reveal that the repair appears stable and has prevented the headcut from migrating into the wetland. As discussed in section 1.2.2, Wetland B had previously been noted to have poor woody stem growth and therefore supplemental planting occurred in April 2020 with appropriate wetland tree and shrub species.
