As-Built Baseline Monitoring Report FINAL Whittier Creek Mitigation Project

Surry County, North Carolina DMS Project ID No. 100020 DEQ Contract No. 7182 DWR# 17-1044 Yadkin River Basin: 03040101-110040 DMS RFP #16-006993 (Issued: 9/16/16) USACE Action ID No. SAW-2017-01503

Baseline Data Collection Period: Survey August 2021, Vegetation January 2022

Submission Date: April 2022

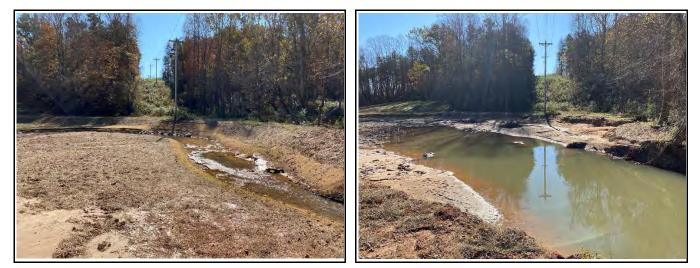
Upper R7 Before Storm (10/14/20)

Upper R7 After Storm (11/4/20)

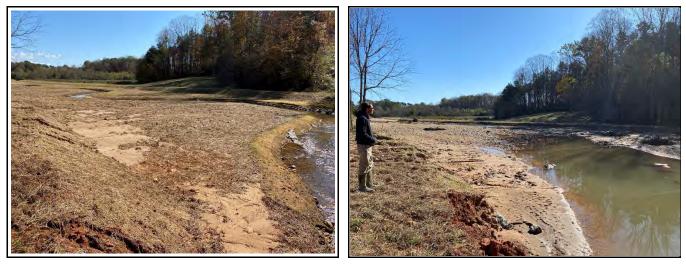
Upper R7 Before Storm (10/14/20)

Upper R7 After Storm (11/4/20)

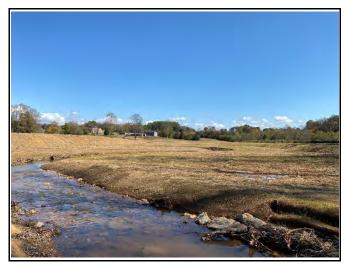
Middle R7 Before Storm (10/14/20)

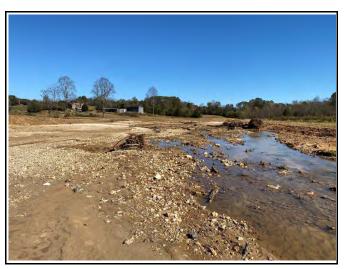
Middle R7 After Storm (11/4/20)
