MONITORING YEAR 0 ANNUAL REPORT FINAL

DYNAMITE CREEK MITIGATION SITE

Rockingham County, NC
Roanoke River Basin
HUC 03010103

DYNAMITE CREEK MITIGATION SITE
Monitoring Year 0 Annual Report

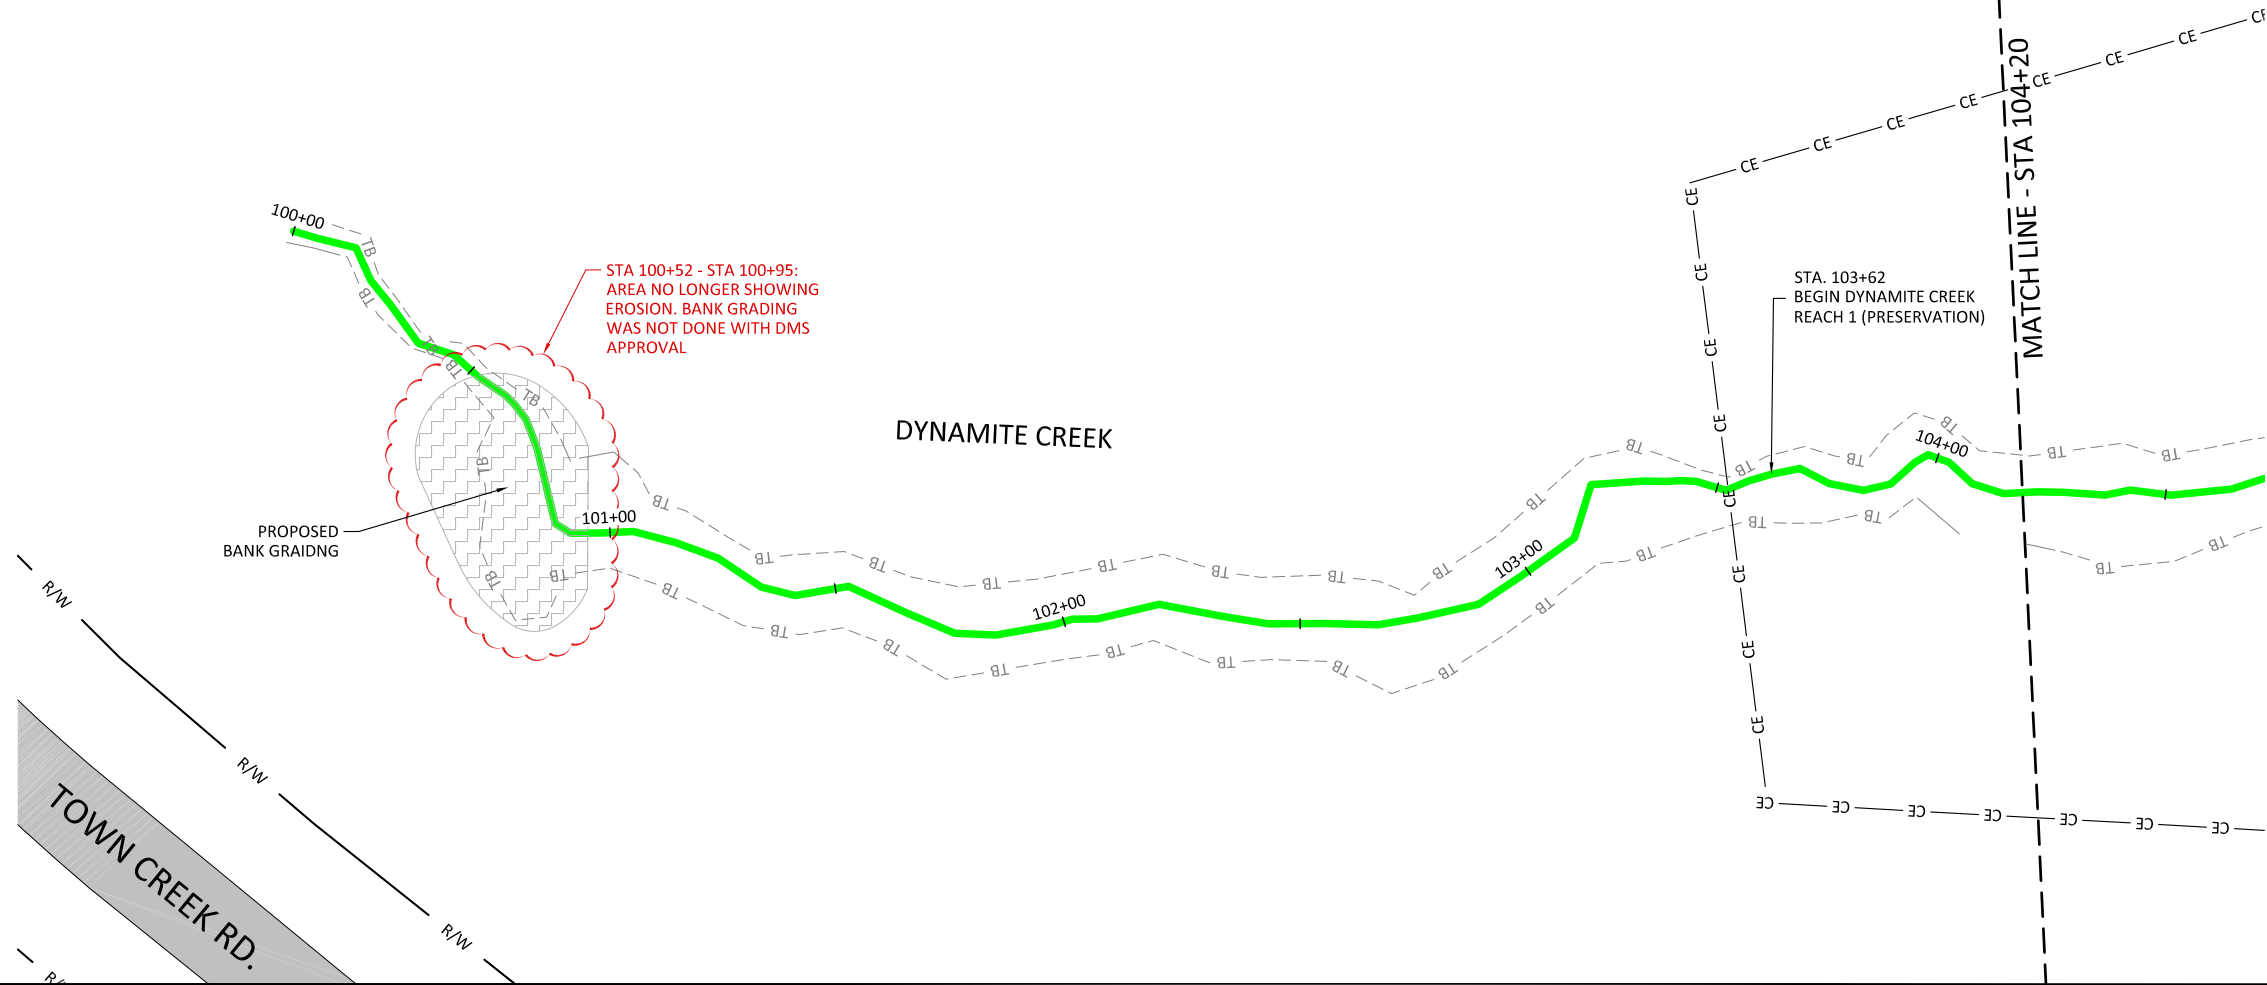
STA 100+52 - STA 100+95:
AREA NO LONGER SHOWING
EROSION. BANK GRADING
WAS NOT DONE WITH DMS
APPROVAL

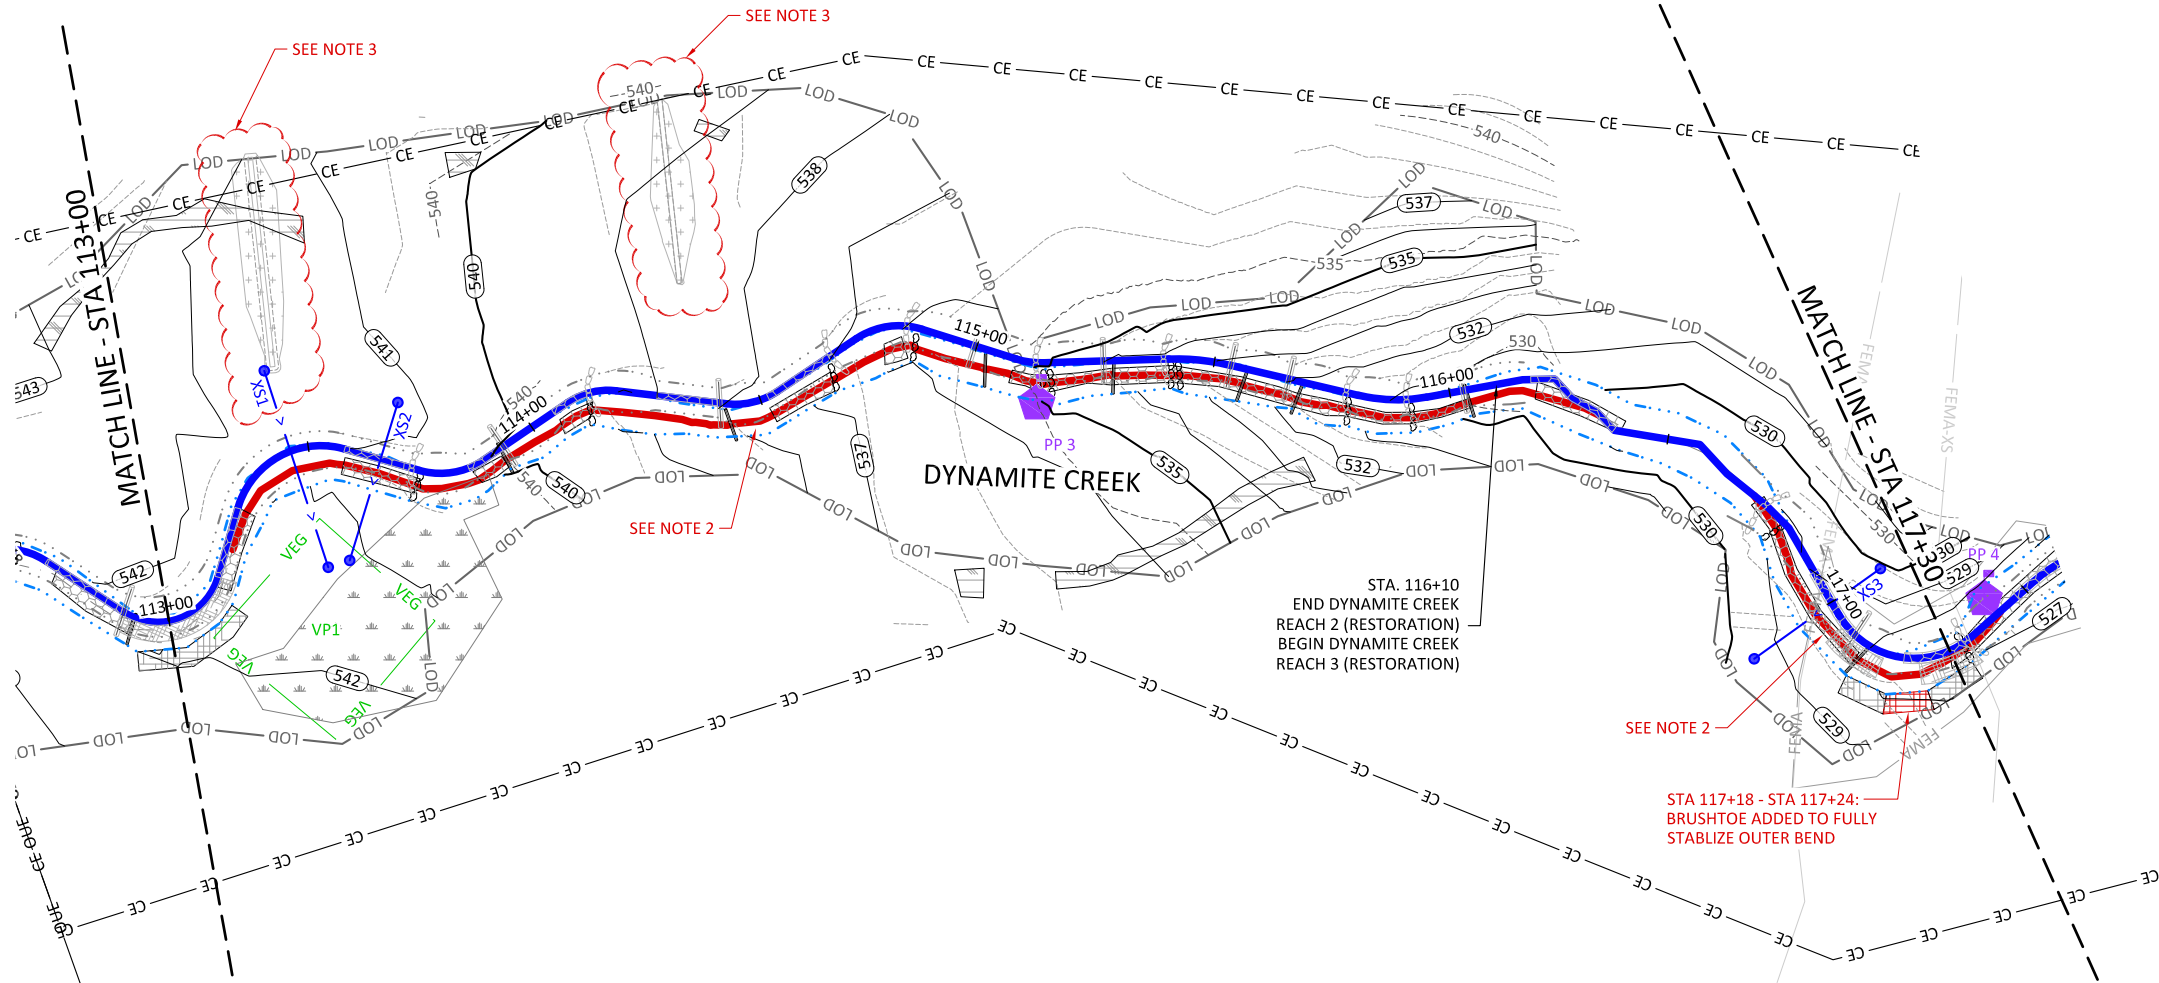
- NOTES:**
1. DEVIATIONS FROM THE DESIGN WILL BE SHOWN IN RED.
 2. STA 113+20 - STA 116+35 (308 LF) & STA 116+72 - STA 117+43 (76.5 LF): DYNAMITE CREEK ALIGNMENT CHANGED DUE TO GPS ERROR BECAUSE OF DENSE TREE CANOPY.
 3. STA 113+49 & STA 114+26: VALLEY SILLS INSTALLED BUT NOT LOCATED.

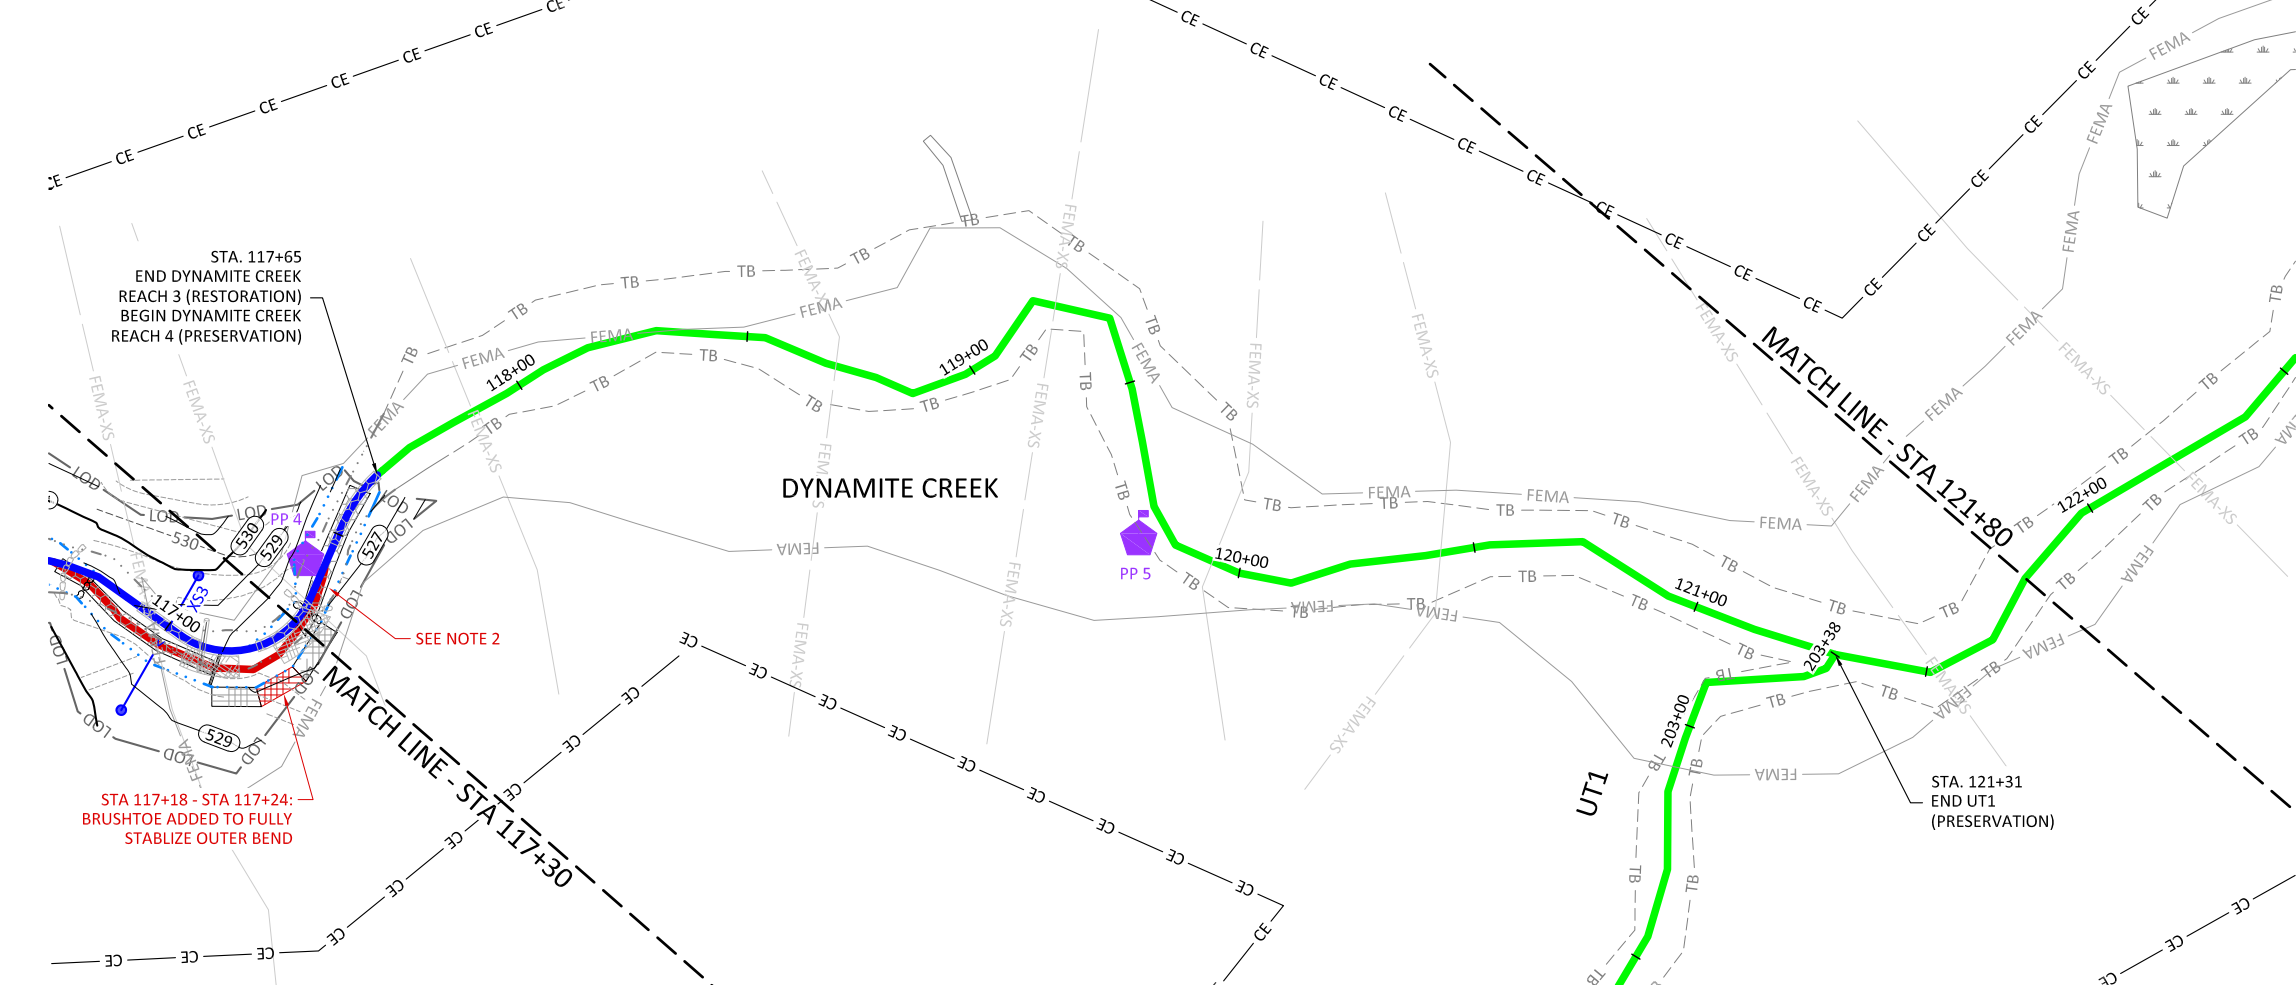
- NOTES:**
- DEVIATIONS FROM THE DESIGN WILL BE SHOWN IN RED.
 - STA 116+72 - STA 117+43 (76.5 LF): DYNAMITE CREEK ALIGNMENT CHANGED DUE TO GPS ERROR BECAUSE OF DENSE TREE CANOPY.

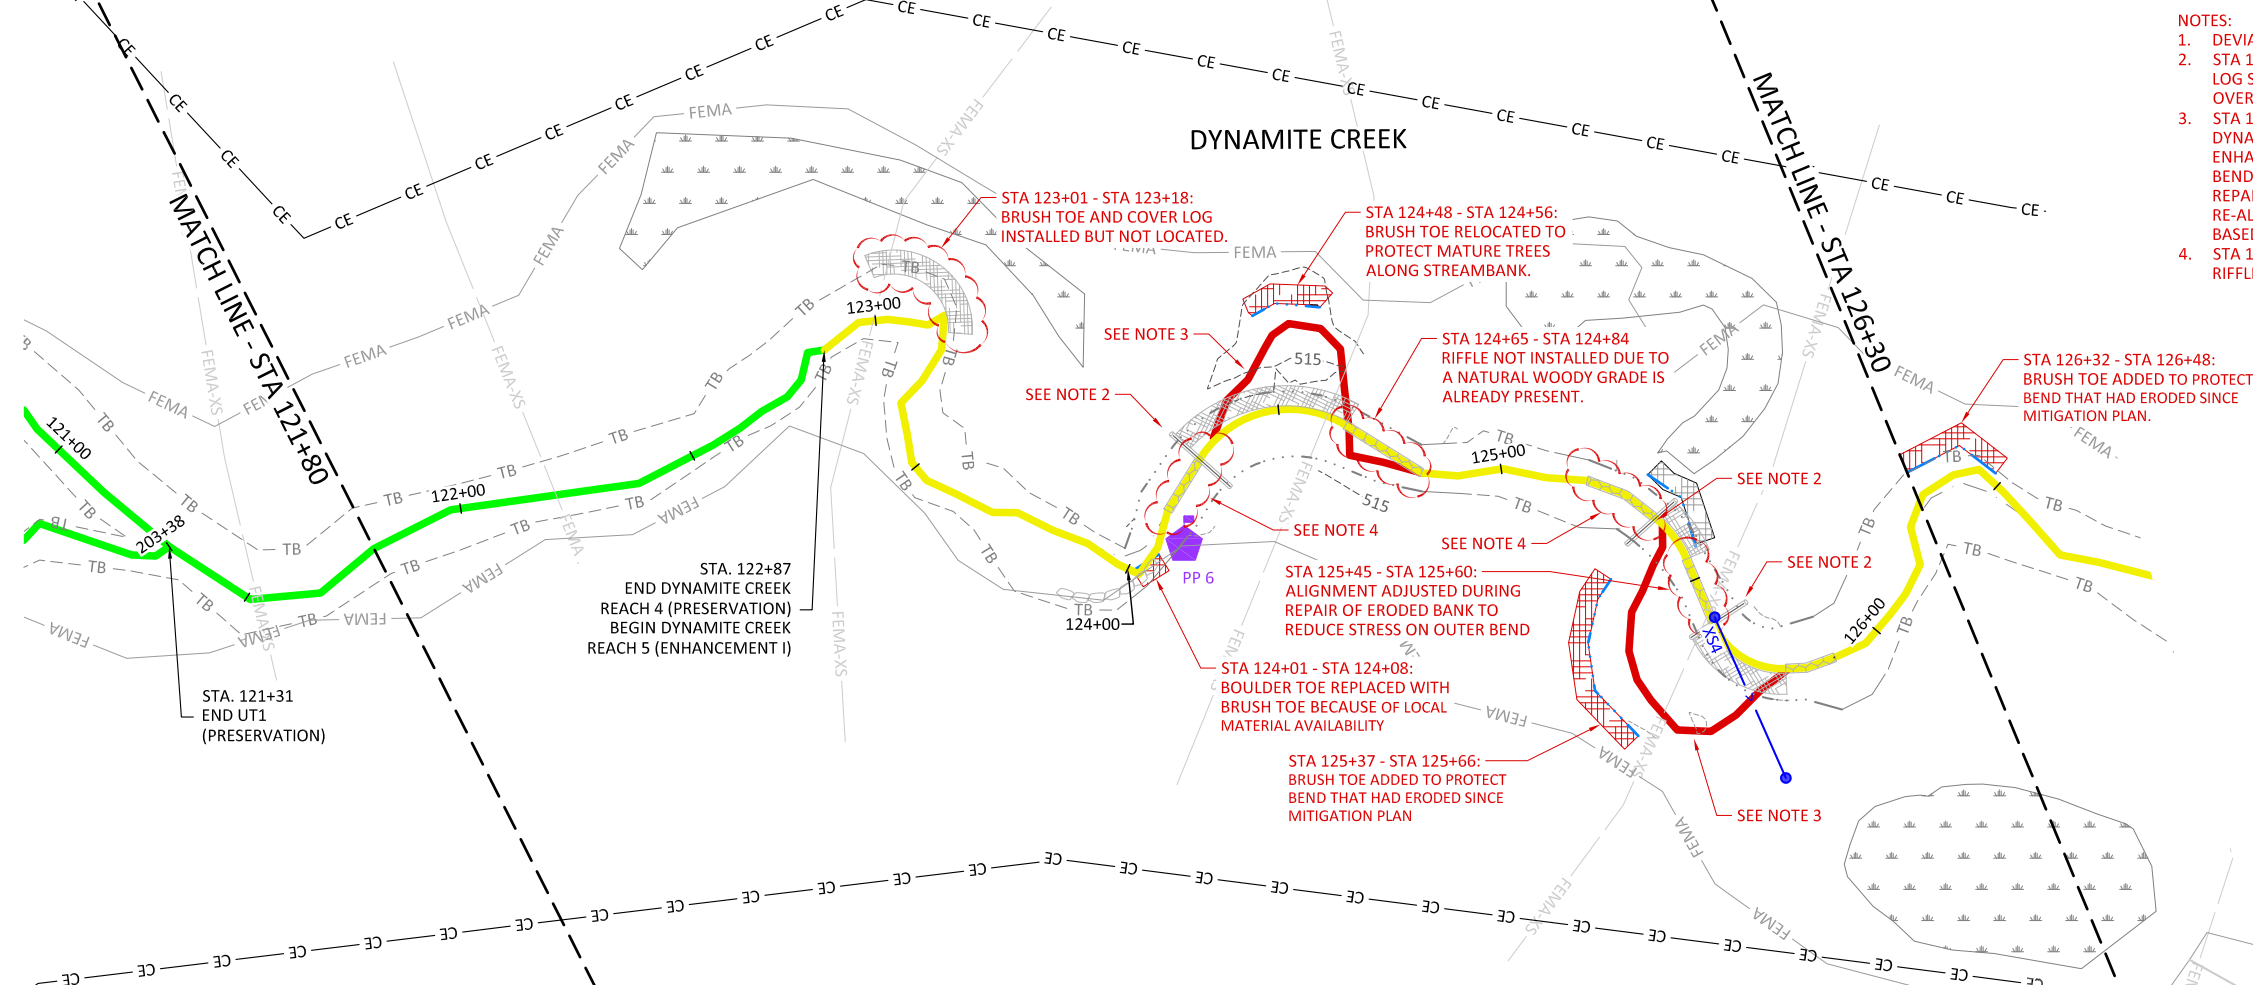
- NOTES:**
1. DEVIATIONS FROM THE DESIGN WILL BE SHOWN IN RED.
 2. STA 124+29, STA 125+35 & STA 125+59:
LOG SILLS NOT INSTALLED TO SAVE EXISTING TREES AND REDUCE OVERALL IMPACT.
 3. STA 124+35 - STA 124+83 (80 LF) & STA 125+36 - STA 125+80 (75.5 LF)
DYNAMITE CREEK REACH 5 WAS DESIGNED TO BE A LIGHT TOUCH ENHANCEMENT APPROACH WITH THE FOCUS ON REPAIRING MEANDER BENDS. TWO AREAS WERE PROPOSED FOR RE-ALIGNMENT IN ORDER TO REPAIR BENDS. THE BENDS WERE ABLE TO BE REPAIRED WITHOUT RE-ALIGNING THE ADJACENT RIFFLES. STREAM CREDITS ARE PRESENTED BASED ON THE ORIGINAL DESIGN ALIGNMENT IN THE MITIGATION PLAN.
 4. STA 124+17 - STA 124+30 & 125+18 - STA 125+34:
RIFFLES NOT INSTALLED BECAUSE CHANNEL NOT REALIGNED.

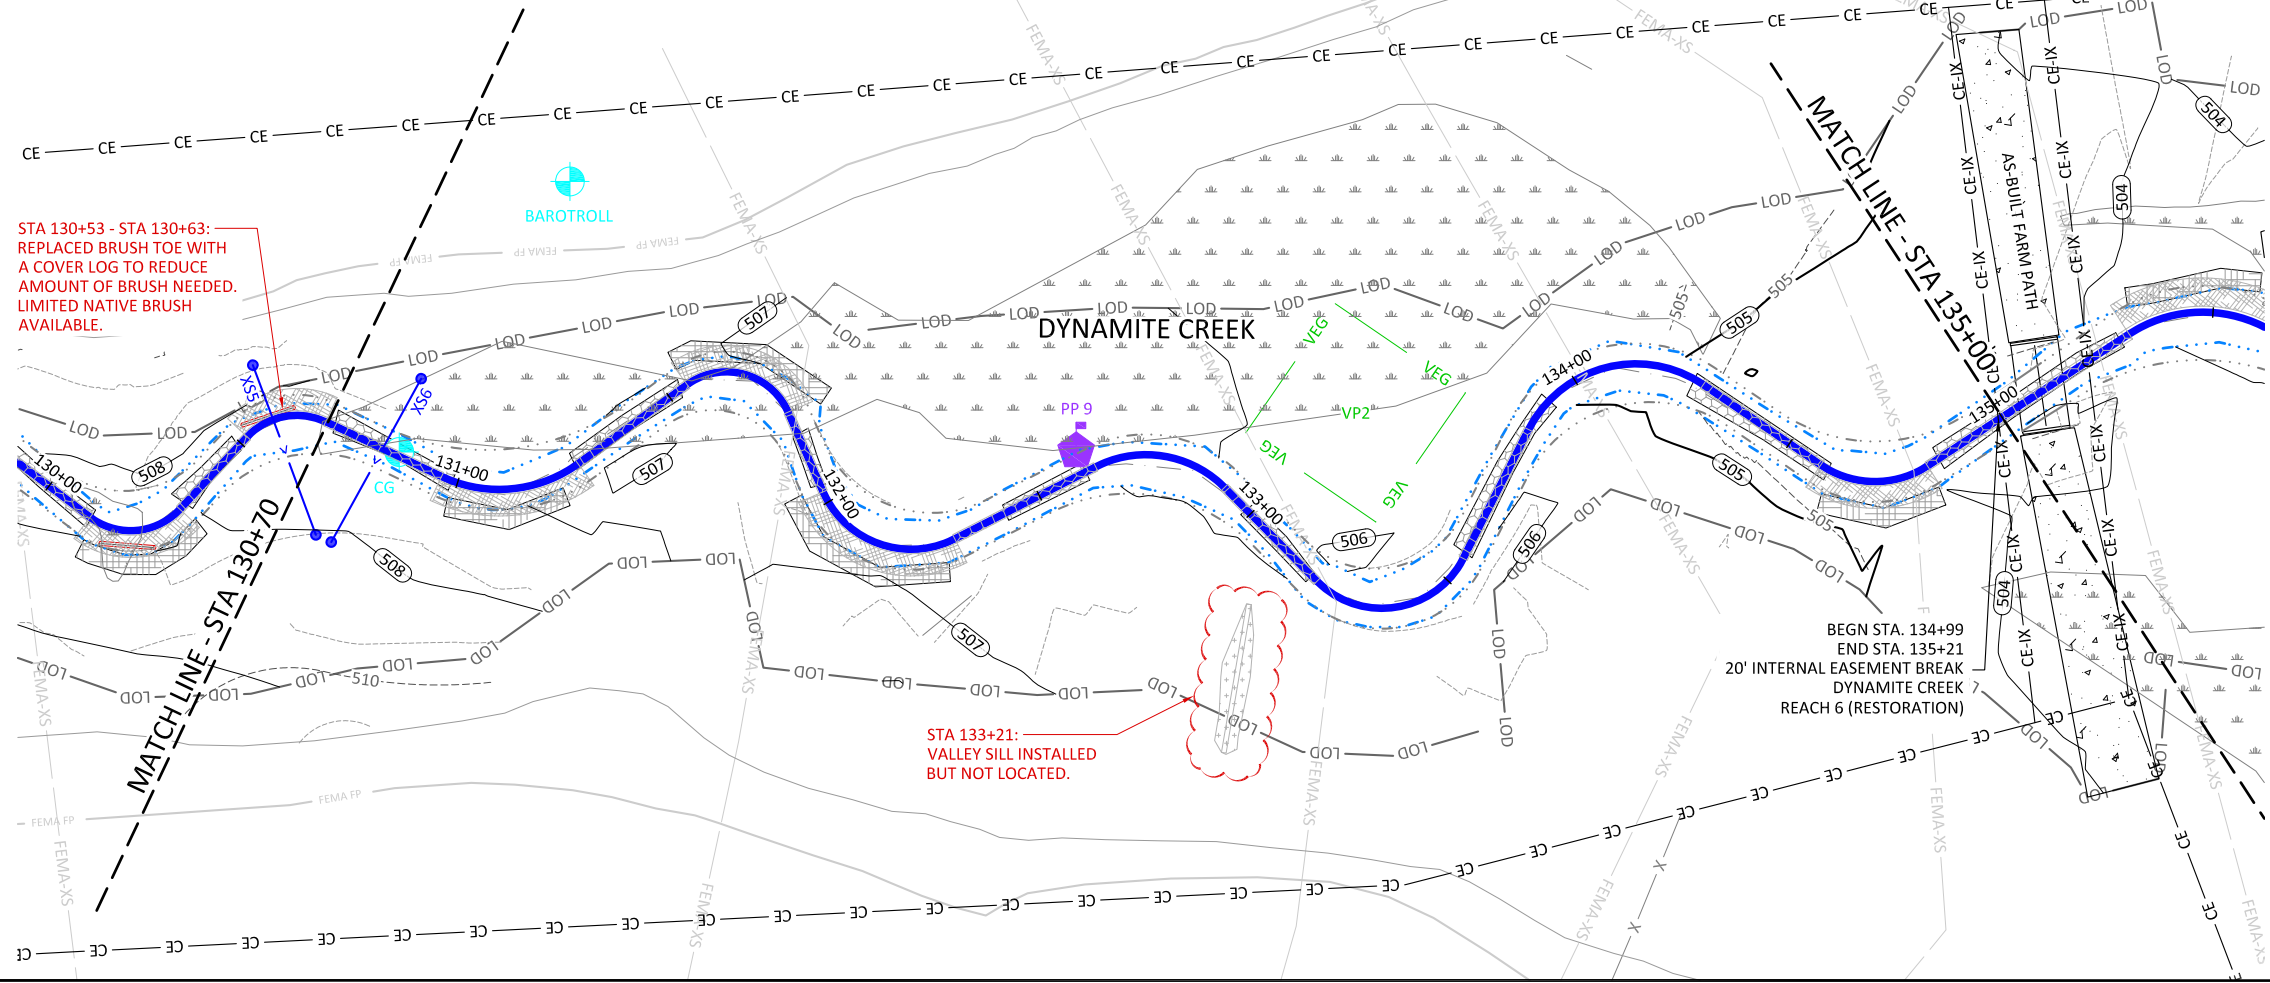
1.8

STA 130+53 - STA 130+63:
REPLACED BRUSH TOE WITH
A COVER LOG TO REDUCE
AMOUNT OF BRUSH NEEDED.
LIMITED NATIVE BRUSH
AVAILABLE.

STA 133+21:
VALLEY SILL INSTALLED
BUT NOT LOCATED.

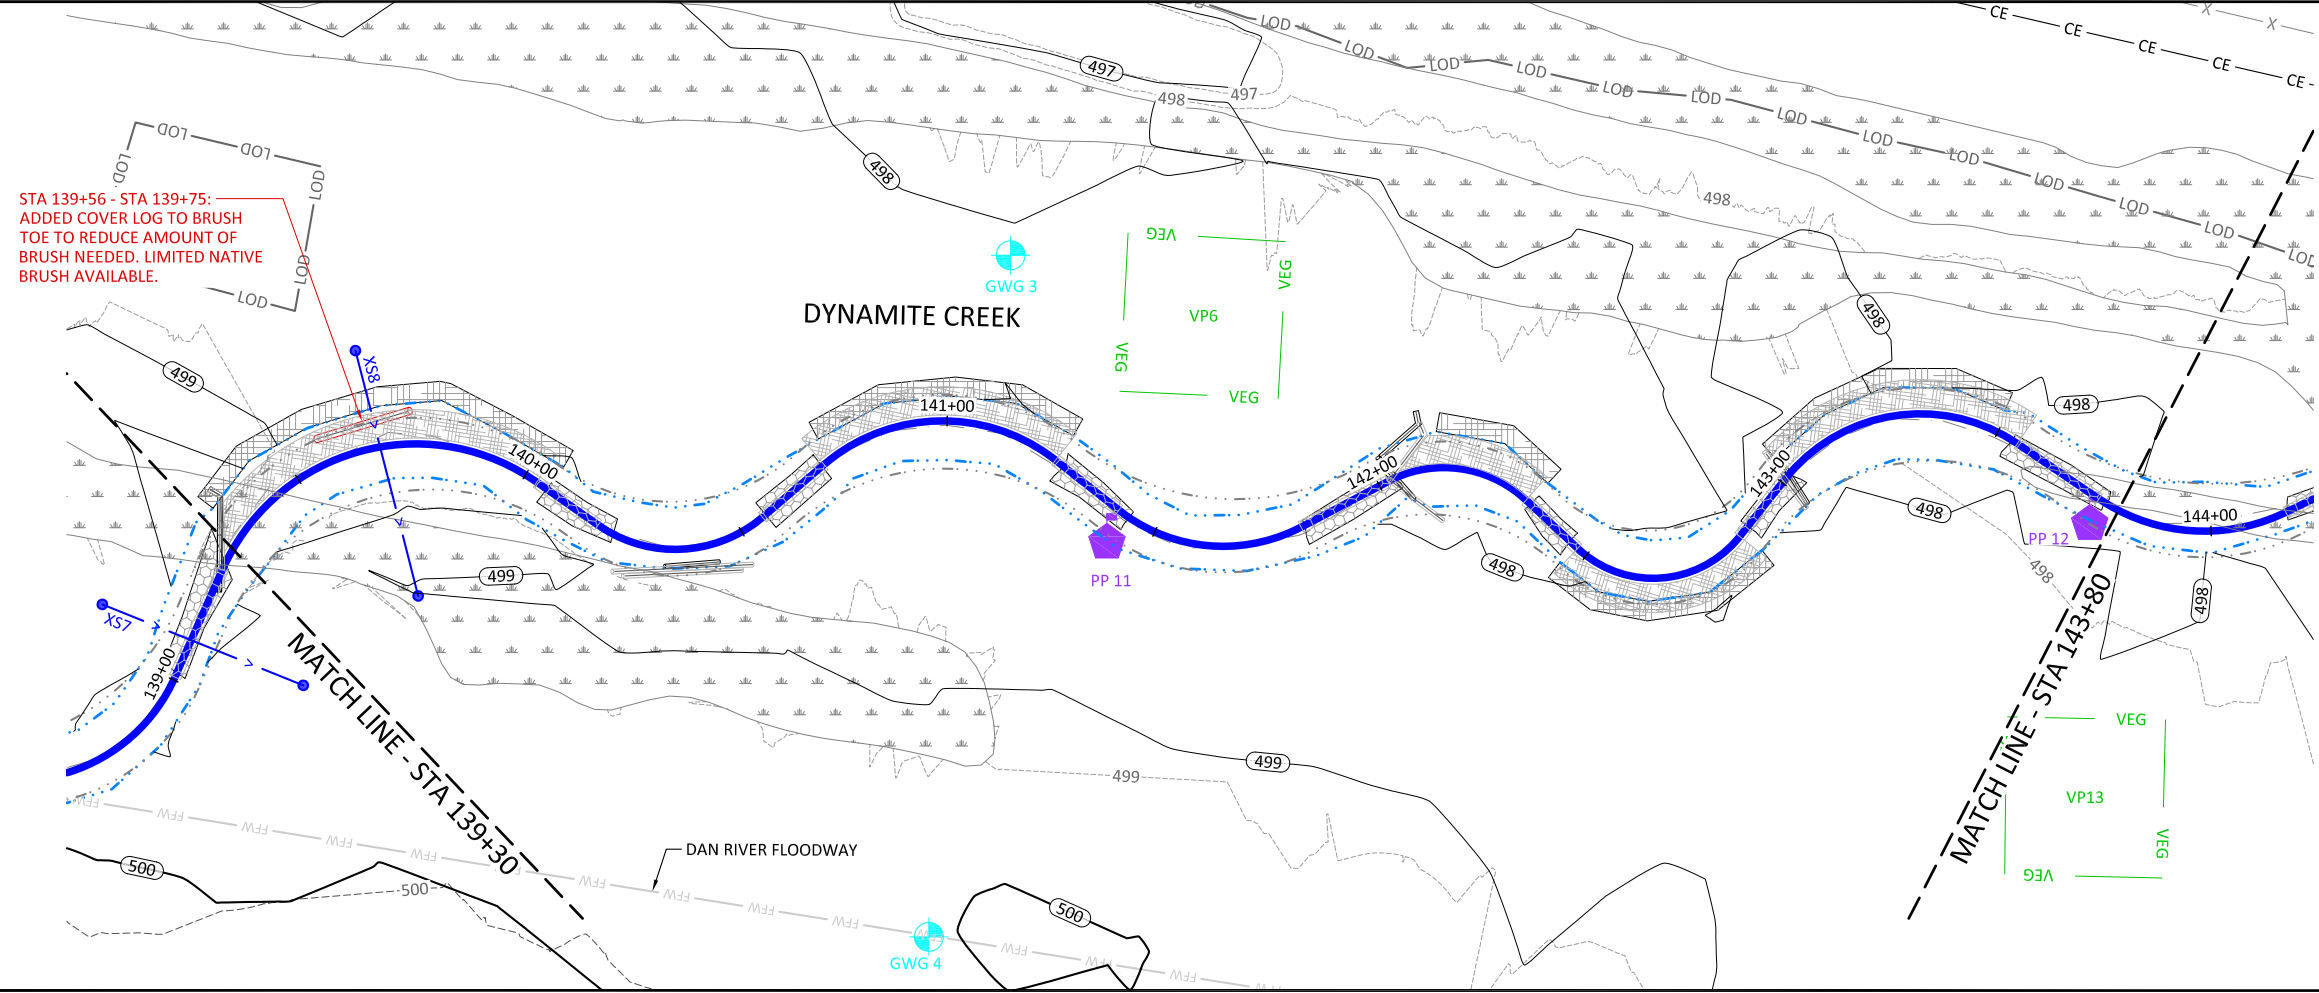
STA 139+56 - STA 139+75:
ADDED COVER LOG TO BRUSH
TOE TO REDUCE AMOUNT OF
BRUSH NEEDED. LIMITED NATIVE
BRUSH AVAILABLE.

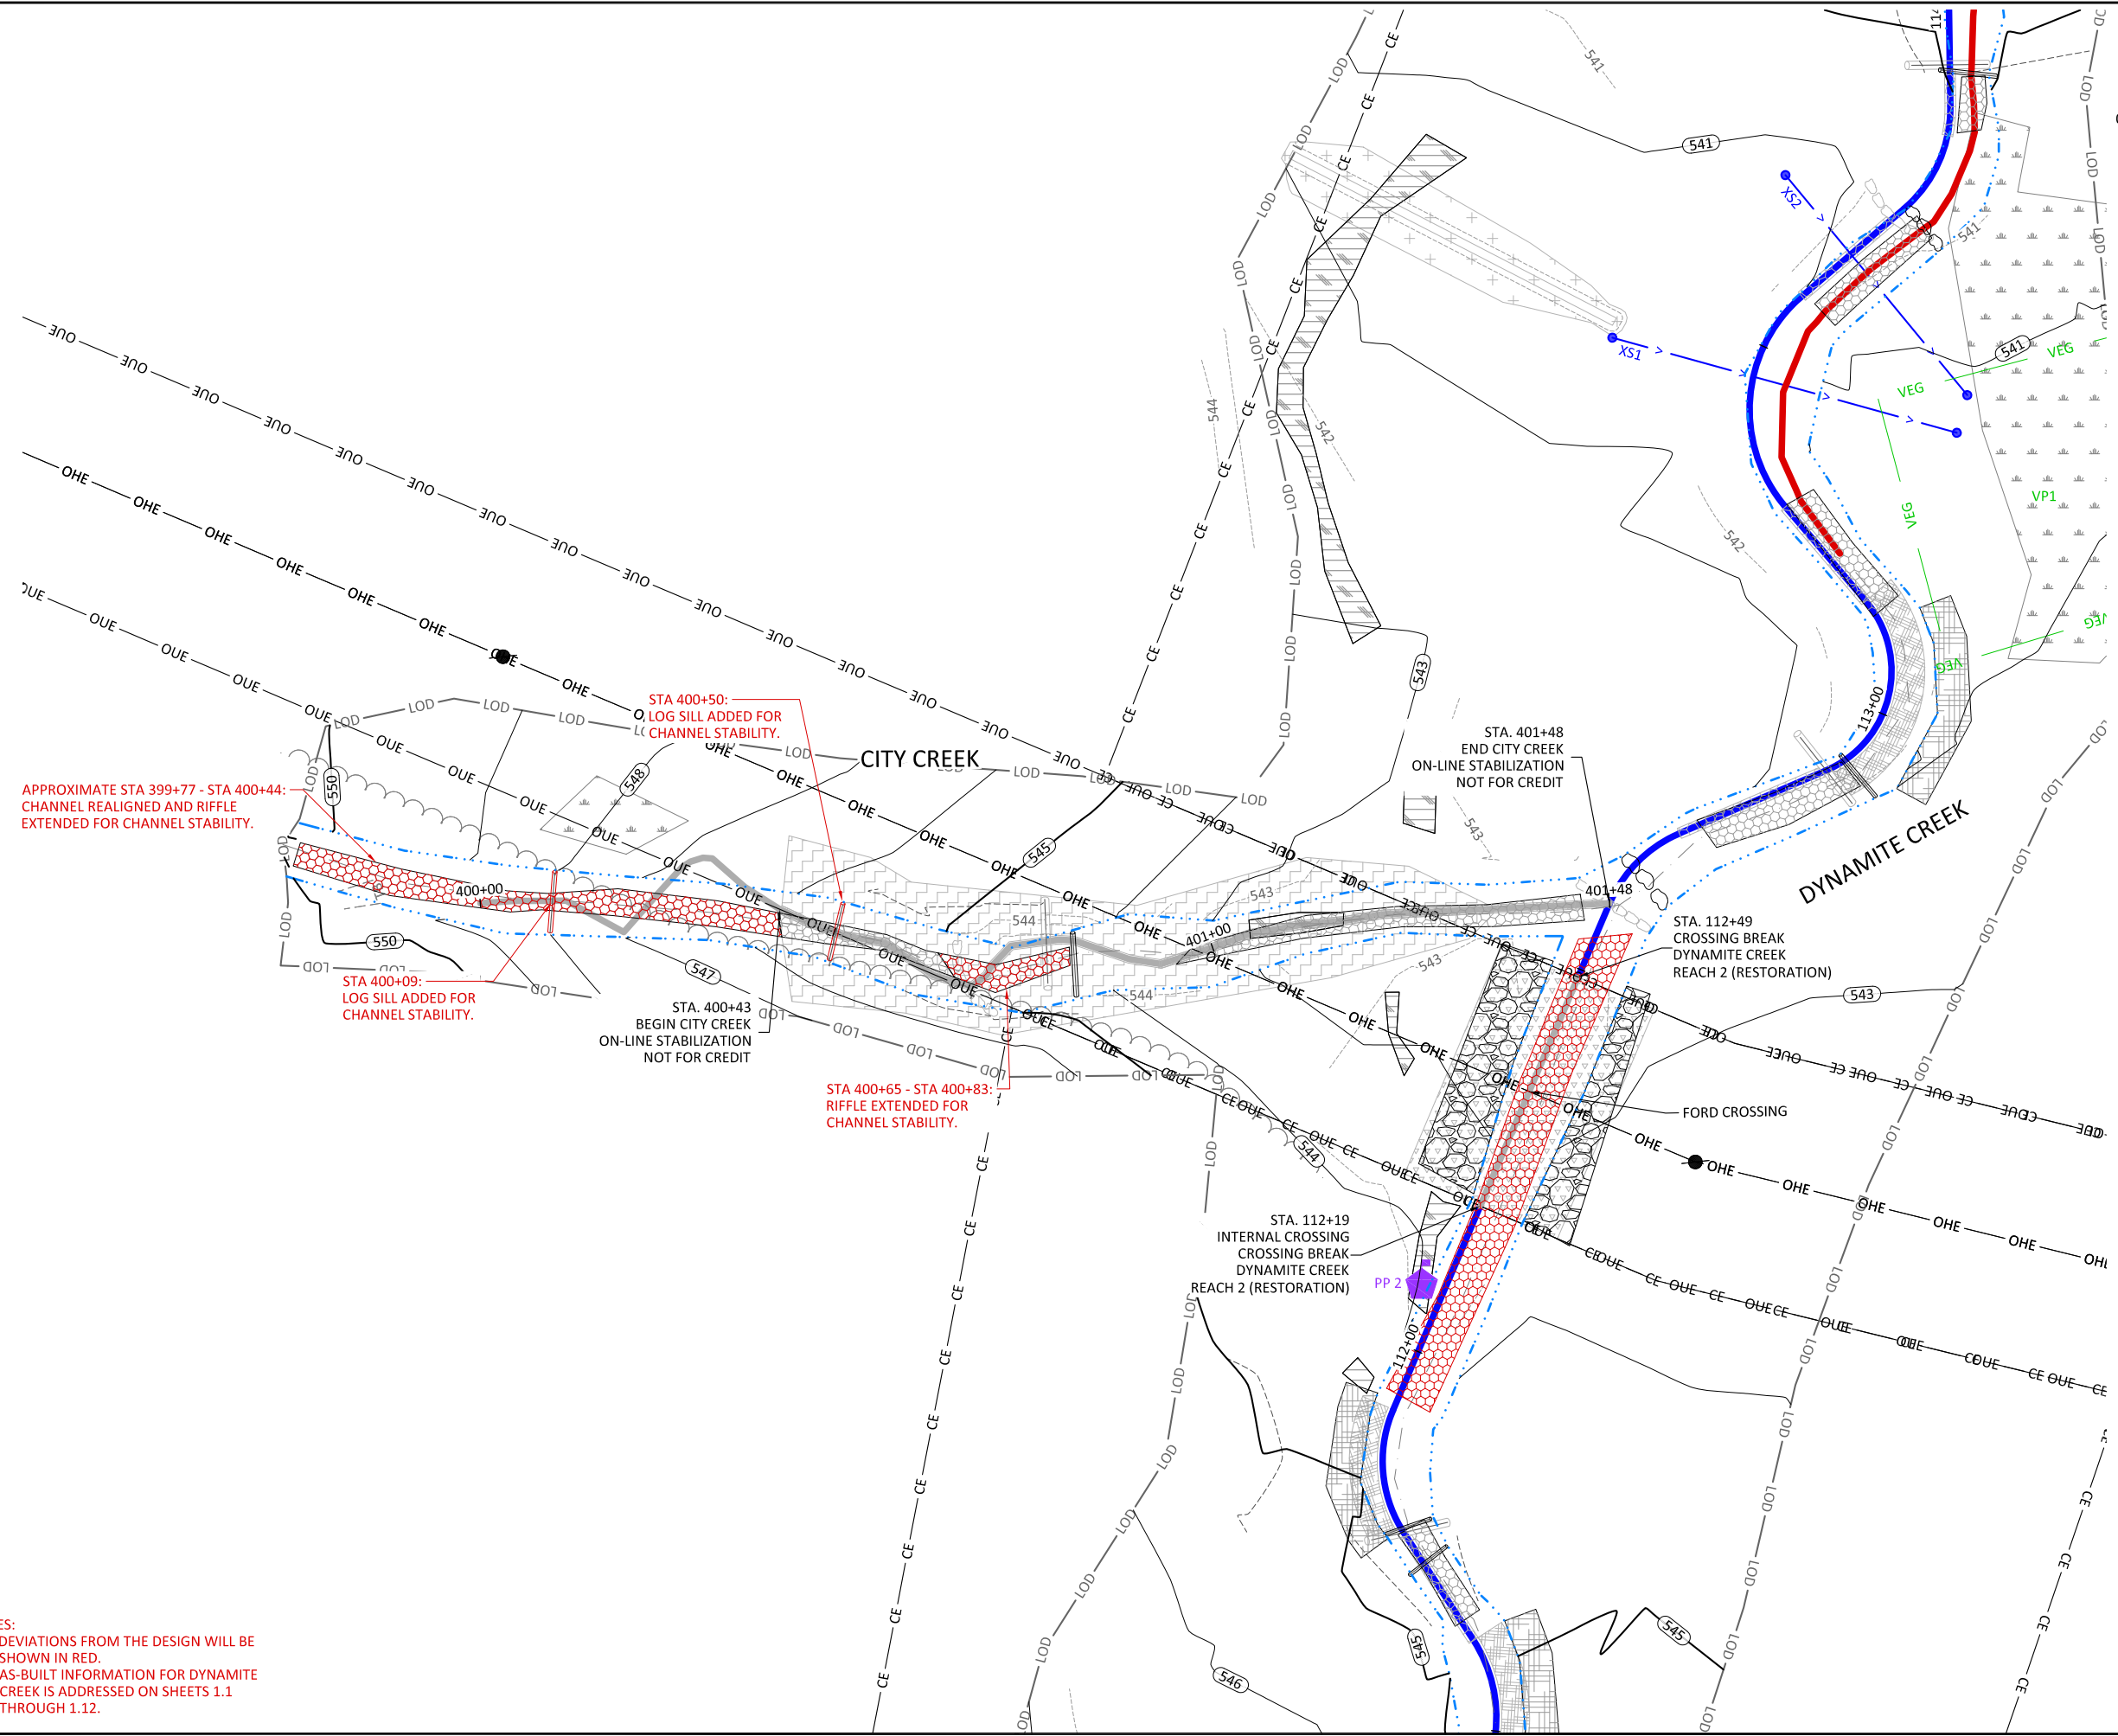
APPROXIMATE STA 399+77 - STA 400+44:
CHANNEL REALIGNED AND RIFFLE
EXTENDED FOR CHANNEL STABILITY.
