MONITORING YEAR 0 ANNUAL REPORT FINAL

CARPENTER BOTTOM MITIGATION SITE

Gaston County, NC
Catawba River Basin
HUC 03050102
(03050103 Expanded Service Area)

DMS Project No. 100090
NC DEQ Contract No. 7731
DMS RFP No. 16-007133-CT03
Date of Issue: April 24, 2017
USACE Action ID No. SAW-2018-02062
DWR Project No. 2019-0049
Data Collection Dates: August 2021 - February 2022

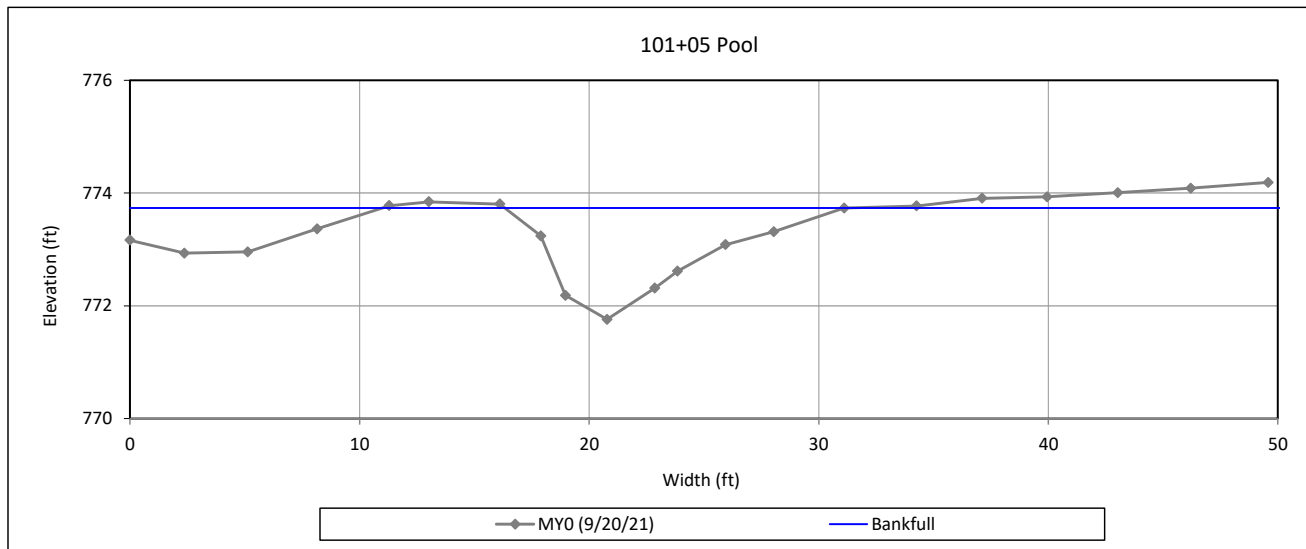
Cross-Section 1 - Carpenter Branch Reach 1

13.1	x-section area (ft.sq.)
14.8	width (ft)
0.9	mean depth (ft)
2.0	max depth (ft)
15.5	wetted perimeter (ft)
0.8	hydraulic radius (ft)
16.7	width-depth ratio

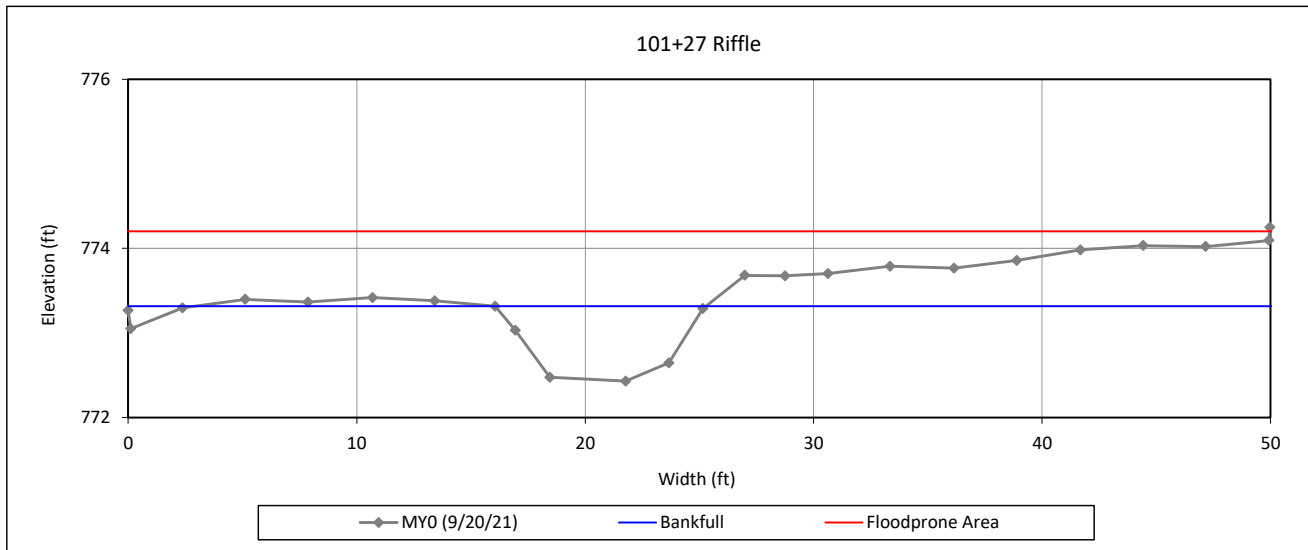
Cross-Section 2 - Carpenter Branch Reach 1

- 5.8 x-section area (ft.sq.)
- 9.2 width (ft)
- 0.6 mean depth (ft)
- 0.9 max depth (ft)
- 9.5 wetted perimeter (ft)
- 0.6 hydraulic radius (ft)
- 14.6 width-depth ratio
- 50.0 W flood prone area (ft)
- 5.4 entrenchment ratio
- 1.0 low bank height ratio

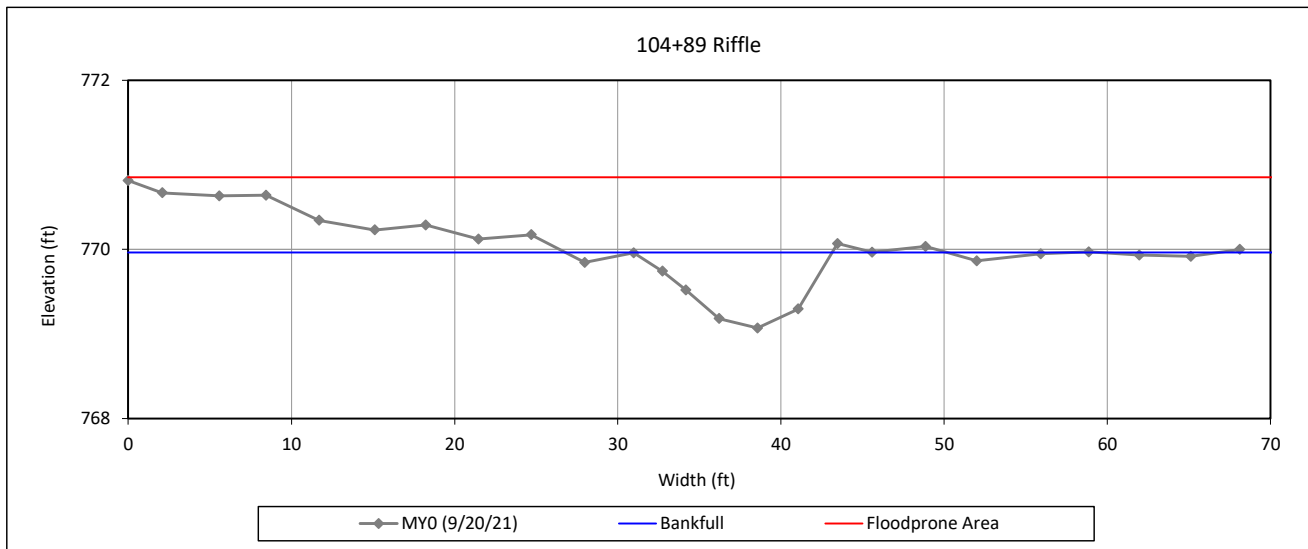
Cross-Section 3 - Carpenter Branch Reach 1

6.5	x-section area (ft.sq.)
12.2	width (ft)
0.5	mean depth (ft)
0.9	max depth (ft)
12.3	wetted perimeter (ft)
0.5	hydraulic radius (ft)
22.7	width-depth ratio
68.1	W flood prone area (ft)
5.6	entrenchment ratio
1.0	low bank height ratio

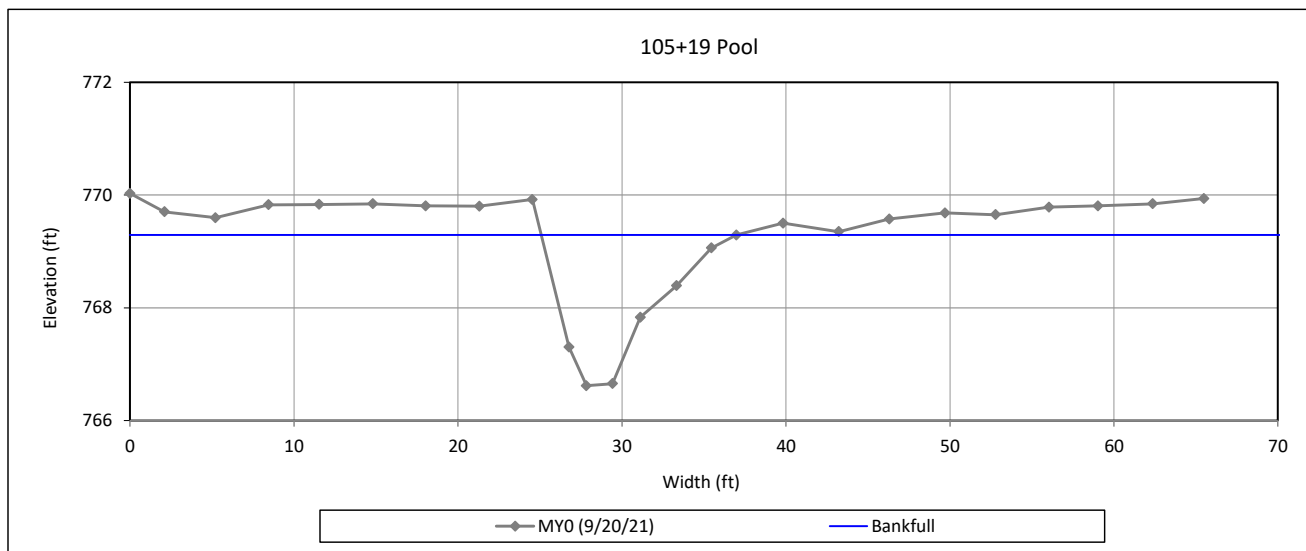
Cross-Section 4 - Carpenter Branch Reach 1

15.8	x-section area (ft.sq.)
11.9	width (ft)
1.3	mean depth (ft)
2.7	max depth (ft)
13.6	wetted perimeter (ft)
1.2	hydraulic radius (ft)
9.0	width-depth ratio

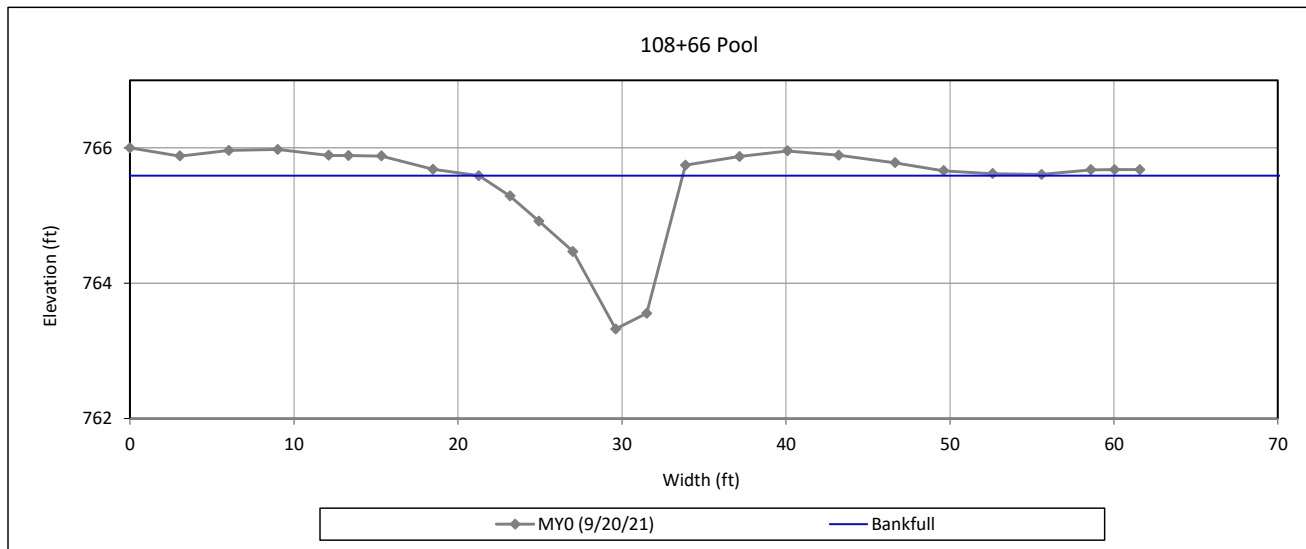
Cross-Section 5 - Carpenter Branch Reach 1

13.7	x-section area (ft.sq.)
12.4	width (ft)
1.1	mean depth (ft)
2.3	max depth (ft)
13.6	wetted perimeter (ft)
1.0	hydraulic radius (ft)
11.3	width-depth ratio

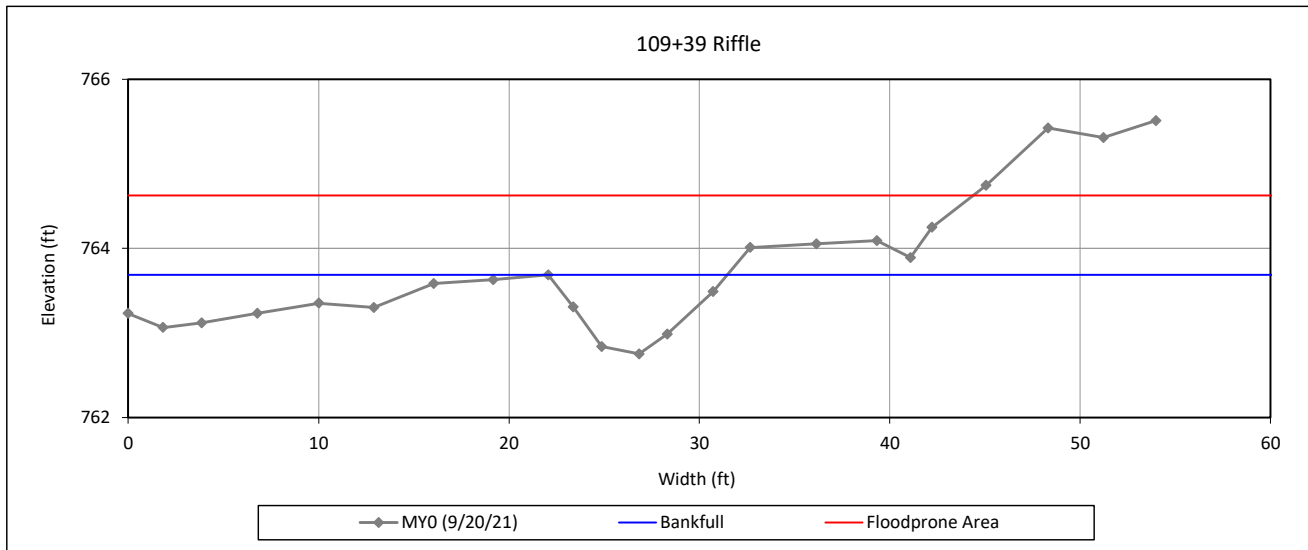
Cross-Section 6 - Carpenter Branch Reach 1

5.3	x-section area (ft.sq.)
9.4	width (ft)
0.6	mean depth (ft)
0.9	max depth (ft)
9.6	wetted perimeter (ft)
0.5	hydraulic radius (ft)
16.7	width-depth ratio
44.4	W flood prone area (ft)
4.7	entrenchment ratio
1.0	low bank height ratio

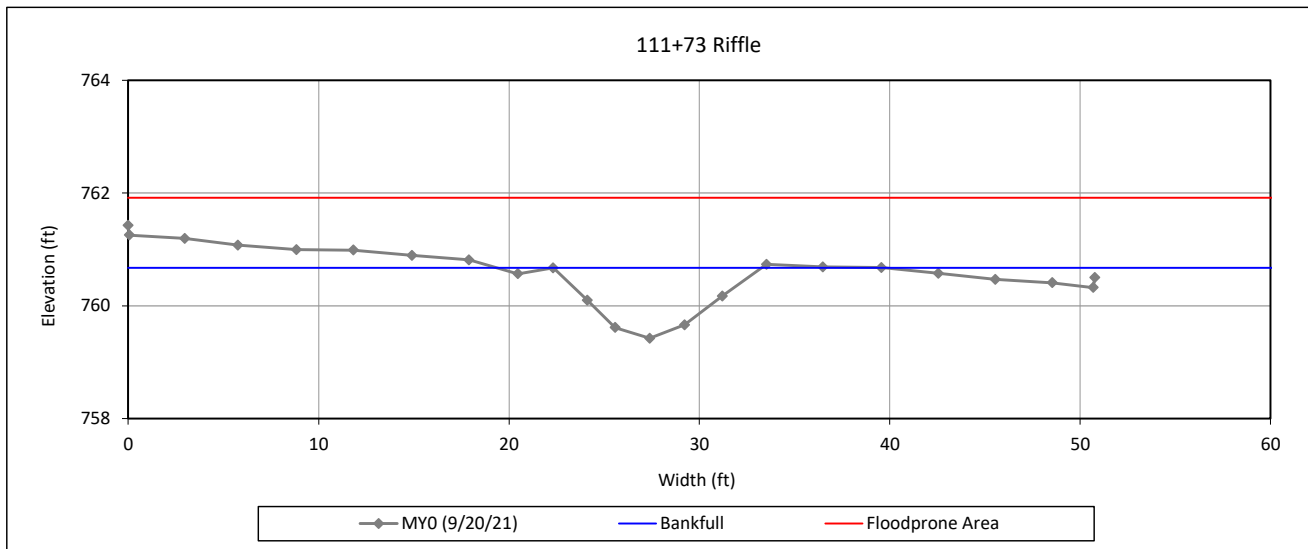
Cross-Section 7 - Carpenter Branch Reach 1

7.9	x-section area (ft.sq.)
10.9	width (ft)
0.7	mean depth (ft)
1.2	max depth (ft)
11.2	wetted perimeter (ft)
0.7	hydraulic radius (ft)
15.2	width-depth ratio
50.8	W flood prone area (ft)
4.6	entrenchment ratio
1.0	low bank height ratio

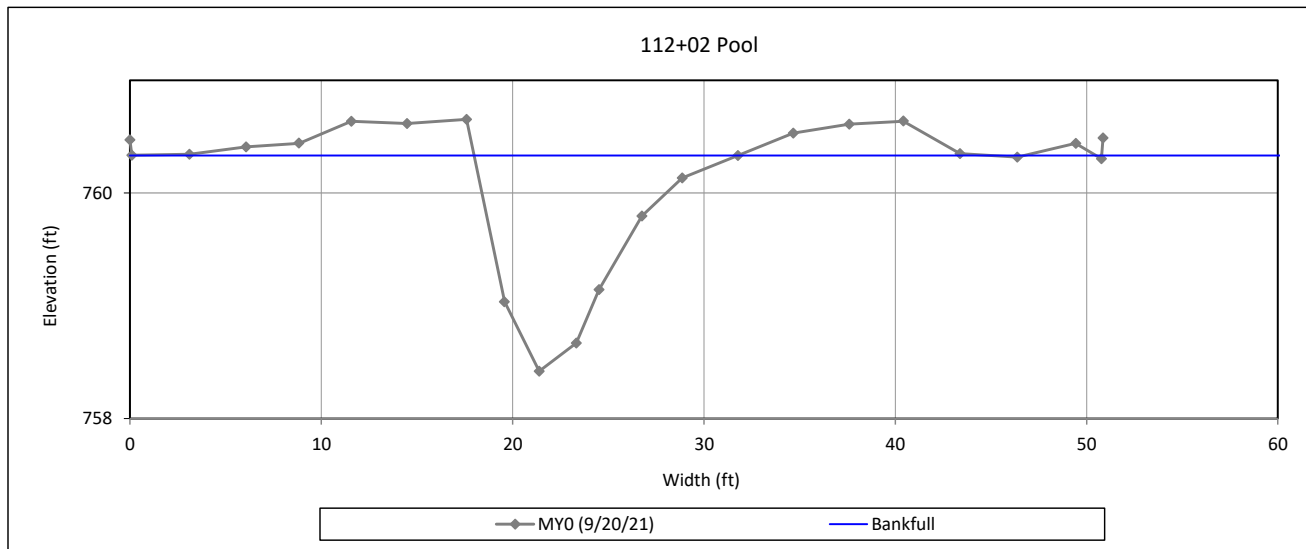
Cross-Section 8 - Carpenter Branch Reach 1

12.1	x-section area (ft.sq.)
13.8	width (ft)
0.9	mean depth (ft)
1.9	max depth (ft)
14.6	wetted perimeter (ft)
0.8	hydraulic radius (ft)
15.7	width-depth ratio

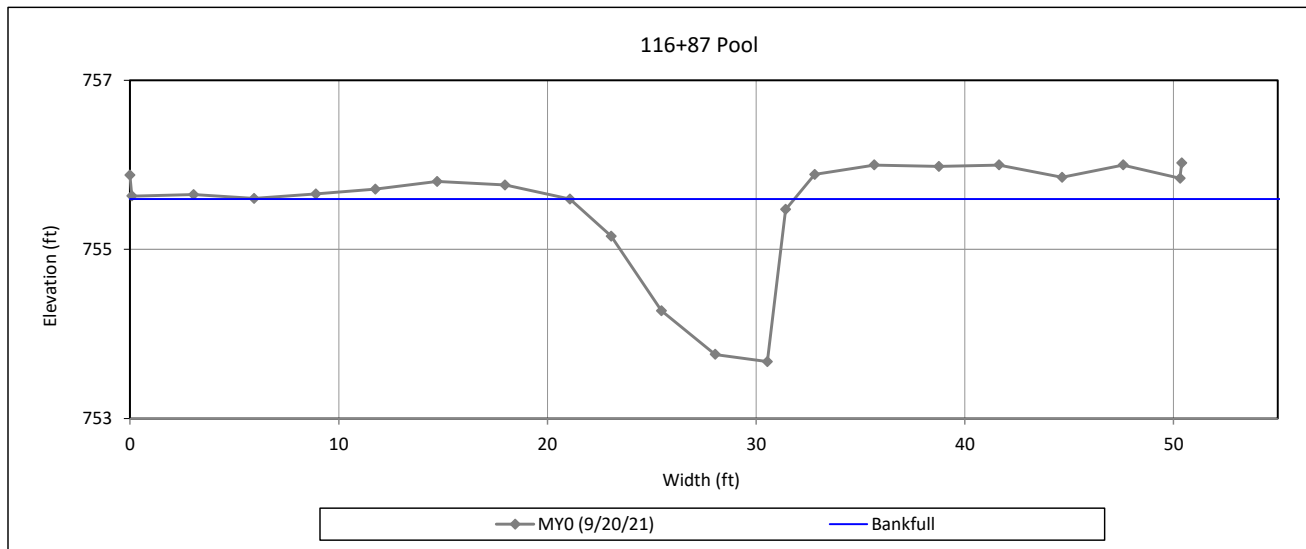
Cross-Section 9 - Carpenter Branch Reach 1

12.2	x-section area (ft.sq.)
10.8	width (ft)
1.1	mean depth (ft)
1.9	max depth (ft)
12.2	wetted perimeter (ft)
1.0	hydraulic radius (ft)
9.5	width-depth ratio

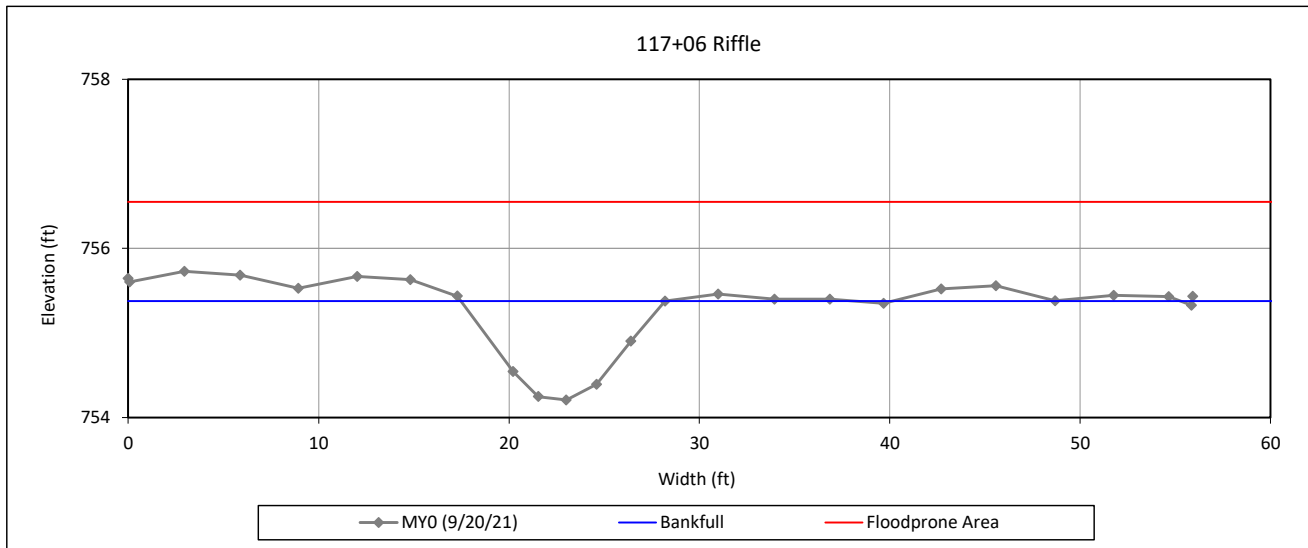
Cross-Section 10 - Carpenter Branch Reach 1

7.6	x-section area (ft.sq.)
10.7	width (ft)
0.7	mean depth (ft)
1.2	max depth (ft)
11.0	wetted perimeter (ft)
0.7	hydraulic radius (ft)
15.1	width-depth ratio
55.9	W flood prone area (ft)
5.2	entrenchment ratio
1.0	low bank height ratio

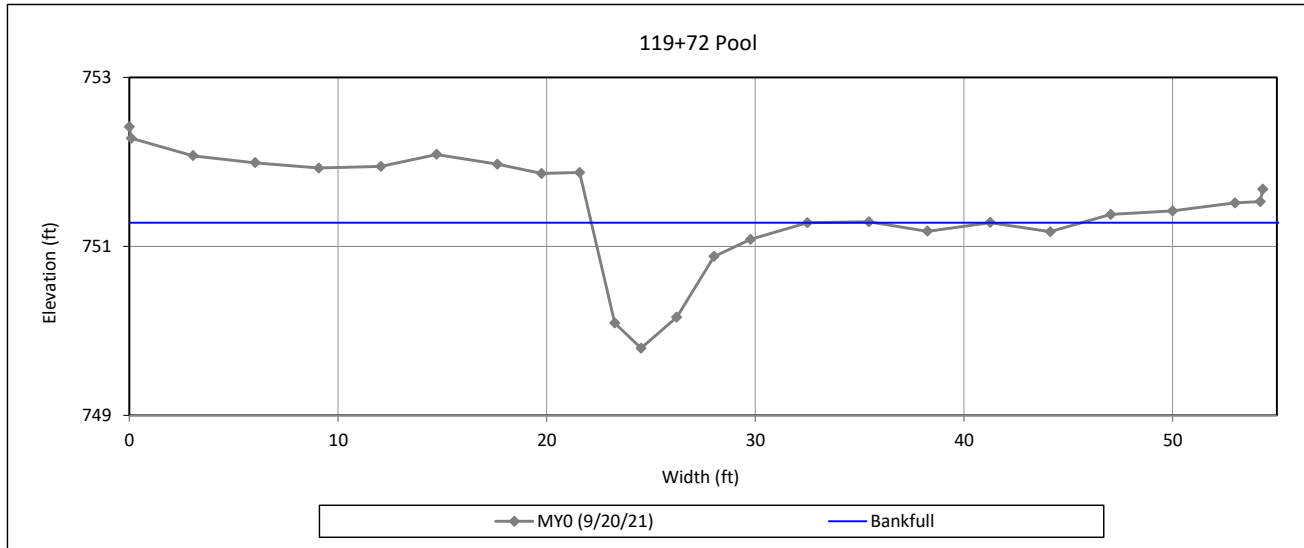
Cross-Section 11 - Carpenter Branch Reach 1

6.7	x-section area (ft.sq.)
10.4	width (ft)
0.6	mean depth (ft)
1.5	max depth (ft)
11.1	wetted perimeter (ft)
0.6	hydraulic radius (ft)
15.9	width-depth ratio

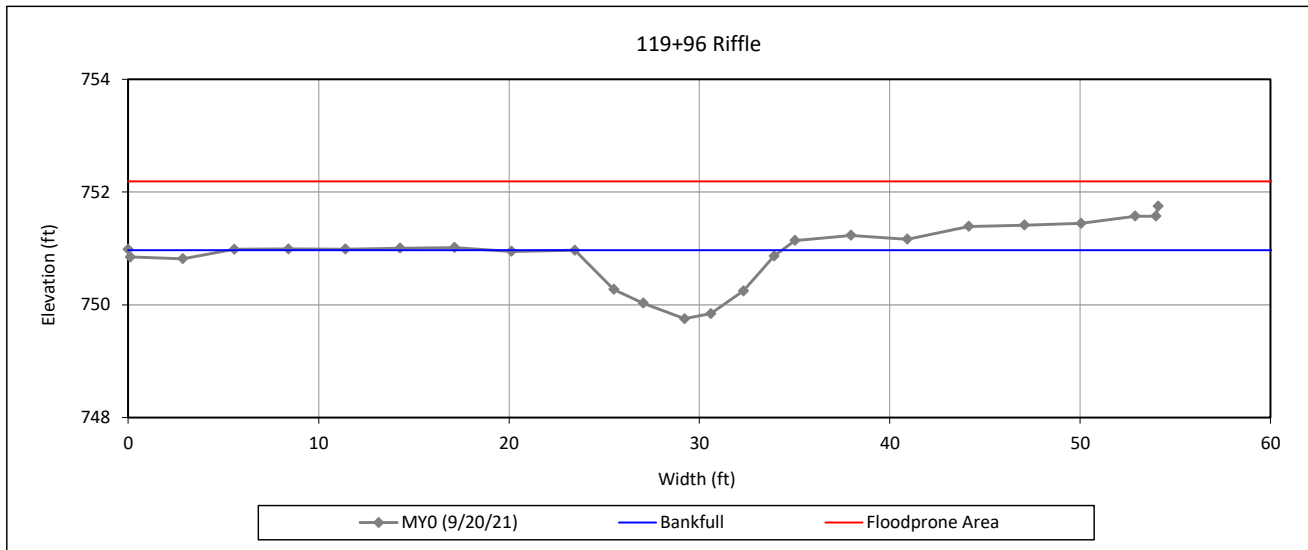
Cross-Section 12 - Carpenter Branch Reach 1

8.2	x-section area (ft.sq.)
10.9	width (ft)
0.8	mean depth (ft)
1.2	max depth (ft)
11.2	wetted perimeter (ft)
0.7	hydraulic radius (ft)
14.4	width-depth ratio
54.1	W flood prone area (ft)
5.0	entrenchment ratio
1.0	low bank height ratio

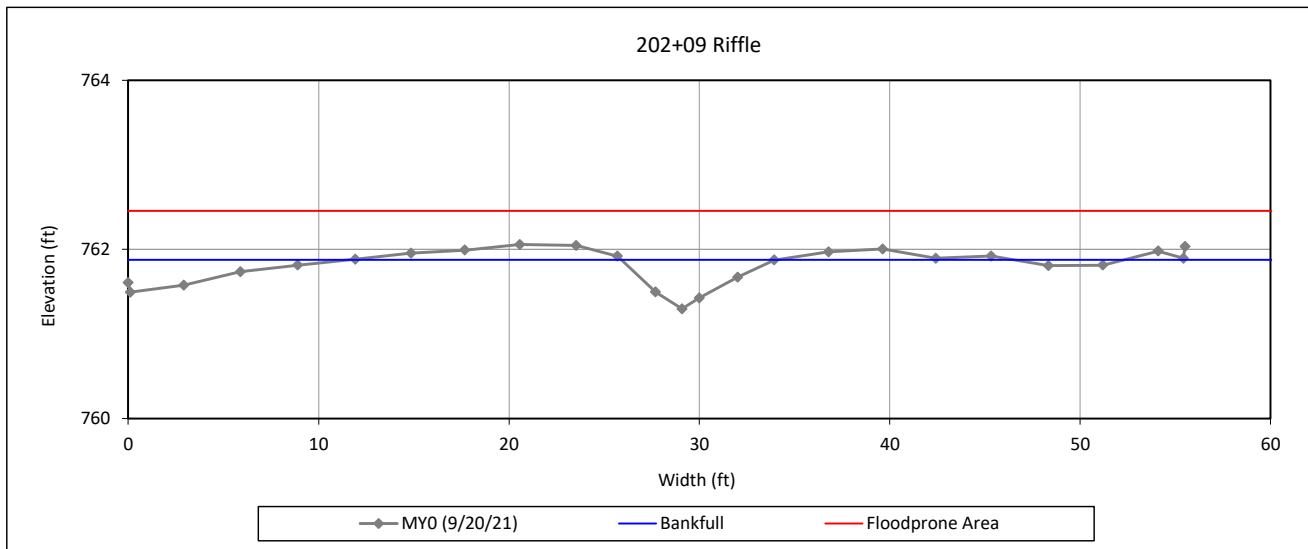
Cross-Section 13 - UT1

2.3	x-section area (ft.sq.)
8.0	width (ft)
0.3	mean depth (ft)
0.6	max depth (ft)
8.1	wetted perimeter (ft)
0.3	hydraulic radius (ft)
27.6	width-depth ratio
55.5	W flood prone area (ft)
6.9	entrenchment ratio
1.0	low bank height ratio

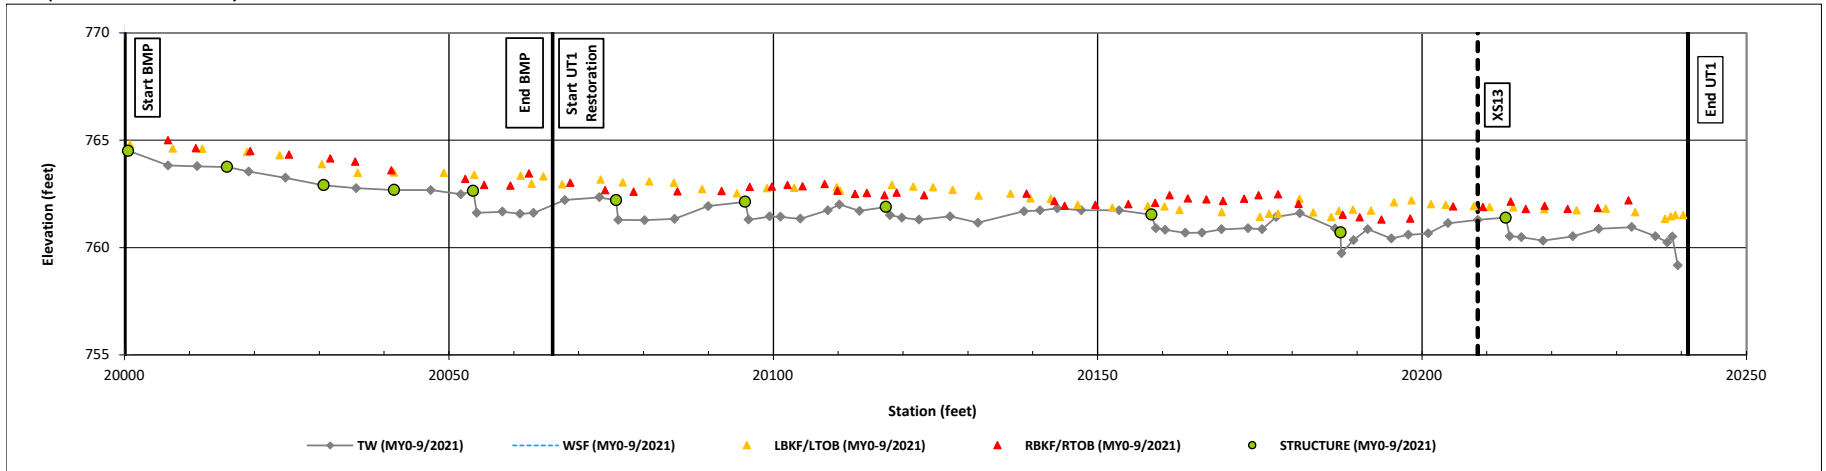
UT1 (STA 200+00 to 202+41)

* - Channel was dry during As-Built Survey.

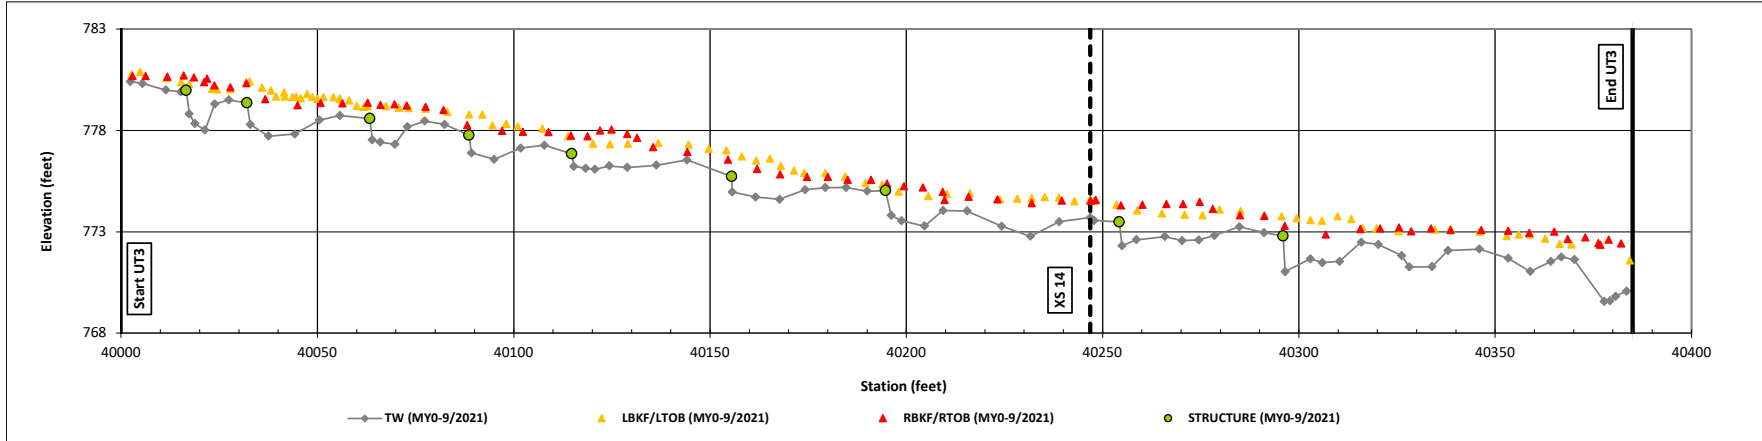
UT3 (STA 400+00 to 403+85)

* - Channel was dry during As-Built Survey.
