**As-Built Baseline Monitoring Report**

**COWFORD PROJECT**

NCDMS Project #100095 (Contract #0007746)

Onslow County, North Carolina

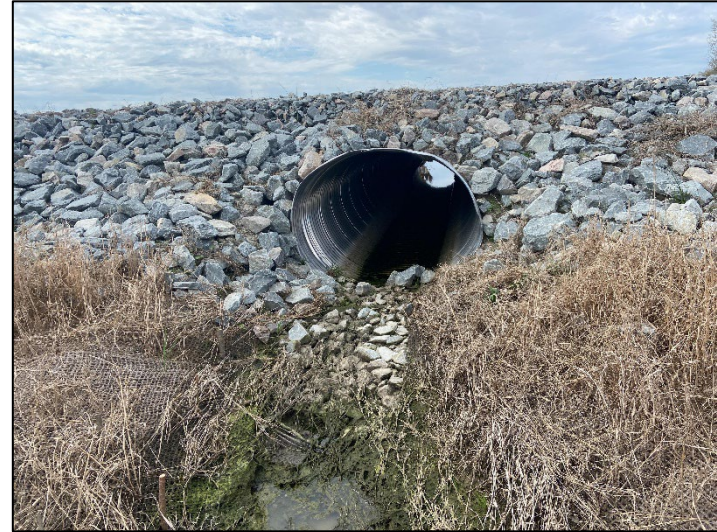
Culvert at the bottom of KJ1-B (3/8/2022)

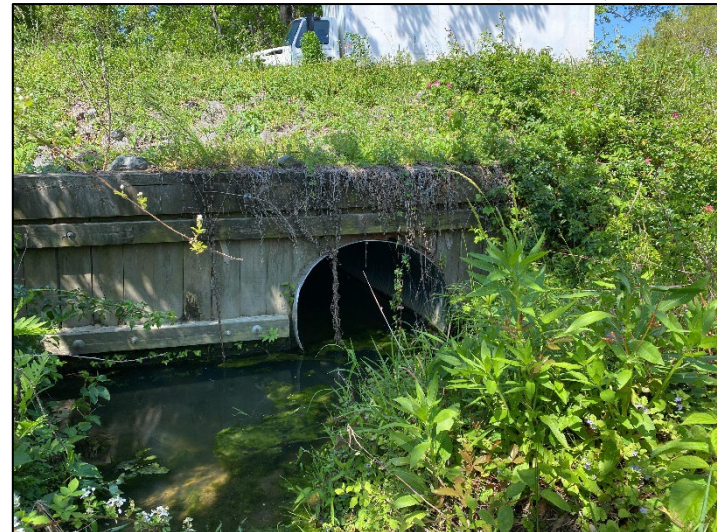
Culvert at Kinston Highway (4/28/2022)

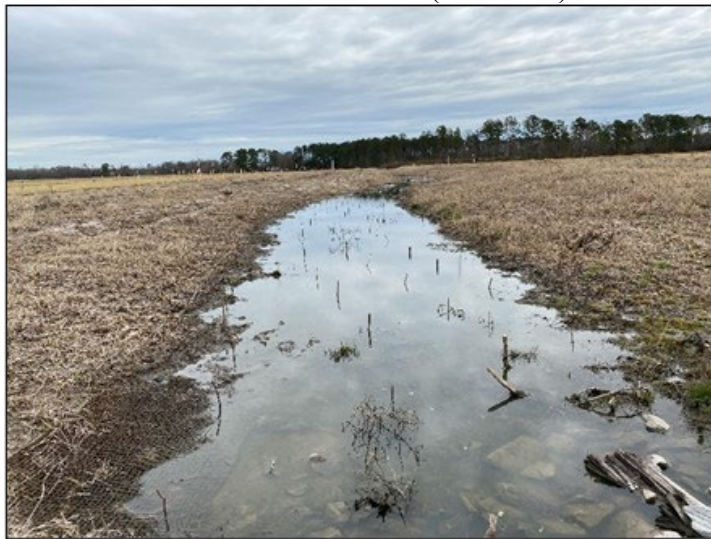
Headwater Valley (3/16/2022)

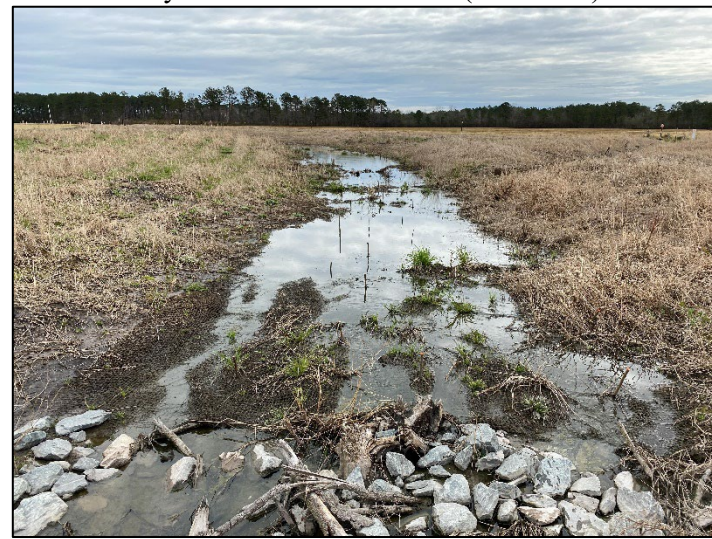
Headwater Valley (3/16/2022)

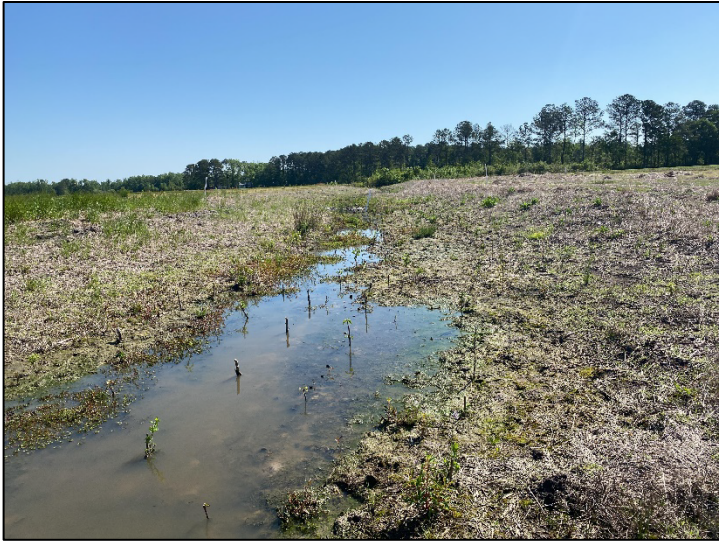
Headwater Valley (4/28/2022)

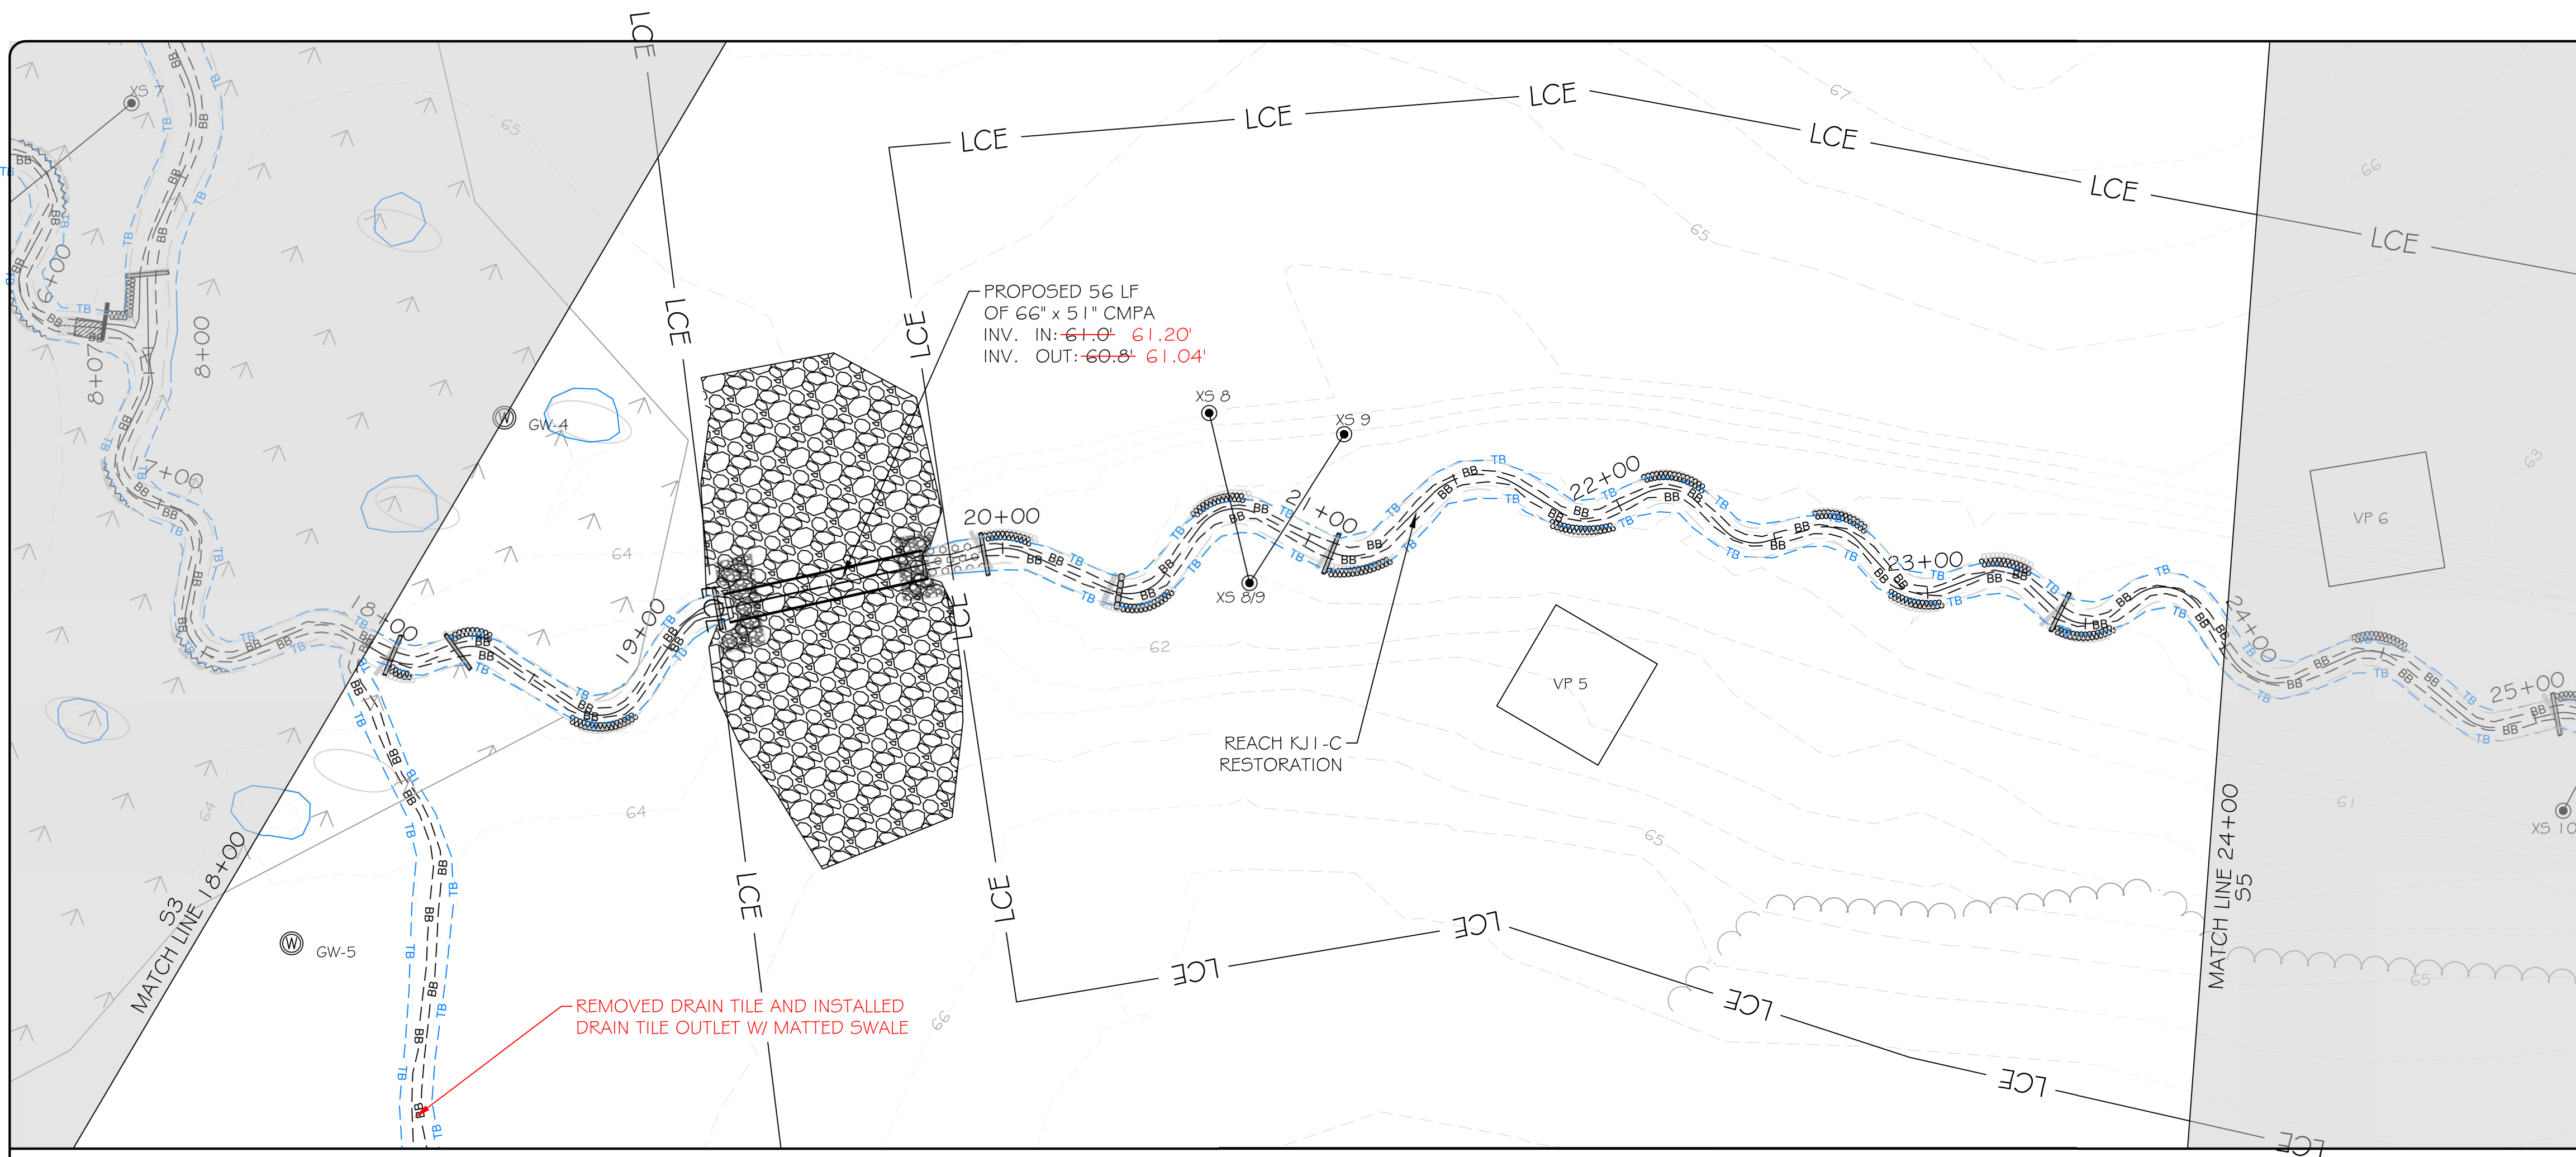
REMOVED DRAIN TILE AND INSTALLED DRAIN TILE OUTLET W/ MATTED SWALE
