MY00 MONITORING REPORT

Round Hill Branch Restoration Site
Buncombe County, North Carolina
French Broad River Basin - 06010105

DMS Project #100066

MEMORANDUM

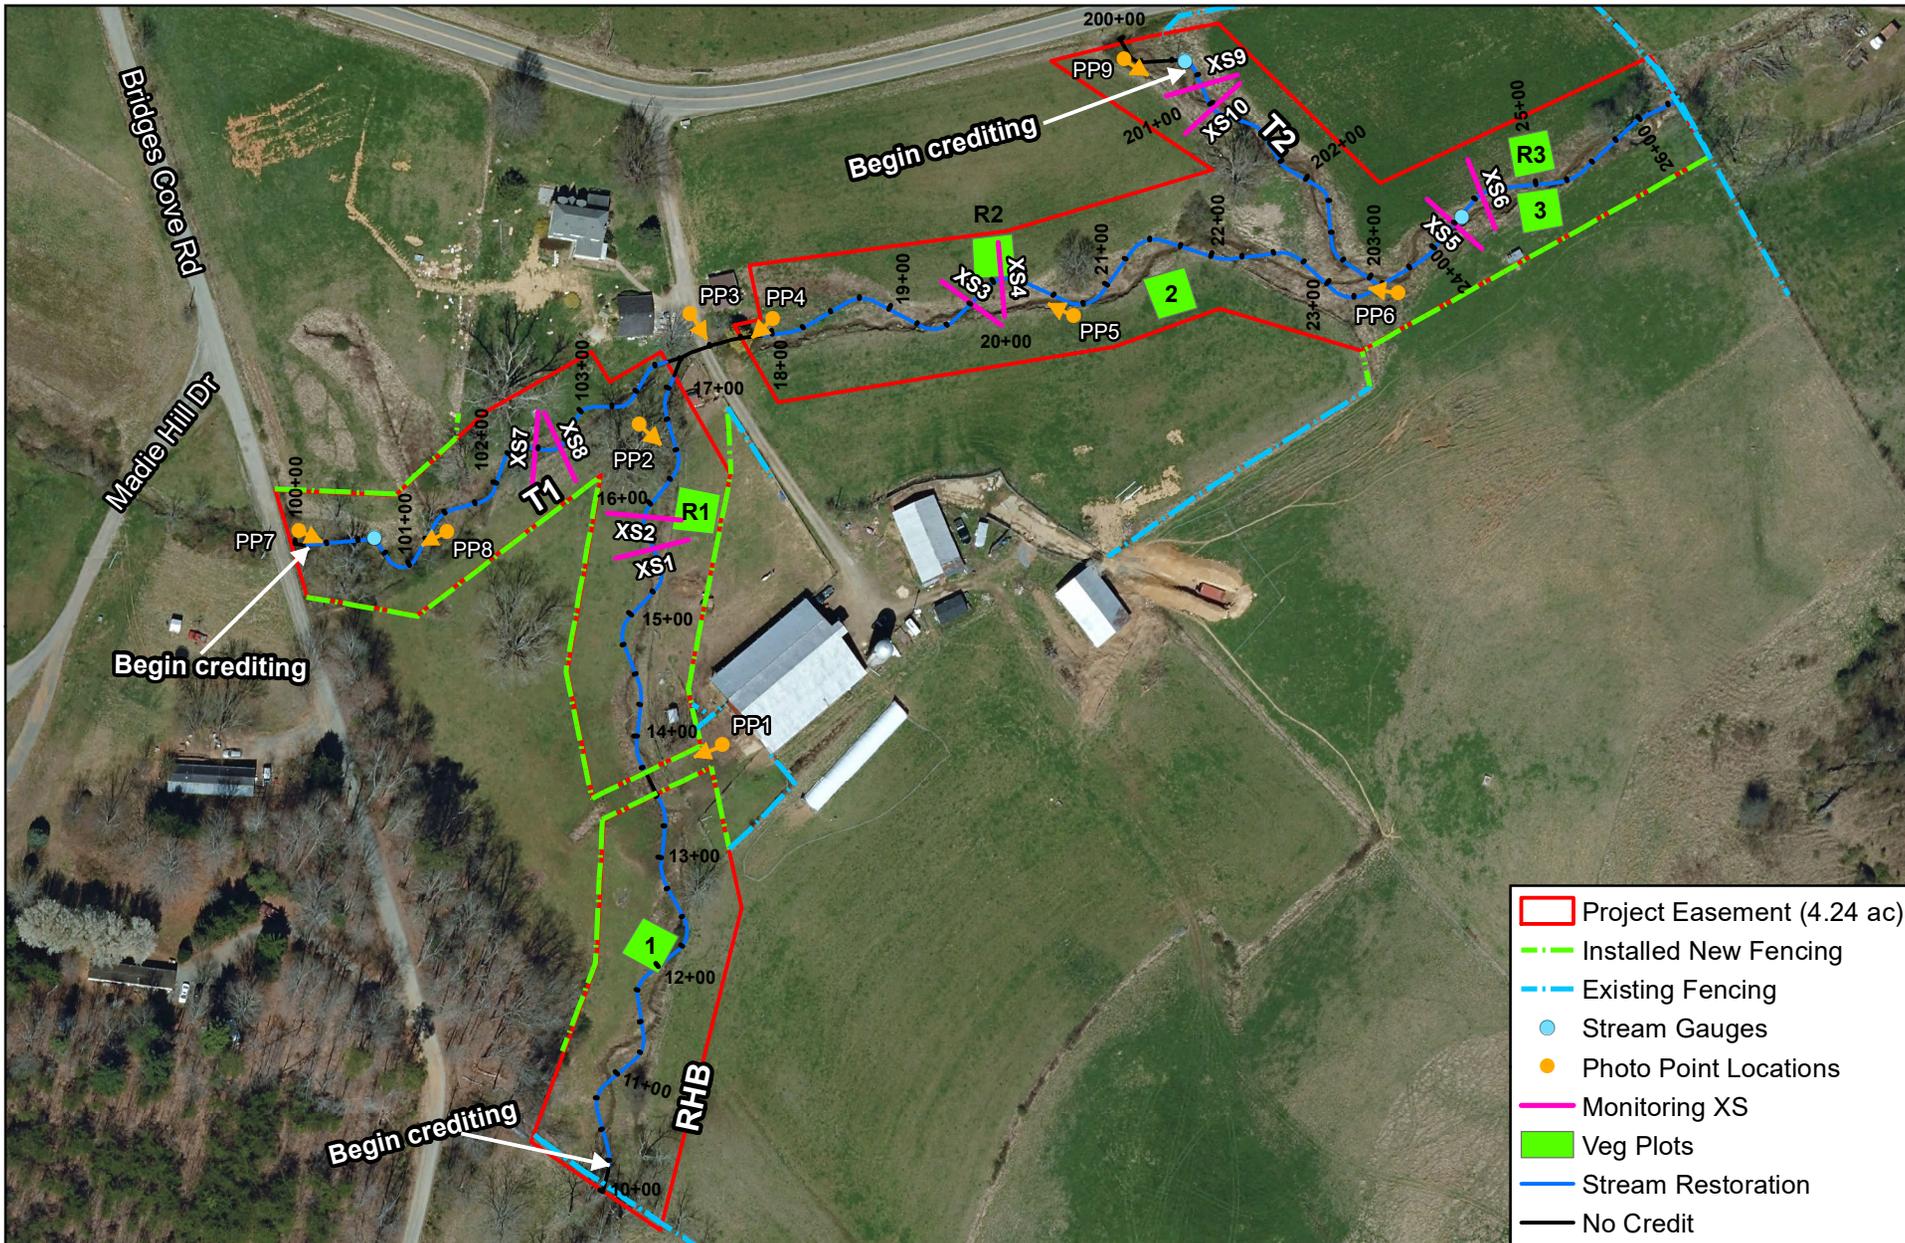
**CURRENT CONDITIONS PLANVIEW
 ROUND HILL BRANCH RESTORATION SITE
 BUNCOMBE COUNTY, NC**

4. Photo point 5 and SG2 are shown in the incorrect position on the CCPV relative to the asbuilt. Please review and revise.
KCI Response: The locations shown on the CCPV are the correct ones. The as-built drawings will be corrected to match the actual locations of these features. This error has been corrected.

5. XS3, XS4, photo point 5 and SG2 all shifted upstream by one meander length. This appears to be the only deviation from the proposed monitoring plan in the approved mitigation plan. Please provide a brief explanation why the location was changed.
KCI Response: Photo point 5 was installed in the location shown on the proposed monitoring plan (the location shown on the as-builts was not correct and has been corrected). XS3 and 4 were moved upstream to avoid the large tree that was left intact in the location of the proposed cross-sections. SG2 (which has been relabeled as SG-RHB) was moved downstream from its proposed location to XS5 to better capture bankfull events that occur on site.

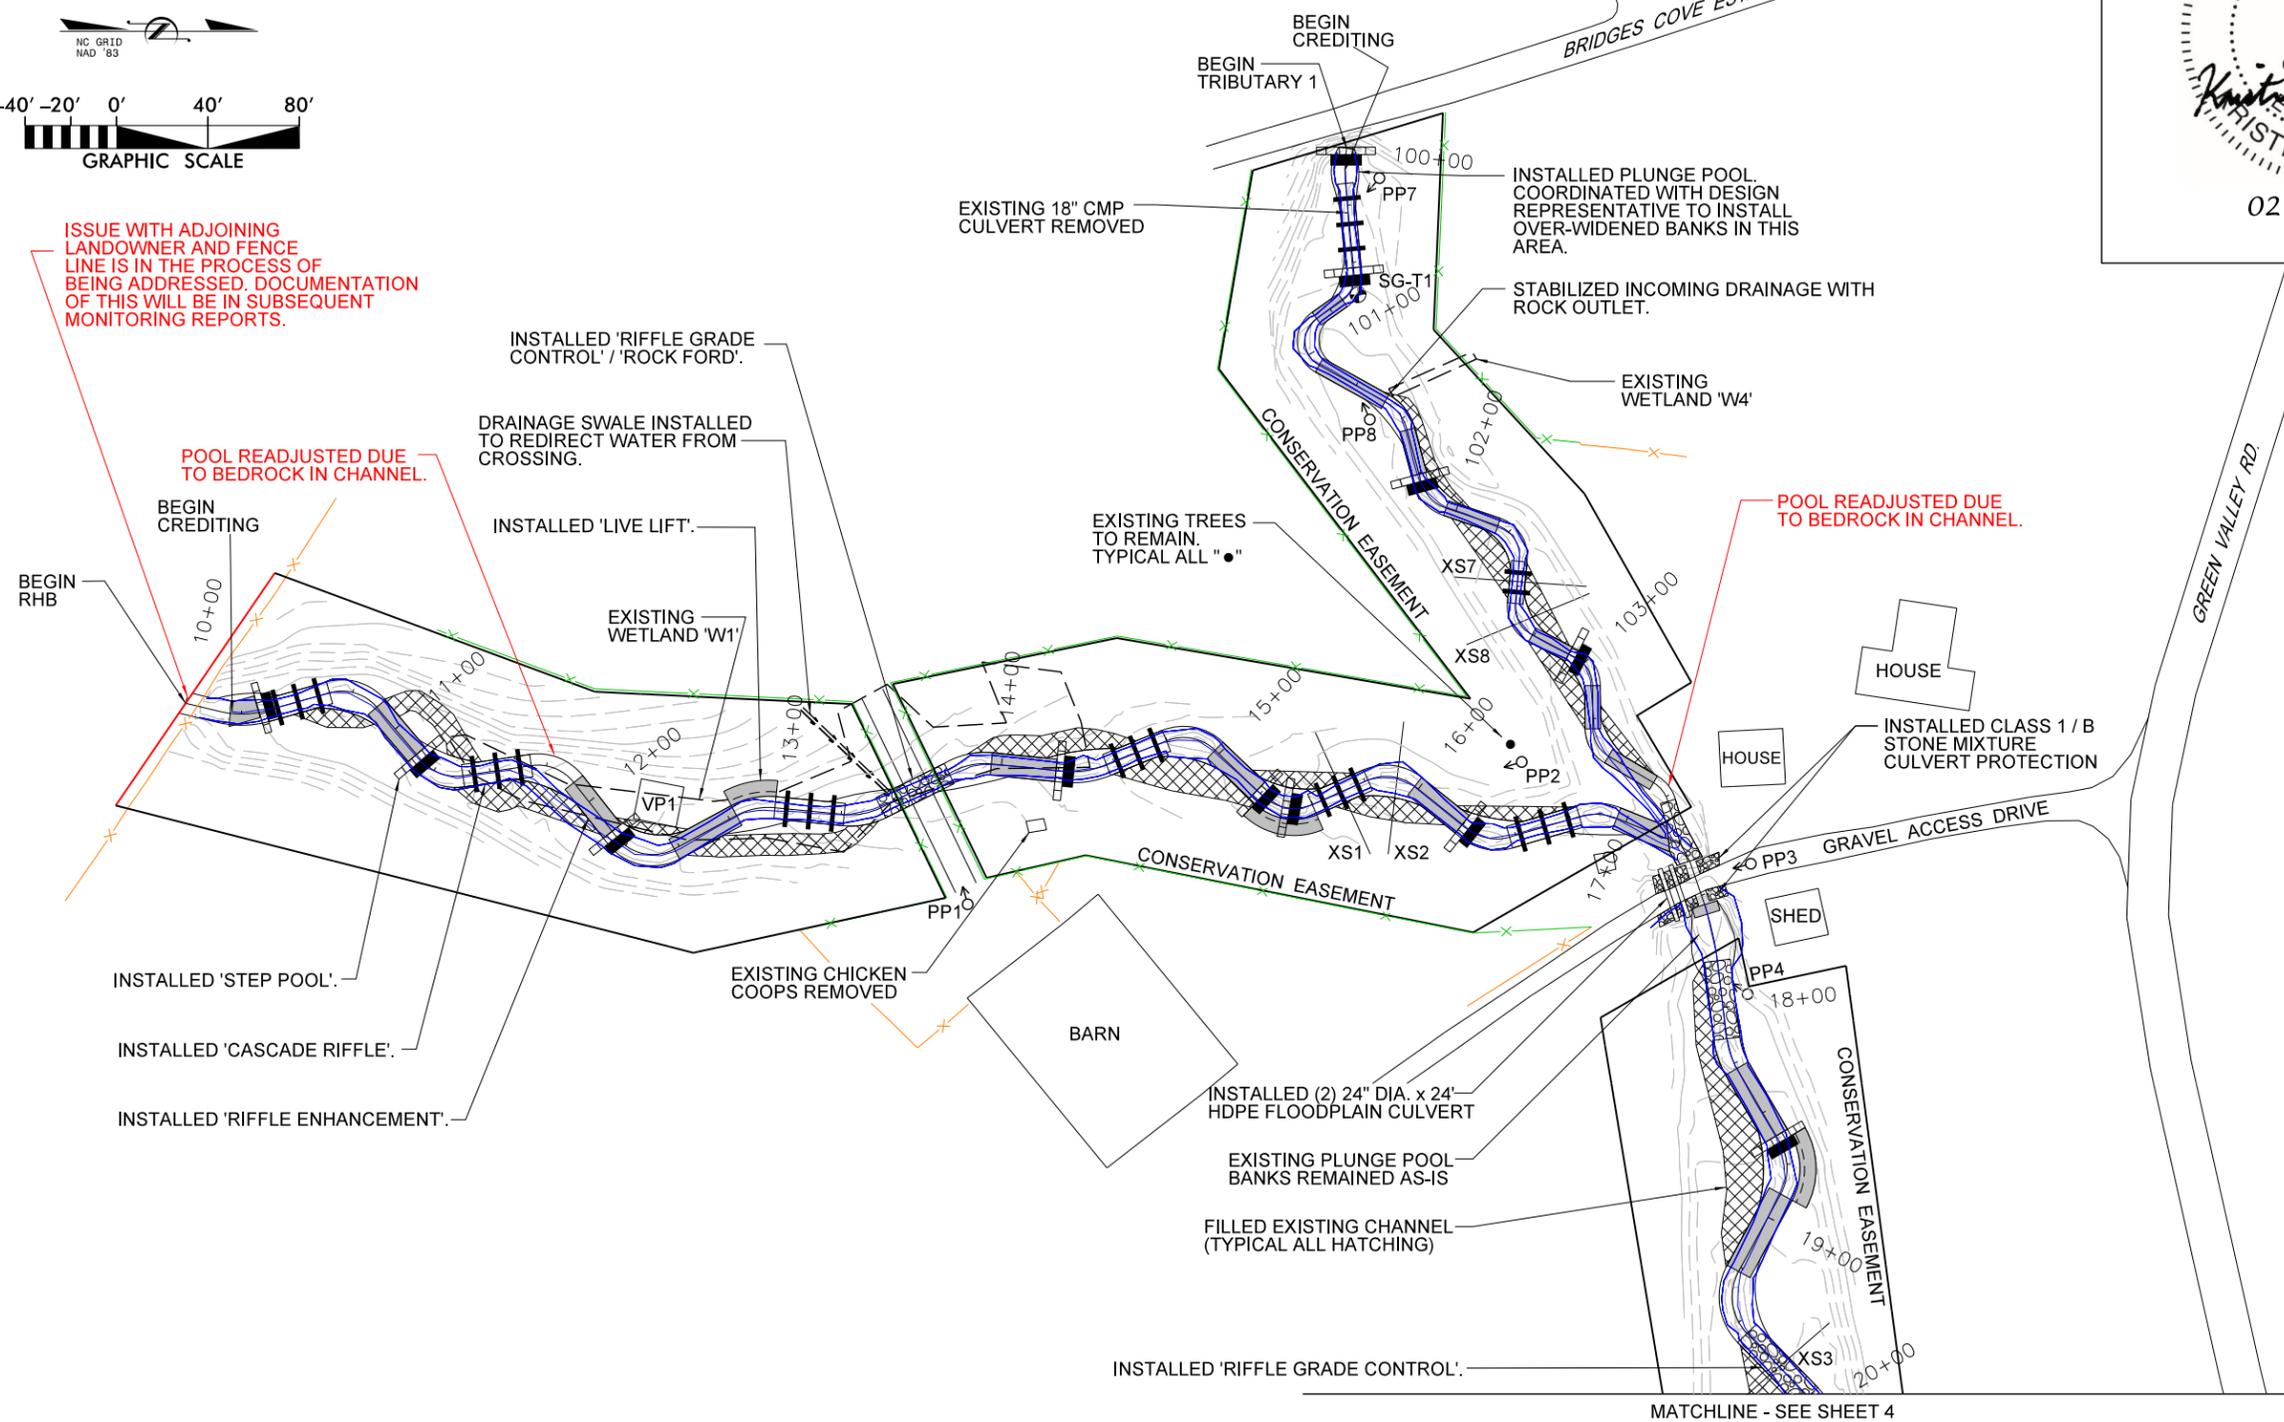
POOL READJUSTED DUE TO BEDROCK IN CHANNEL.
