MONITORING YEAR 0 ANNUAL REPORT FINAL

HUNTSMAN MITIGATION SITE

Wilkes County, NC
Yadkin River Basin
HUC 03040102

DMS Project No. 100123

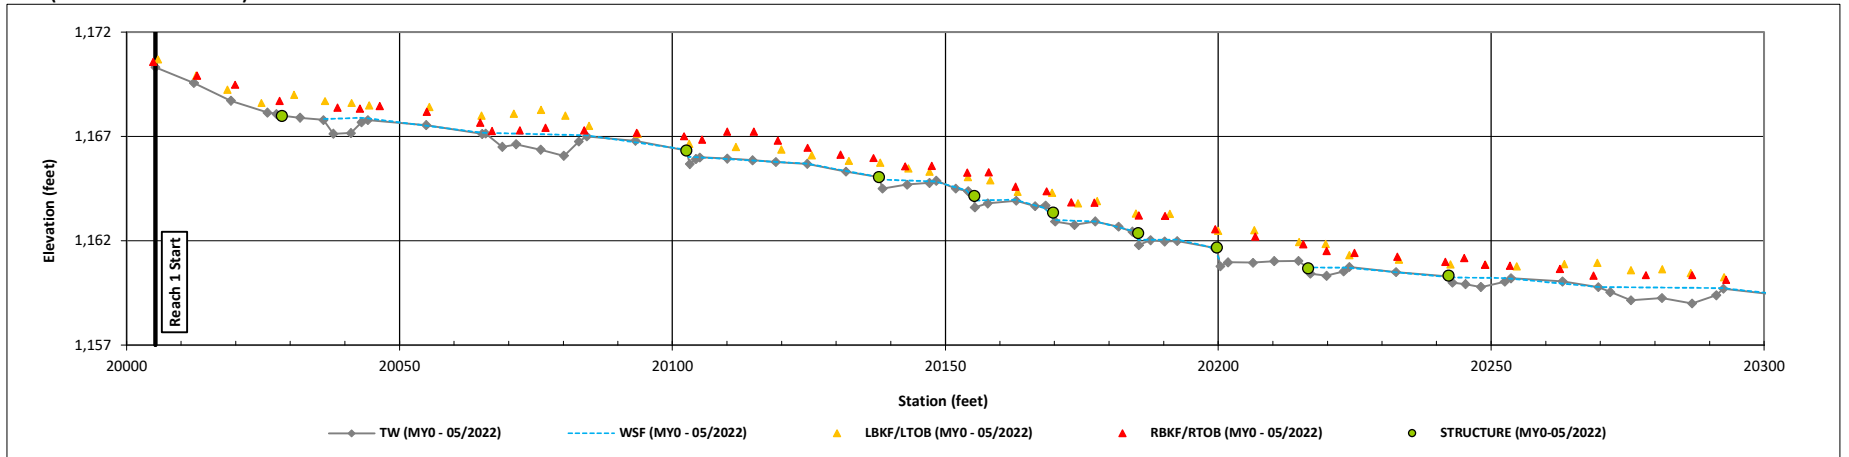
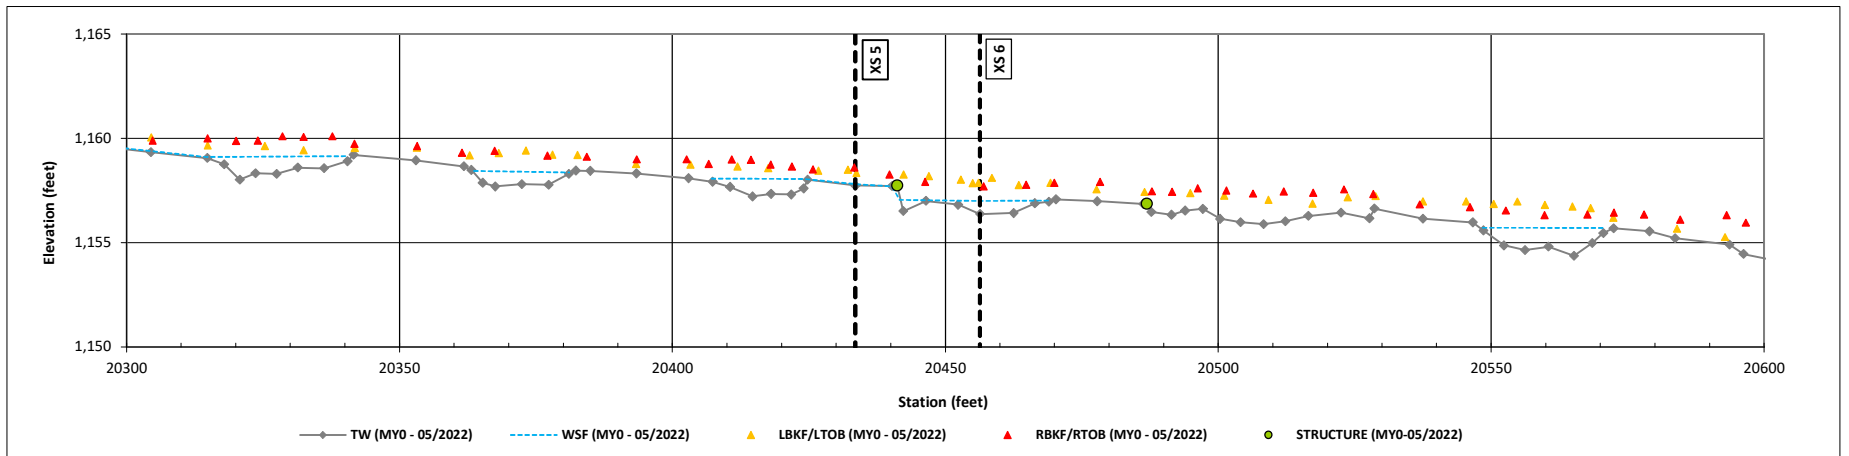
UT1 (STA 200+05 to 220+21)

Portions of the reach were dry during survey.

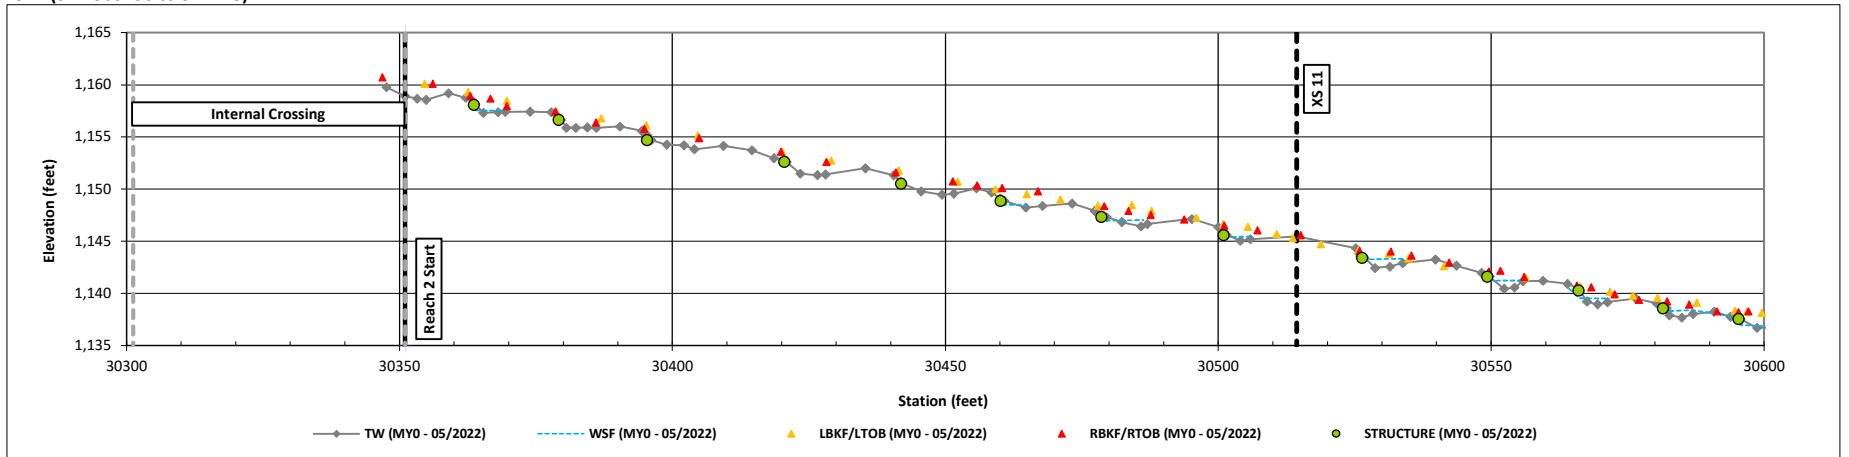
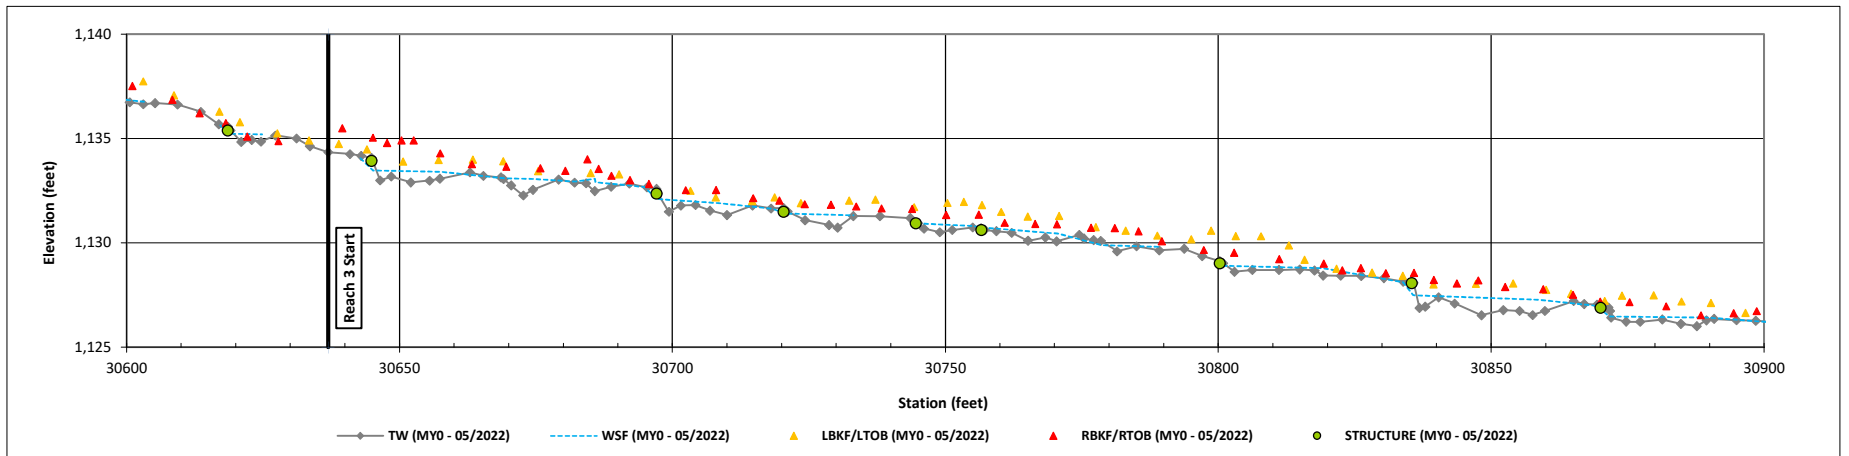
UT2 (STA 303+50 to 317+28)

Portions of the reach were dry during survey.

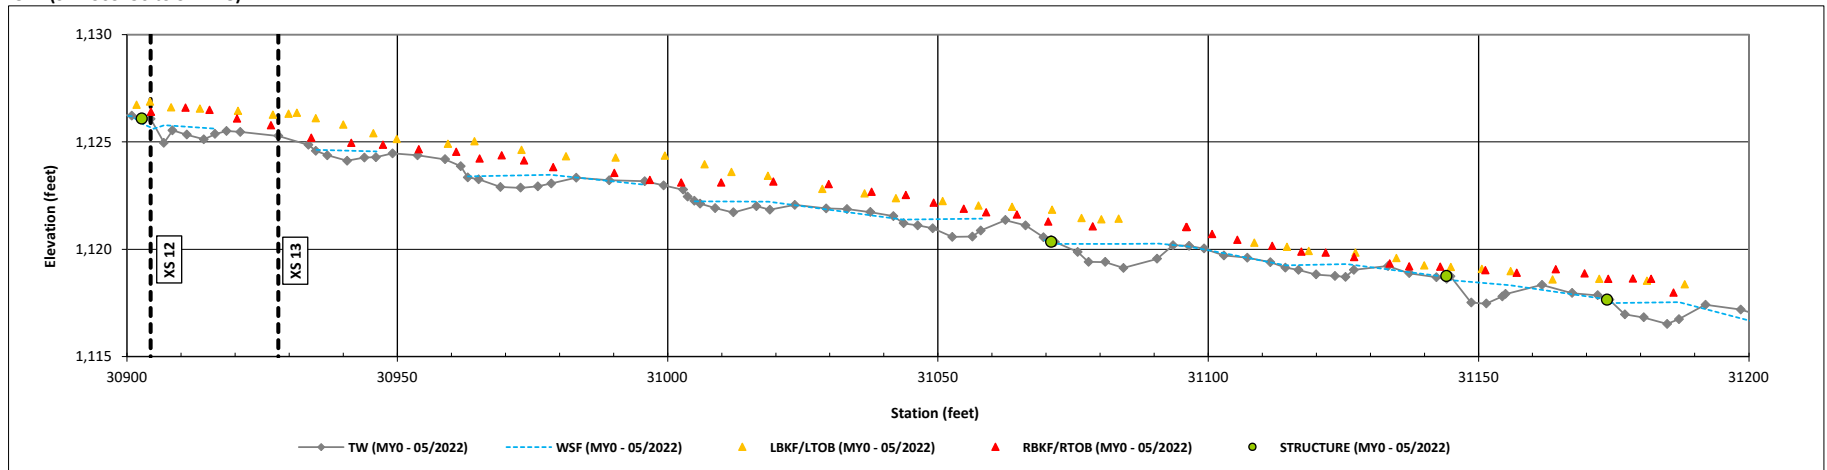
UT2 (STA 303+50 to 317+28)

Portions of the reach were dry during survey.

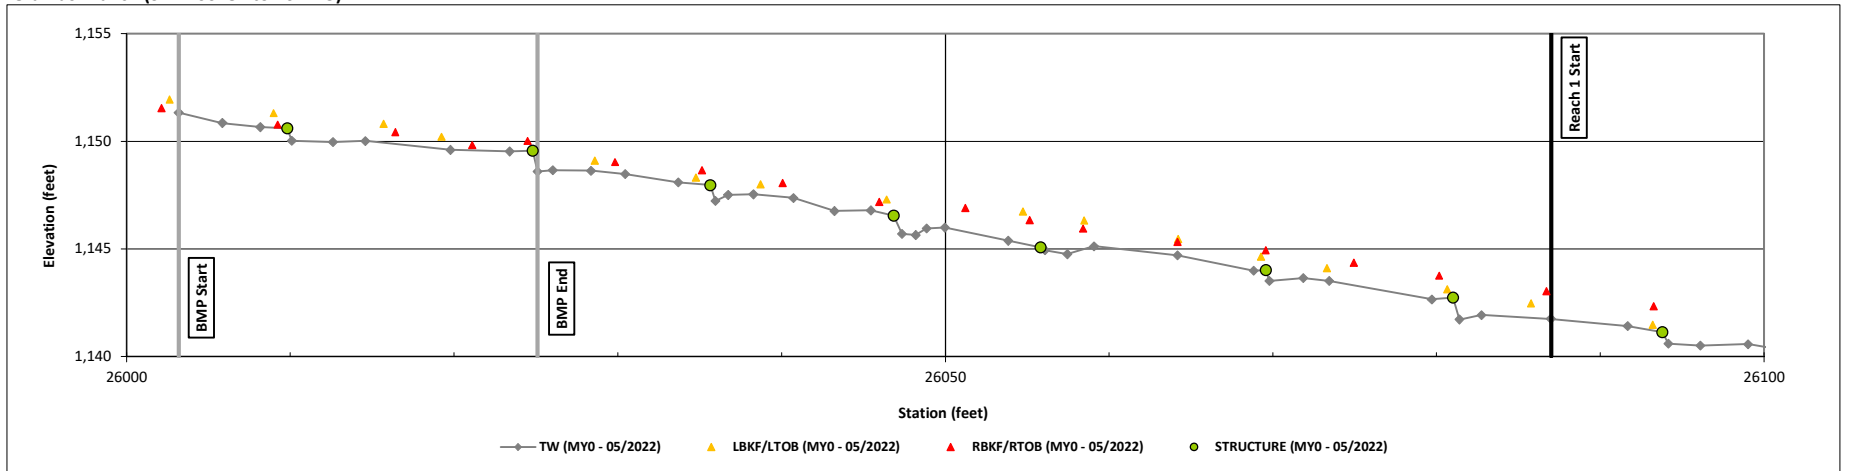
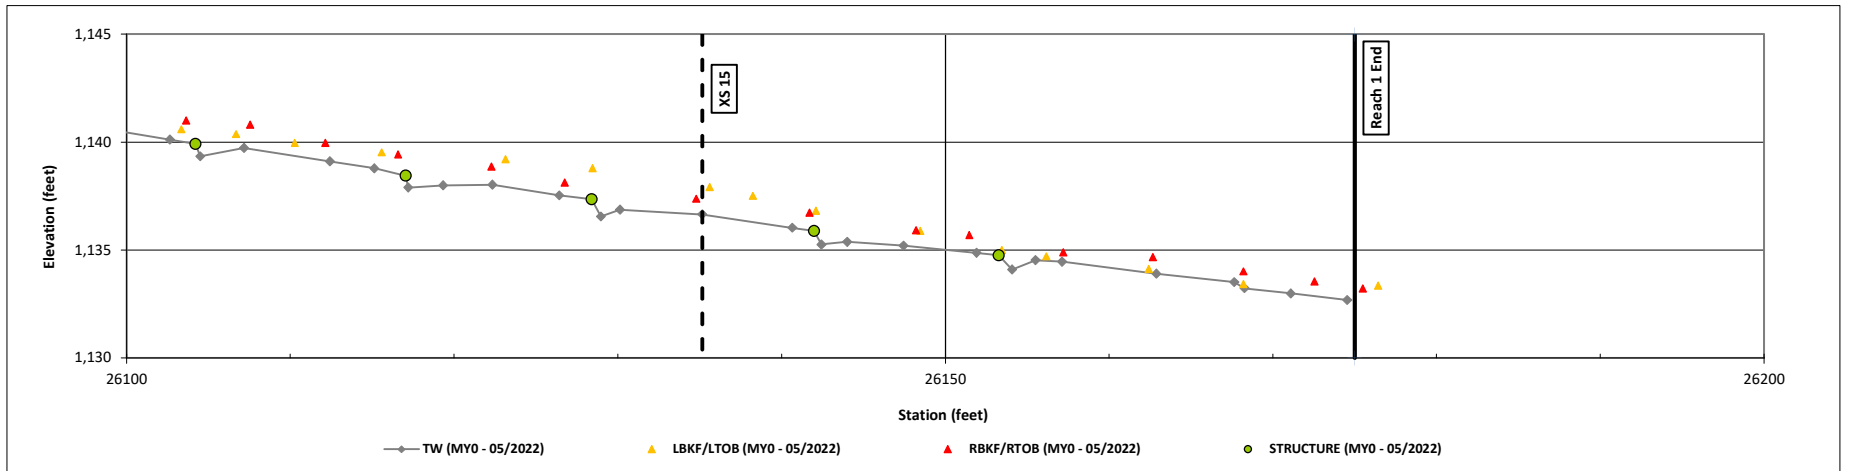
Old Bus Branch (STA 260+87 to 261+75)

Channel was dry at the time of survey.
