# **PHASE II MONITORING YEAR 0 ANNUAL REPORT**

## **MILLSTONE CREEK MITIGATION SITE**

Randolph County, NC  
Cape Fear River Basin  
HUC 03030003

DMS Project No. # 204  
NCDEQ Contract No. 6741  
USACE Action ID No. 2018-01788  
DWR Project No. 16-1200  
Data Collection Dates: February 2024 – April 2024

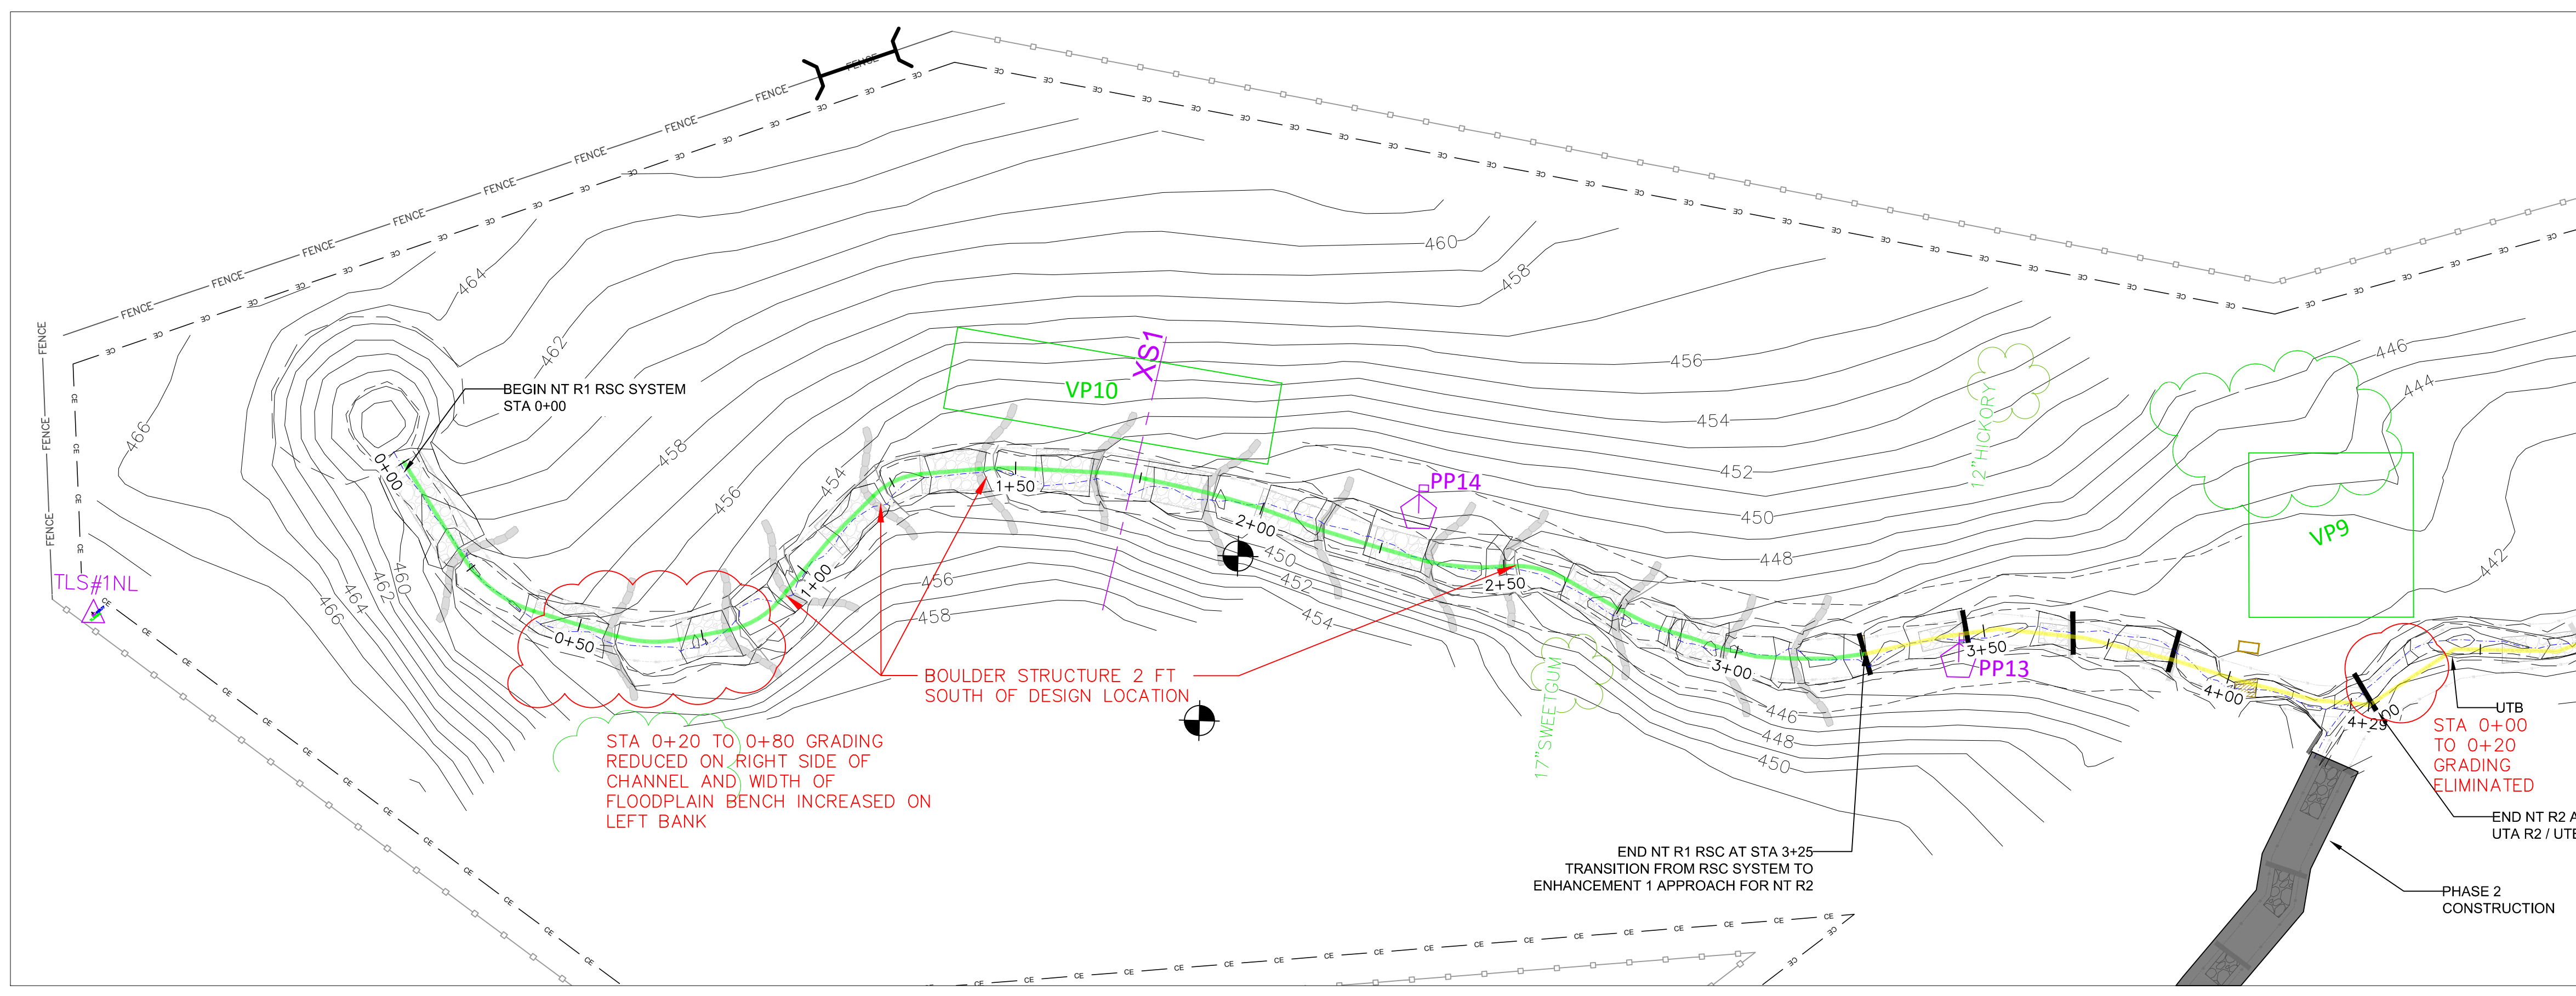
- NOTES:**
1. DEVIATIONS FROM THE DESIGN WILL BE SHOWN IN RED
  2. BOULDERS ARE LARGER THAN SPECIFIED AND EXTEND TO THE BOTTOM OF THE MEDIA TRENCH. AN ADDITIONAL 0.5 FT OF MEDIA WAS ADDED FROM STA 2+50 TO STA 3+25 TO COMPENSATE FOR THE LOSS IN MEDIA VOLUME DUE TO THE LARGER BOULDERS

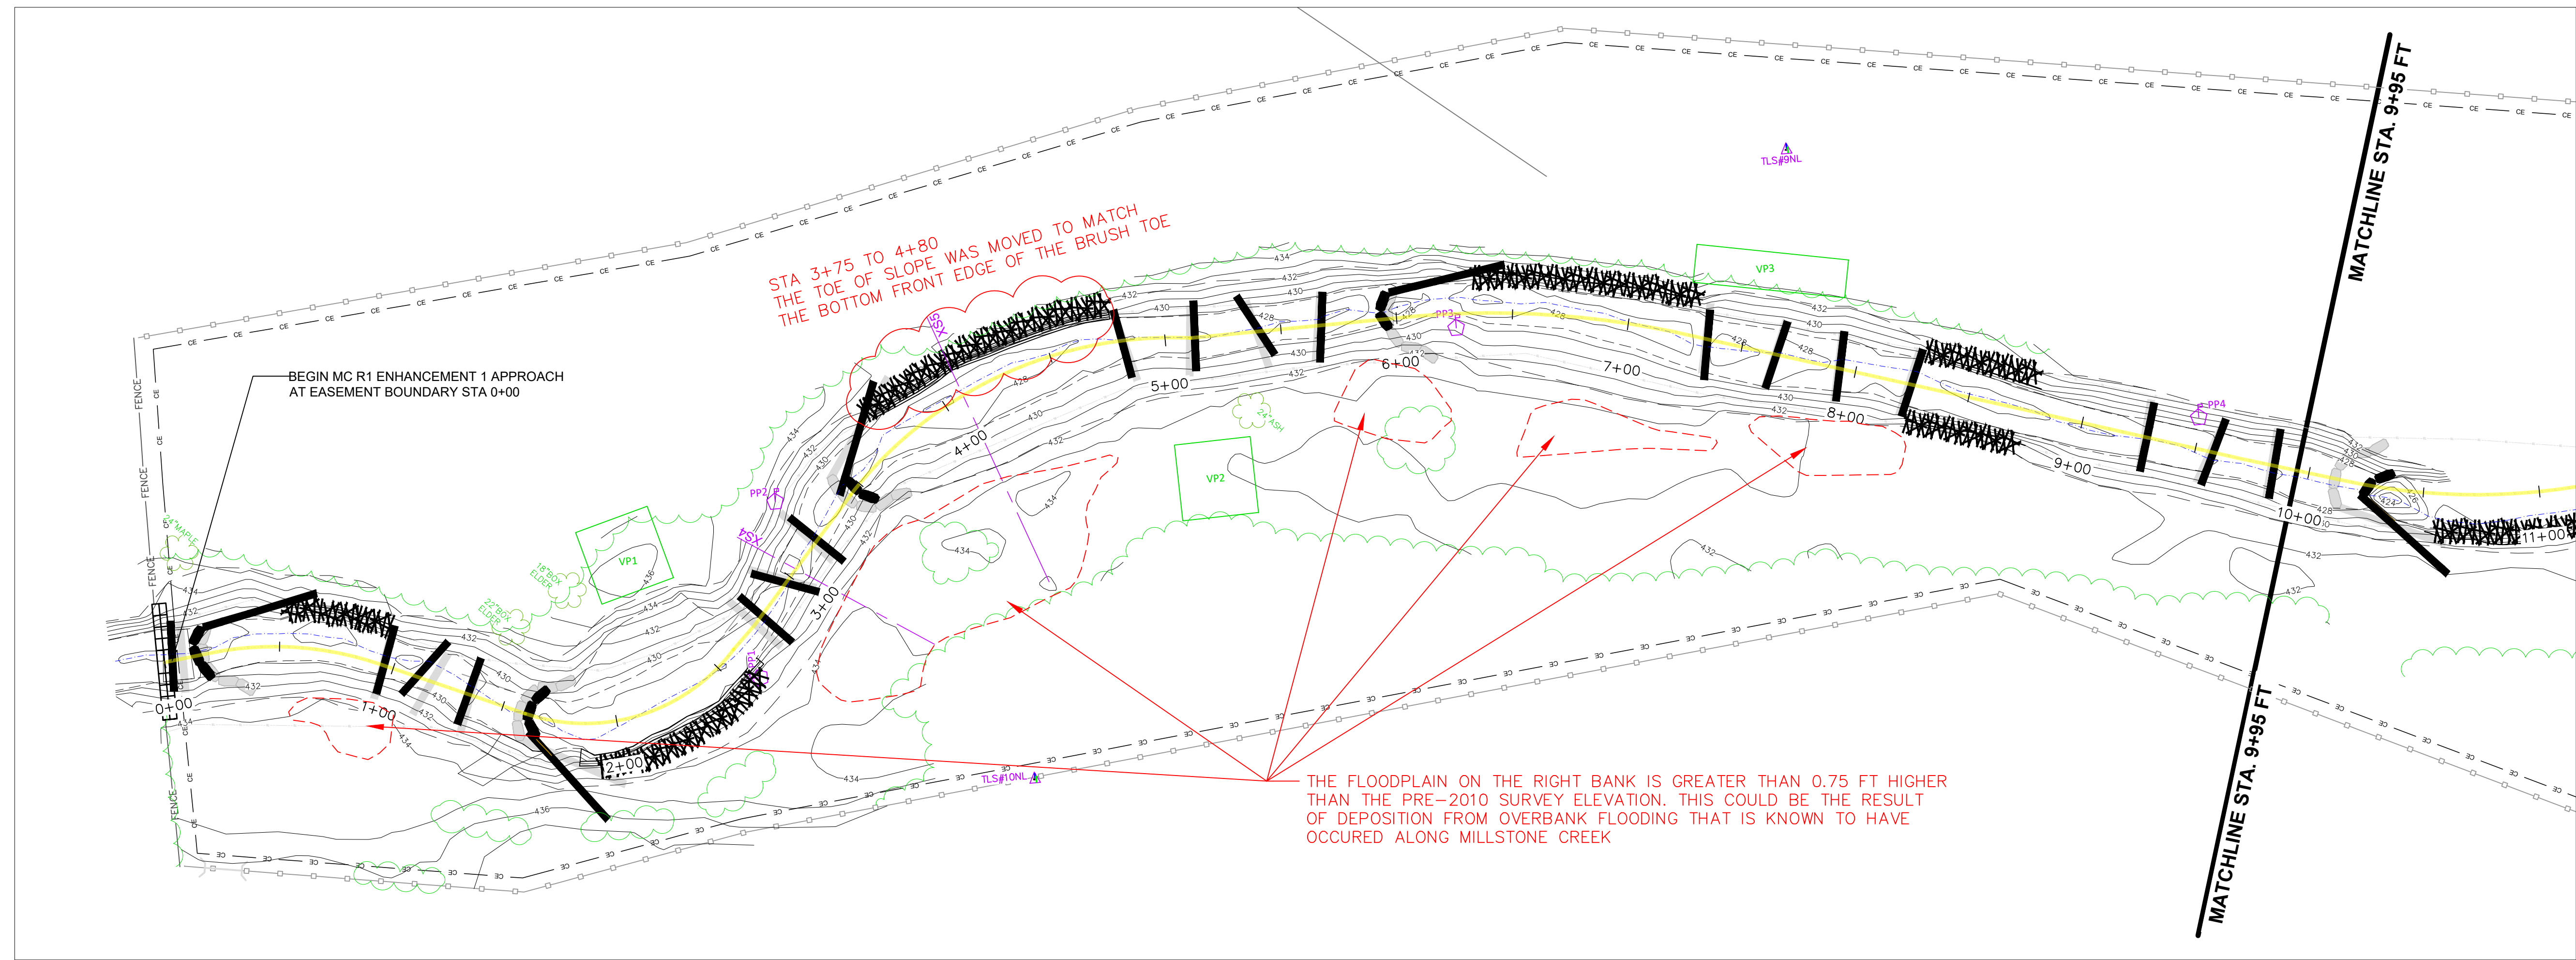
- NOTES:
1. DEVIATIONS FROM THE DESIGN WILL BE SHOWN IN RED
  2. ALL J-HOOKS WERE LOCATED AND ORIENTED ACCORDING TO THE DESIGN DETAIL NOT THE PLAN VIEW LOCATION
  3. ALL POOL DEPTHS WERE MODIFIED TO BE TWO (2) FT BELOW THE THALWEG FOR THE UPSTREAM PC DUE TO THE PRESENCE OF RUNNING SAND

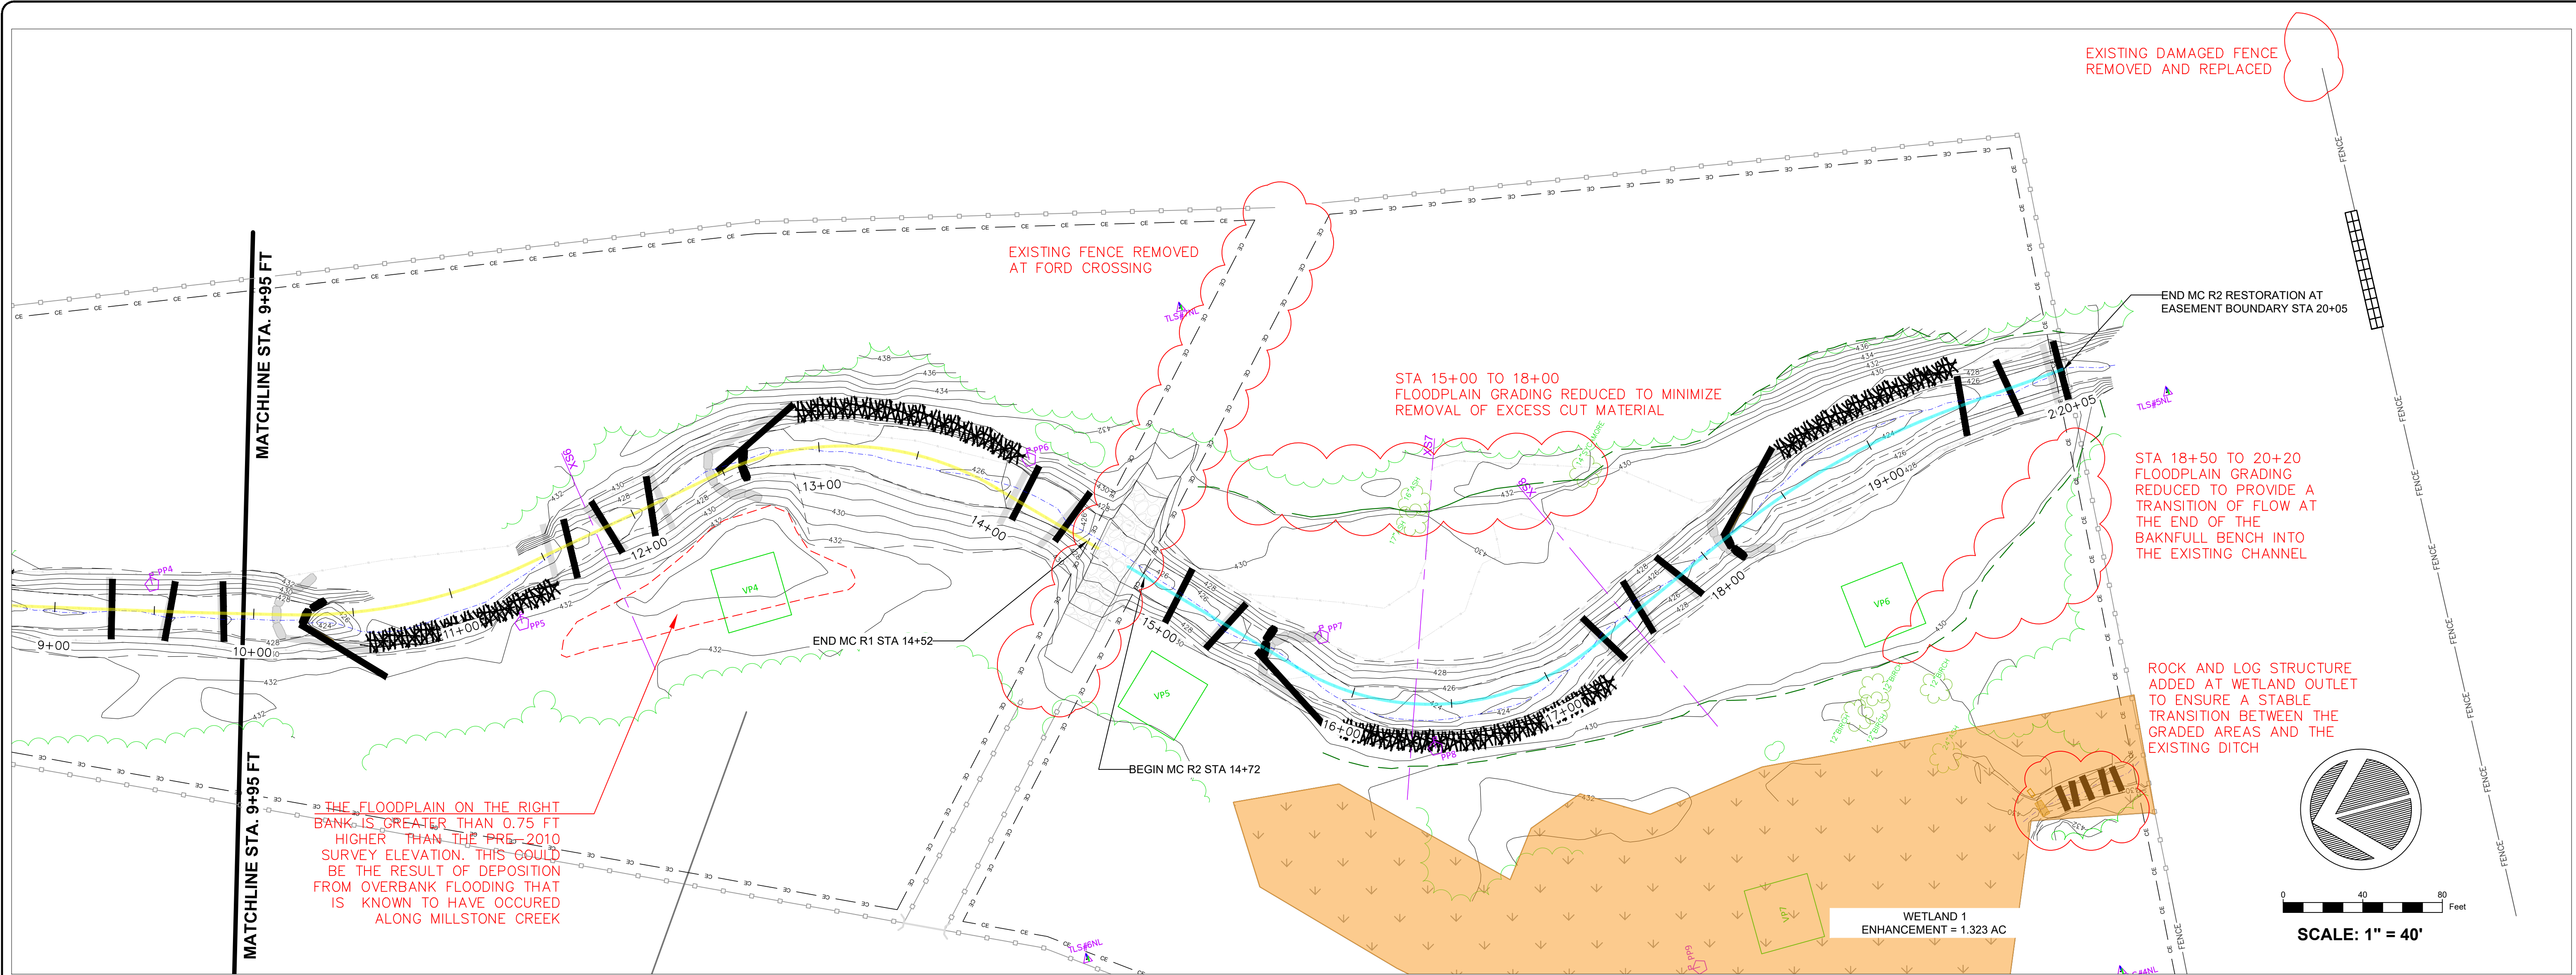
THE FLOODPLAIN ON THE RIGHT BANK IS GREATER THAN 0.75 FT HIGHER THAN THE PRE-2010 SURVEY ELEVATION. THIS COULD BE THE RESULT OF DEPOSITION FROM OVBANK FLOODING THAT IS KNOWN TO HAVE OCCURED ALONG MILLSTONE CREEK

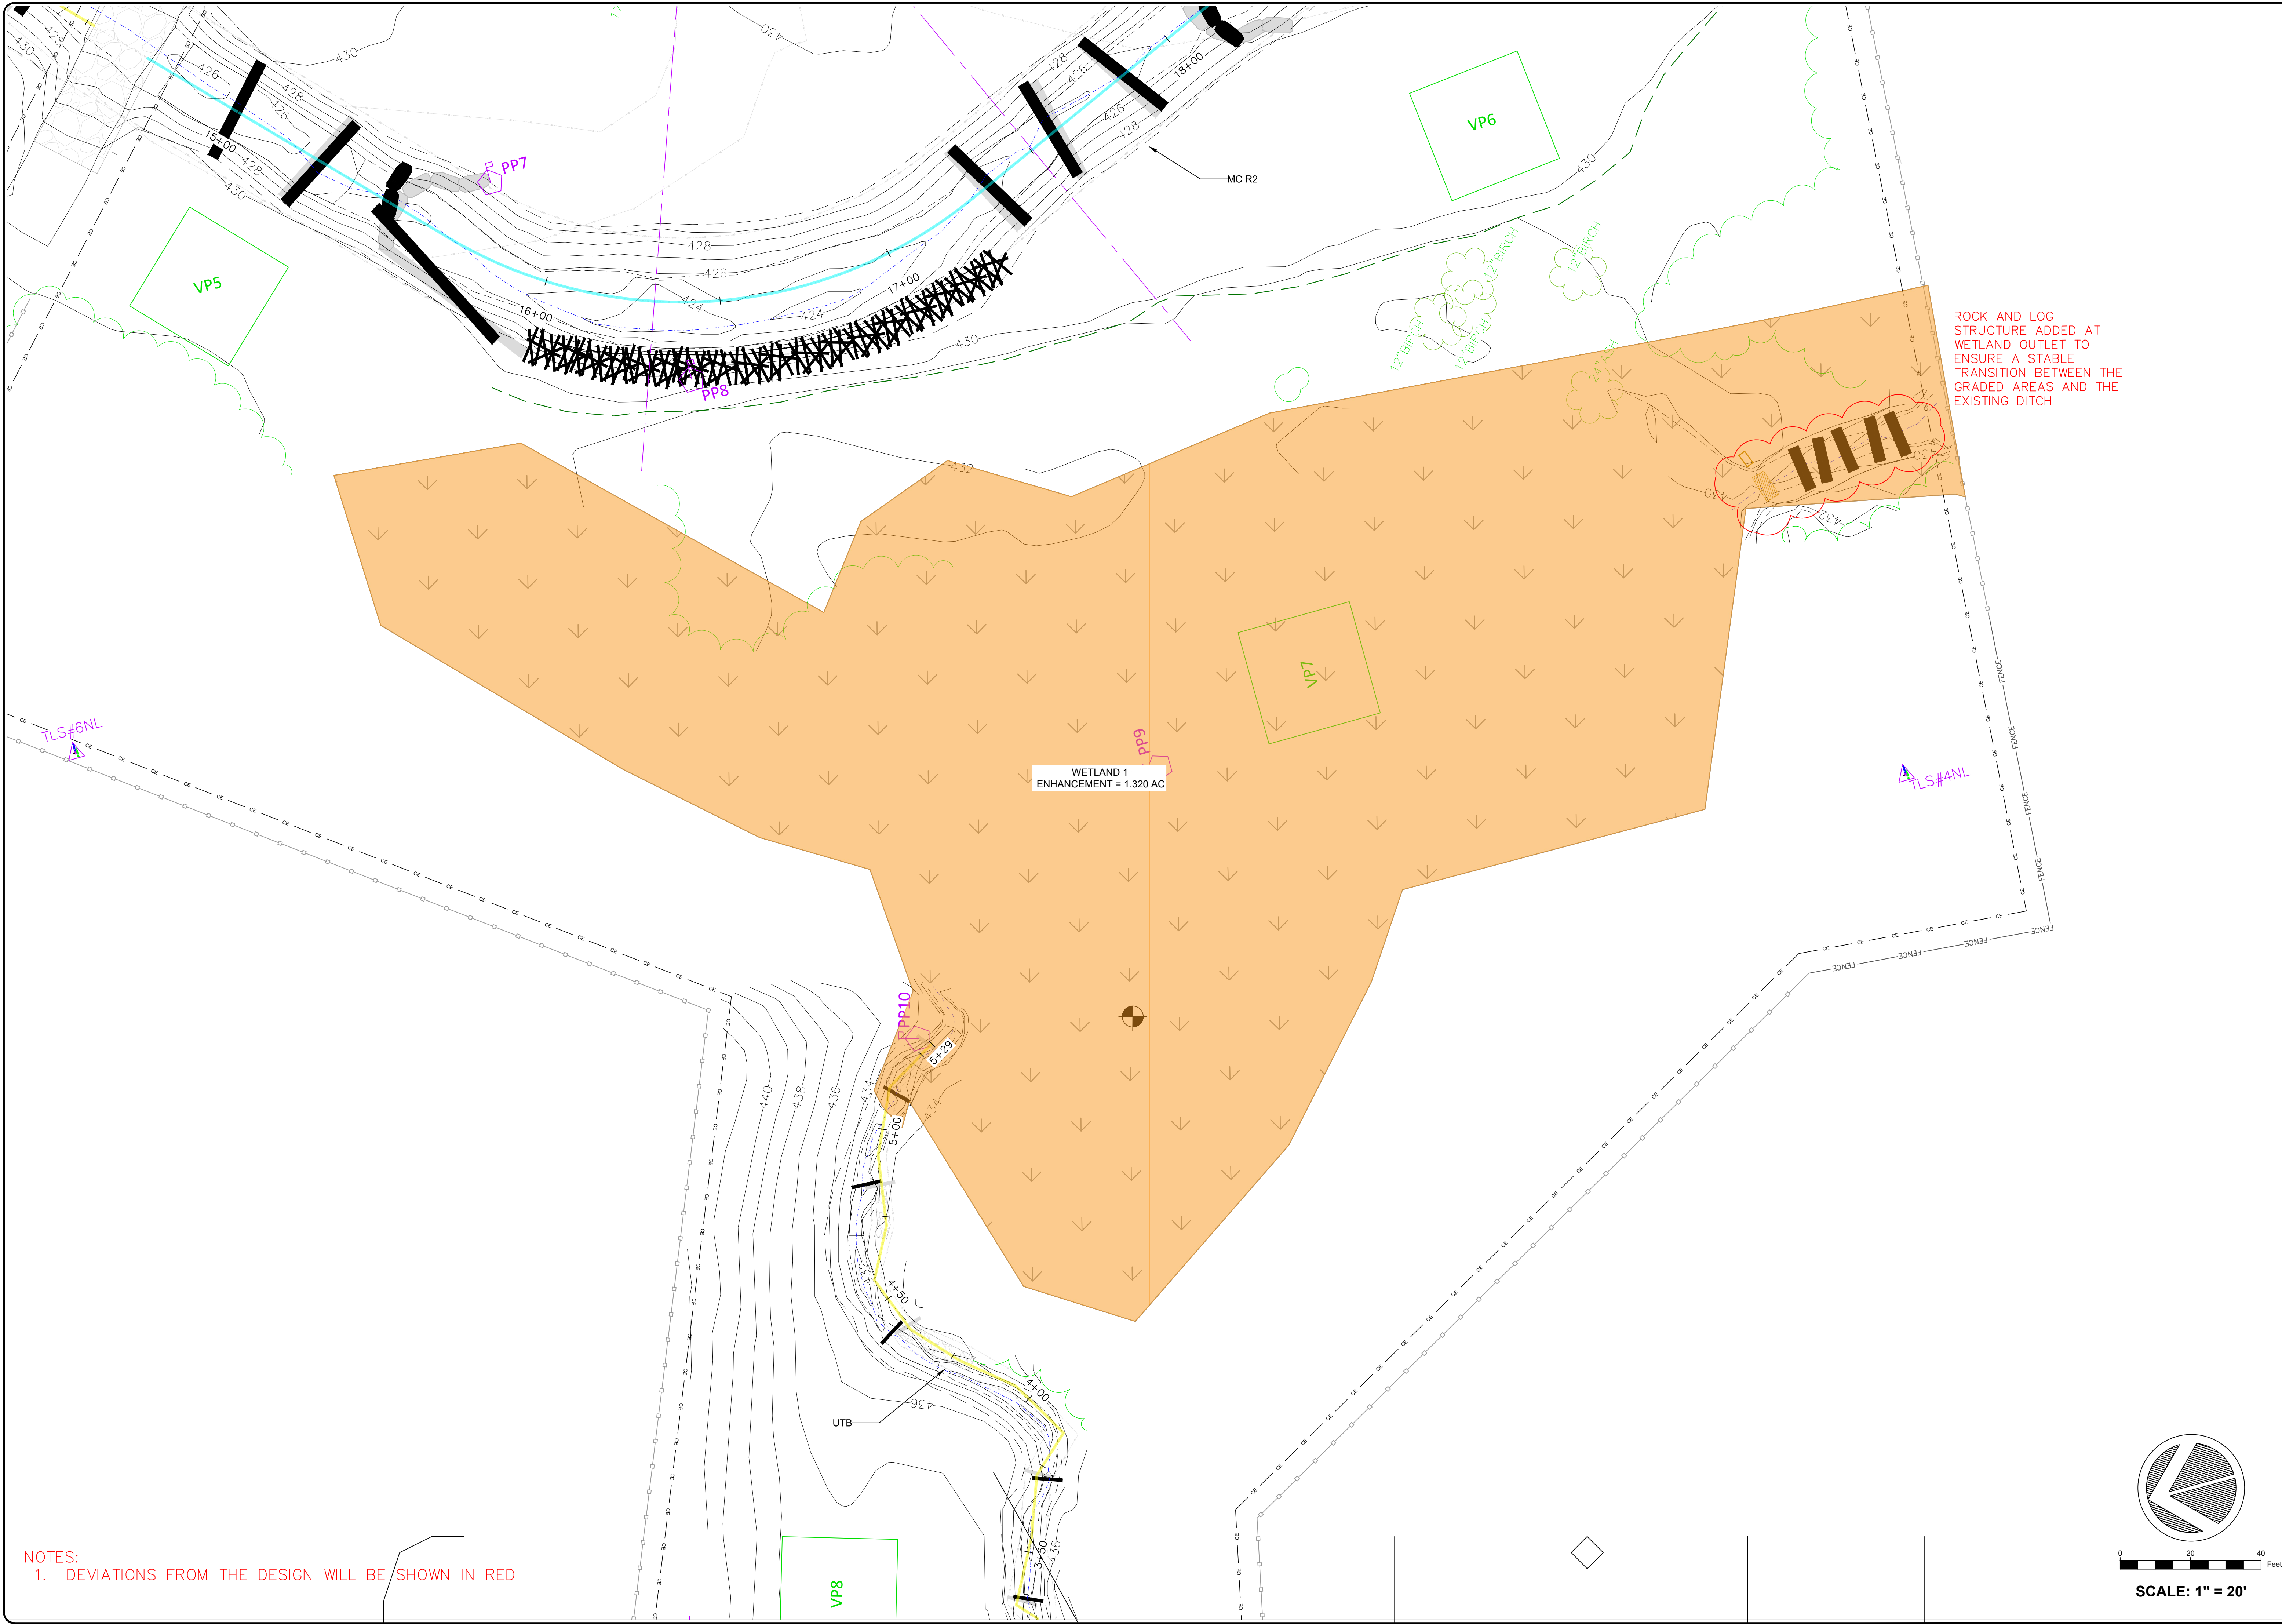
ROCK AND LOG  
STRUCTURE ADDED AT  
WETLAND OUTLET TO  
ENSURE A STABLE  
TRANSITION BETWEEN THE  
GRADED AREAS AND THE  
EXISTING DITCH
