PHASE I MONITORING YEAR 0 ANNUAL REPORT

MILLSTONE CREEK MITIGATION SITE

DMS Project No. # 204
NCDEQ Contract No. 6741
USACE Action ID No. 2018-01788
DWR Project No. 16-1200
Data Collection Dates: August 2021 – January 2022

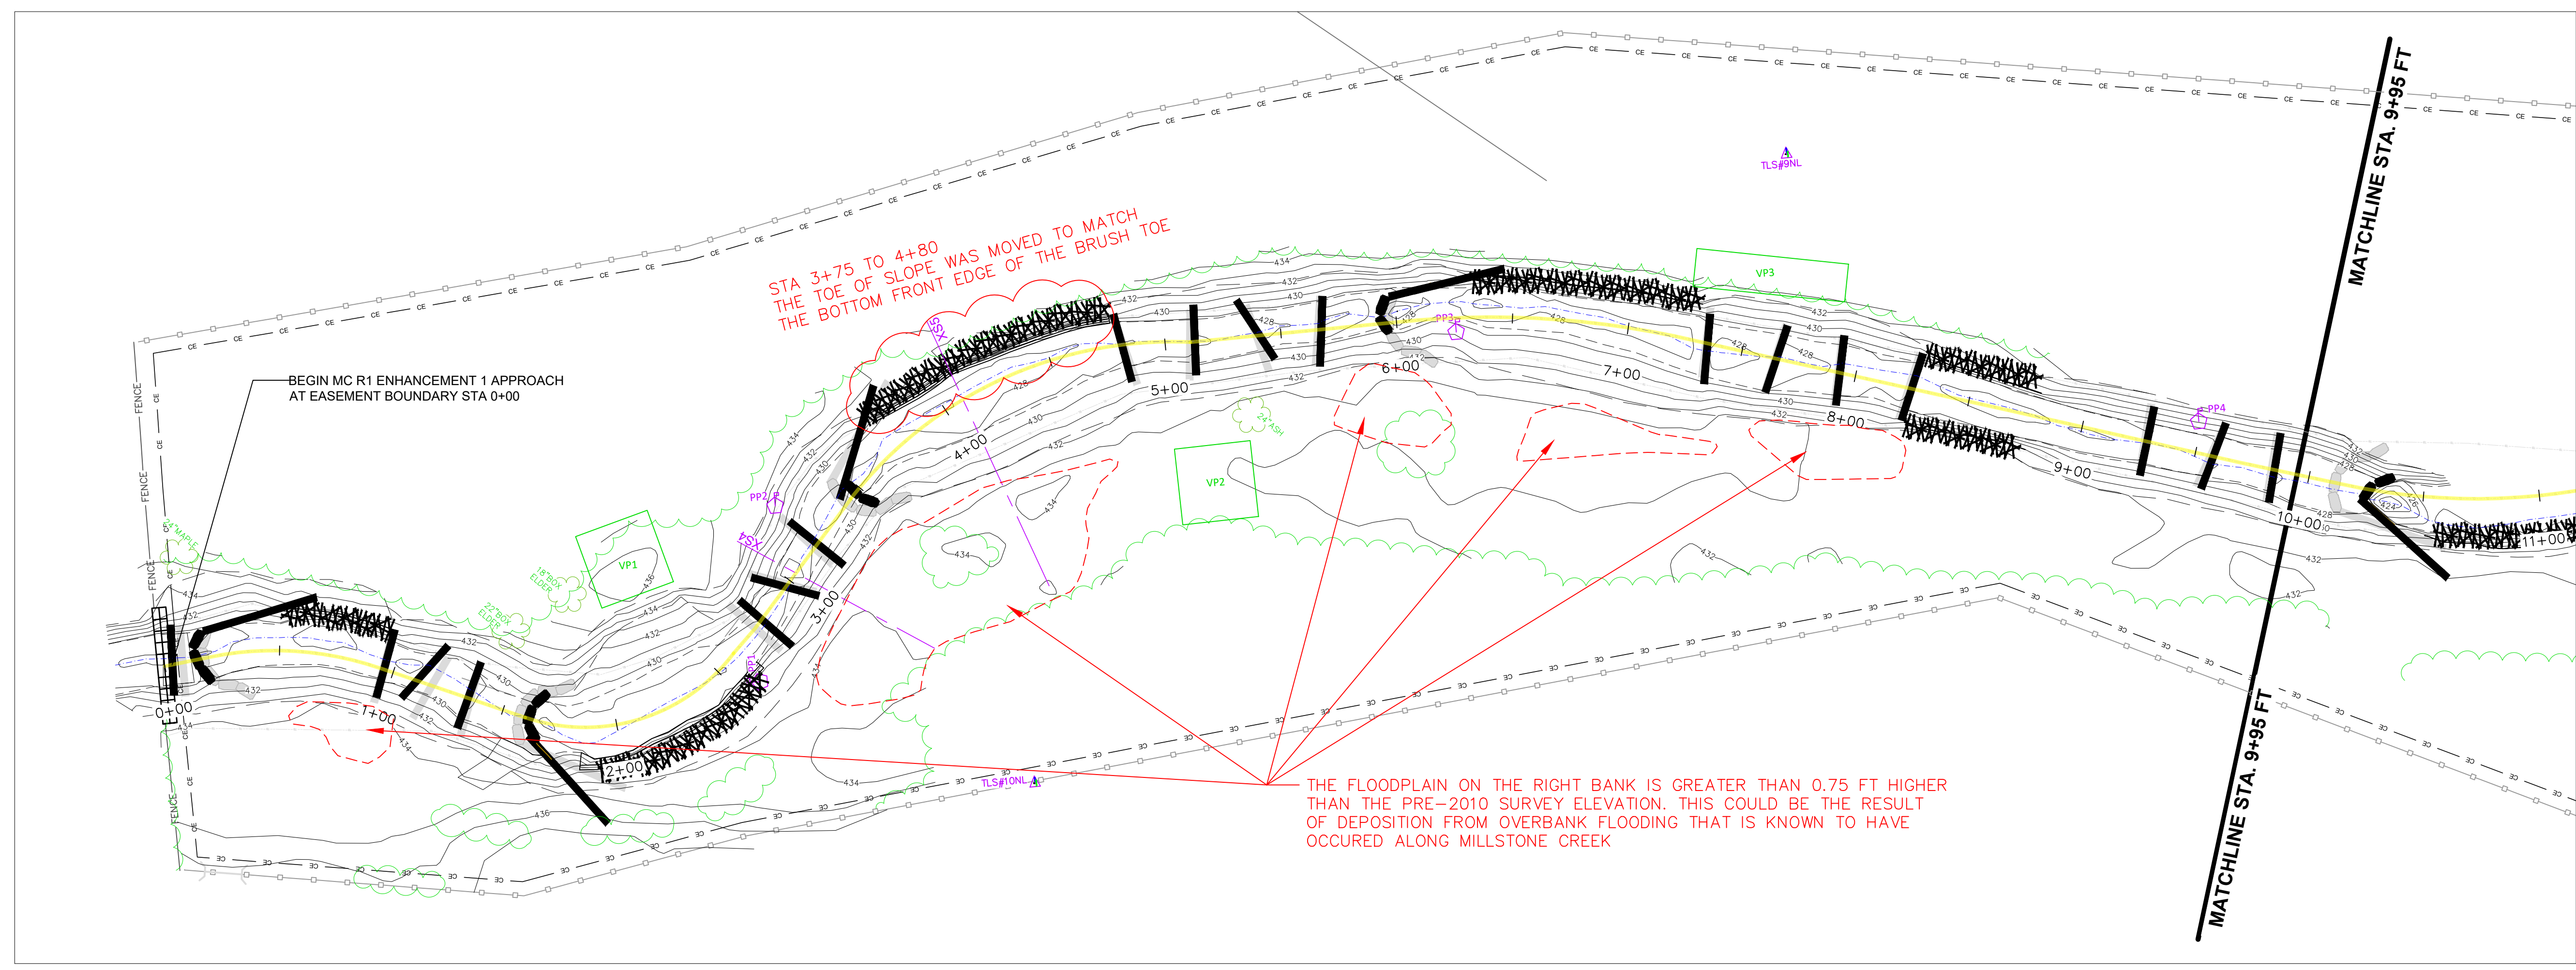
- NOTES:
1. DEVIATIONS FROM THE DESIGN WILL BE SHOWN IN RED
 2. ALL J-HOOKS WERE LOCATED AND ORIENTED ACCORDING TO THE DESIGN DETAIL NOT THE PLAN VIEW LOCATION
 3. ALL POOL DEPTHS WERE MODIFIED TO BE TWO (2) FT BELOW THE THALWEG FOR THE UPSTREAM PC DUE TO THE PRESENCE OF RUNNING SAND
