# **MYO FINAL MONITORING REPORT**

# LAUREL SPRINGS STREAM AND WETLAND MITIGATION SITE

Avery County, North Carolina French Broad River Basin Cataloging Unit 06010108

DMS Project No. 100122
Full Delivery Contract No. 7890
DMS RFP No. 16-007725 (issued 11/13/18)
USACE Action ID No. SAW-2019-00835
DWR Project No. 2019-0865

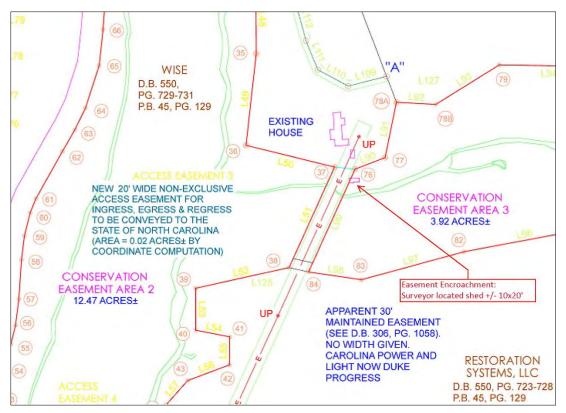
During the MYO site visit with the NCDMS, it was noted that a small (approximately 10'x20') shed was located within the easement and UT3. Through discussions with DMS and the landowner, it was agreed the best course of action was to decommission and remove the shed as opposed to modifying the conservation easement. RS has offered, and the landowner has agreed, to construct a new shed, outside of the easement boundary, and to remove the old shed and equipment from the easement. This work is being schedule and will be completed before the final Year 1 Monitoring Report.

Figure 1 – Location of shed within the Site's conservation easement

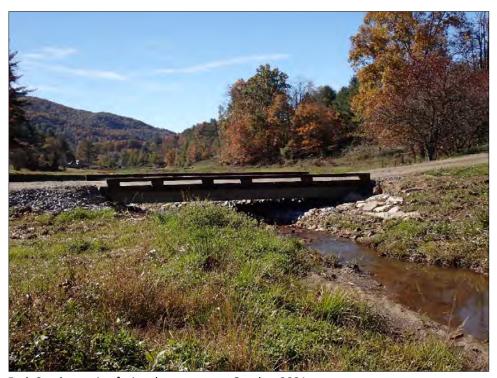
Fork Creek crossing facing downstream – October 2021

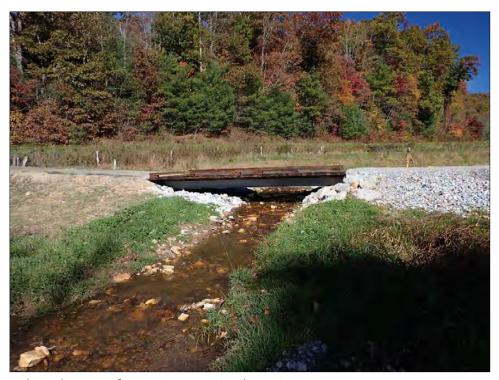
Fork Creek crossing facing upstream – October 2021

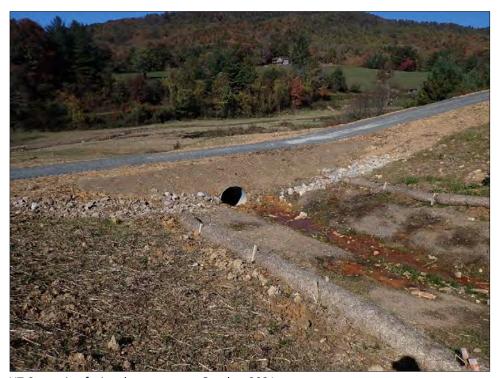
UT-2 crossing facing downstream – October 2021

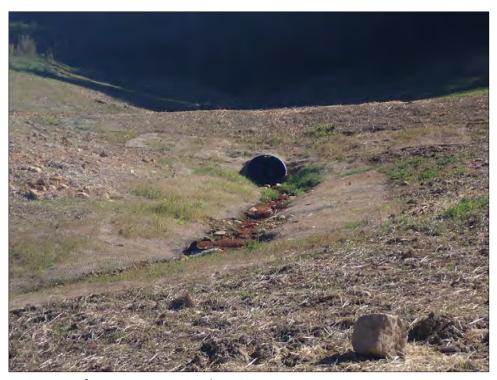
UT-2 crossing facing upstream – October 2021

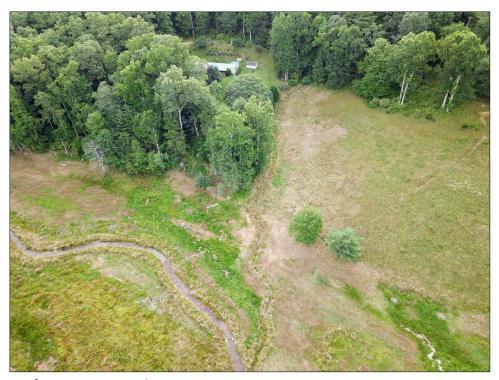
UT3 facing upstream – July 13, 2022

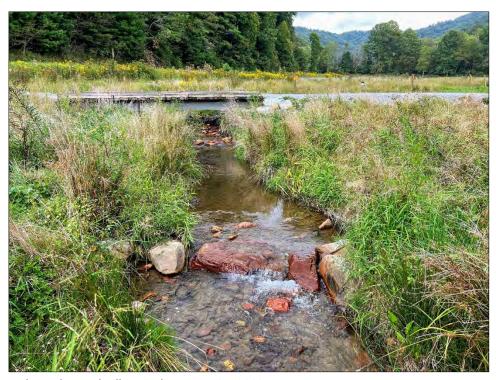
Fork Creek – Rock sill, typical – August 25, 2022

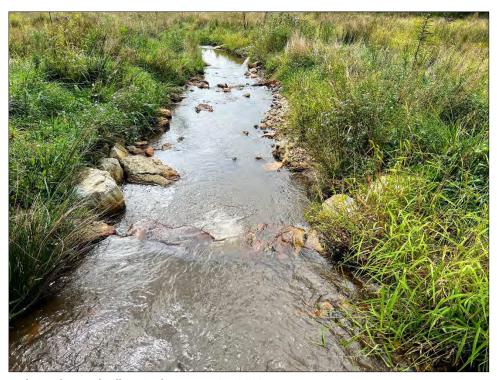
Fork Creek – Rock sill, typical – August 25, 2022

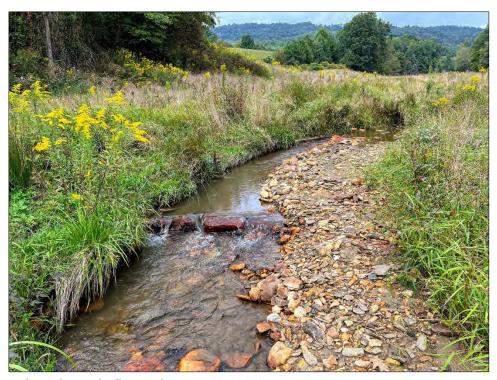
Fork Creek – Rock sill, typical – August 25, 2022
