# Monitoring Report MY06

**Sandy Bridge Restoration Site  
DMS Contract 6400  
DMS Project Number 96920**

**DWR #: 15-0414  
USACE Action ID: 201500827  
Rutherford County, North Carolina**

**Monitoring Data Collected: 2022  
Date Submitted: December 2022**

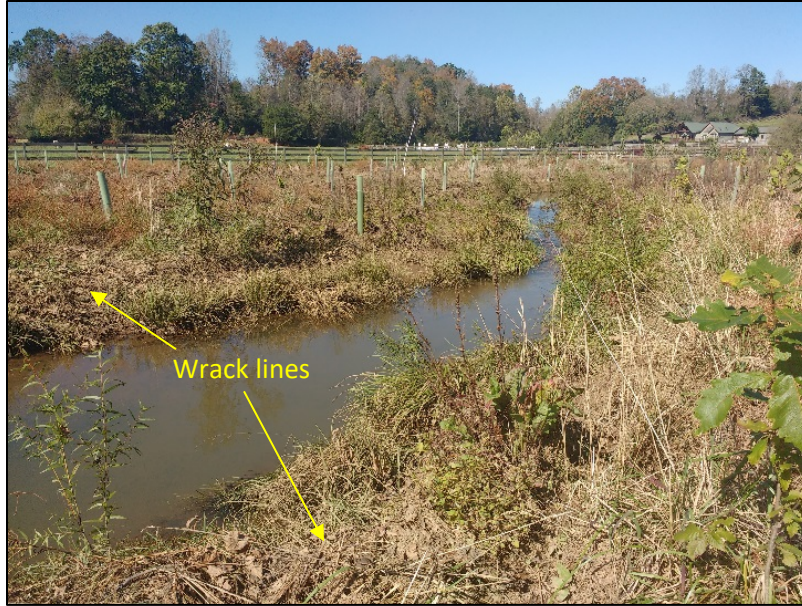
Photo 1. Sediment on plants and wrack lines above bankfull, 10/26/2017

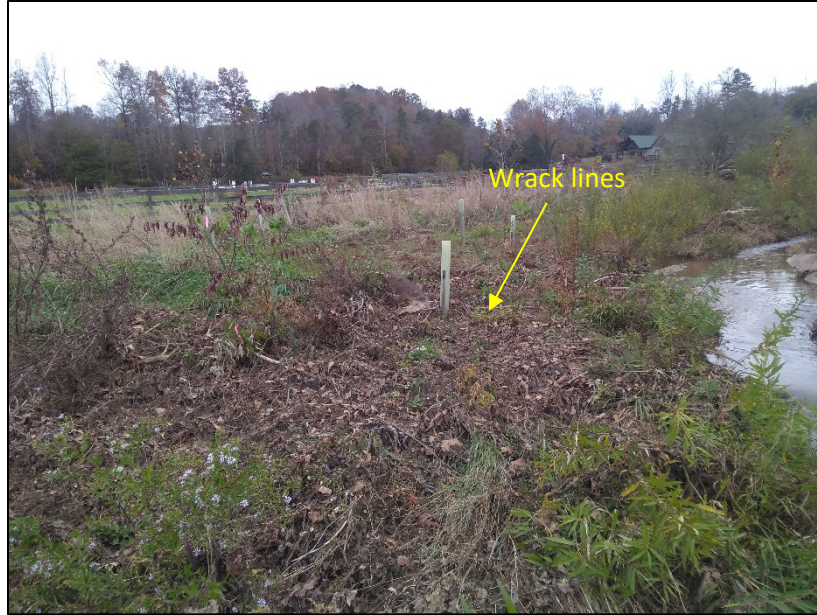
Photo 3. Wrack lines above bankfull, 11/7/2018

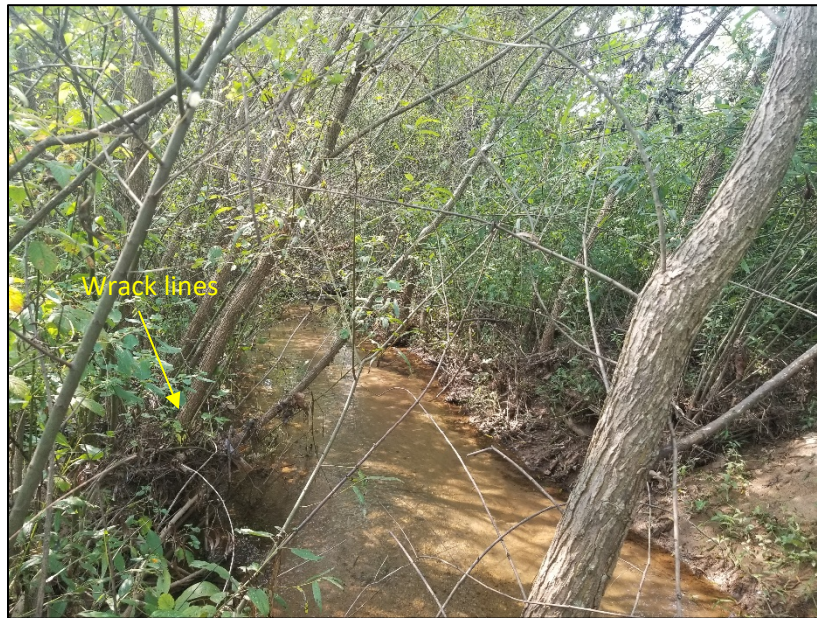
Photo 4. Wrack lines above bankfull, 9/13/2021
