601 East Stream Restoration Site
(EEP Project #95756)
Union County, North Carolina

Baseline Monitoring Document and As-Built Baseline Report Final

Data Collected from December 2014 – February 2015

Submitted May 12, 2015

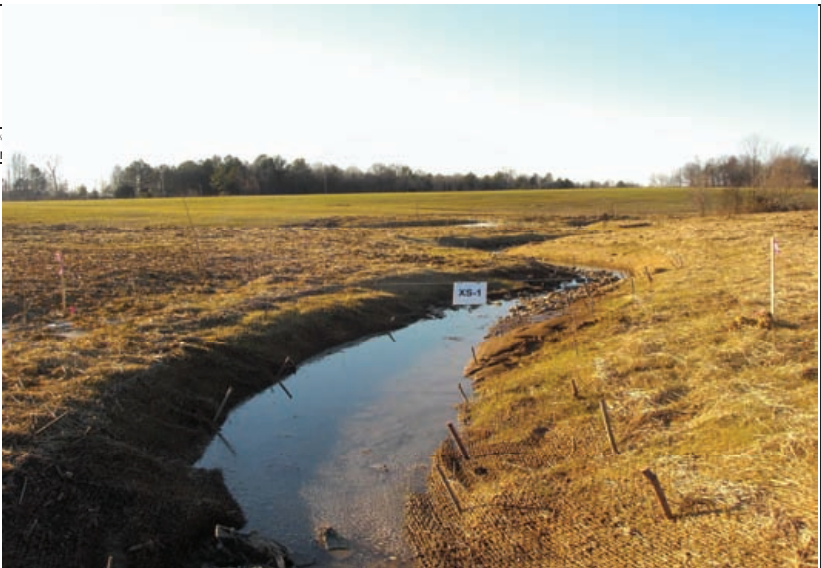
601 East, Reach 1: Cross Section 1

Photo of XS-1, looking in the downstream direction

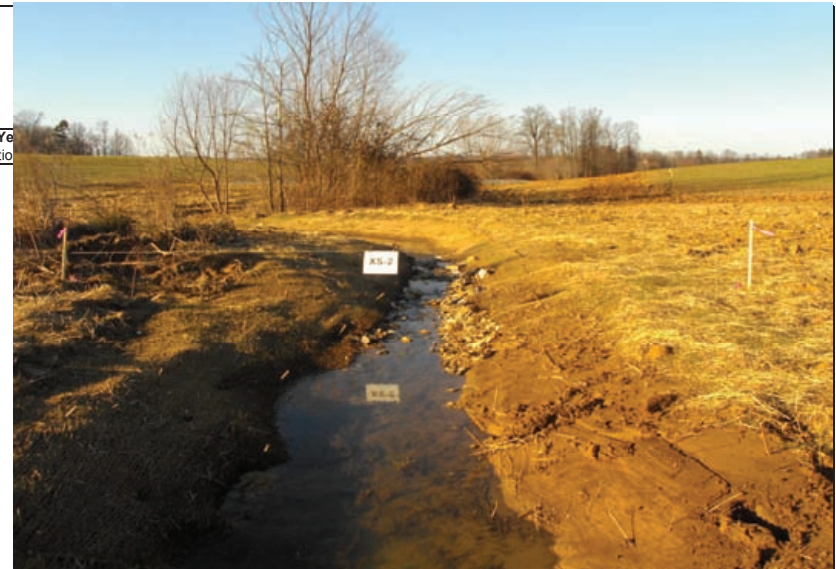
601 East, Reach 1: Cross Section 2

Photo of XS-2, looking in the downstream direction

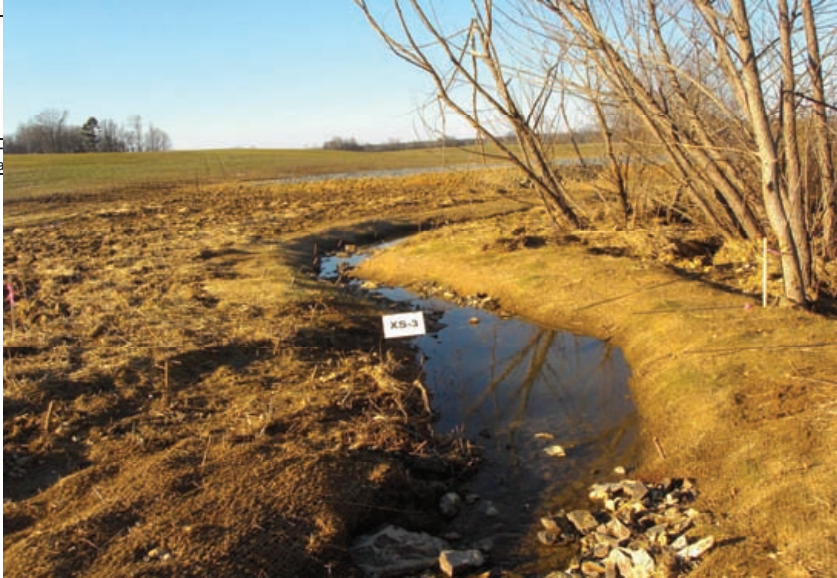
601 East, Reach 1: Cross Section 3

Photo of XS-3, looking in the downstream direction

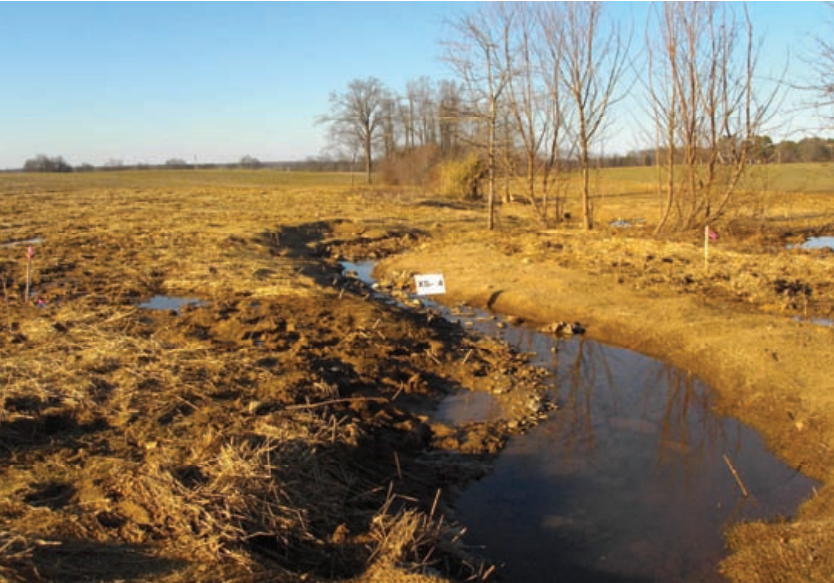
601 East, Reach 1: Cross Section 4

Photo of XS-4, looking in the downstream direction

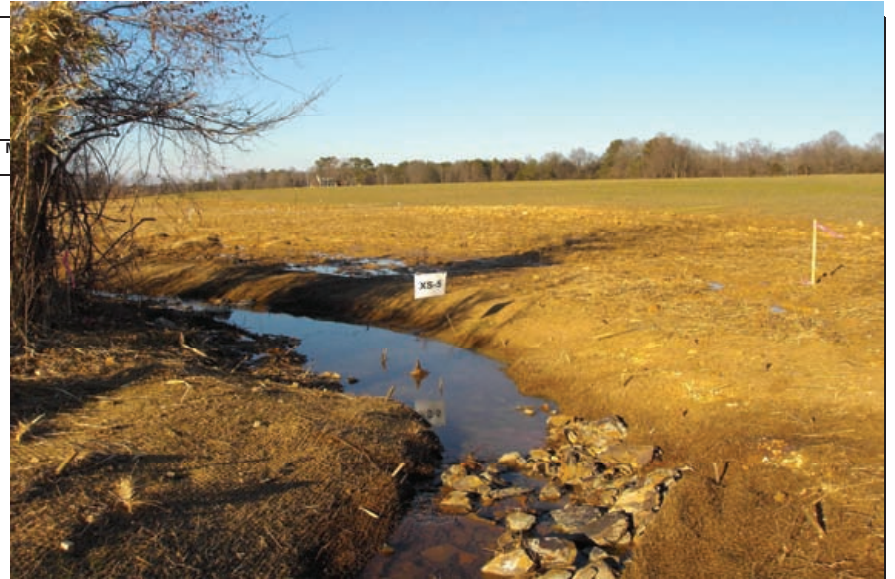
601 East, Reach 1: Cross Section 5

Photo of XS-5, looking in the downstream direction

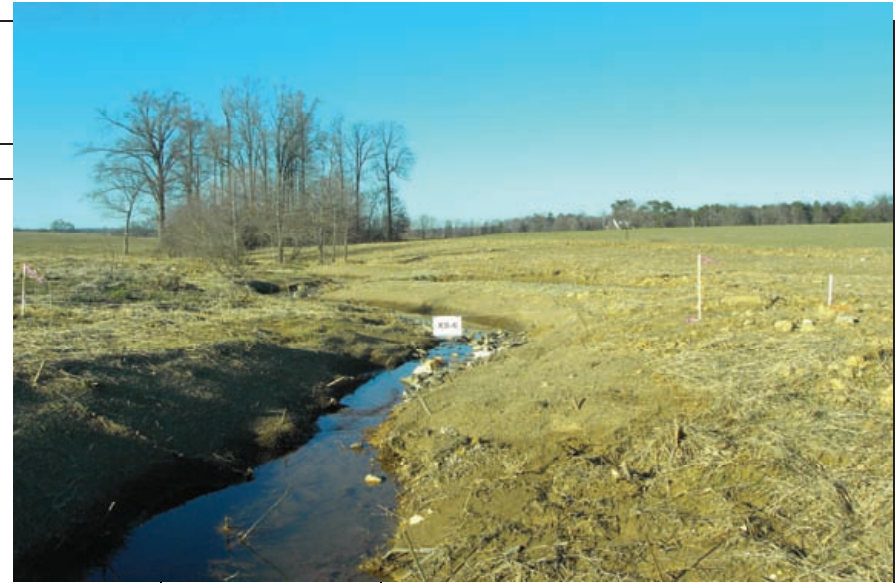
601 East, Reach 1: Cross Section 6

Photo of XS-6 looking in the downstream direction

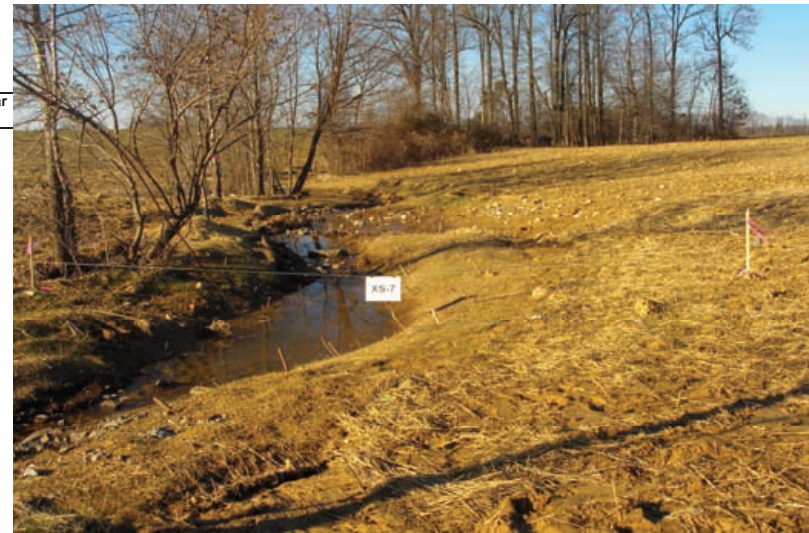
601 East, Reach 1: Cross Section 7

Photo of XS-7 looking in the downstream direction

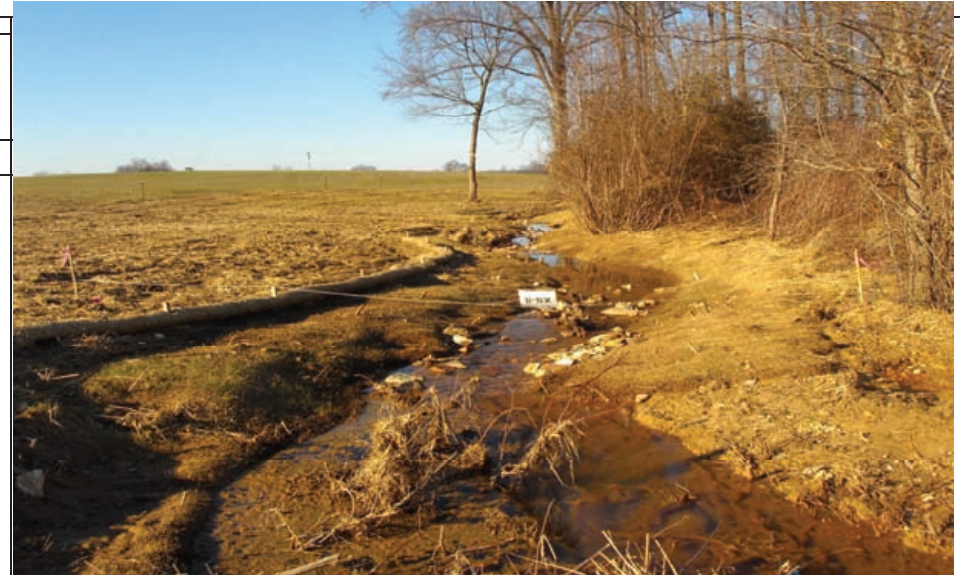
601 East, Reach 1: Cross Section 8

Photo of XS-8 looking in the downstream direction

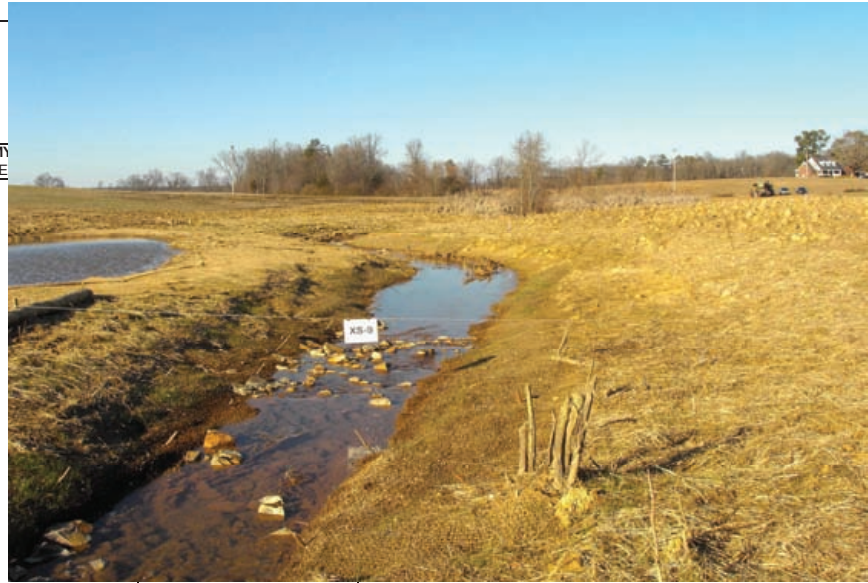
601 East, Reach 2: Cross Section 9

Photo of XS-9, looking in the downstream direction

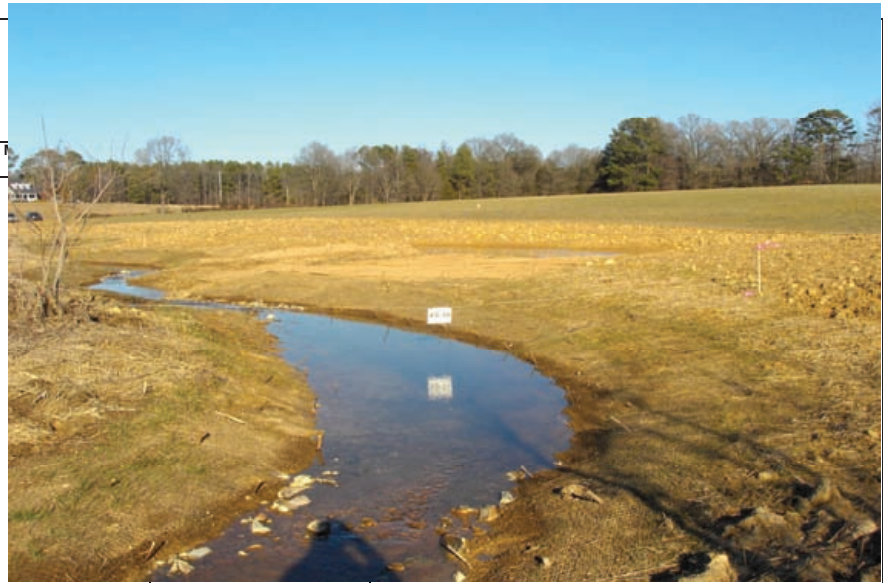
601 East, Reach 2: Cross Section 10

Photo of XS-10, looking in the downstream direction

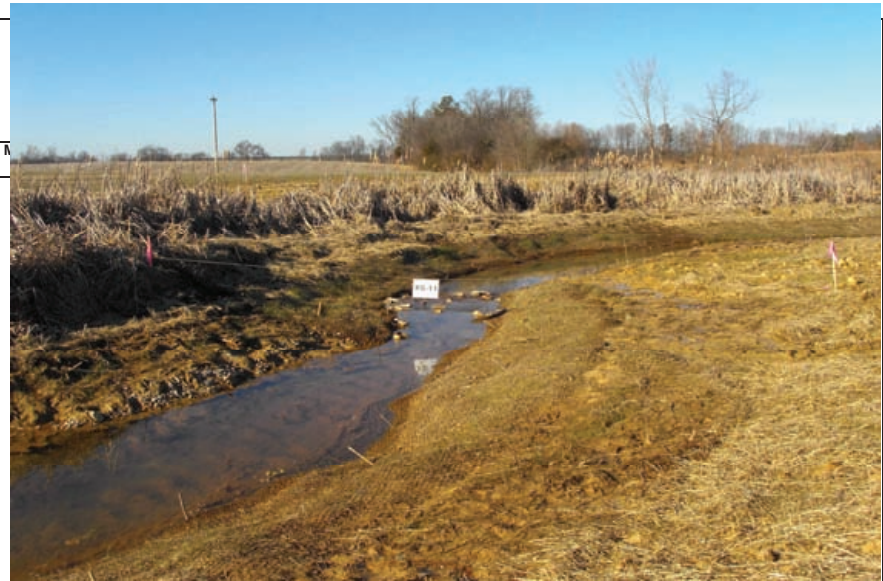
601 East, Reach 2: Cross Section 11

Photo of XS-11 looking in the downstream direction

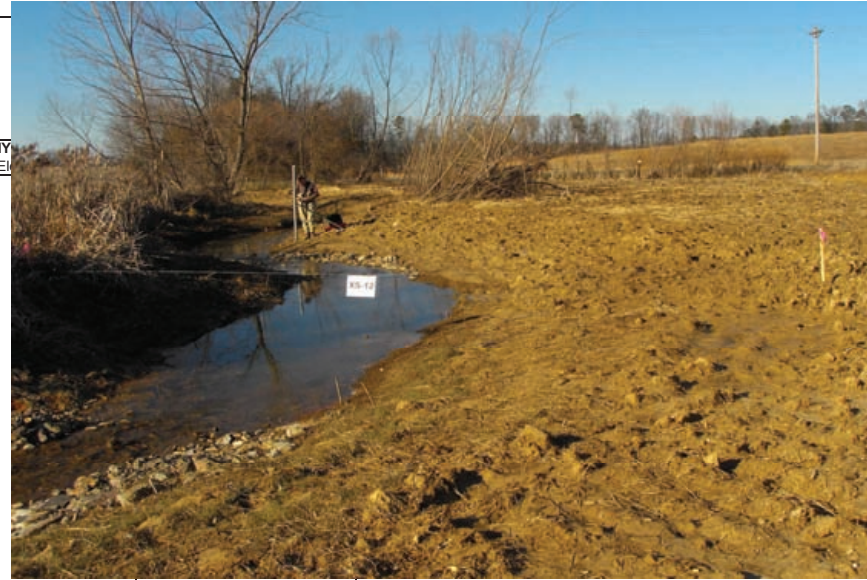
601 East, Reach 2: Cross Section 12

Photo of XS-12, looking in the downstream direction

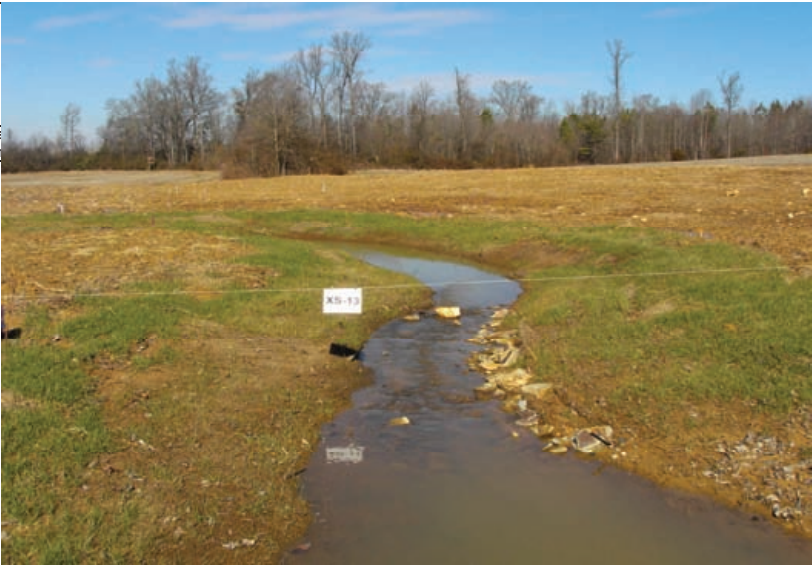
601 East, Reach 3: Cross Section 13

Photo of XS-13, looking in the downstream direction

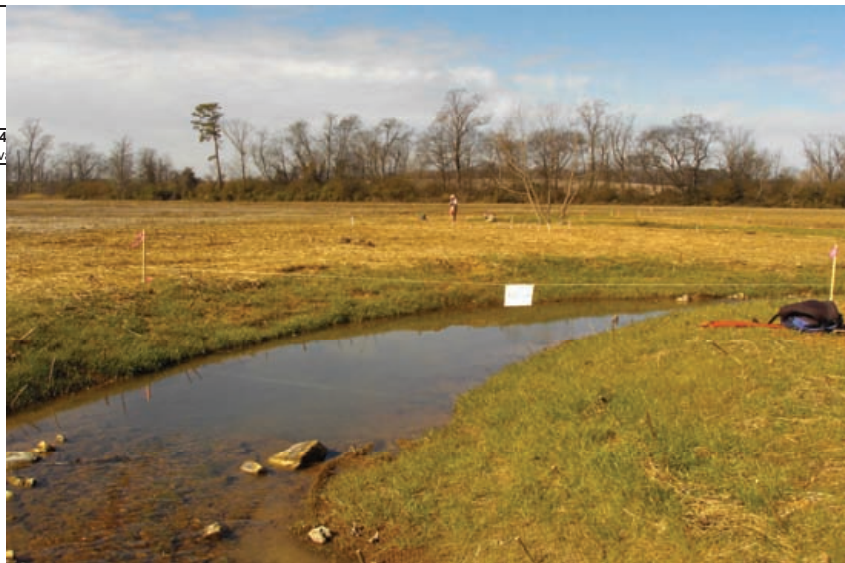
601 East, Reach 3: Cross Section 14

Photo of XS-14, looking in the downstream direction

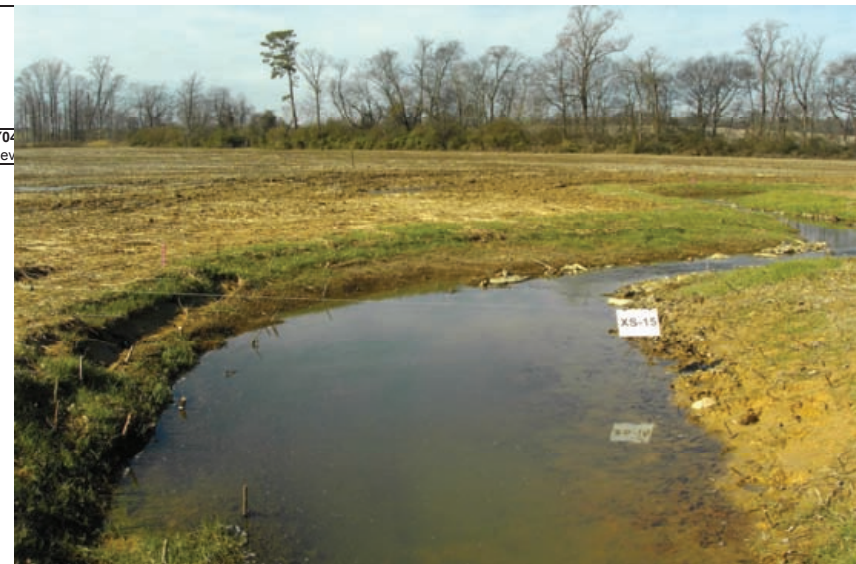
601 East, Reach 3: Cross Section 15

Photo of XS-15 looking in the downstream direction

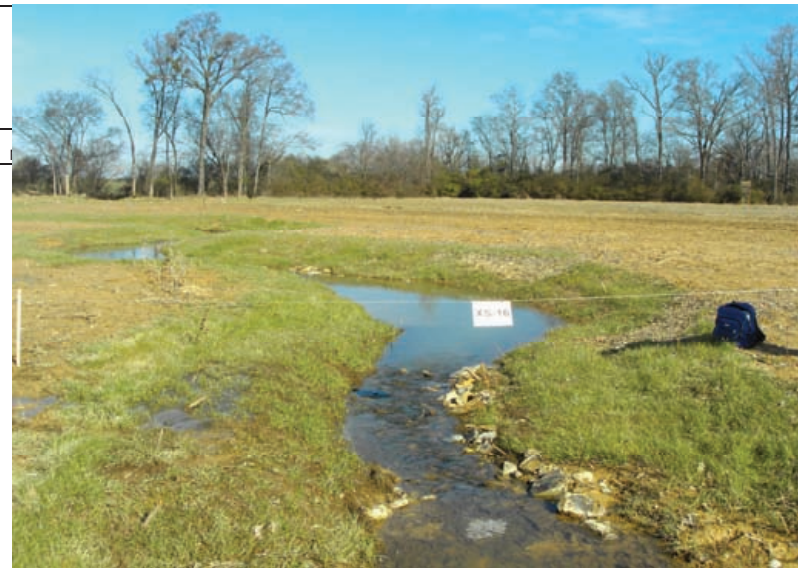
601 East, Reach 3: Cross Section 16

Photo of XS-16, looking in the downstream direction

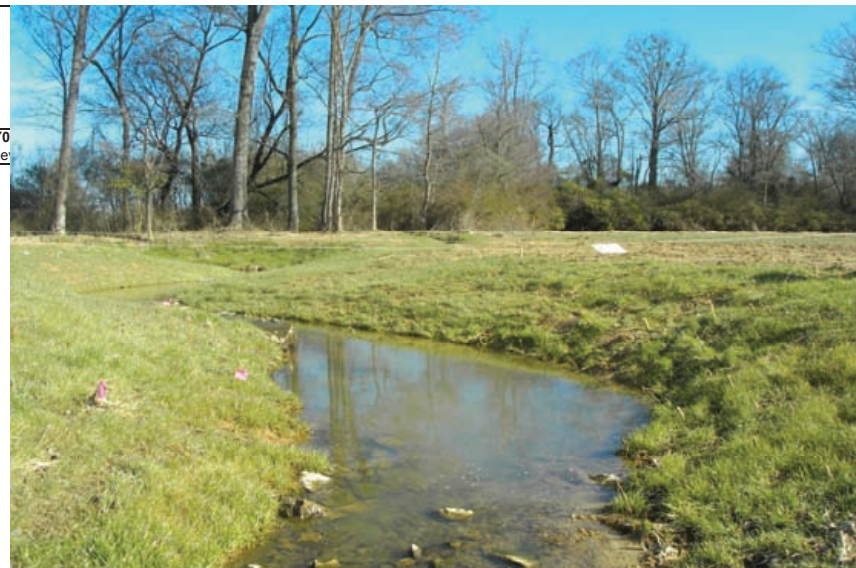
601 East, Reach 4: Cross Section 17

Photo of XS-17, looking in the downstream direction

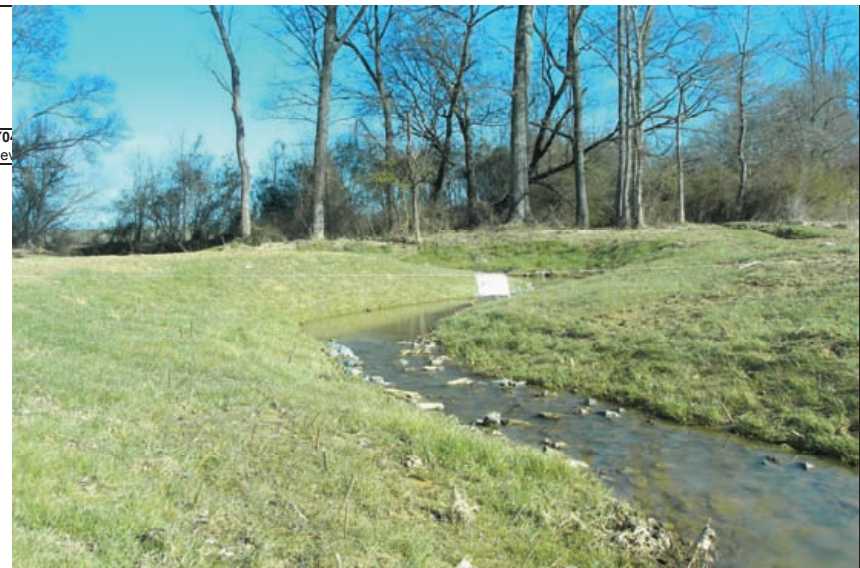
601 East, Reach 4: Cross Section 18

Photo of XS-18, looking in the downstream direction

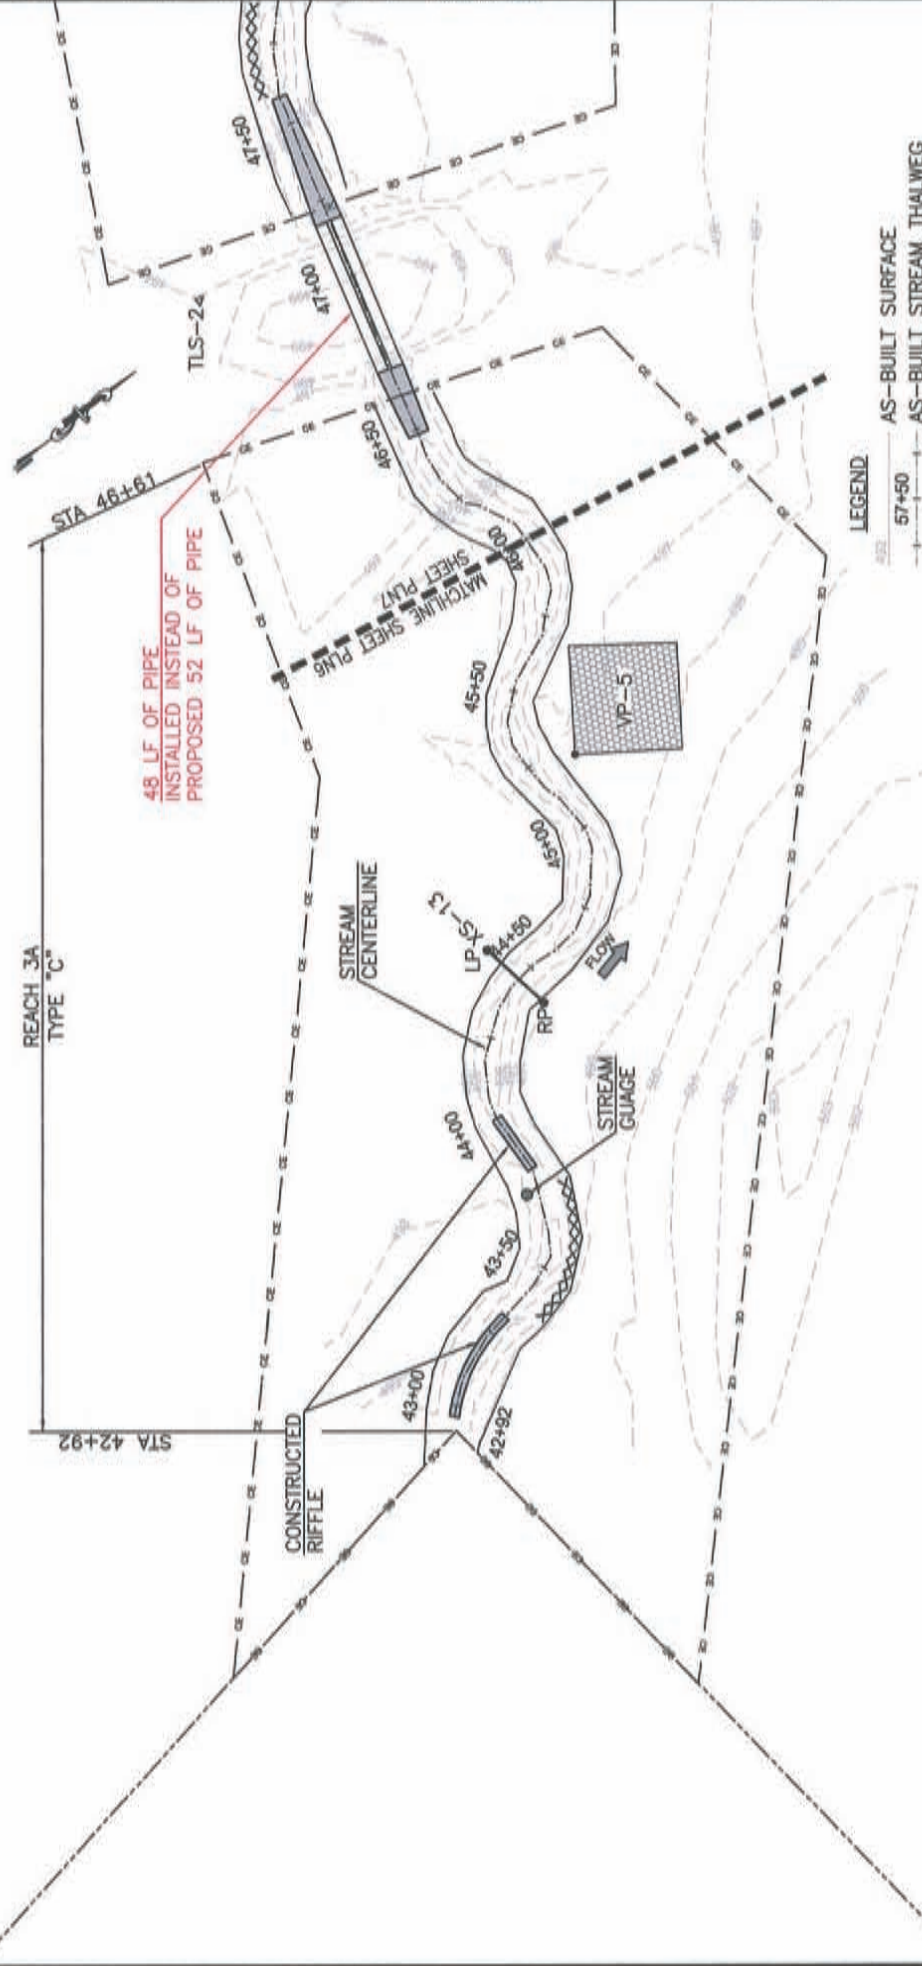
48 LF OF PIPE
 INSTALLED INSTEAD OF
 PROPOSED 52 LF OF PIPE
