# **Annual Monitoring Report**

Monitoring Year 1 of 7

Project Name: 601 East Stream Restoration

Data Collected: September 2015 – November 2015

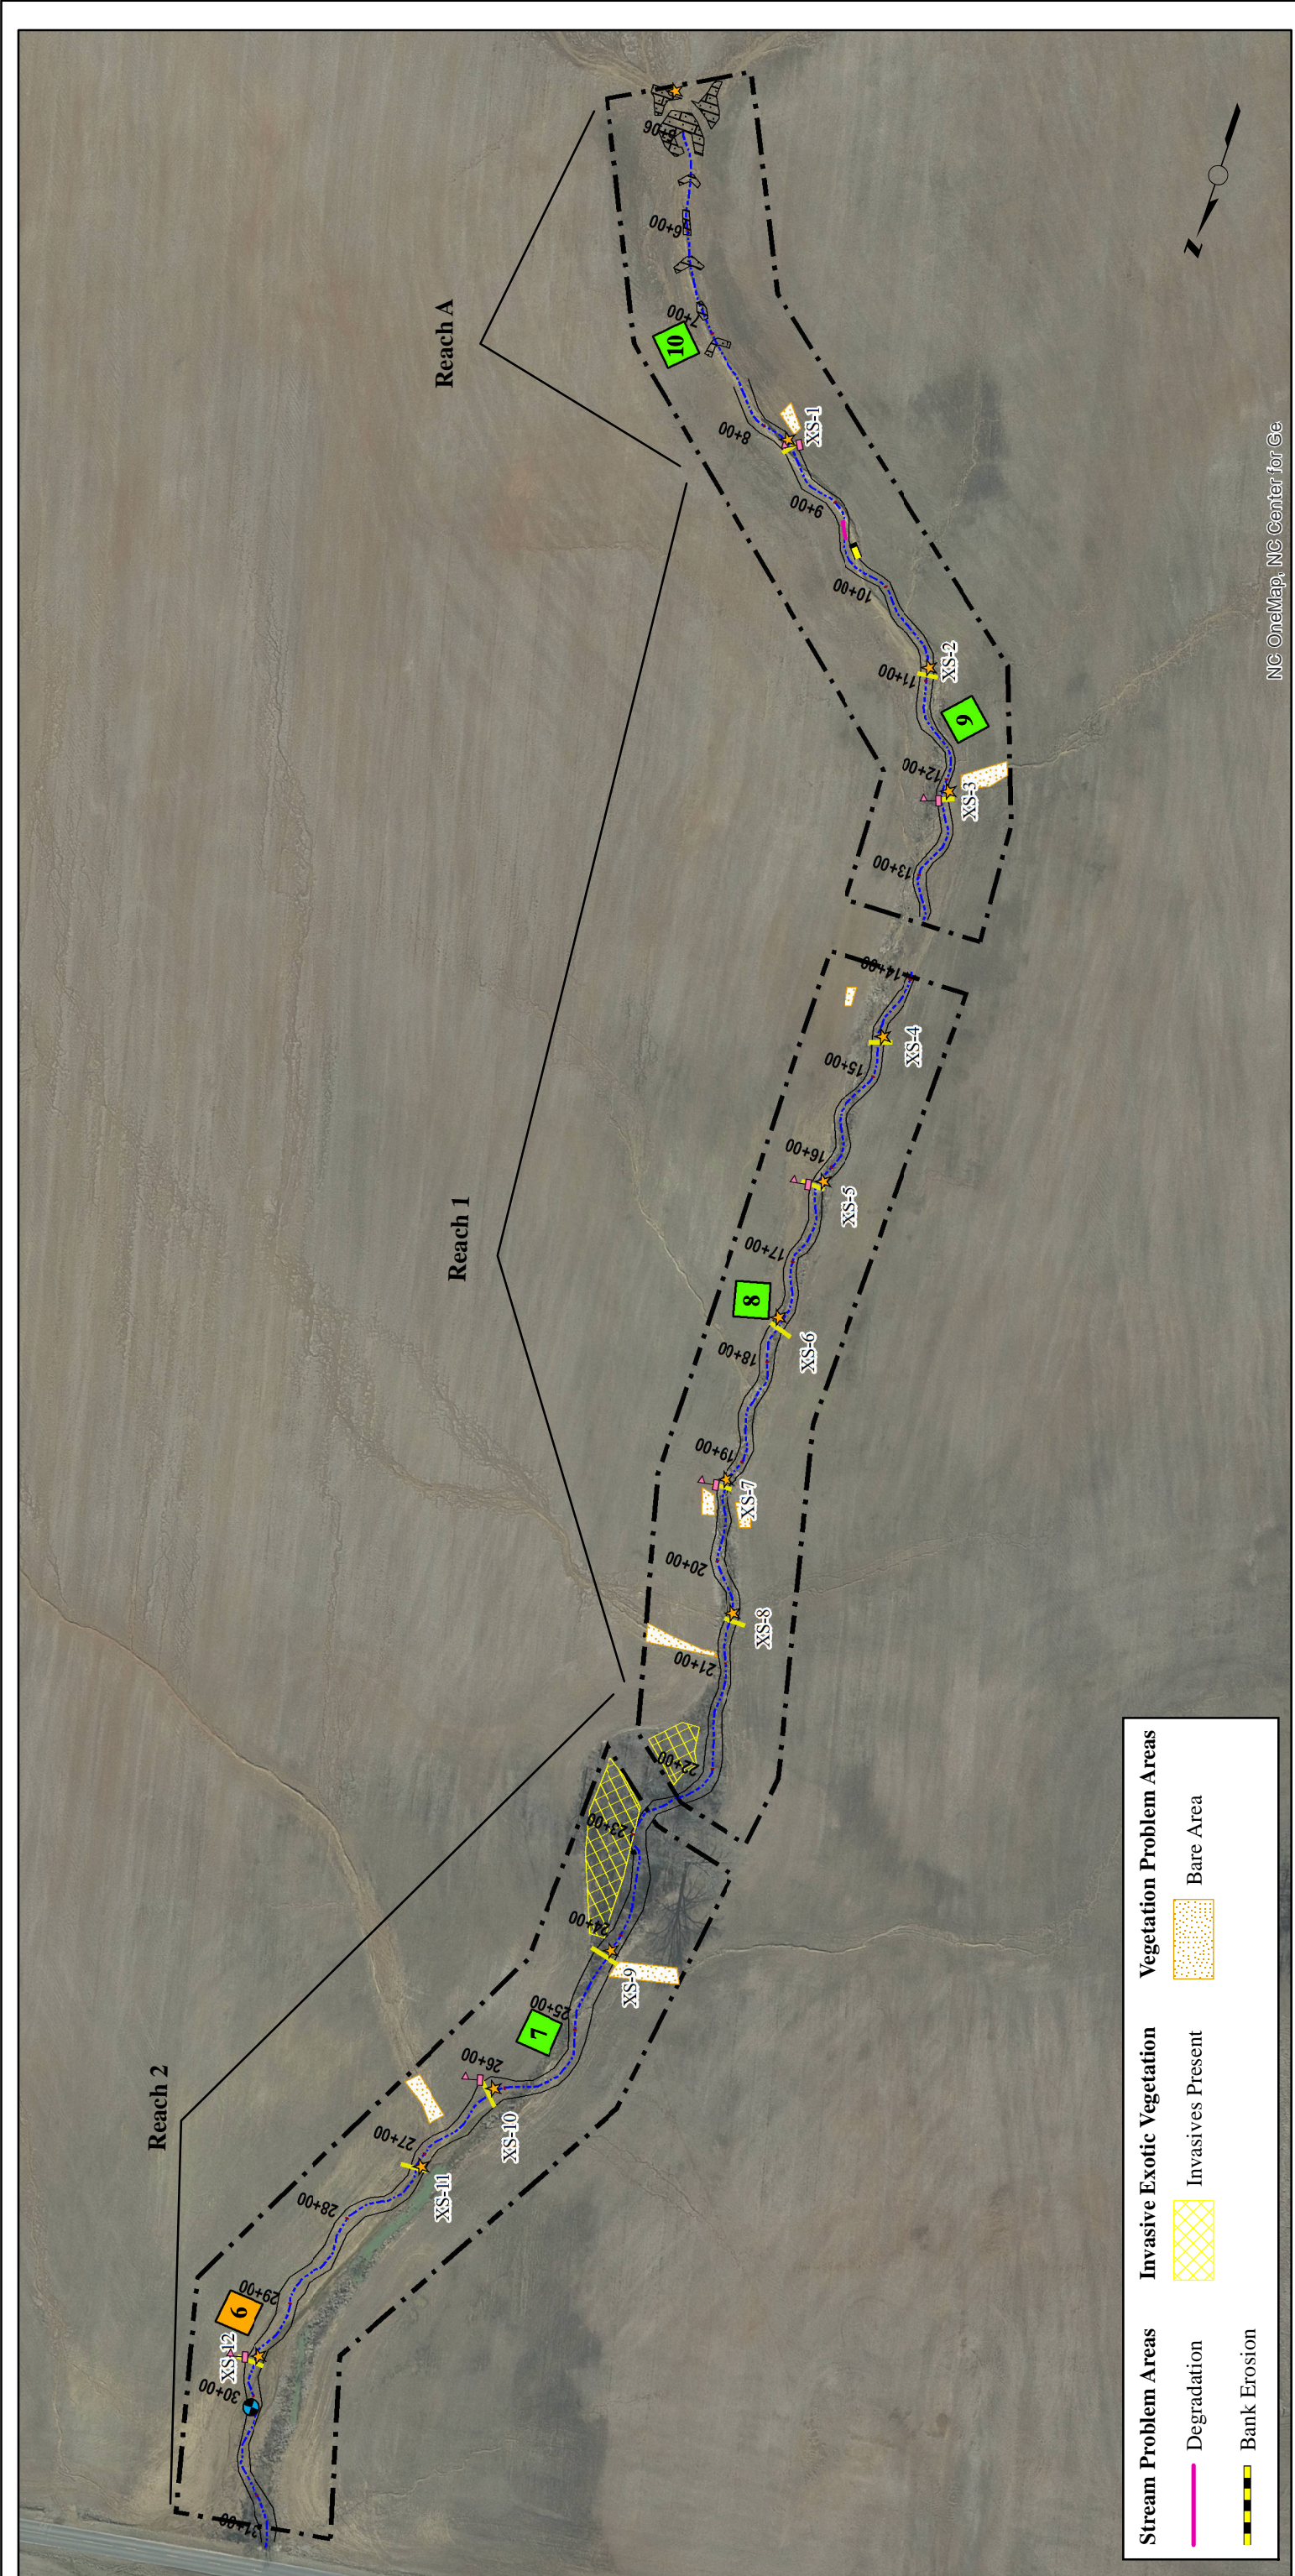
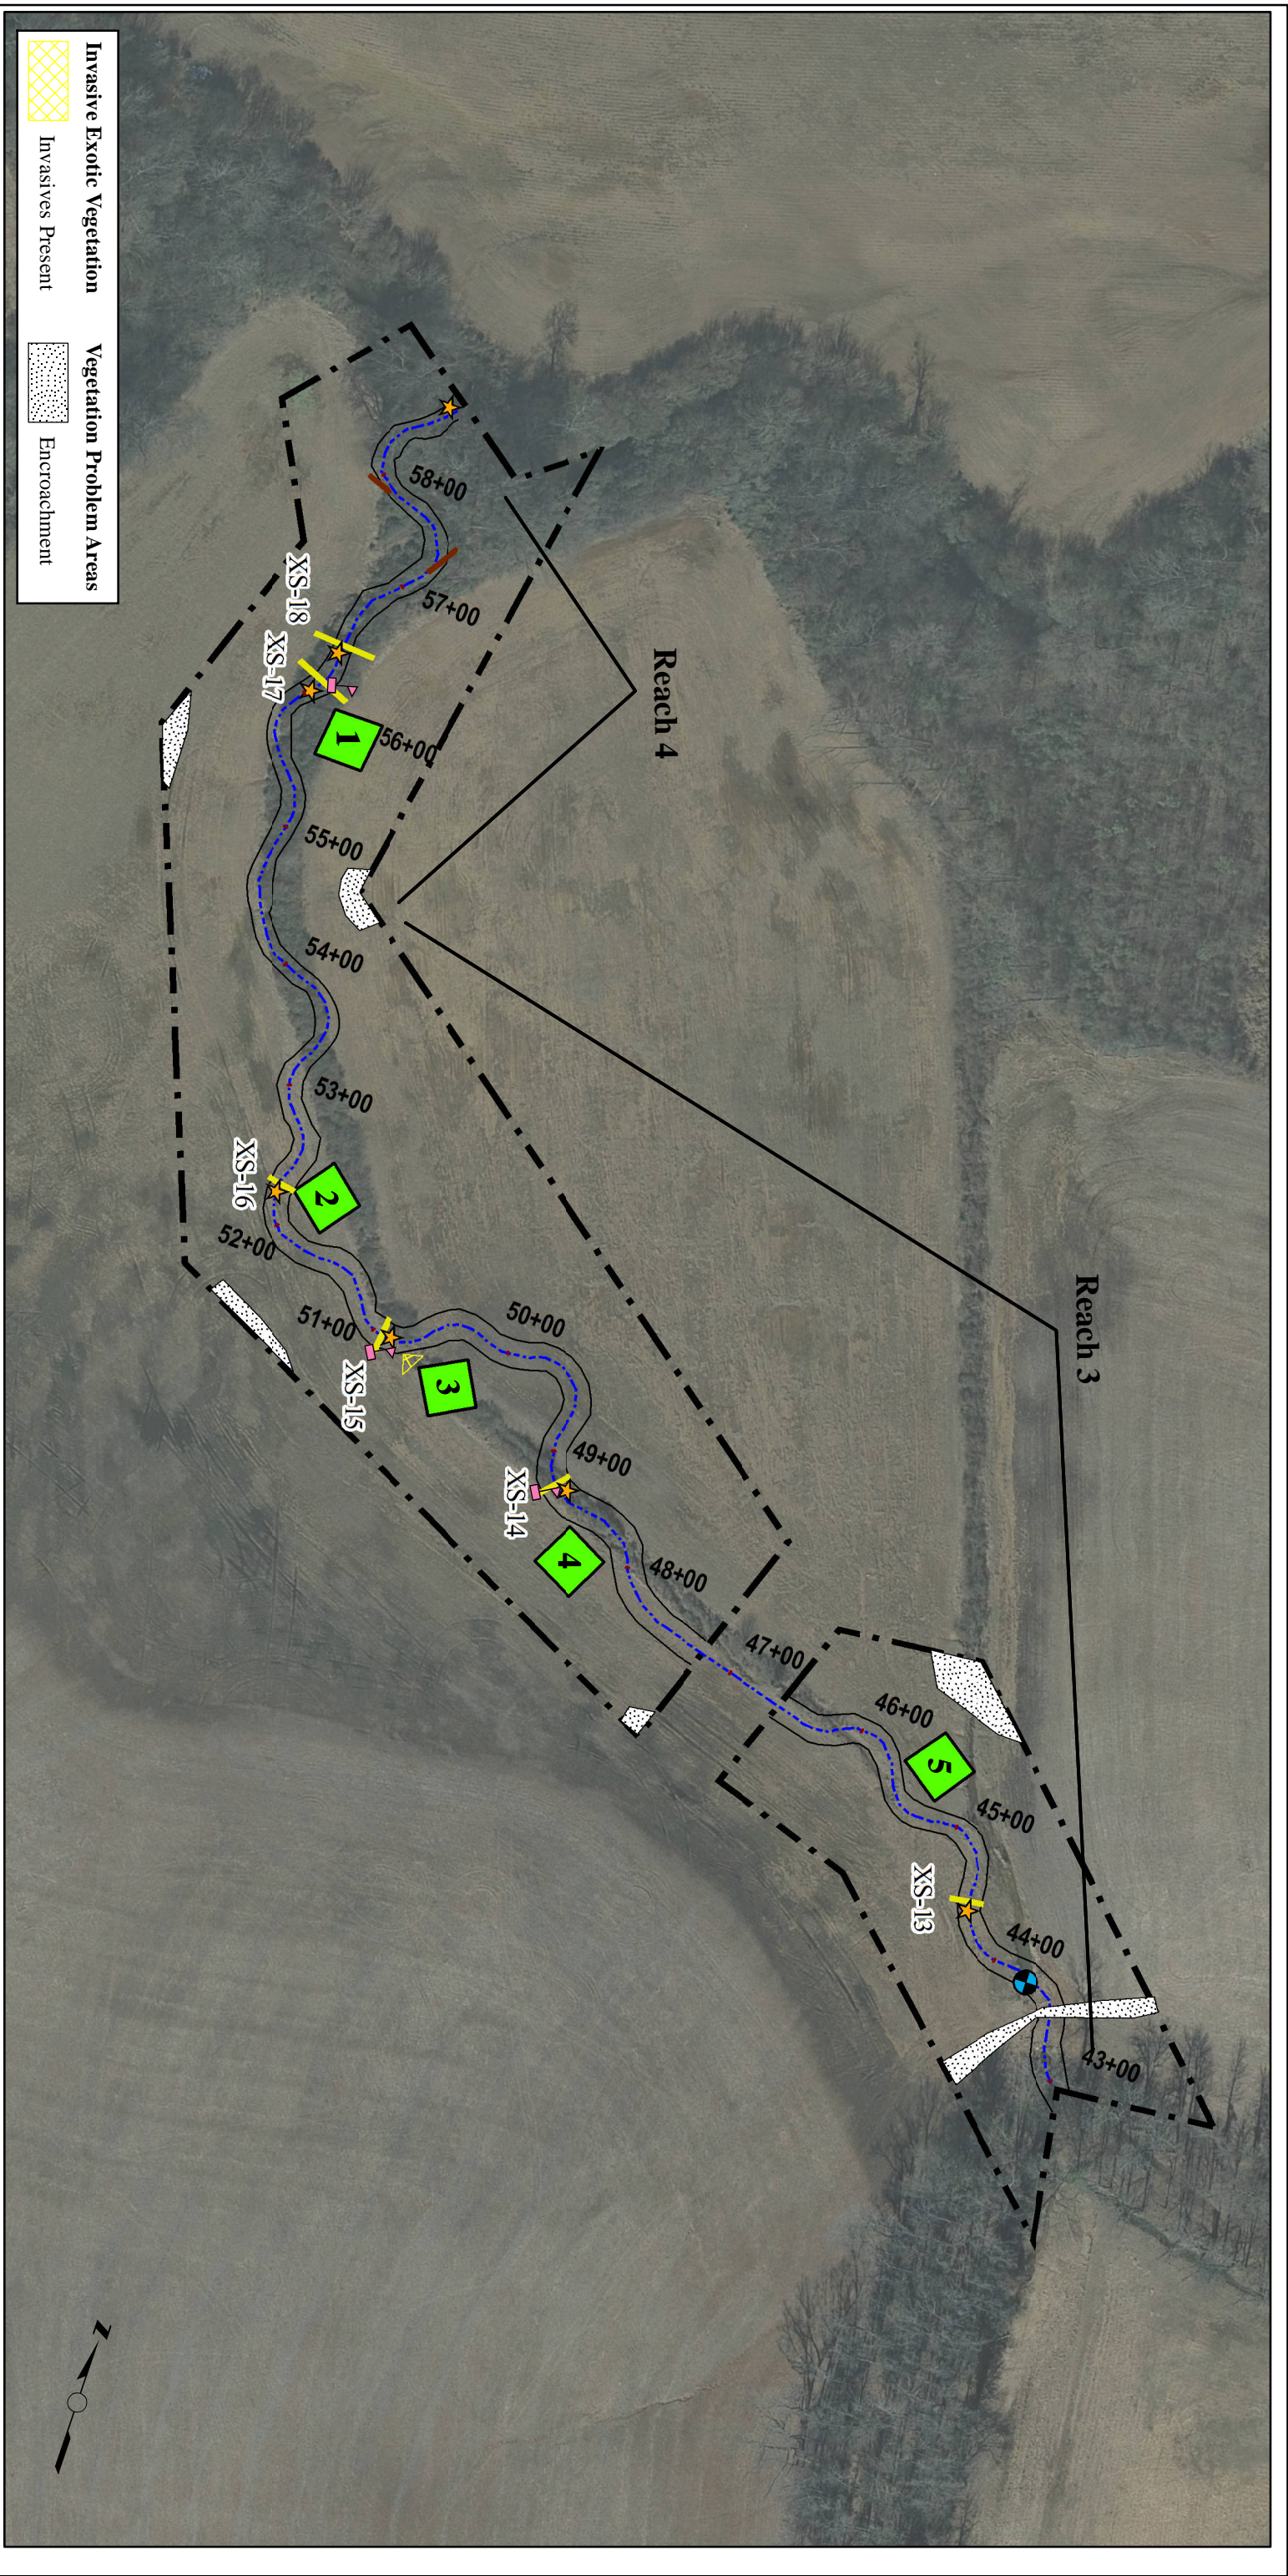
Figure 2. Current Condition Plan View  
 Sheet 1 of 2  
 601 East Stream Restoration Site  
 Union County, North Carolina  
 NCDMS Contract No. 004925  
 NCDMS Project No.: 95756  
 November 2015

Visual assessment of the stream was performed to document signs of instability, such as eroding banks, structural instability, or excessive sedimentation. Only a few stream problem areas were noted during visual assessment (Table 5 and Figure 2). Structures are intact and performing as designed. The project approach on the ephemeral channel at the upstream end of the project—Reach A—was to install a series of energy dissipating structures to provide vertical stability and sediment settling capacity within the reach. Visual assessment of this reach indicate that structures are performing as designed, stabilizing incision and capturing sediment from the upstream contributing area. No indications of new incision were observed during the assessment. Thus far, the settling areas are not in need of maintenance; however they will be assessed during upcoming site visits and maintained if needed.

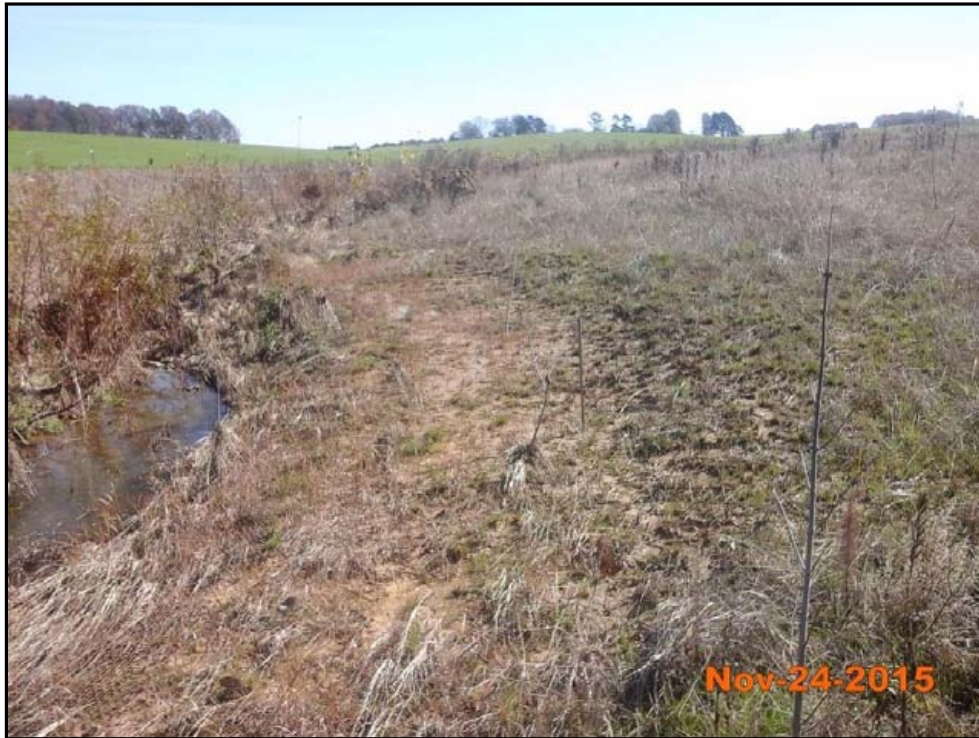
Project Reach 1 – Bare Area 8+50 Left Descending Bank

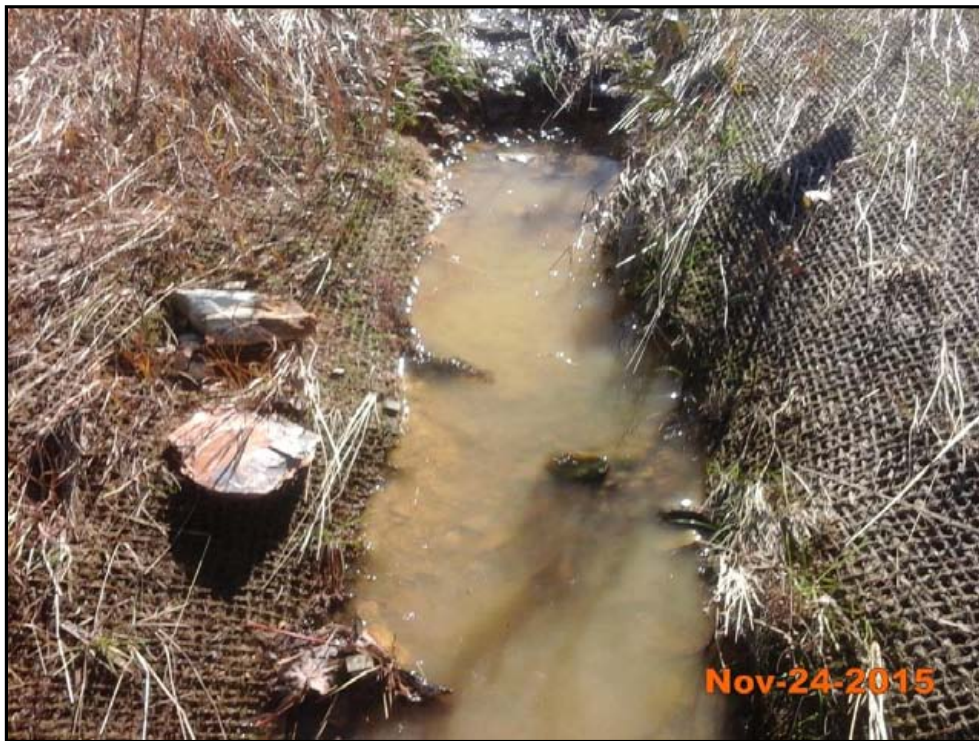
Project Reach 1 – Headcut/ Degradation 9+25

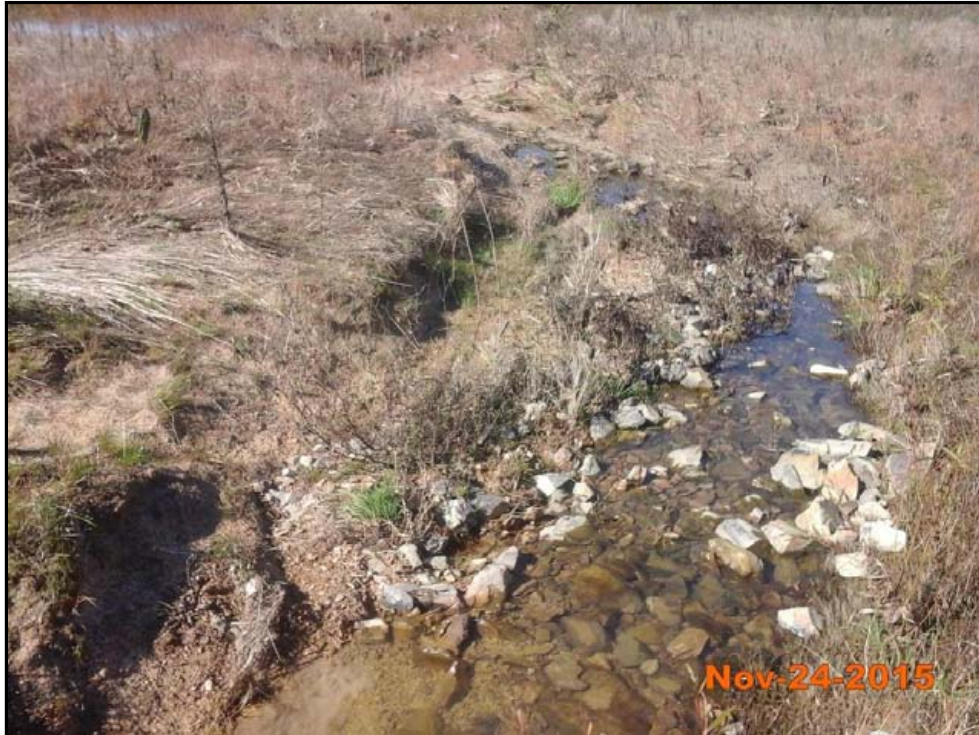
Project Reach 1 – Bank Erosion 9+50

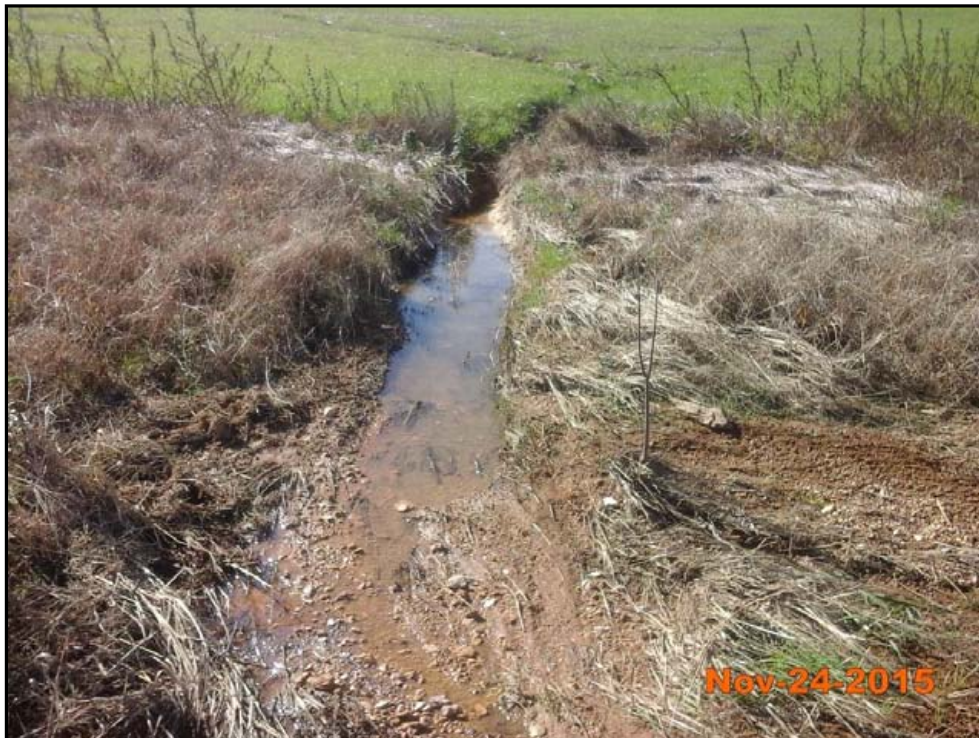
established throughout the easement (Figure 2 and Table 6). These bare areas consist mainly of small ditches that have migrated into the easement, each coinciding with existing ditches from outside the easement. No rip rap or grade control structures were observed, however RES will coordinate to make repairs in the coming monitoring year. Bare areas associated with ditches will be matted and seeded and grade control will be installed as necessary to stabilize channels within the easement.. At the downstream portion of Reach 2, a large plot of cattails was noted below XS-12, creating a monoculture within the wetland area. Additionally, an area of honeysuckle and privet were noted at the upper end of Reach 2, totaling 0.16 acres. Treatment is scheduled for spring 2016. Planted stems were difficult to assess with dense herbaceous vegetation covering the stems throughout most of the easement, however areas of sparse vegetation were noted during MY1 (Table 6 and Figure 2). These conditions are typical of a new mitigation site until the vegetation becomes established following construction activities. These areas will continue to be monitored in subsequent site visits. Encroachment was noted on Reaches 3 and 4, where an ATV had driven across the easement and tractors had turned into the easement while planting adjacent fields. RES is currently coordinating with the landowners and will be installing additional signage marking the easement in spring of 2016.

Project Reach 1 – Ditch/ Bare Area 12+00 Left Descending Bank

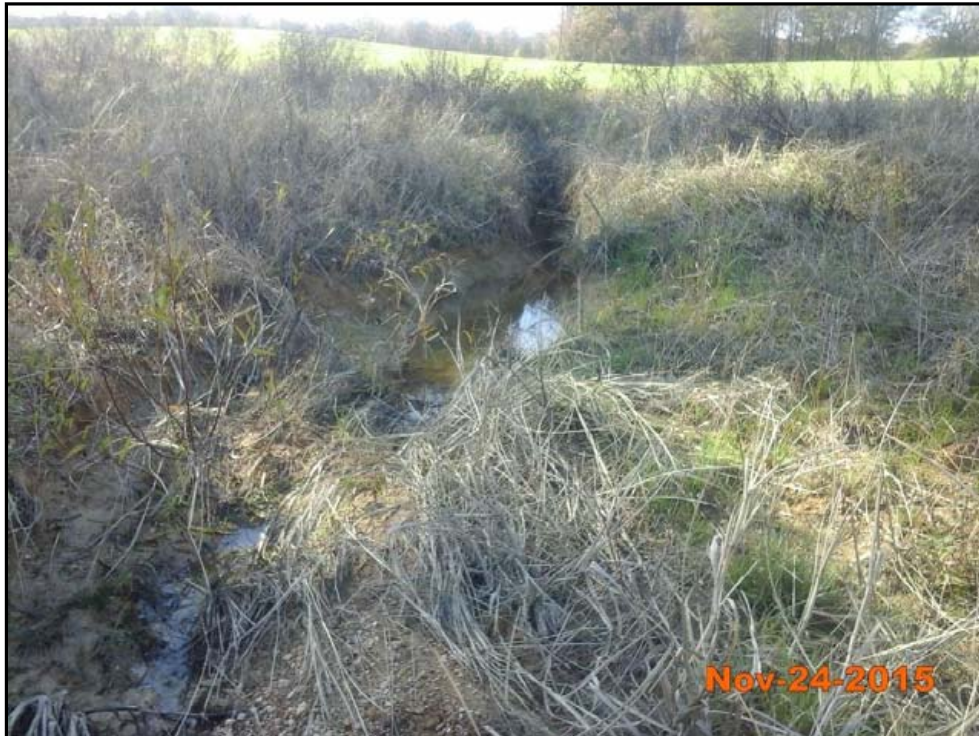
Project Reach 2 – Bare Area/ Ditch 24+25 Left Descending Bank

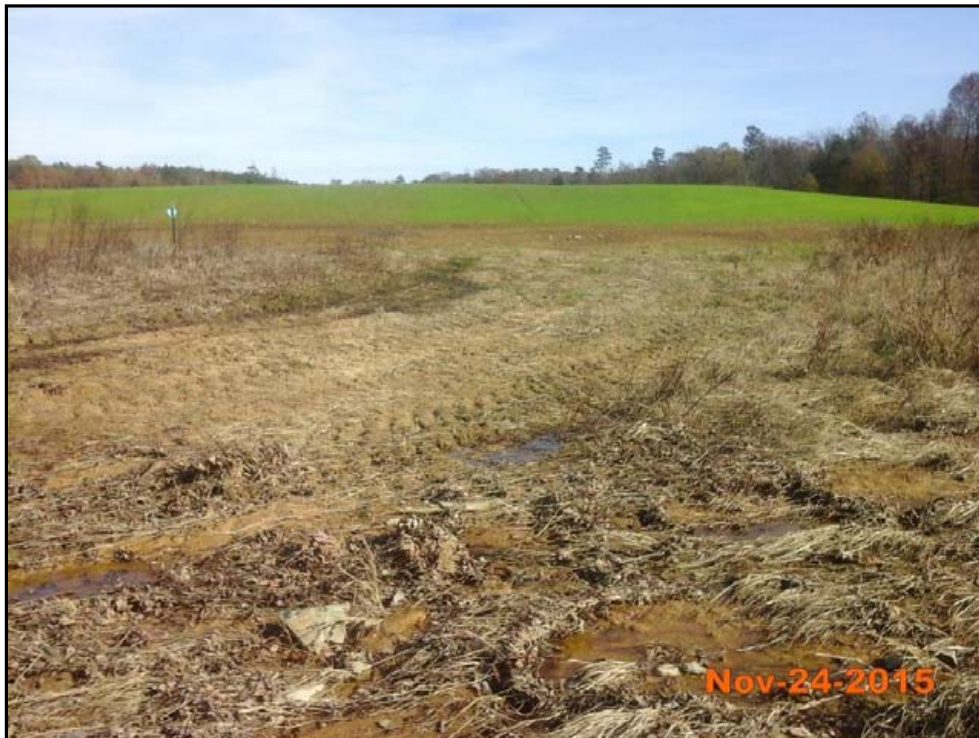
Project Reach 3 – Encroachment 45+50

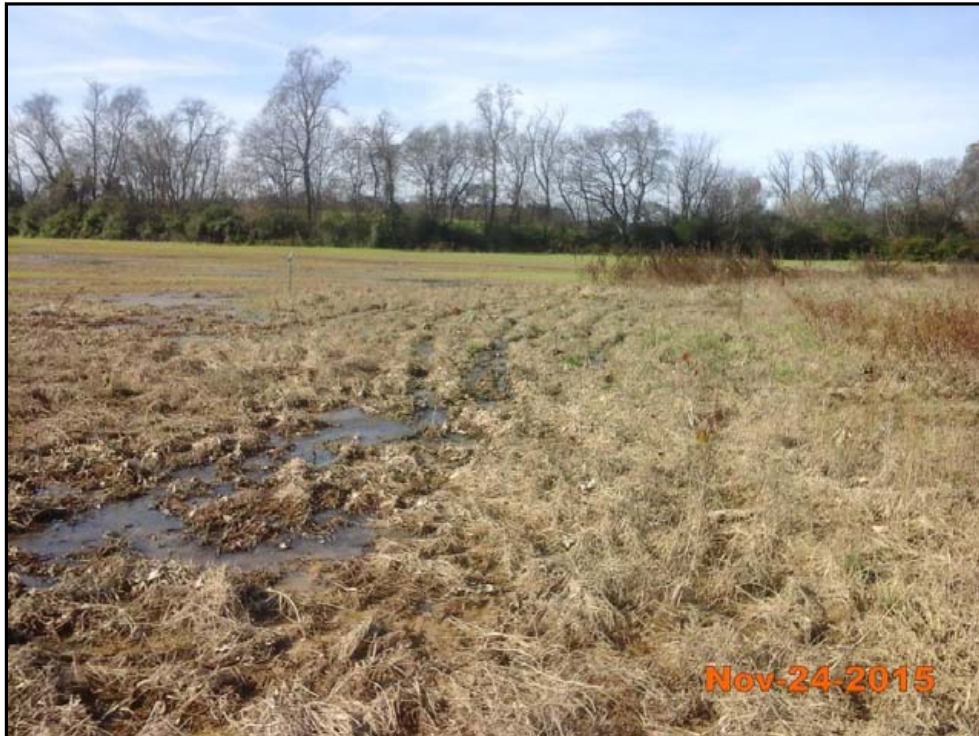
Project Reach 3 – Encroachment 51+50 Left Descending Bank
