# **Annual Monitoring Report**

Monitoring Year 2 of 7

Project Name: 601 East Stream Restoration

NCDMS Project No.: 95756

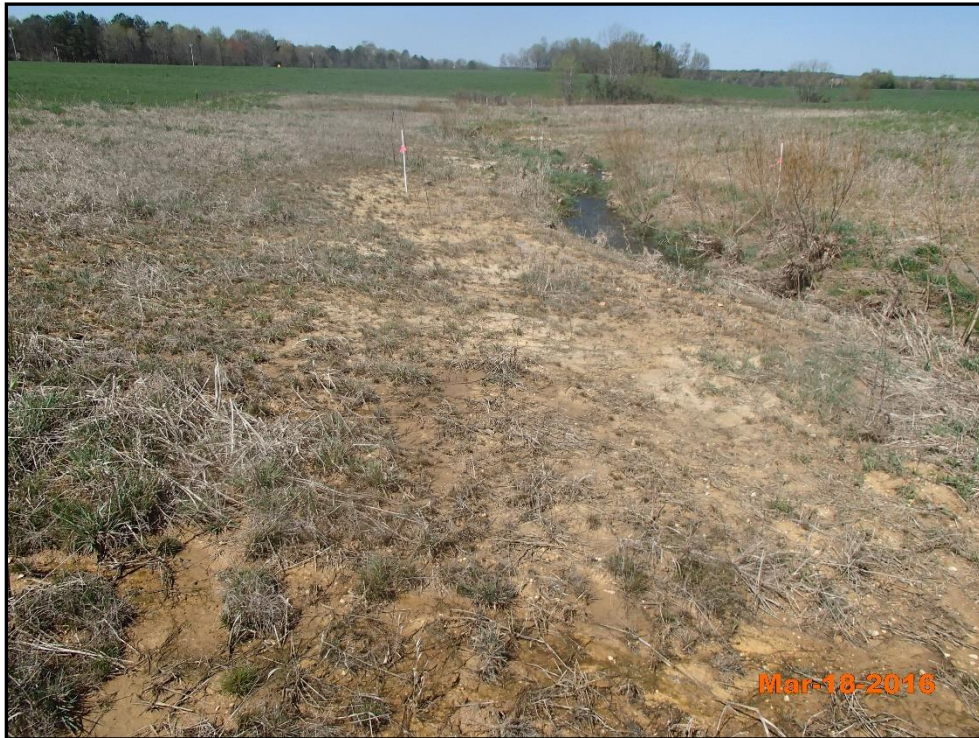
Visual assessment of the easement (Appendix B – Table 6; Figure 2) indicates that with the exception of a few bare areas, totaling 0.13 acre, vegetation is becoming well established throughout the easement (Figure 2 and Table 6). Small bare areas are typical of a newly constructed mitigation site and usually become vegetated after a couple of growing seasons. These areas will be monitored in subsequent site

Project Reach 1 – Bare Area 8+25 Left Descending Bank

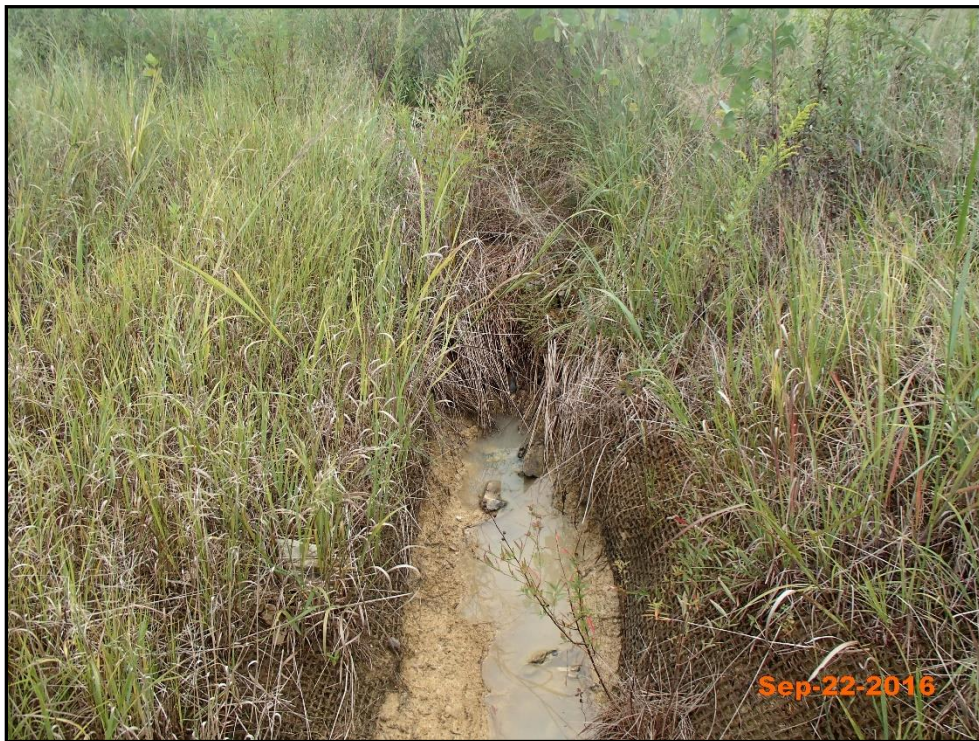
Visual assessment of the stream was performed to document signs of instability, such as eroding banks, structural instability, or excessive sedimentation. Only a few stream problem areas were noted during visual assessment (Table 5 and Figure 2). Structures are intact and performing as designed. The project approach on the ephemeral channel at the upstream end of the project—Reach A—was to install a series of energy dissipating structures to provide vertical stability and sediment settling capacity within the reach. Two small areas of degradation were noted on reach 1. These areas are associated with small headcuts that formed within riffles located at STA 9+25 and 10+00. The headcuts have remained stable between MY1 and MY2 and have not migrated upstream or caused the riffle to cut down any further. Visual assessment of this reach indicates that the structures are performing as designed, reducing downcutting and capturing sediment from the upstream contributing area. No indications of new incision were observed during the assessment.

Project Reach 1 – Headcut/Degradation 9+25

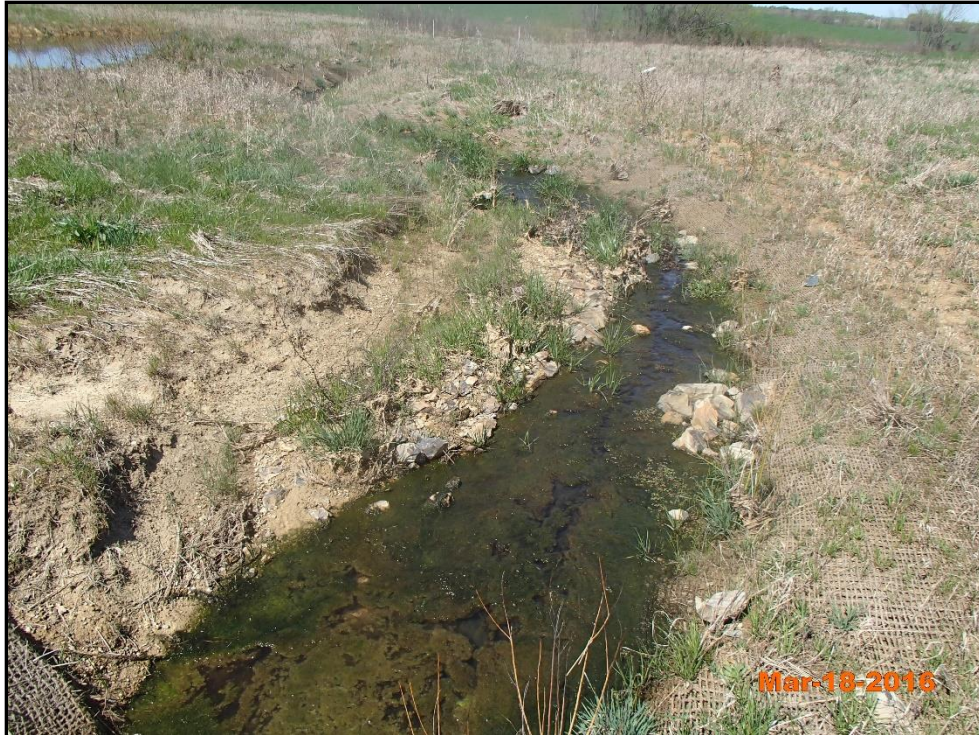
Project Reach 1 – Bank Erosion 9+50 Left Descending Bank

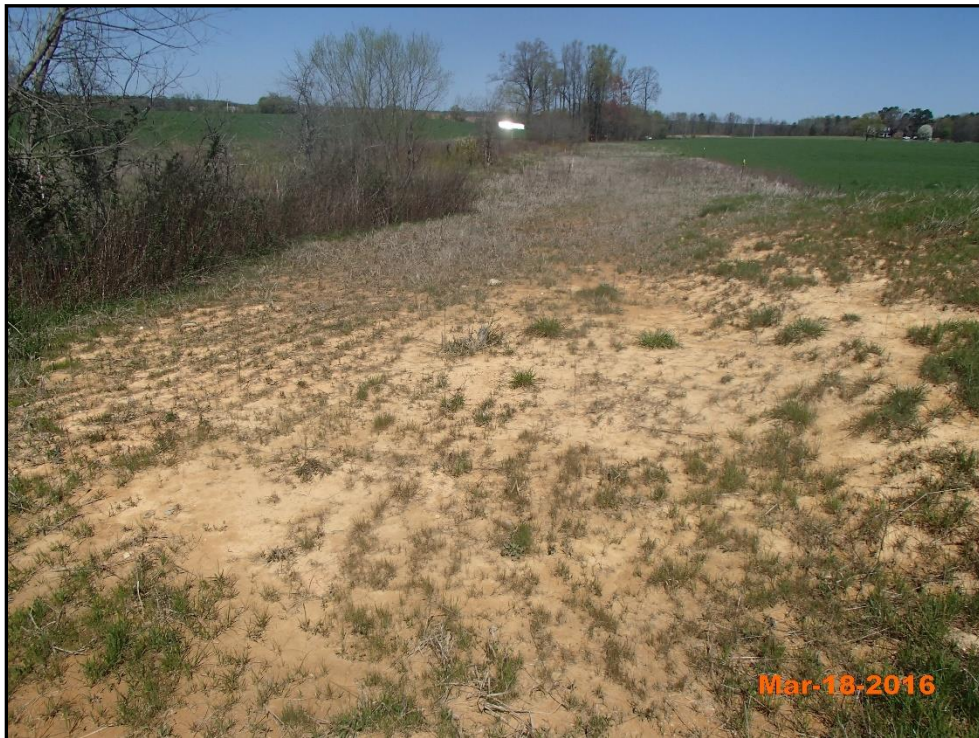
visits. During MY1, small bare areas were noted, coinciding with ditches from outside the easement that had migrated into the easement. These areas have since become vegetated and have not caused increased sedimentation or instability within the easement, so no action was taken during MY2. These areas will be monitored in the future to make sure they remain stabilized. At the downstream portion of Reach 2, a large monoculture plot of cattails within the wetland below XS-12, was noted. The invasive exotic plant, Parrot Feather (*Microphyllum aquaticum*), was also noted in pools from STA 26+00 to STA 27+50. Additionally, a 0.16 acre area of honeysuckle (*Lonicera japonica*) and privet (*Lingustrum sinense*) were noted at the upper end of Reach 2. Invasive populations have remained stable at the site. While no treatments were performed during MY2, treatment of these areas will be scheduled as needed in coming monitoring years. Easement encroachment was noted on Reaches 3 and 4 where it appears a tractor had turned into the easement while planting adjacent fields. A complete replanting of the site occurred in April 2016, which included all of the encroachment areas. Efficacy of the replanting and area of the encroachment will be monitored in future site visits. RES is currently coordinating with the landowners and will be installing additional signage marking the easement boundary during 2017. Fencing or another type of deterrent will be added as necessary to keep tractors from driving through the easement.

Project Reach 1 – Ditch / Bare Area 14+00 Right Descending Bank

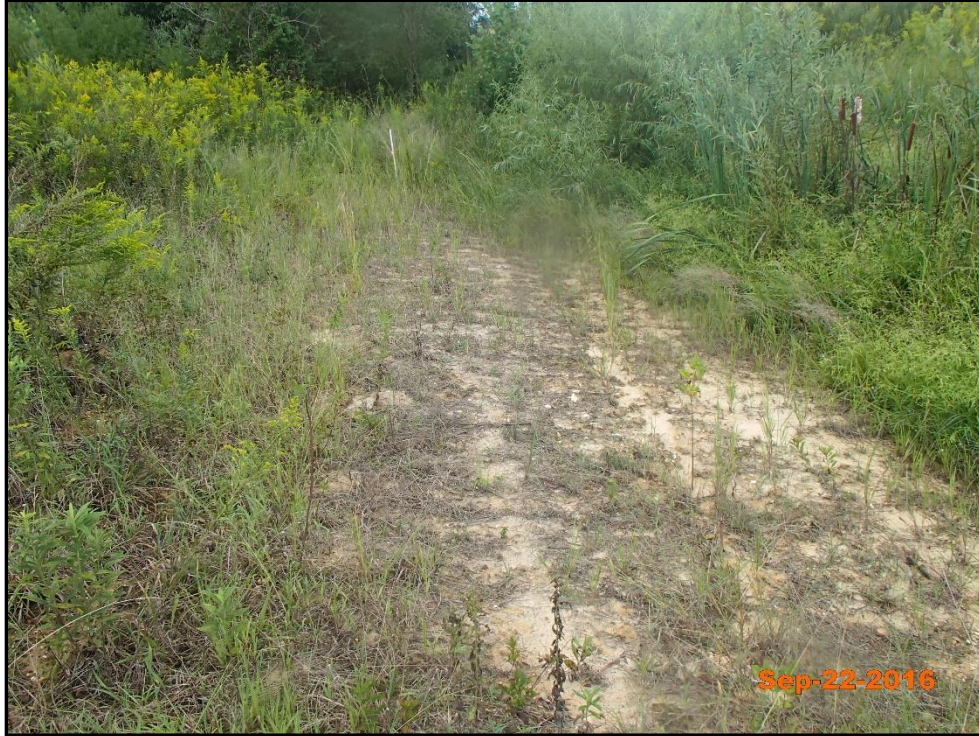
Project Reach 2 – Bare Area 24+50 Right Descending Bank

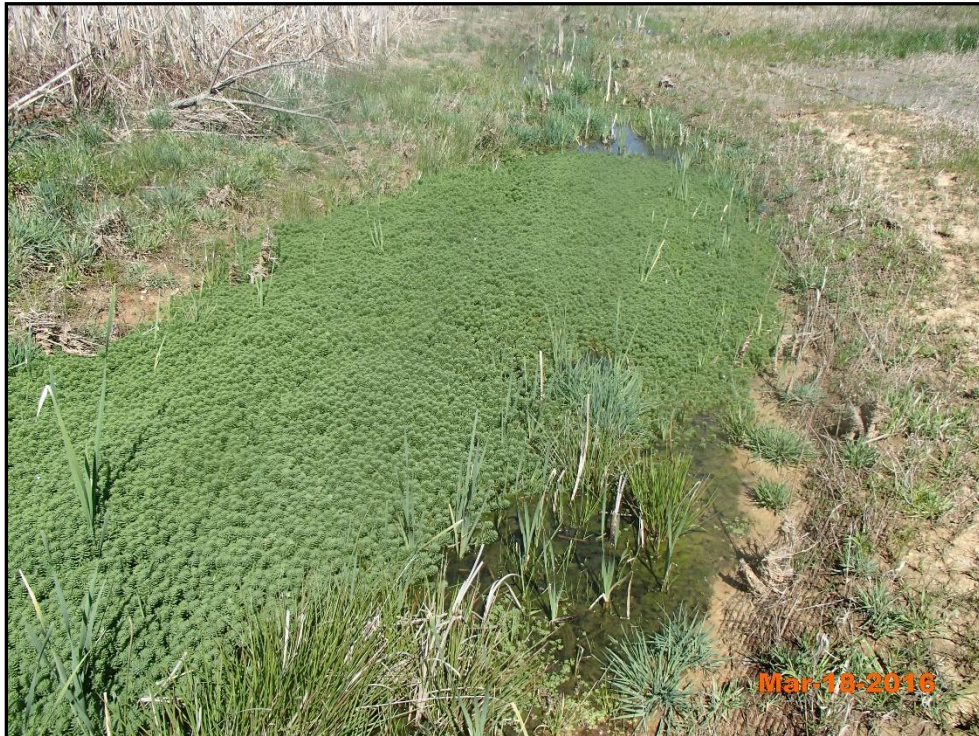
Project Reach 2 – 26+25 Parrot Feather within Pool

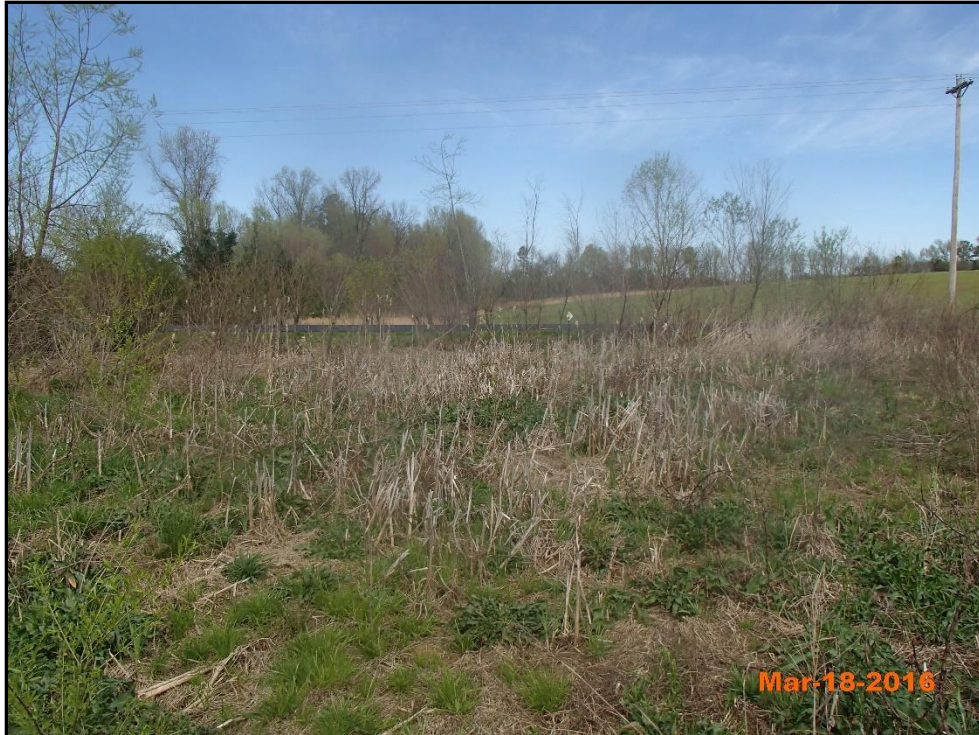
Project Reach 2 – Cattail monoculture along Left Descending Bank

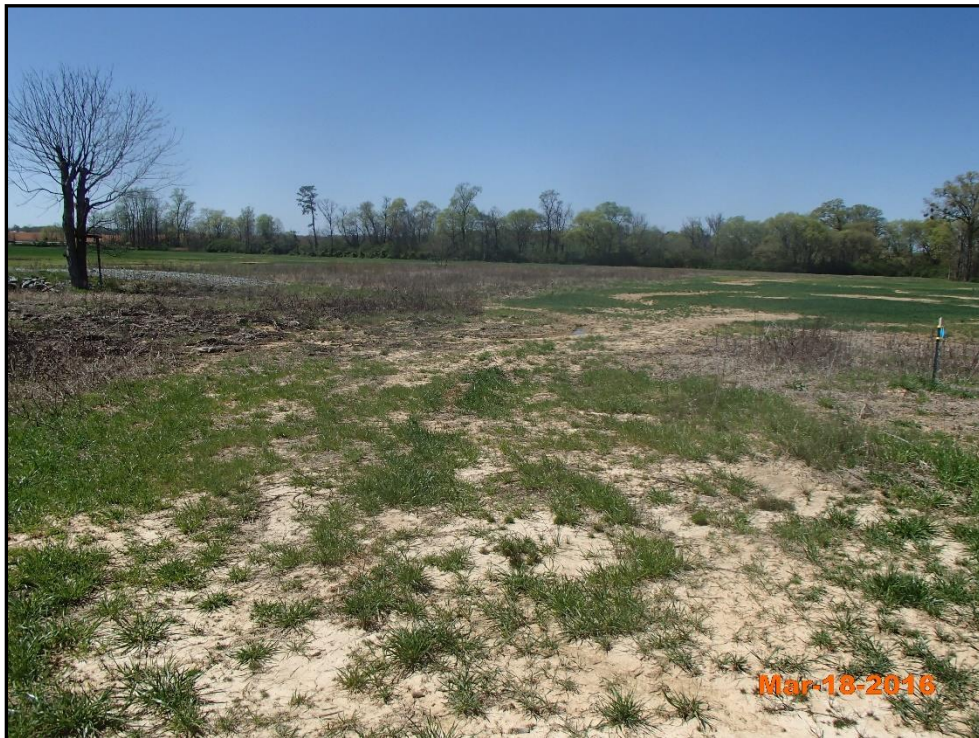
Project Reach 3 – Easement Encroachment 45+50

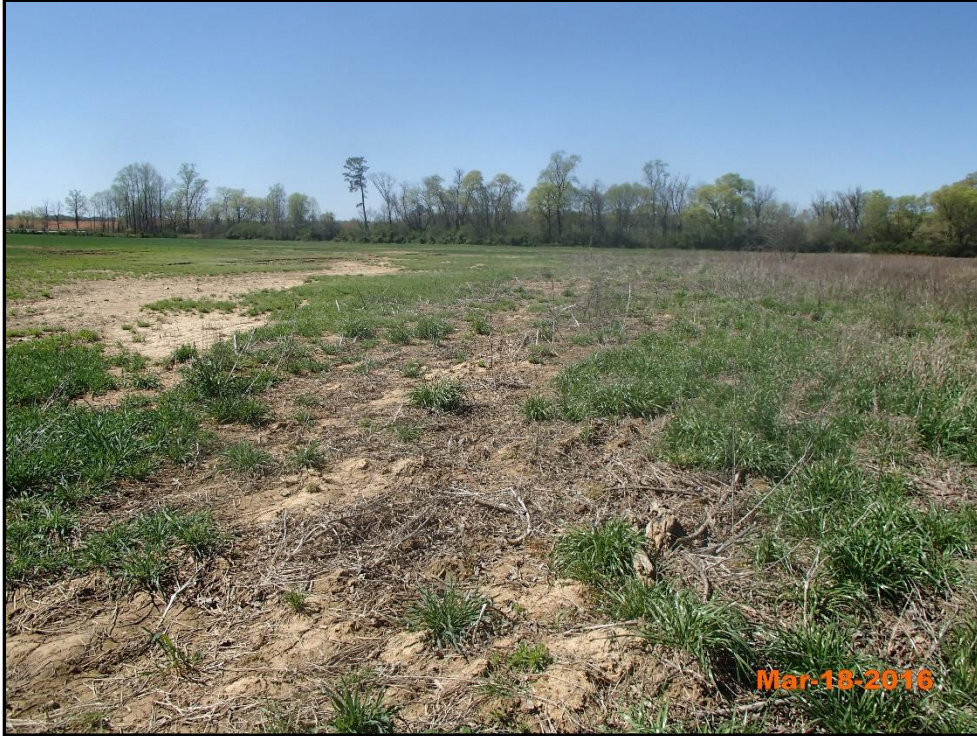
Project Reach 3 – Easement Encroachment 47+50 Left Descending Bank

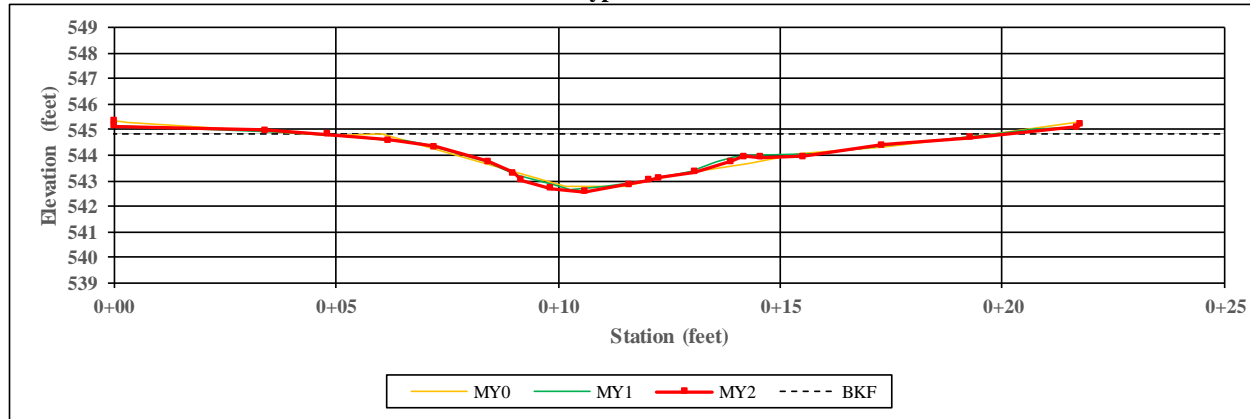
**XS Number:** 1  
**XS Type:** Pool

The bank pin arrays indicate that no erosion is taking place in the pools with the exception of the upstream end of XS-1. Field data indicated that there was localized erosion around the upstream pin at XS-1, at a rate of 0.04 foot/year (Table 12).
