Annual Monitoring Report

Monitoring Year 3 of 7

601 East Stream Restoration Project
NCDMS Contract No.: 004925
NCDMS Project No.: 95756
USACE Permit Action ID: 2013-00265
DWR Project No.: 14-0547

Union County, NC
Data Collected: January – November 2017
Date Submitted: January 2018

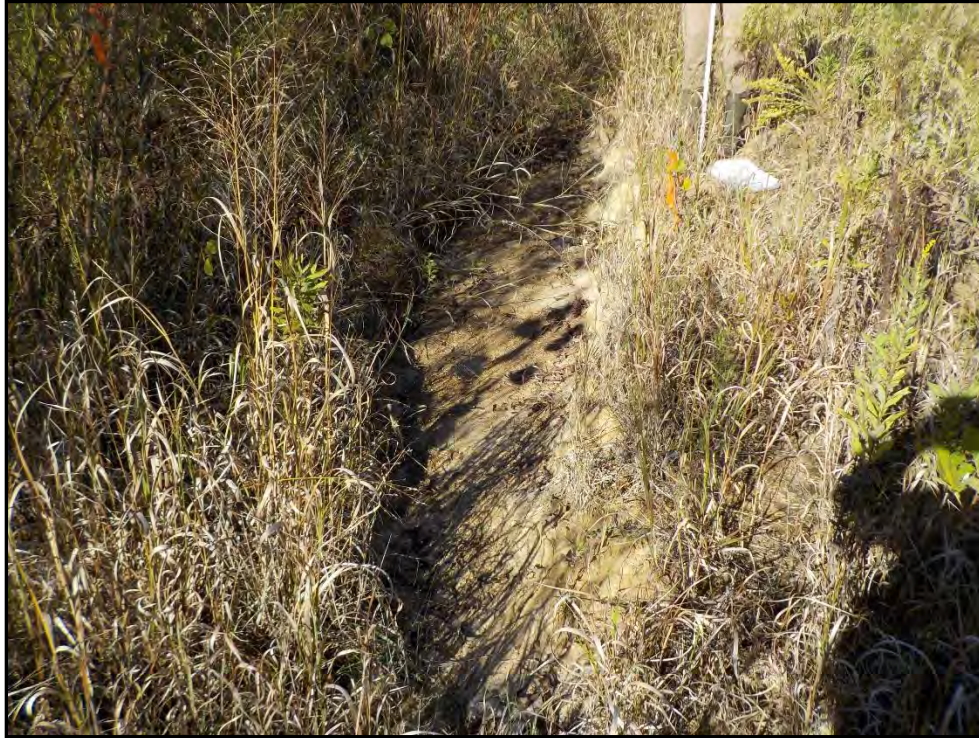
Reach 1 Right Bank – Bare Area

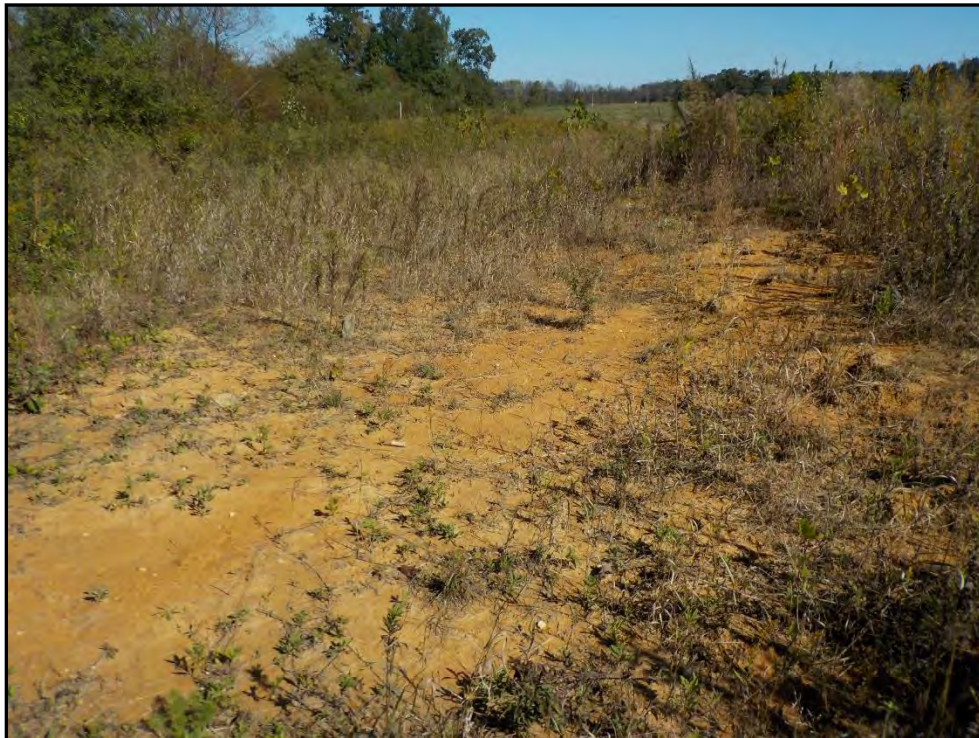
Reach 1 Right Bank – Bare Area

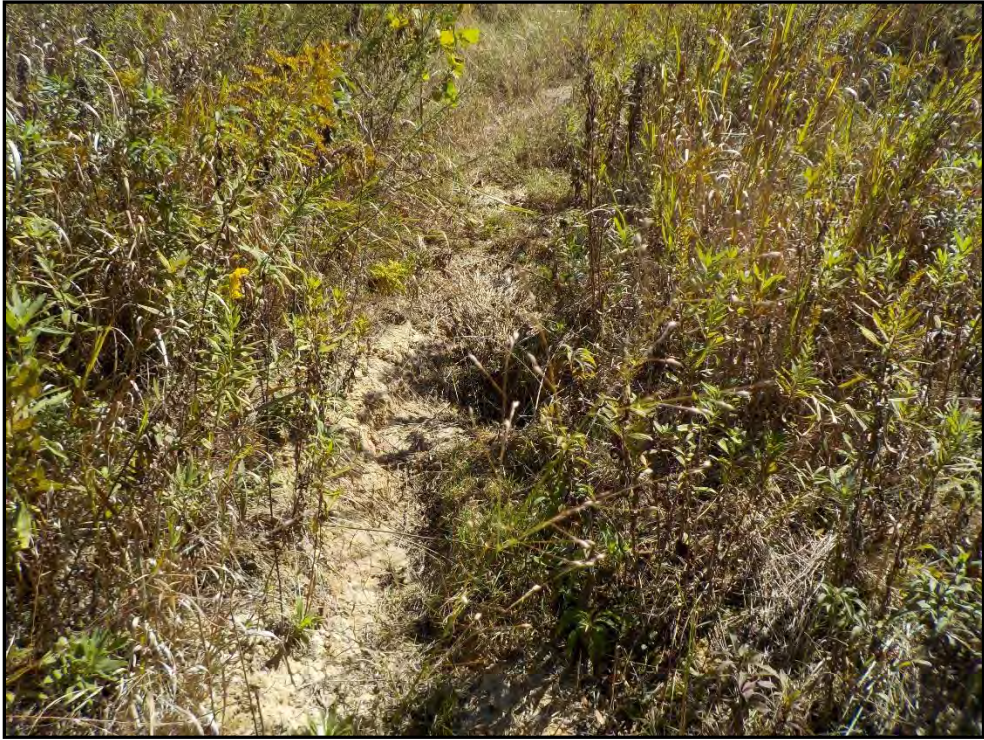
Reach 1 – Erosional Feature entering from farm field

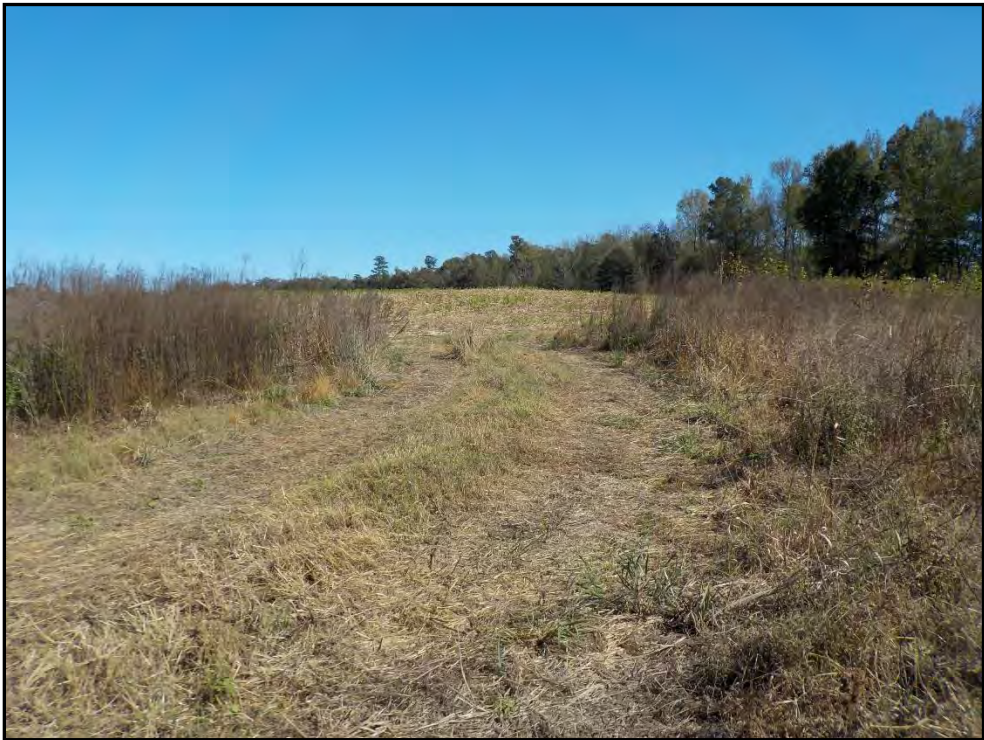
Reach 3 – Easement Encroachment

General: Encroachment has been an issue on the 601 East site since MY1 (2015). EBX/ RES indicated in both 2015 and 2016 that the encroachment would be eliminated by working with the landowner, installing additional signage, and providing an alternate tractor crossing. The encroachment on the site needs to be resolved in 2018. In the revised report, please document 2015-2017 efforts to resolve the encroachment. Please also provide a firm 2018 date for the installation of these additional measures on the project site. DMS property staff is willing to provide assistance enforcing the recorded conservation easement if requested.

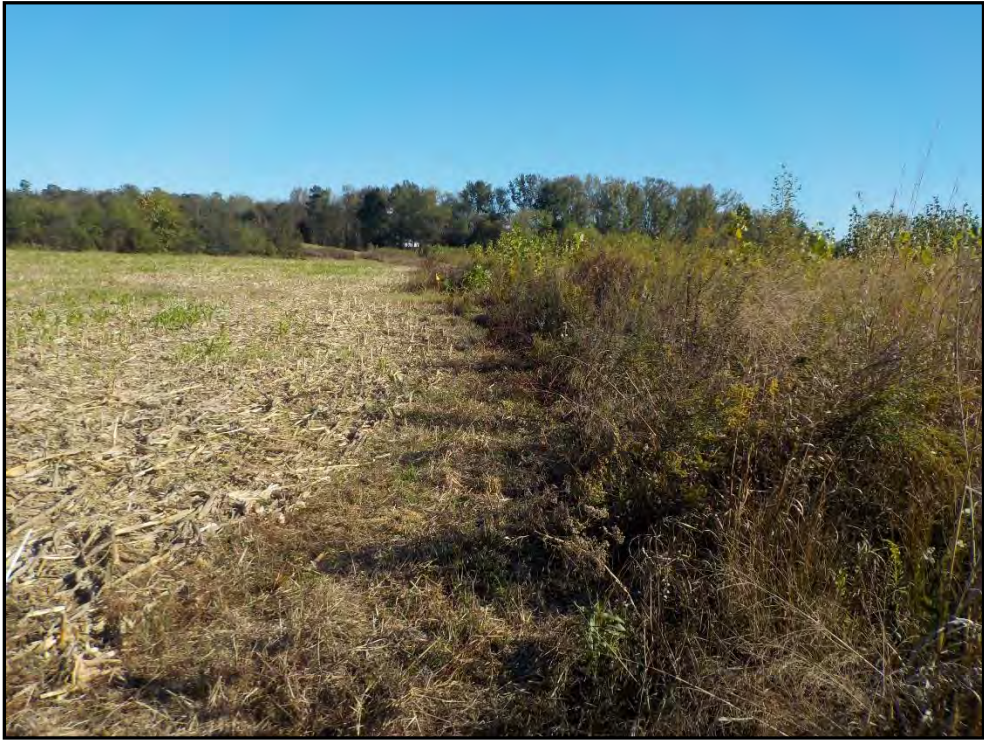
Reach 3 – Easement Encroachment

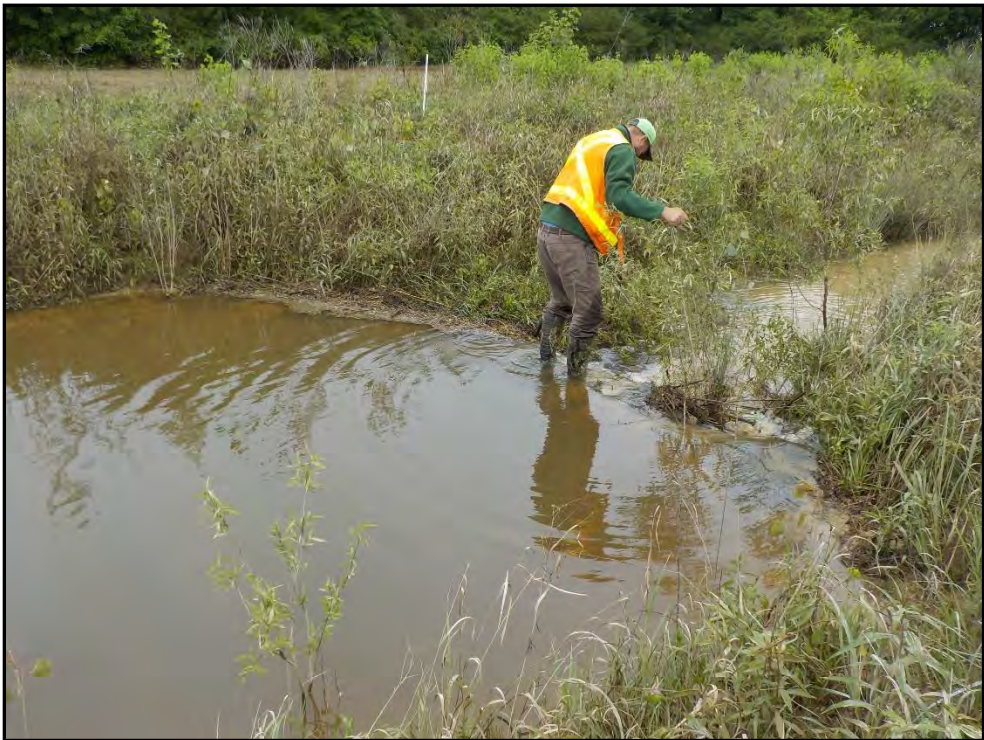
Reach 4 – Beaver Dam

*Beaver dam directly downstream of XS-17 caused unusually high water and localized bank erosion.

Section 1.4.2 – Stream Geomorphology: Please note that beaver should be trapped and the associated dams removed from the project site for the entirety of the monitoring term. This should be completed as early as possible in MY4 (2018).

Beavers were trapped in May 2017 and dams will be removed in early 2018. This has been added to the report.

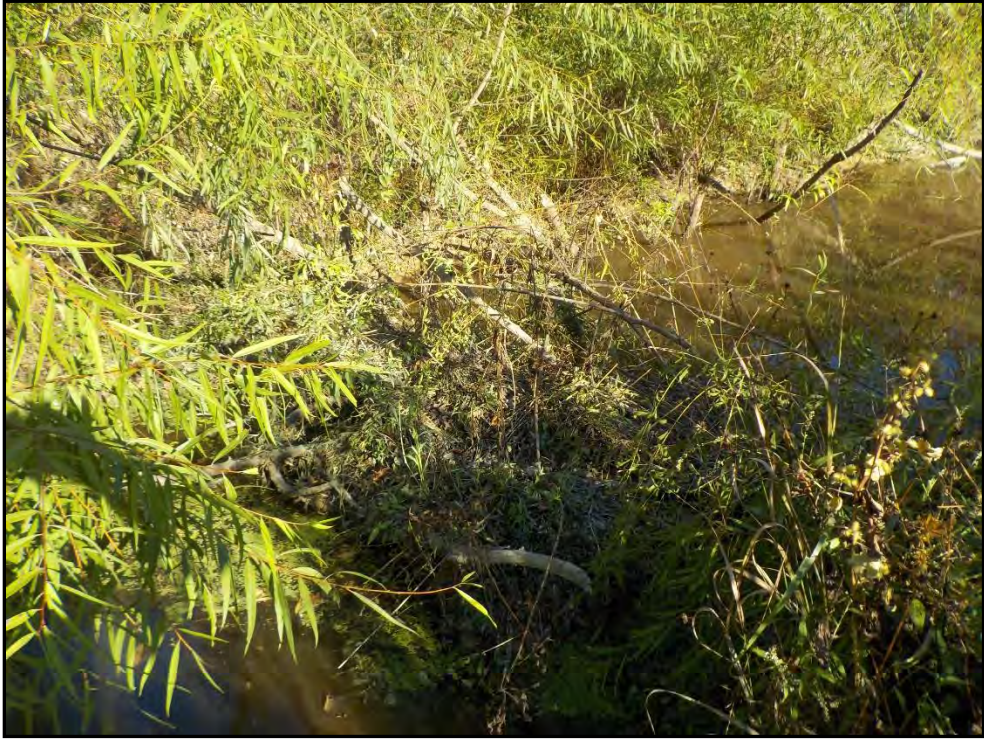
Reach 4 – Beaver Dam

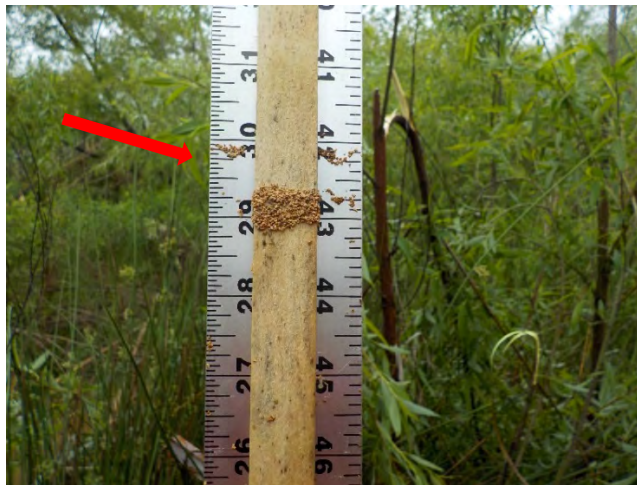
Crest Gauge @ Reach 2 – 30 in. (2.5 ft.)

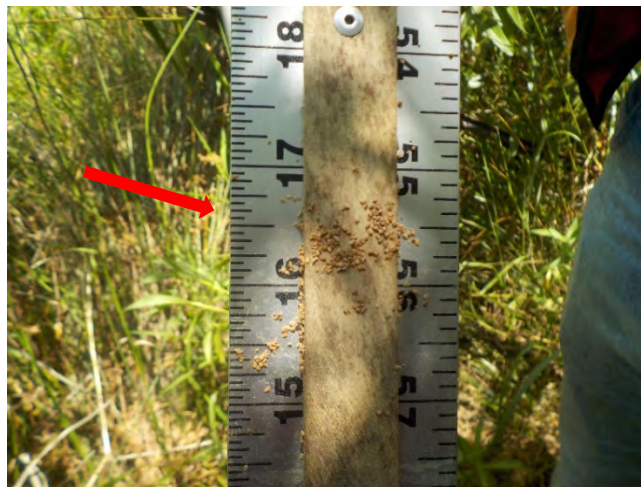
Crest Gauge @ Reach 3 – 16.75 in. (1.4 ft.)
