Annual Monitoring Report

Monitoring Year 4 of 7

601 East Stream Restoration Project
NCDMS Contract No.: 004925
NCDMS Project No.: 95756
USACE Permit Action ID: 2013-00265
DWR Project No.: 14-0547

Union County, NC
Data Collected: November 2018
Date Submitted: January 2019

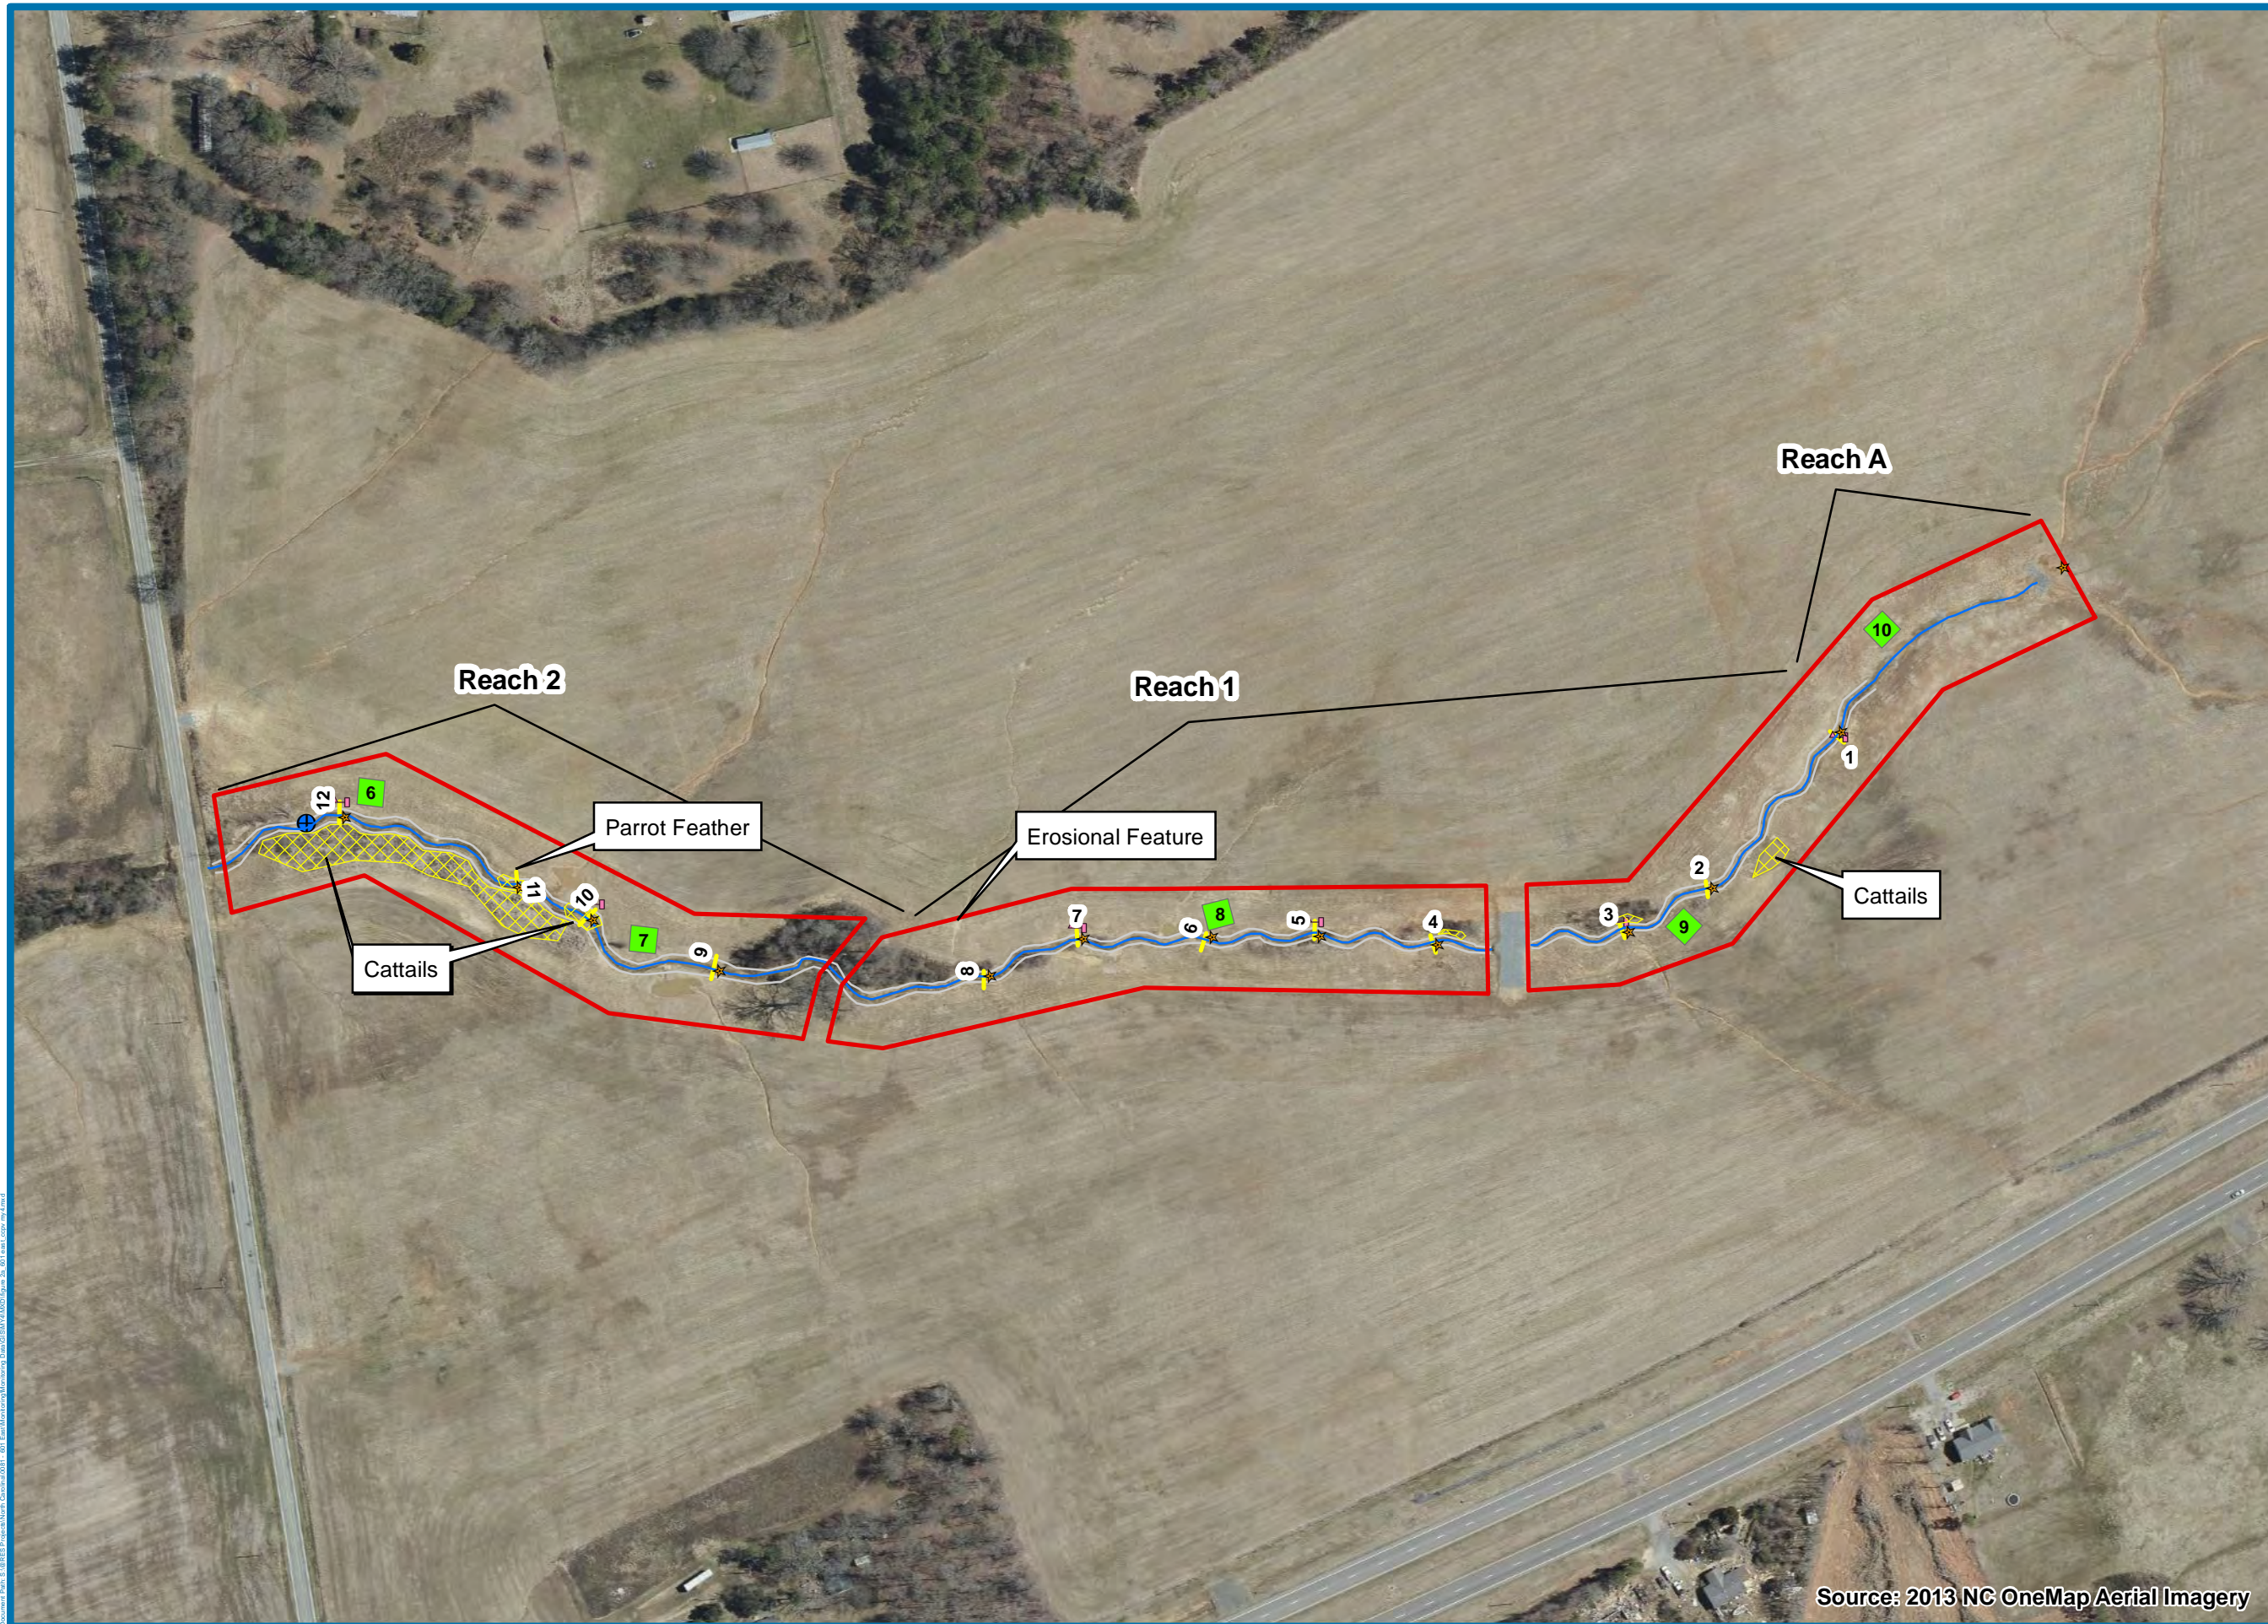
CCPV Sheets/ Report Text: In the report text, please describe/ discuss the erosional feature shown on Figure 2b (Reach 1). The erosional feature is a small headcut that formed at the edge of the easement from a field drain. The feature has stabilized with the maturation of vegetation in the buffer. If conditions worsen, RES will stabilize the headcut with rock and add coir logs along the feature. This has been added to the report.

Visual assessment of the stream was performed to document signs of instability, such as eroding banks, structural instability, or excessive sedimentation (**Table 6**). The erosional feature noted in the right buffer of Reach 1 is a headcut that formed at the edge of the easement from a field drain. The feature has stabilized with the maturation of vegetation in the buffer. If conditions worsen, RES will stabilize the headcut with rock and add coir logs along the feature. The major stream problem areas from MY3 were two beaver dams on Reach 4. These dams and beavers were removed in March 2018 and the dams were completely taken out and the banks were stabilized and replanted. The beavers, however, returned in MY4 and built new dams on Reach 4. Beaver management, including trapping and dam removal, will be performed again in MY5.

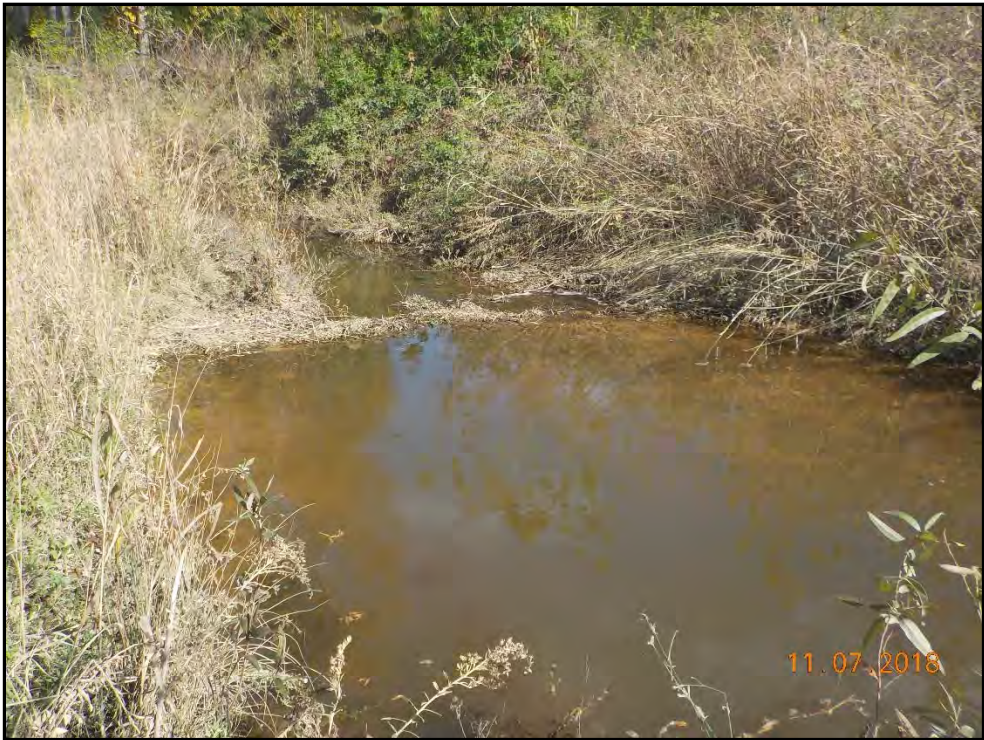
Reach 4 – Beaver Dam

Section 1.4.2 – Stream Geomorphology: Please note that beaver should be trapped, and the associated dams removed from the project site for the entirety of the monitoring term. This should be completed as quickly as possible to avoid project damage and abnormal monitoring data. Beaver management, including trapping and dam removal, will be performed again in MY5. This has been added to the report.

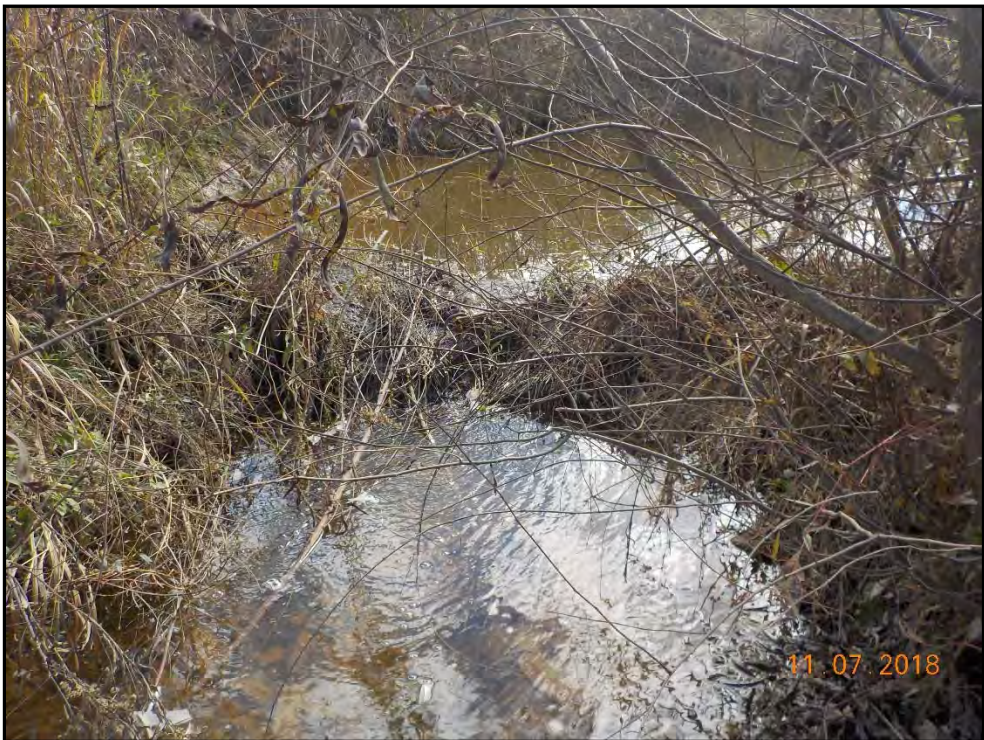
Reach 4 – Beaver Dam

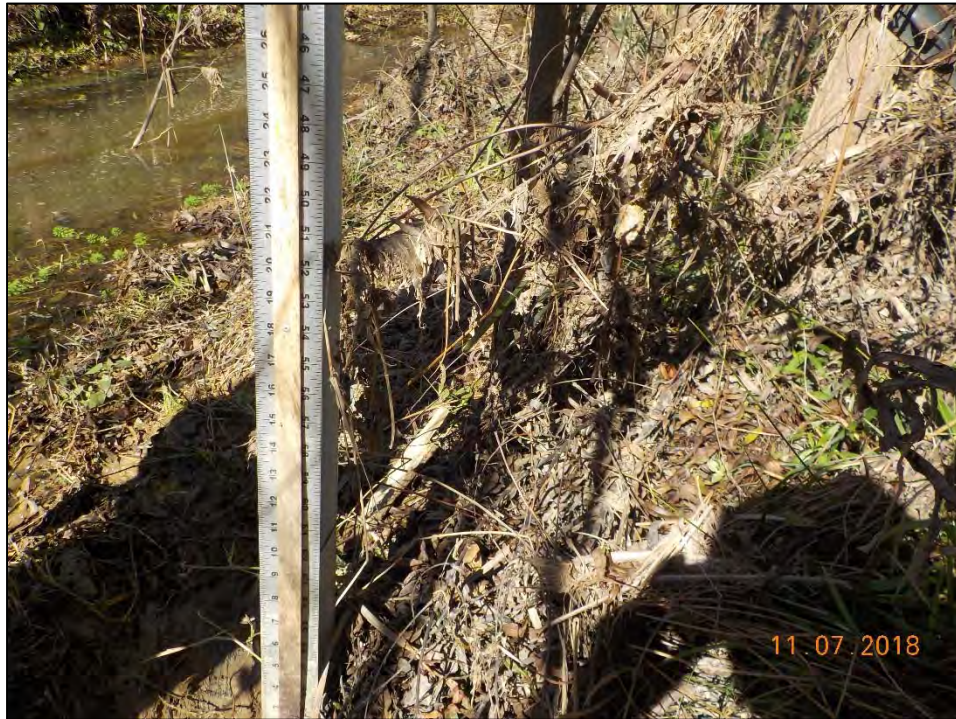
Wrack lines @ Crest Gauge Reach 2 – 0.66 feet

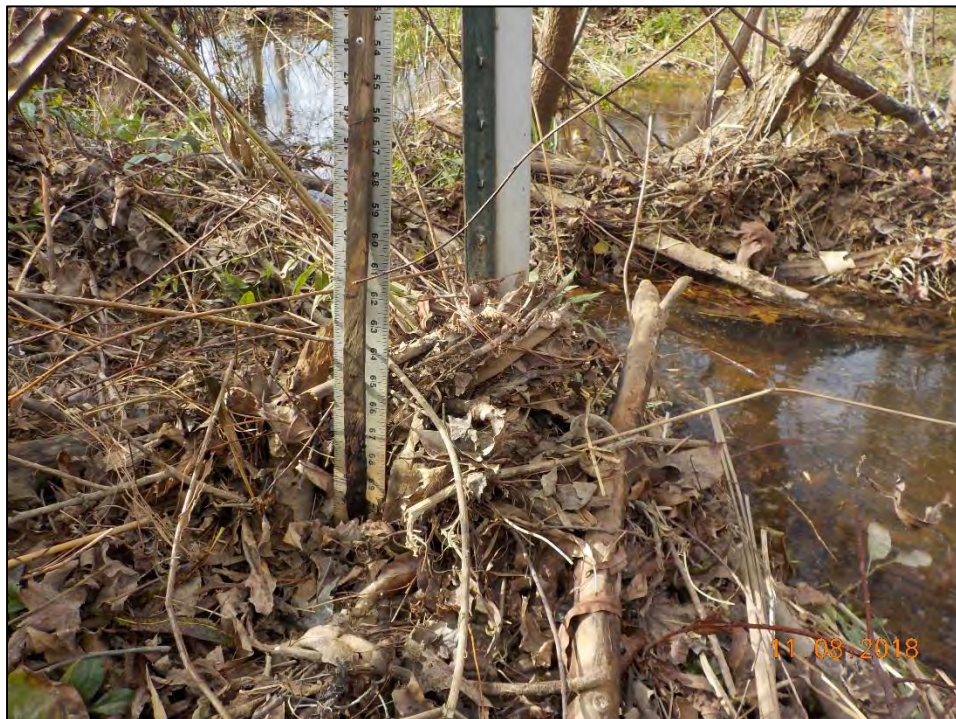
Wrack lines @ Crest Gauge Reach 3 – 0.79 feet

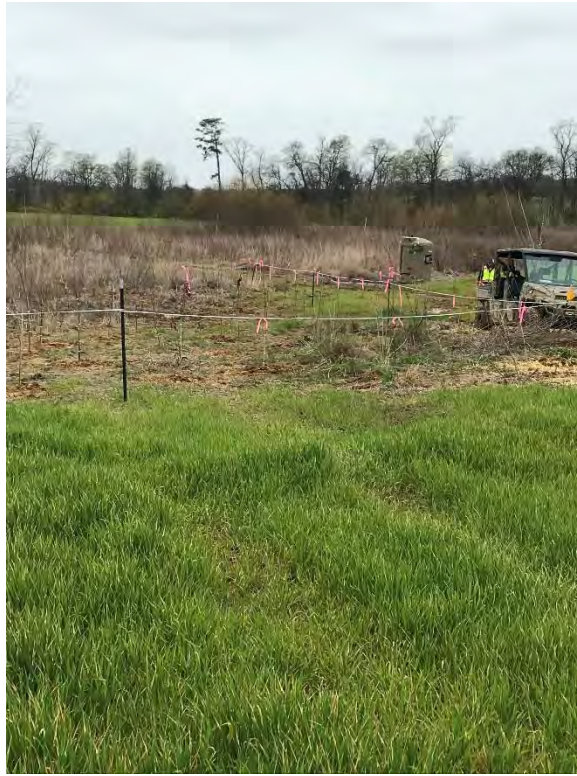
Encroachment area planting and easement marking near VP5. (3/27/2018)

RES addressed the encroachment areas on Reach 3 and 4. The work included adding posts and tape to block off the encroachment area as well as repairing the appropriate crossing outside of the easement near VP5. RES also found another encroachment area on Reach 4 during a site visit in early 2018. This area is near the end of the project and was remarked with additional posts. Both impacted areas were replanted with about 200 three-gallon container trees.

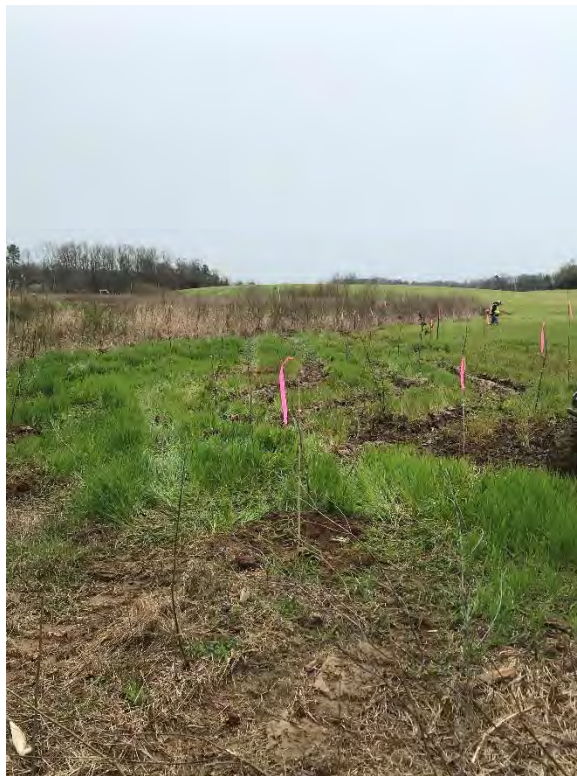
Encroachment area planting and easement marking on Reach 4. (3/27/2018)

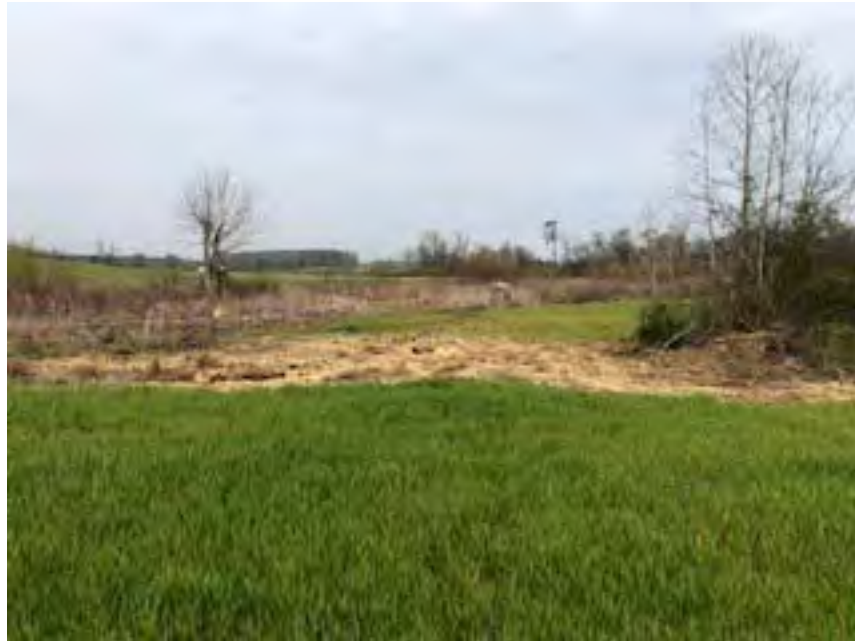
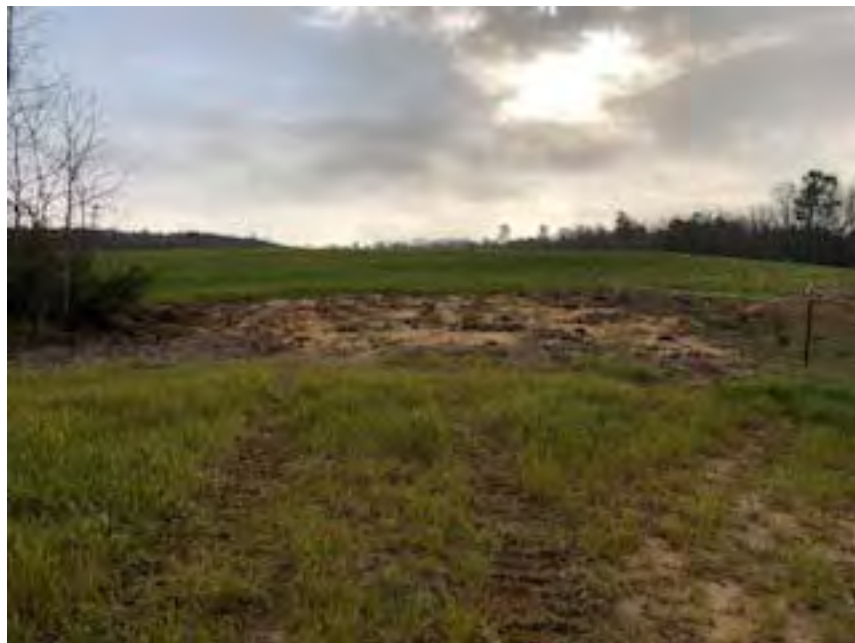
Crossing repair near VP5. (3/27/2018)

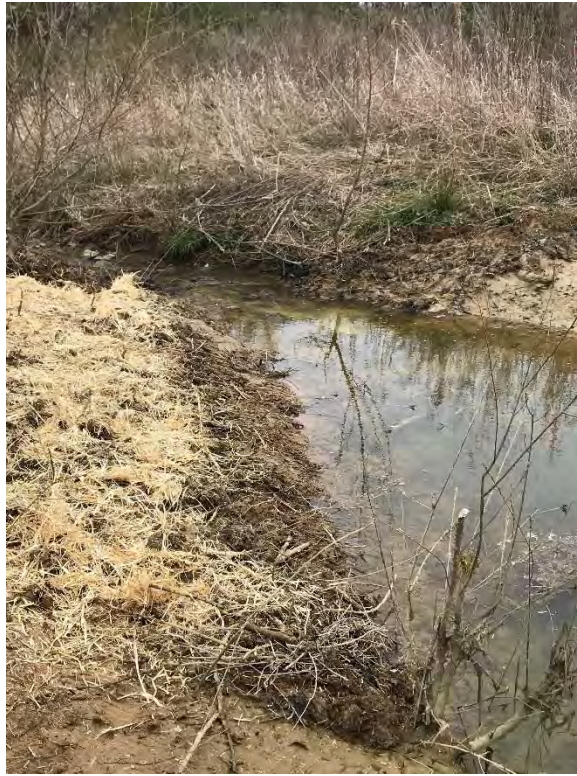
Beaver dam removal and bank stabilization near XS17. (3/27/2018)

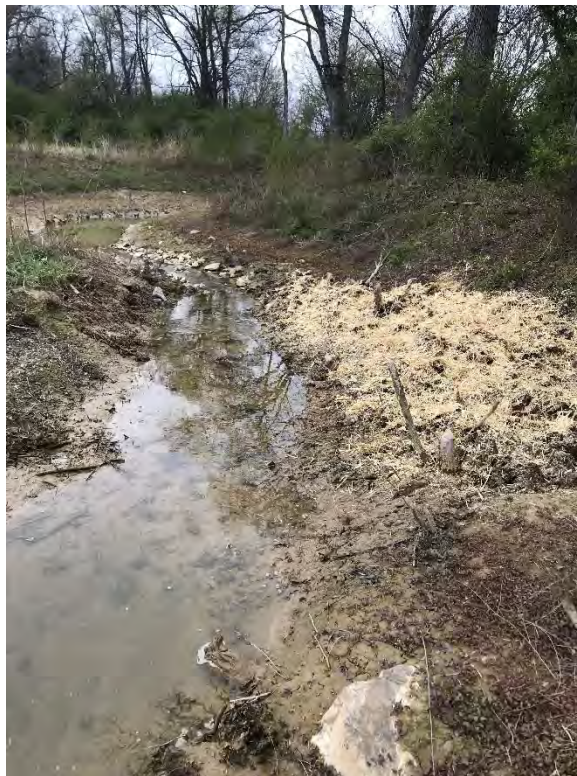
Beaver dam removal and bank stabilization downstream of XS18. (3/27/2018)

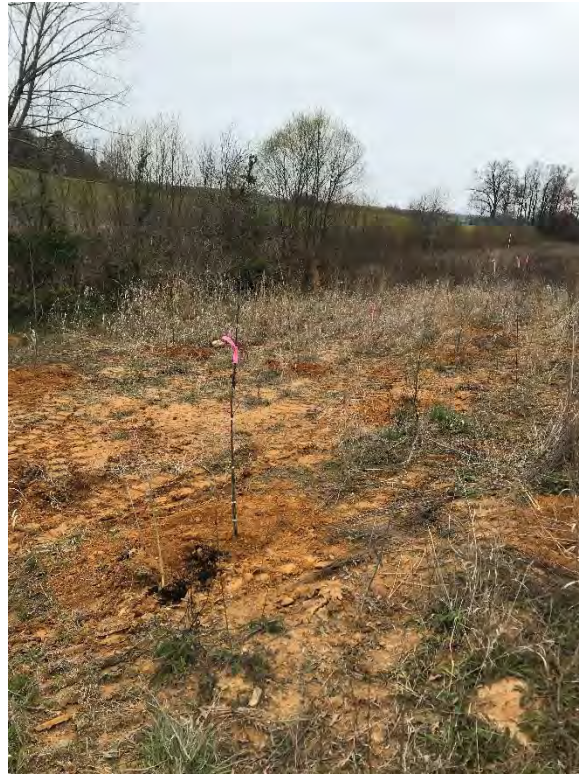
Bare area planting near the crossing on Reach 1. (3/27/2018)
