# **Annual Monitoring Report**

Monitoring Year 5 of 7

601 East Stream Restoration Project  
NCDMS Contract No.: 004925  
NCDMS Project No.: 95756  
USACE Permit Action ID: 2013-00265  
DWR Project No.: 14-0547

Union County, NC  
Data Collected: July/October 2019  
Date Submitted: January 2020

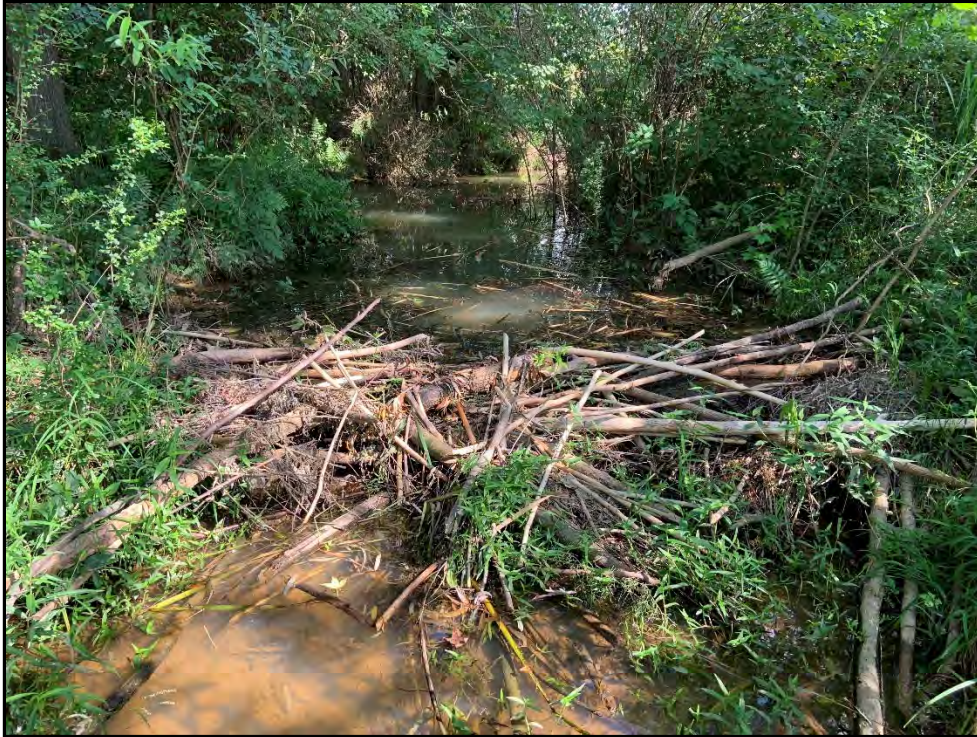
Visual assessment of the stream was performed to document signs of instability, such as eroding banks, structural instability, or excessive sedimentation (**Table 6**). The erosional feature noted in the right buffer of Reach 1 is a headcut is in need of repair. RES will stabilize the headcut with rock and add coir logs along the feature. The major stream problem areas from MY5 were two beaver dams on Reach 4 and three beaver dams on Reach 2. These dams and beavers will be removed in 2020.

Reach 2 – Beaver Dam

**Section 1.4.2:** Please notify DMS when the erosional area has been fixed and the reported beaver dams have been removed. DMS recommends removing beaver dams as soon as possible to avoid potential project damage and additional maintenance.

[RES will notify DMS when these problem areas are repaired.](#)

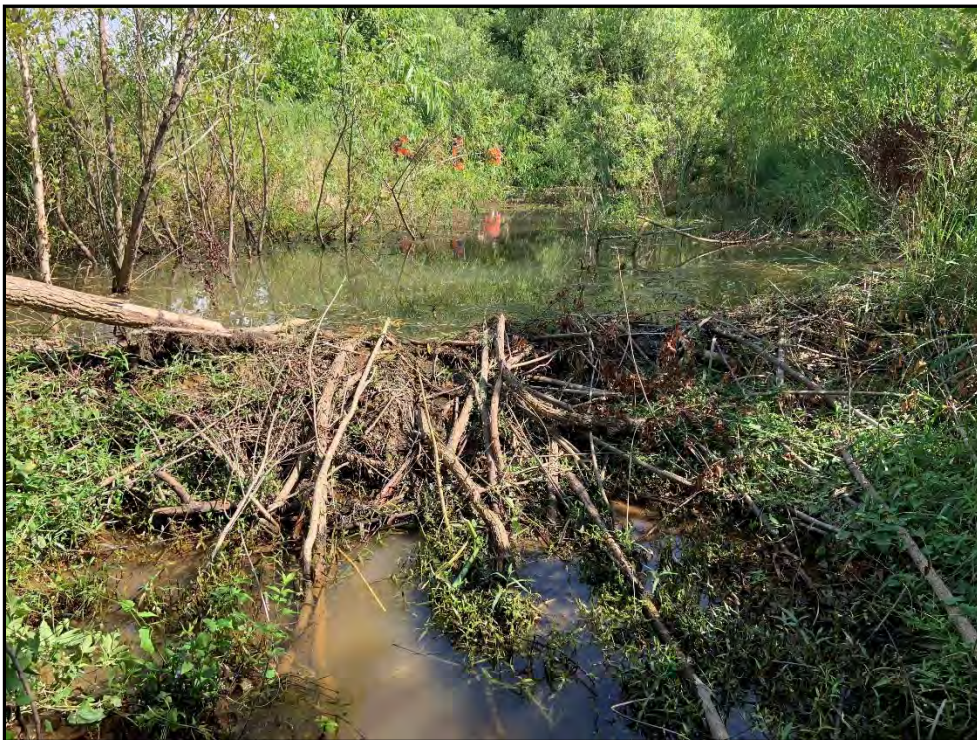
Reach 4 – Beaver Dam

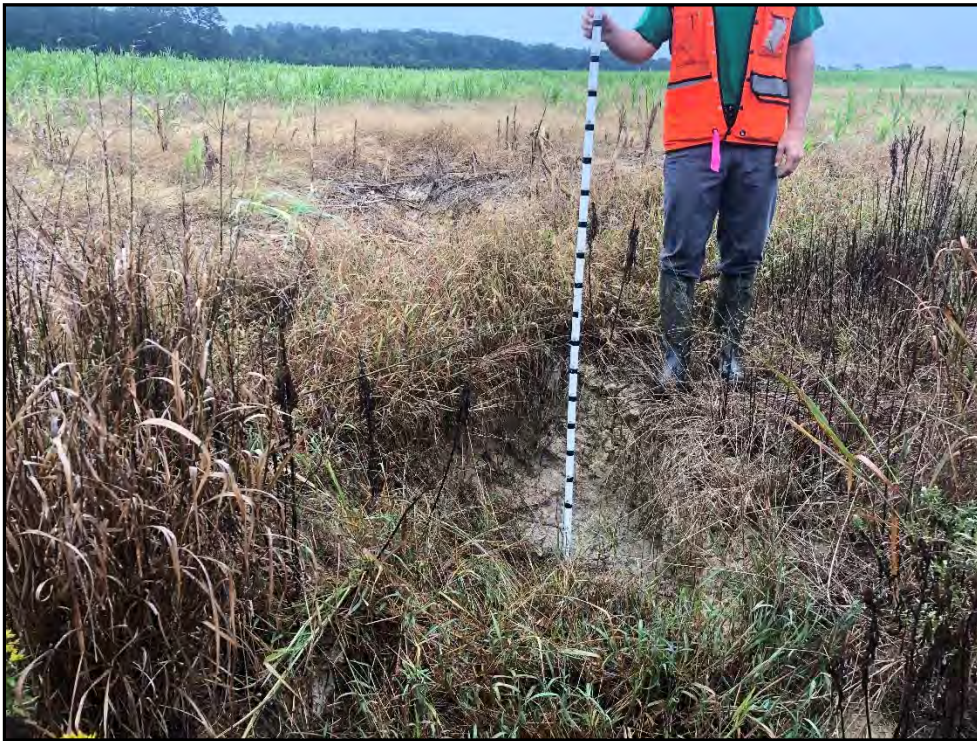
Reach 2 – Erosional Feature

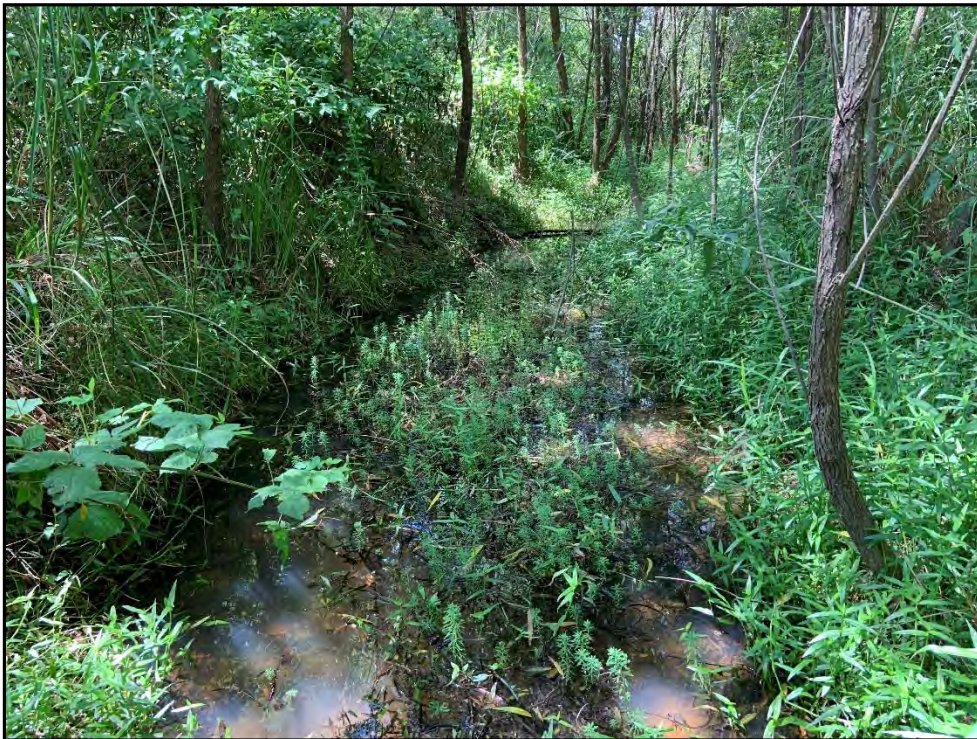
Visual assessment of the easement (**Table 5; Figure 2**) indicates vegetation is well established throughout the easement. There was no encroachment observed in MY5. The parrotfeather areas were treated in 2018 and were still present in MY5 though some were dying back with the dry conditions observed in October. The areas of cattails are still present but only in localized wetland areas. Invasive areas will continue to be monitored and treated as necessary throughout the monitoring period.

Reach 2 – Parrotfeather
