Annual Monitoring Report

Monitoring Year 6 of 7

601 East Stream Restoration Project
NCDMS Contract No.: 004925
NCDMS Project No.: 95756
USACE Permit Action ID: 2013-00265
DWR Project No.: 14-0547

Union County, NC
Data Collected: November 2020
Date Submitted: January 2021

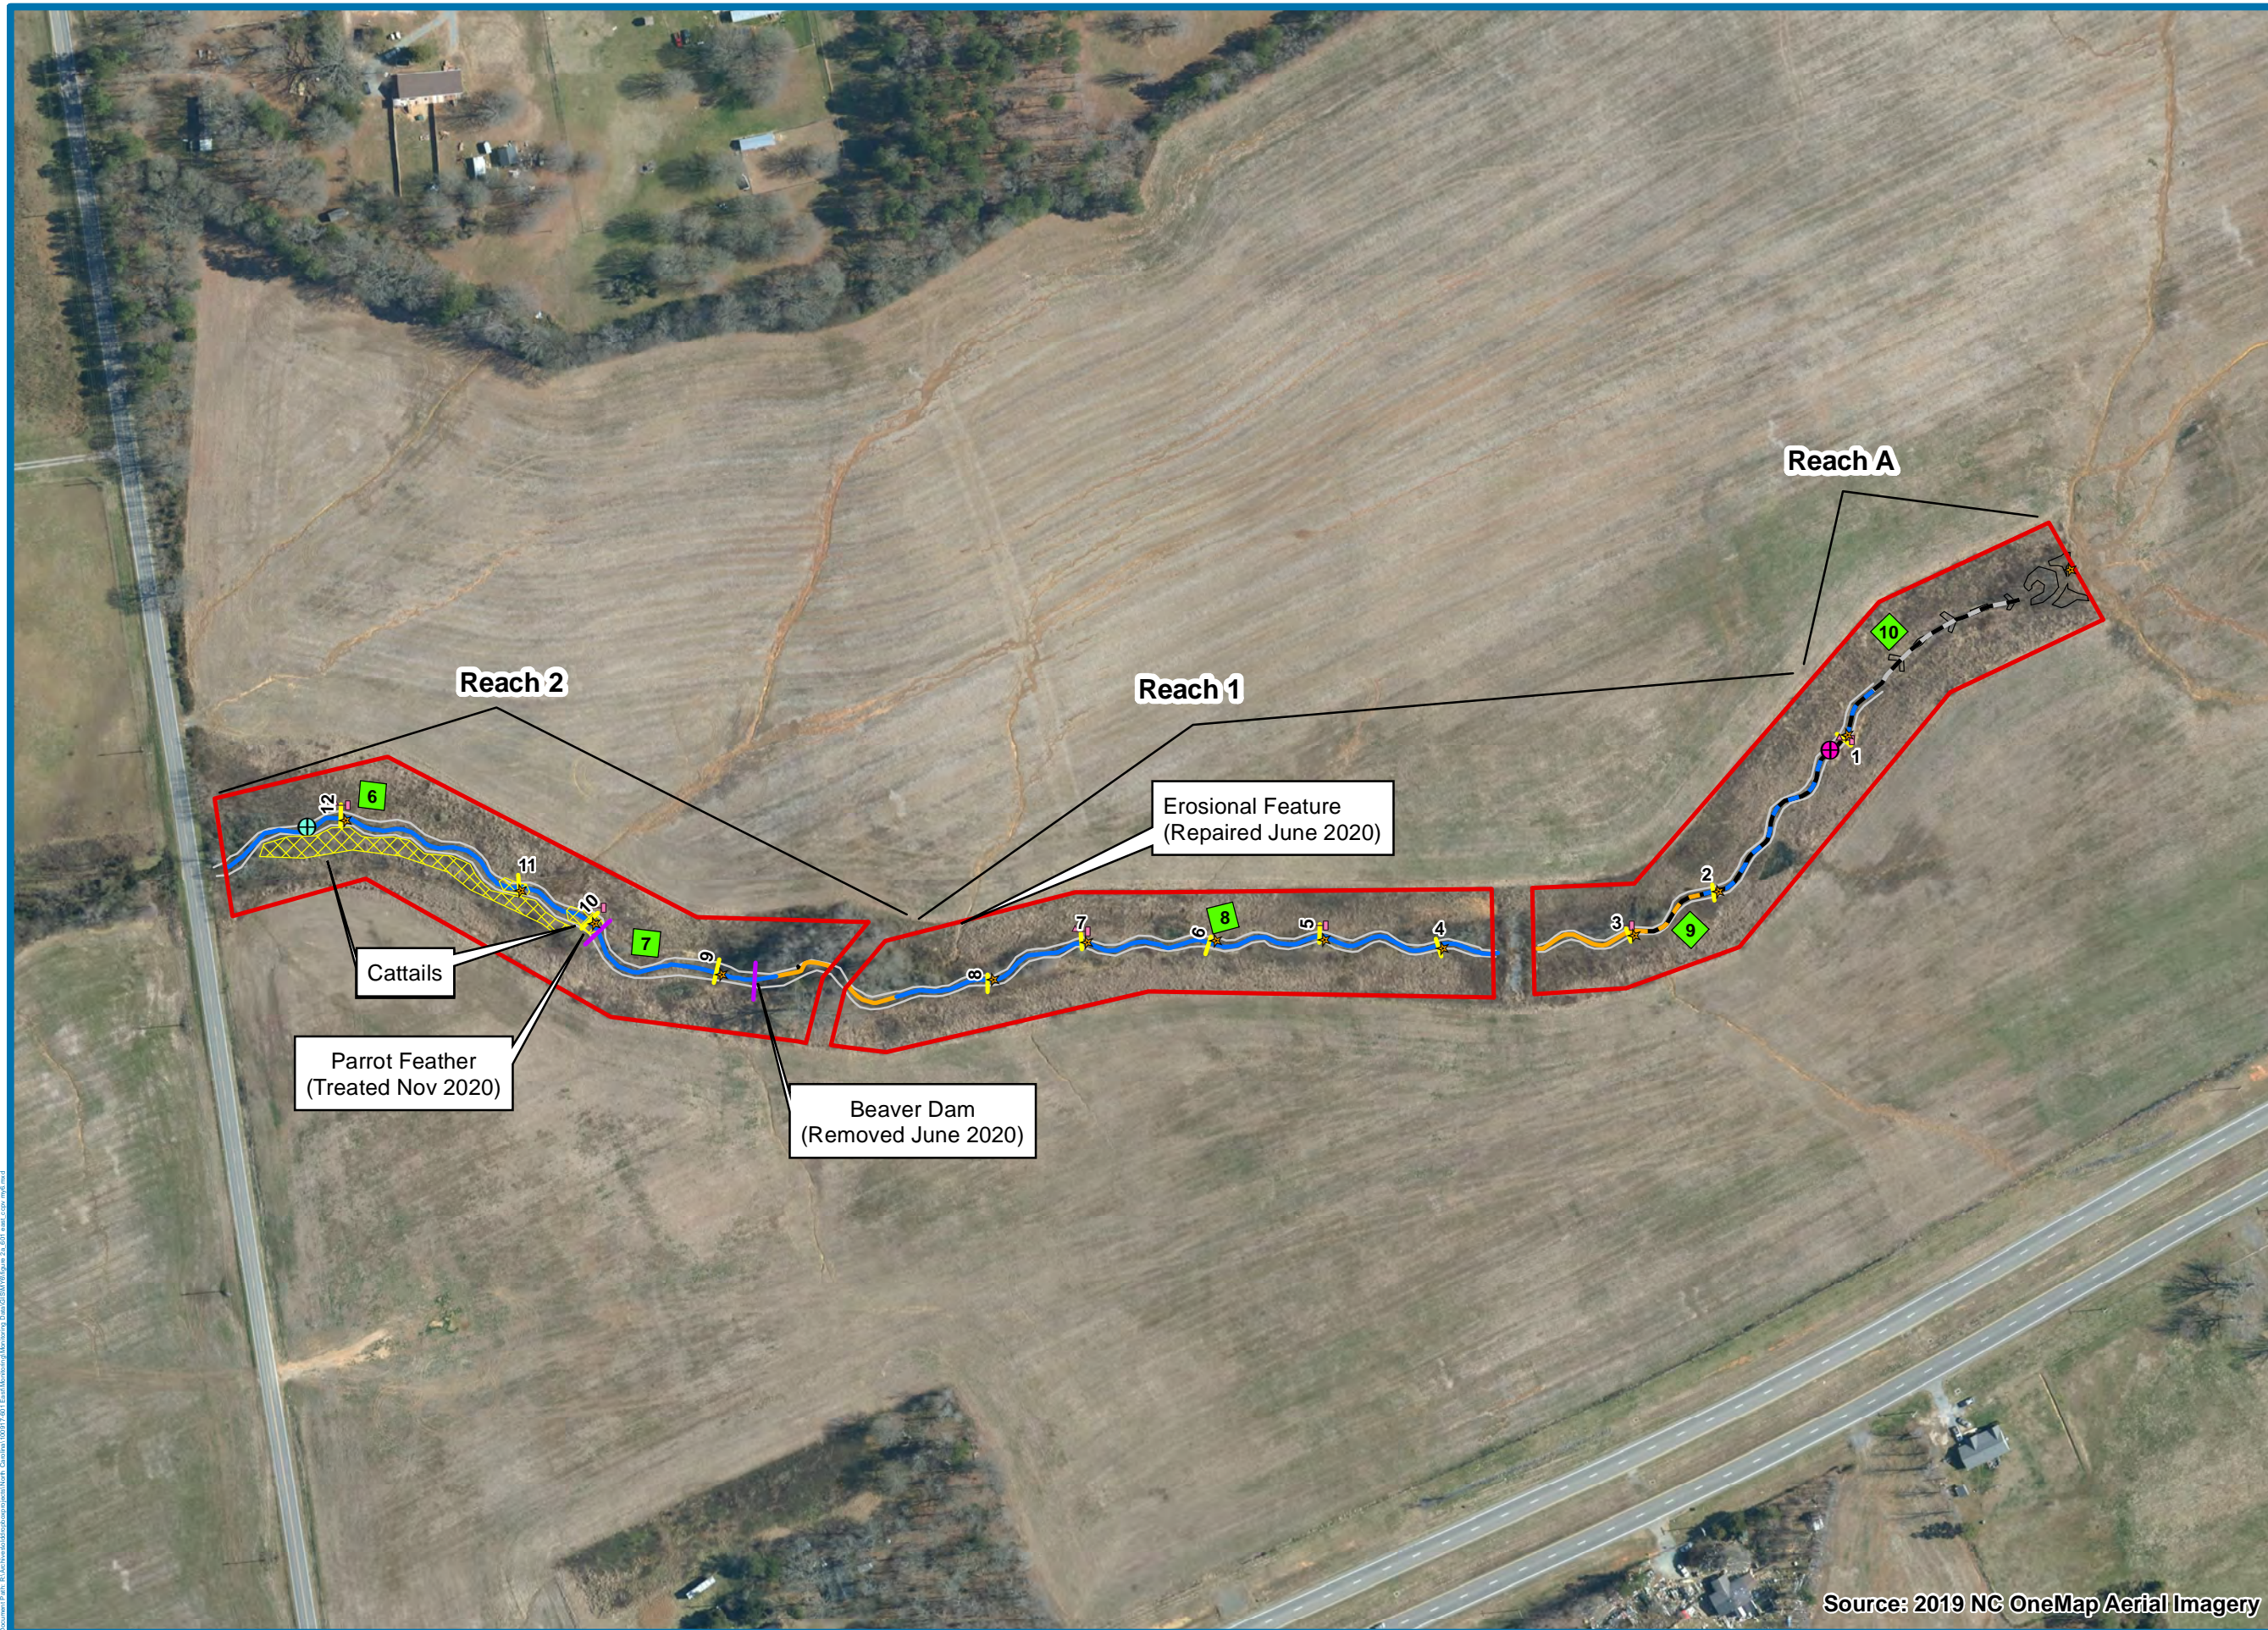
Erosional Feature (Repaired June 2020)

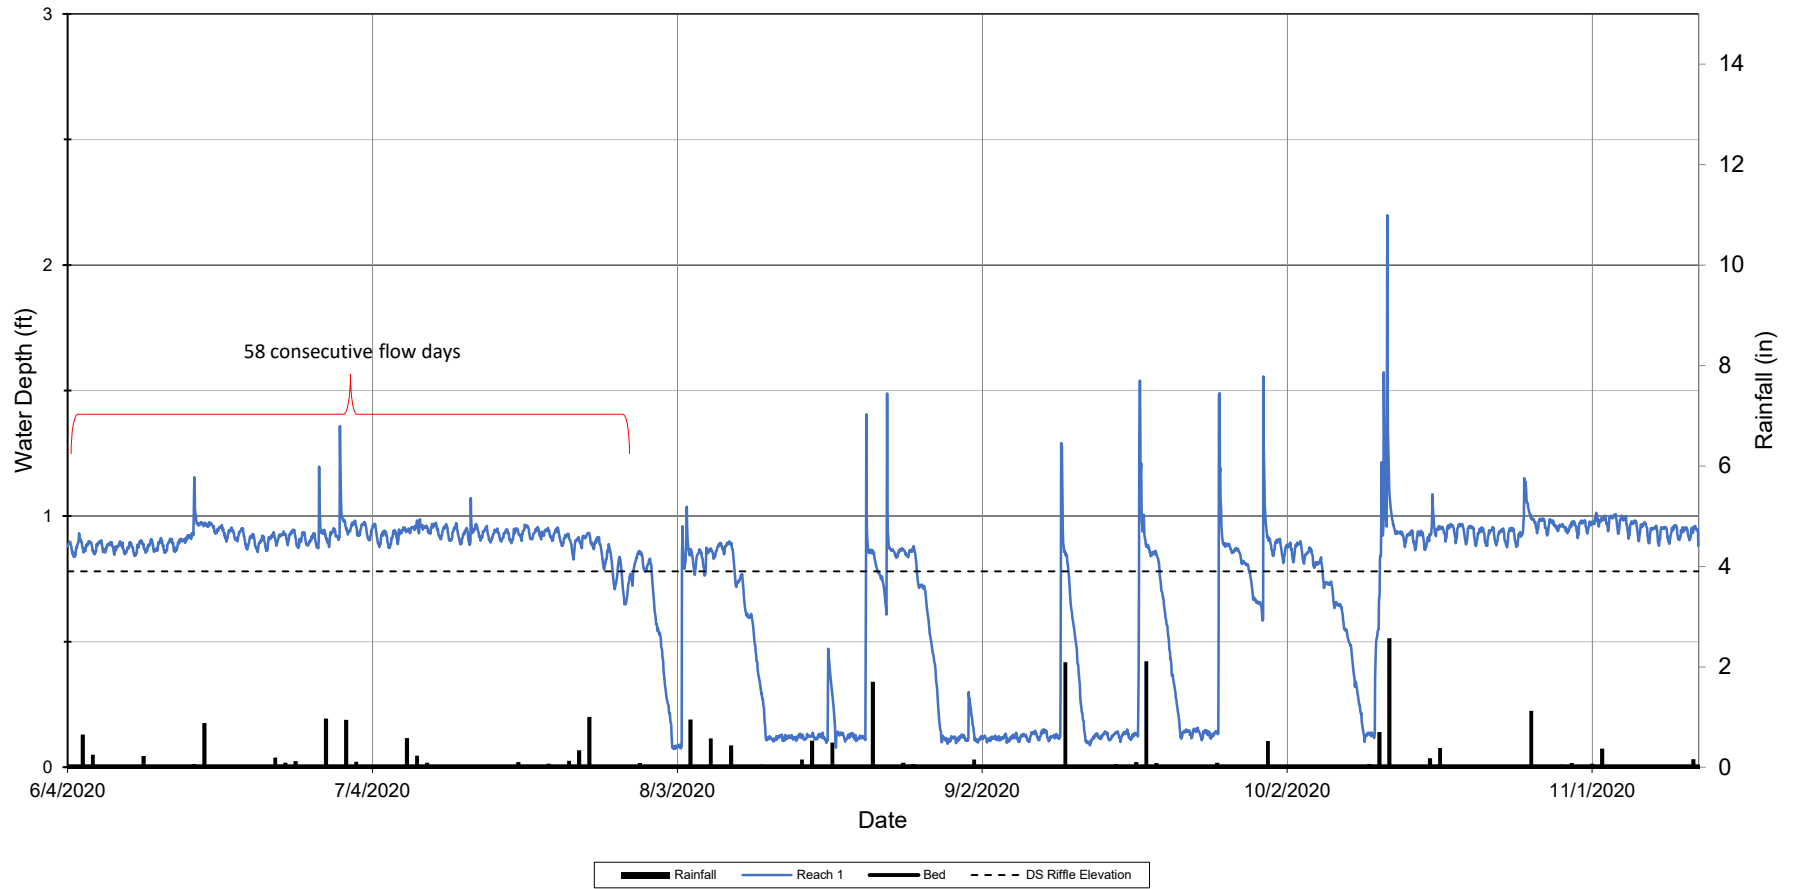
MY6 2020 601 East Reach 1 Flow Gauge

Year	Number of Bankfull Events	Maximum Bankfull Height (ft)	Date of Occurrence
SR Reach 2			
MY1 2015	1	Unknown	9/30/2015
MY2 2016	1	1.40	2/16/2016
MY3 2017	3	2.50	4/24/2017
MY4 2018	1	0.66	9/16/2018
MY5 2019	NA	NA	NA
MY6 2020	5	1.82	5/27/2020
SR Reach 3			
MY1 2015	0	---	---
MY2 2016	1	0.20	Unknown
MY3 2017	3	1.40	6/20/2017
MY4 2018	1	0.79	9/16/2018
MY5 2019	NA	NA	NA
MY6 2020	8	0.95	5/27/2020
MY5 gauges failed due to ant infestations			
MY6 HOBOS were installed and used in place of cork gauges			
Year	Consecutive Flow Days	Total Flow Days	Number of Flow Events
FG Reach 1			
MY6 2020	58	113	7

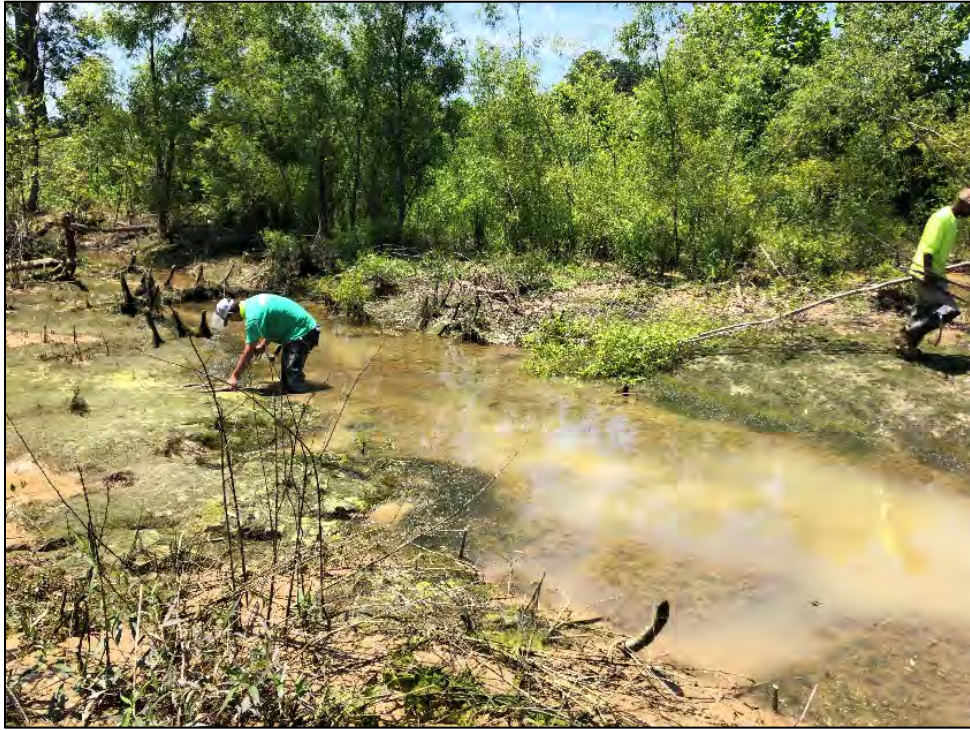
Section 1.4.2 Stream Geomorphology: The report text and CCPV maps indicate that two (2) beaver dams were removed in June 2020 and two (2) beaver dams were removed in November 2020. Beaver have been a persistent issue on the site. Were beaver also trapped as part of the dam removal efforts? Please update the text accordingly.

Beaver dam removal and livestaking

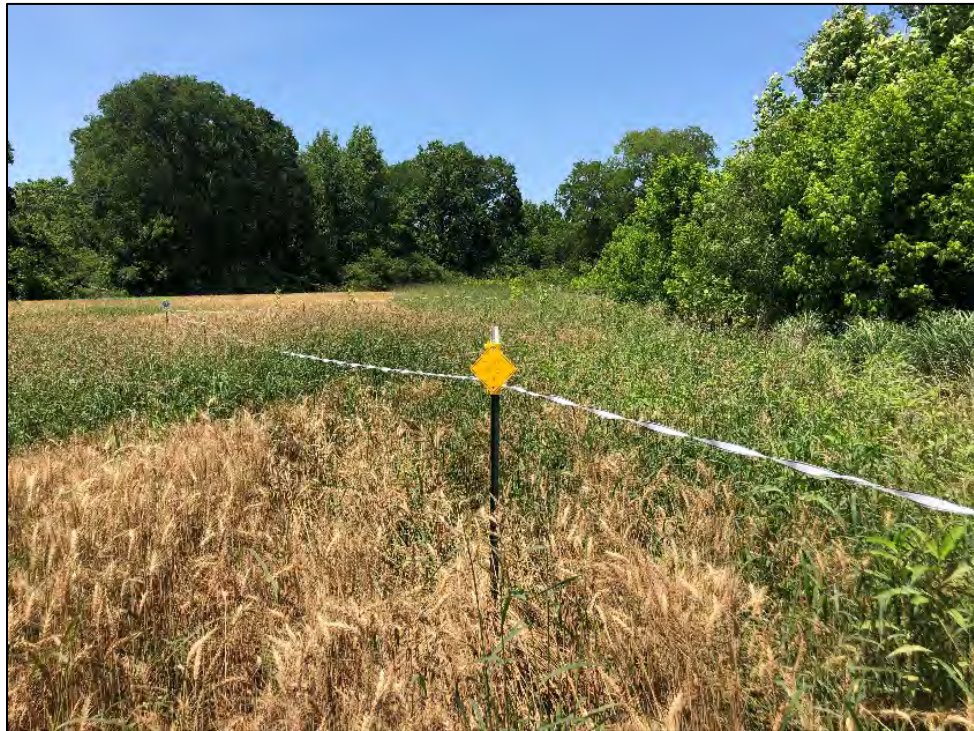
Visual assessment of the easement (**Table 5; Figure 2**) indicates vegetation is well established throughout the easement. One area of encroachment was observed and repaired in June 2020. The encroachment repair included installing t-posts, horse tape, and easement signage along the easement boundary as well as planting 60 three-gallon container trees. The planting was done in June 2020 and species included sycamore, river birch, and willow oak. In January 2021, RES inspected the entire easement boundary and replaced all missing easement signage. Invasive species including Chinese privet and parrotfeather were treated in August 2020. The areas of cattails are still present but only in localized wetland areas. Invasive areas will continue to be monitored and treated as necessary throughout the monitoring period.

Easement marking and planting

[The encroachment repair included installing t-posts, horse tape, and easement signage along the easement boundary as well as planting 60 three-gallon container trees. The planting was done in June 2020 and species included sycamore, river birch, and willow oak. This has been added to Section 1.4.1.](#)

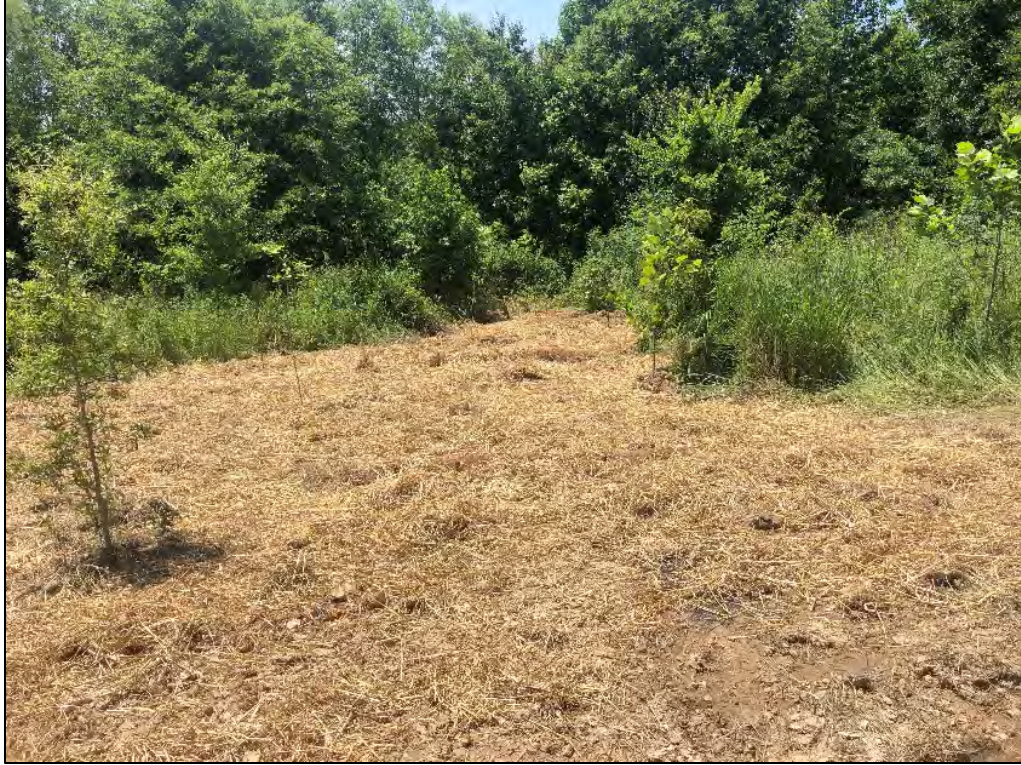
Visual assessment of the stream was performed to document signs of instability, such as eroding banks, structural instability, or excessive sedimentation (**Table 6**). The erosional feature noted in the right buffer of Reach 1 was addressed by stabilizing the headcut with rock and adding coir logs along the feature. RES also removed remnant beaver dam on Reach 2 in June 2020 and on Reach 3 and 4 in November 2020. The beaver dams were no longer active therefore beavers were not trapped in 2020. RES inspects sites quarterly and will perform beaver management (dam removal and trapping) as necessary throughout the remainder of the monitoring period.

Headcut repair with seeding and coir logs
