Annual Monitoring Report

Monitoring Year 7 of 7

601 East Stream Restoration Project
NCDMS Contract No.: 004925
NCDMS Project No.: 95756
USACE Permit Action ID: 2013-00265
DWR Project No.: 14-0547

Union County, NC
Data Collected: June & October 2021
Date Submitted: December 2021

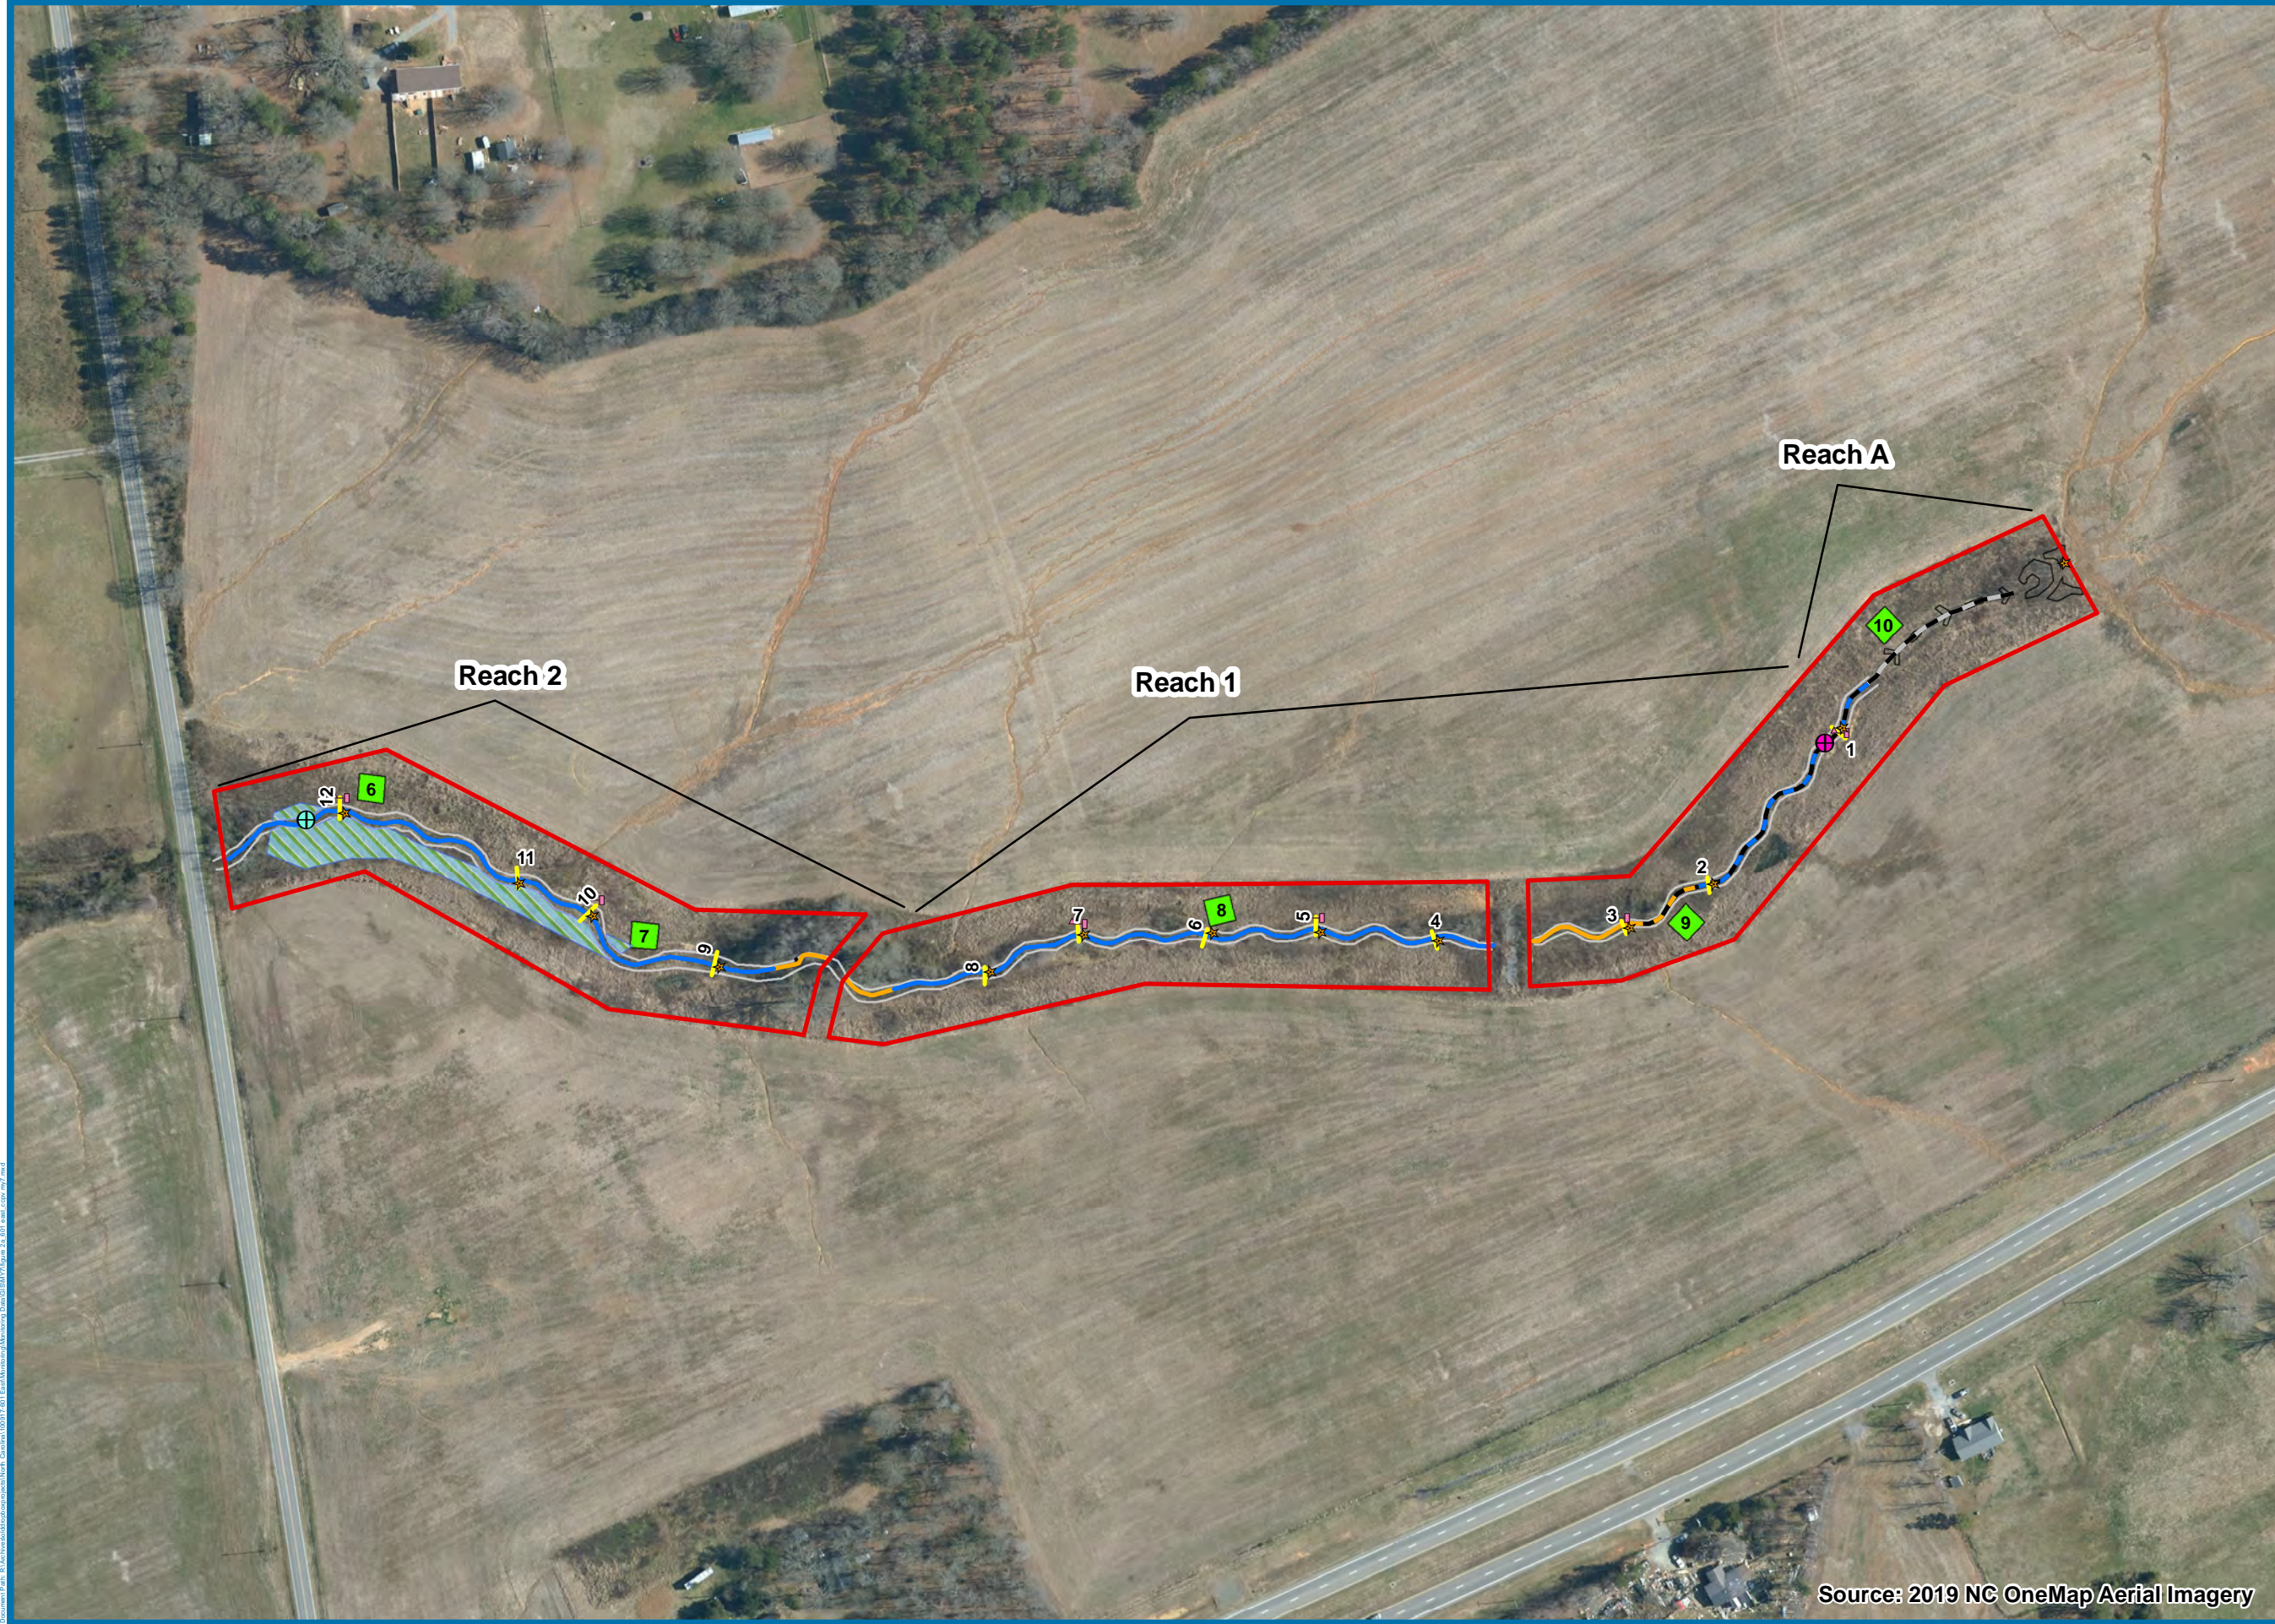
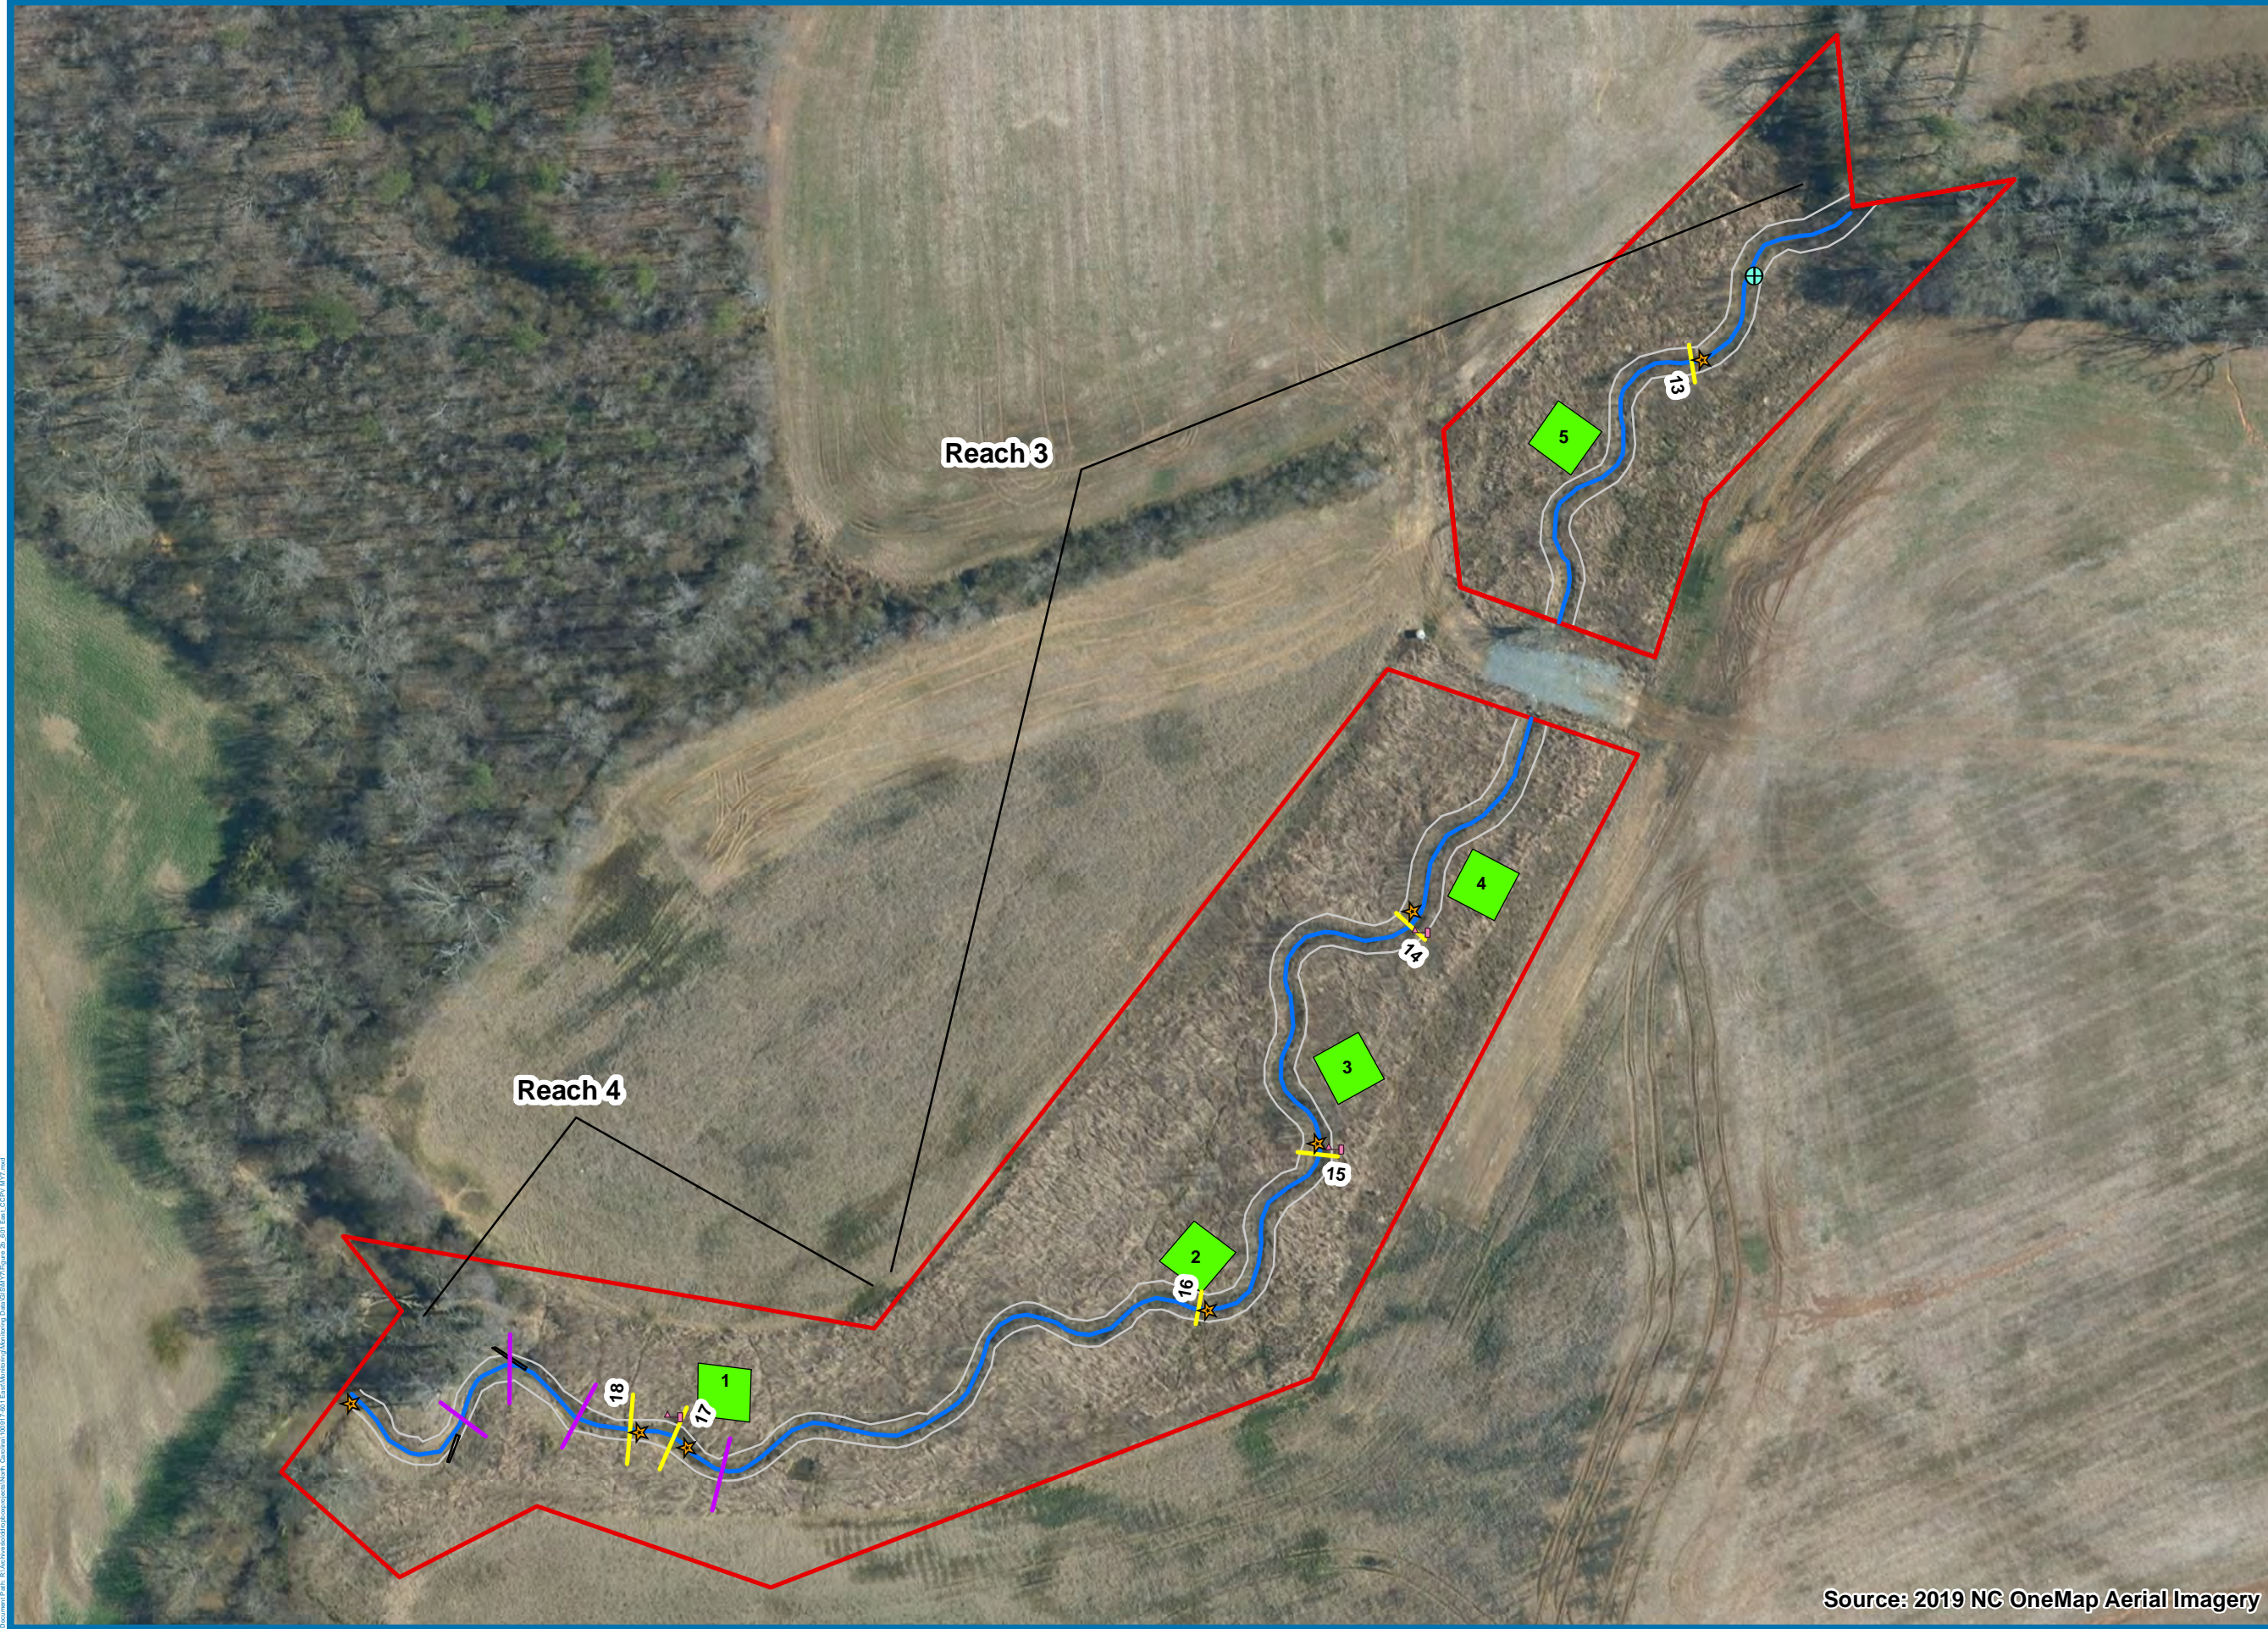
**Current Conditions
Plan View**

Visual assessment of the easement (**Table 5; Figure 2**) indicates vegetation is well established throughout the easement. One area of encroachment was observed and repaired in June 2020. The encroachment repair included installing t-posts, horse tape, and easement signage along the easement boundary as well as planting 60 three-gallon container trees. The planting was done in June 2020 and species included sycamore, river birch, and willow oak. In January and September 2021, RES inspected the entire easement boundary and replaced all missing easement signage. Invasive species including parrotfeather were treated in September 2021. The kill on parrotfeather appeared very effective when observed in October 2021. The areas of cattails are still present but only in localized wetland areas and are not considered problem areas. RES will continue to treat invasive species, as needed, prior to closeout.

Visual assessment of the stream was performed to document signs of instability, such as eroding banks, structural instability, or excessive sedimentation (**Table 6**). The erosional feature noted in the right buffer of Reach 1 was addressed by stabilizing the headcut with rock and adding coir logs along the feature. RES also removed remnant beaver dam on Reach 2 in June 2020 and on Reach 3 and 4 in November 2020. Between October and December 2021, four beaver dams were built on Reach 4. The dams were removed, and beavers were trapped in December 2021. RES will continue to manage beavers, as needed, prior to closeout.
