**601 North II
Stream Restoration Site
NCDMS Project Number: 95025
Monitoring Contract Number: 003991
Monitoring Year 4
2016**

**601 North II
Stream Restoration Site
2016 Monitoring Report (MY 4)**

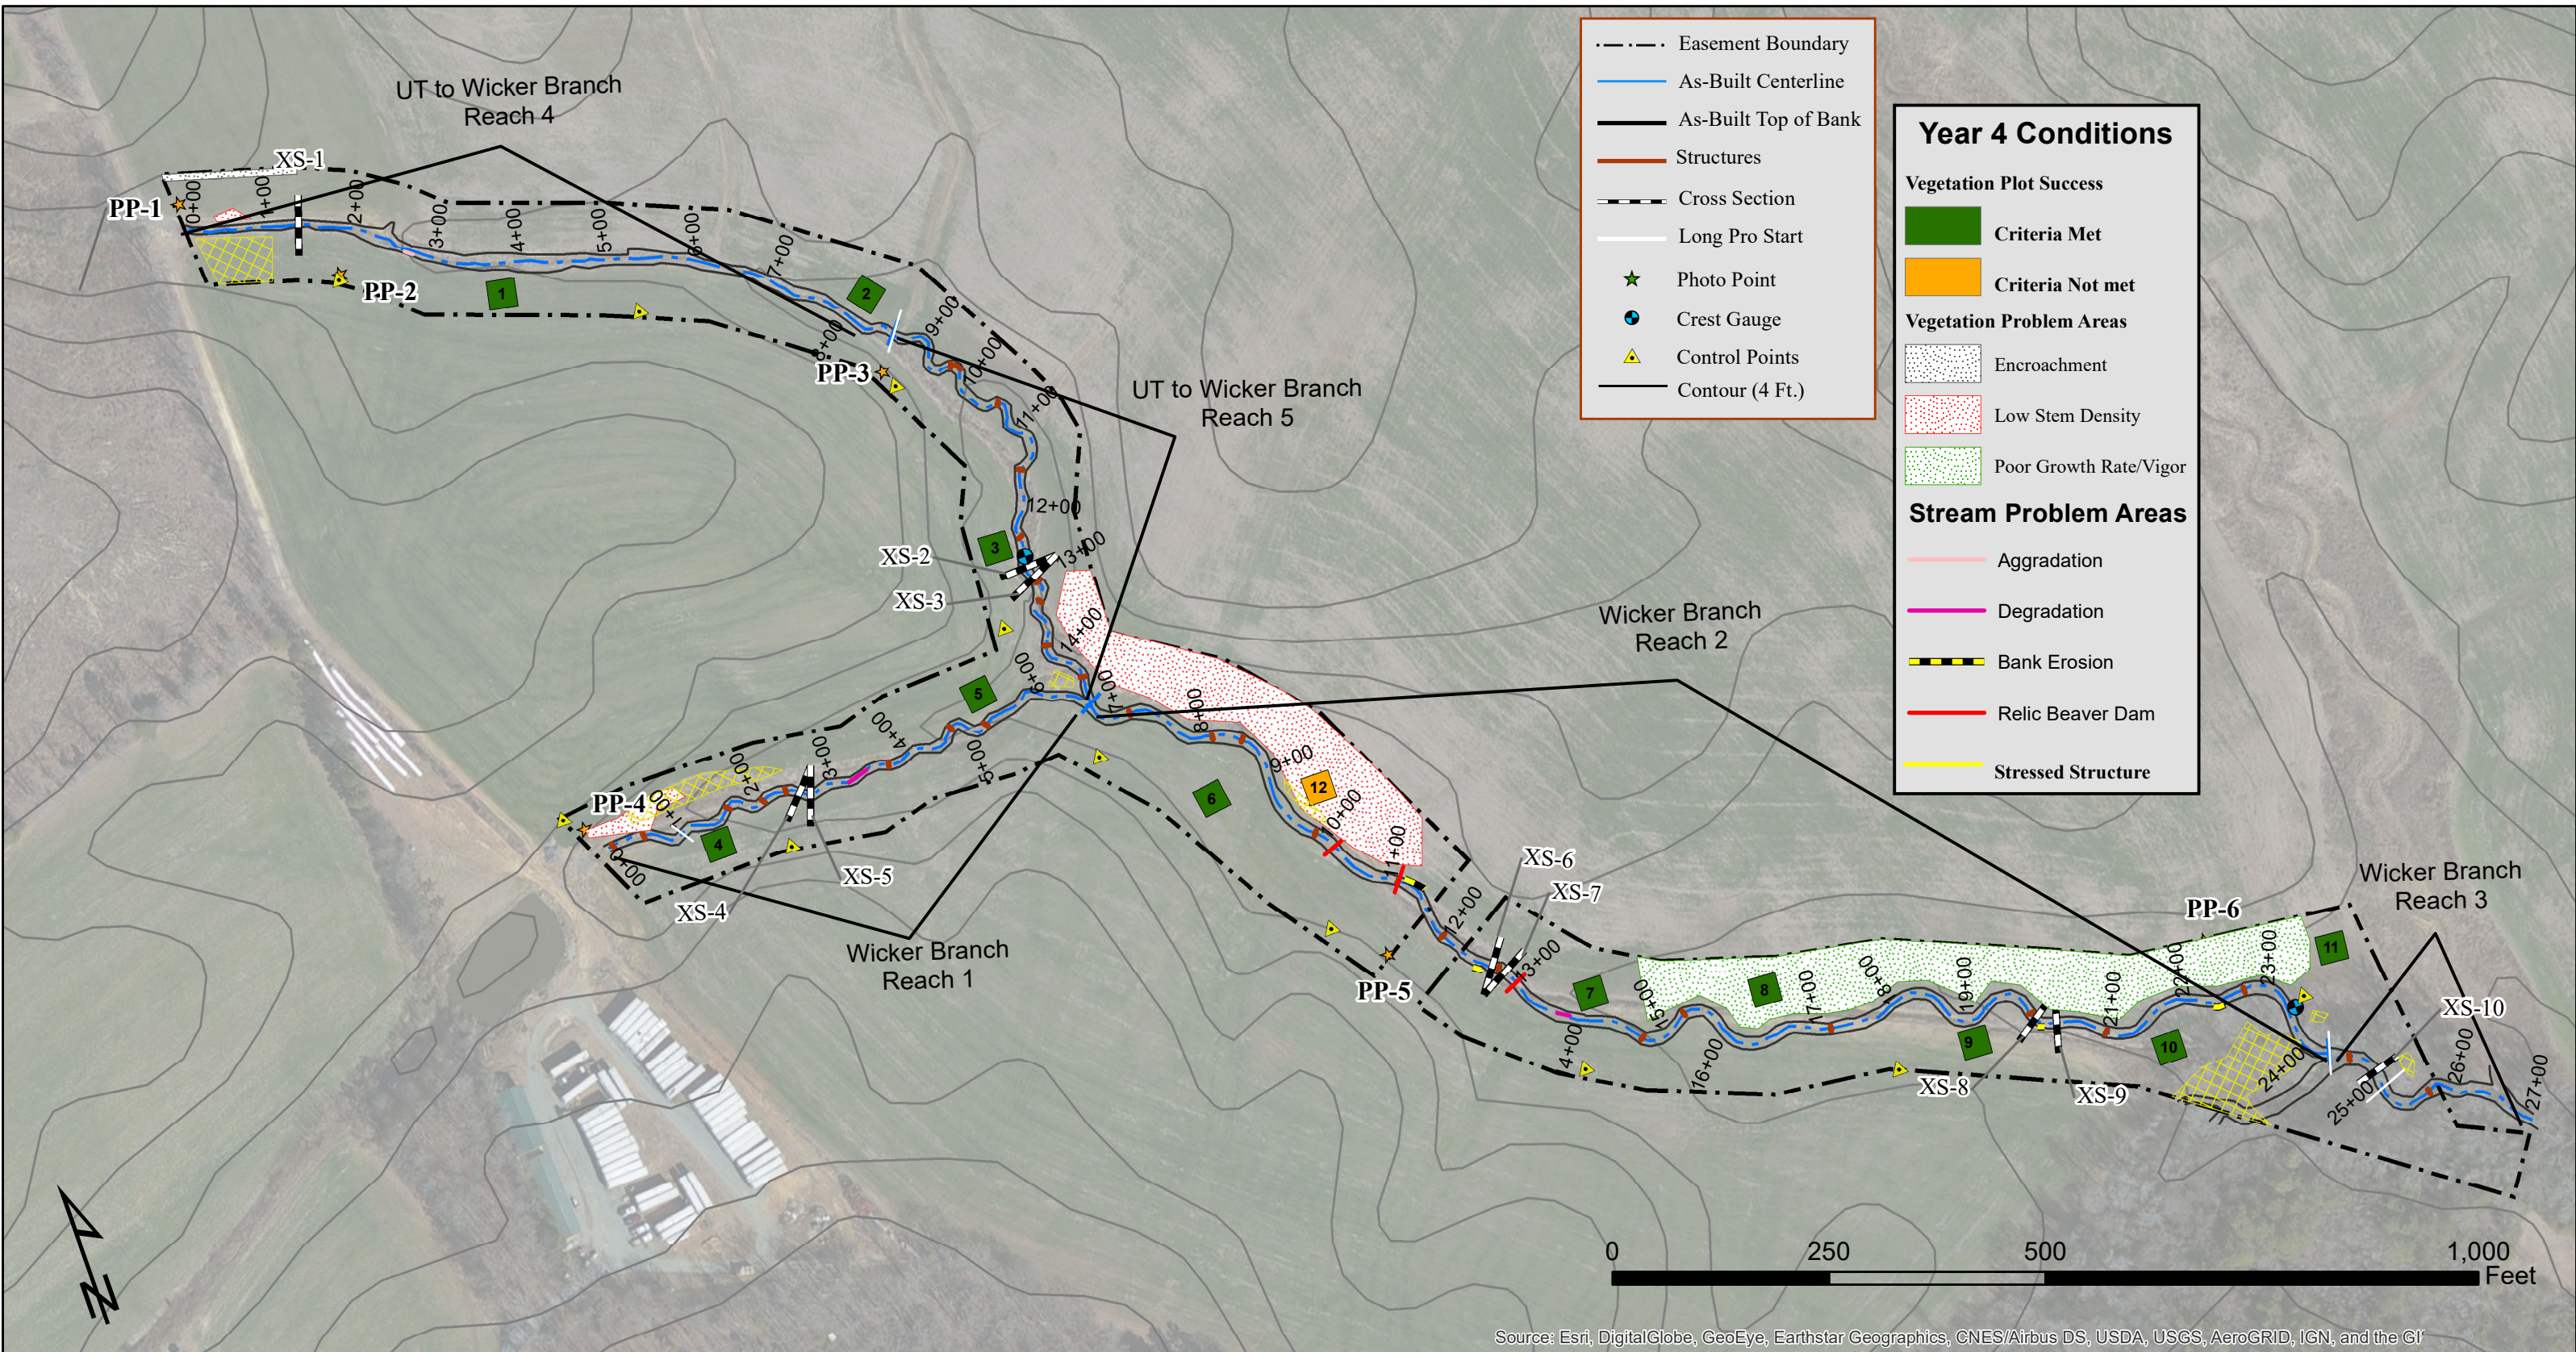
Figure 2. Integrated Current Condition Plan View

Visual assessment of the easement indicates that herbaceous vegetation has become well established throughout the project. Areas of low stem densities ($n = 3$) and poor growth rates ($n = 1$) were noted during MY4 in Reaches 1, 2, and 4 (Figure 2). During MY4, a previously identified easement encroachment was observed on Reach 4, between station 0+00 and 1+50 on the LDB. This area consists of clearing a walking path along the fence line using mowing and the application of herbicides. During MY4 only one continued encroachment occurred on the LDB of Reach from between STA 0+00 and 1+50, where the edge of the easement was sprayed and mowed to clear a walking path along the fence line. Vegetation within all areas of encroachment identified during previous monitoring years has begun to become re-established. Additional boundary marking and signage were installed in the vicinity of the original encroachment in April 2014. Areas of encroachment that have occurred since then will receive supplemental boundary markers in the vicinity of the encroachment and RES will continue efforts to coordinate with the adjacent landowners to avoid future encroachments. Supplemental planting of the easement occurred during January 2015 in areas that had experienced plant mortality. The replanted areas included areas of encroachment, poor growth rate, and low stem densities. Invasive exotic vegetation, consisting of Chinese Privet (*Lingustrum sinense*) and Japanese Honeysuckle (*Lonicera japonica*), was noted in seven locations totaling 0.39 acres, or 3% of the easement area (Figure 2 and Table 6).

Visual assessment of the entire project indicates that the stream is remaining stable with few problem areas noted. One small area of degradation on Reach 1 at approximately Station 3+30, first observed during MY2, is stabilizing. Another small area of degradation totaling 15 feet was noted on Reach 2 at Station 13+75. On Reach 2 bank erosion is occurring at the following locations: 26 feet beginning at STA 11+25, 10 feet near Station 12+50, 8 feet near Station 19+50, and 13 feet near Station 22+30 (Figure 2). Beaver dams were removed in early 2016, however remnants of the dams still exist at STA 10+25, STA 11+25, and STA 13+00. (Figure 2).

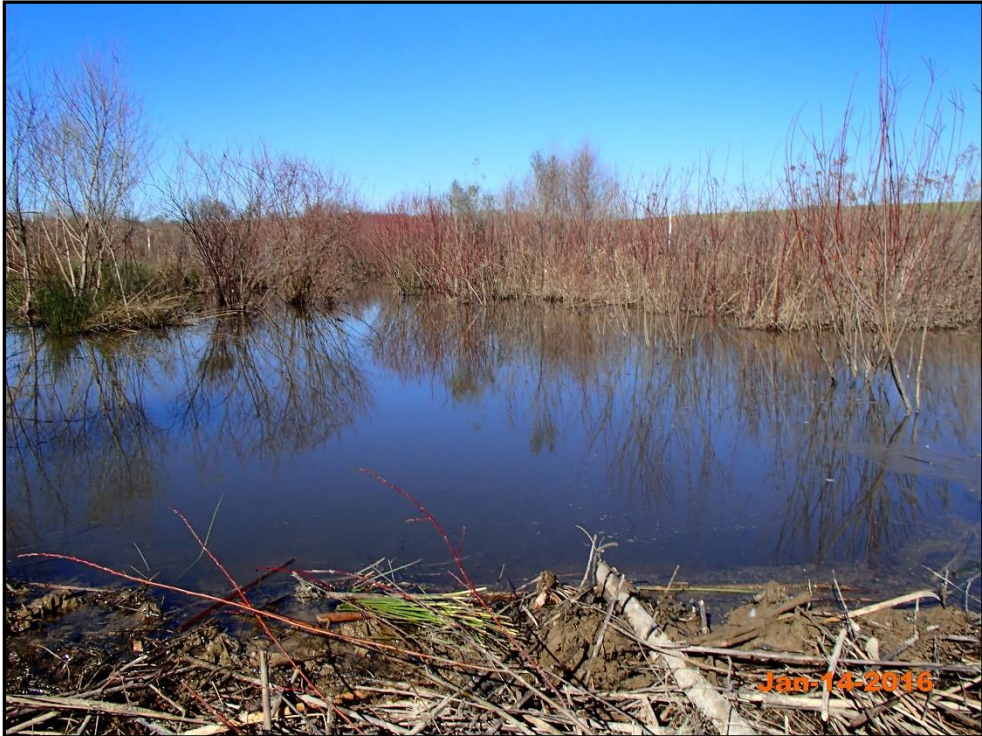
Project Reach 2 – Beaver Dam (removed) 10+25 Looking Upstream

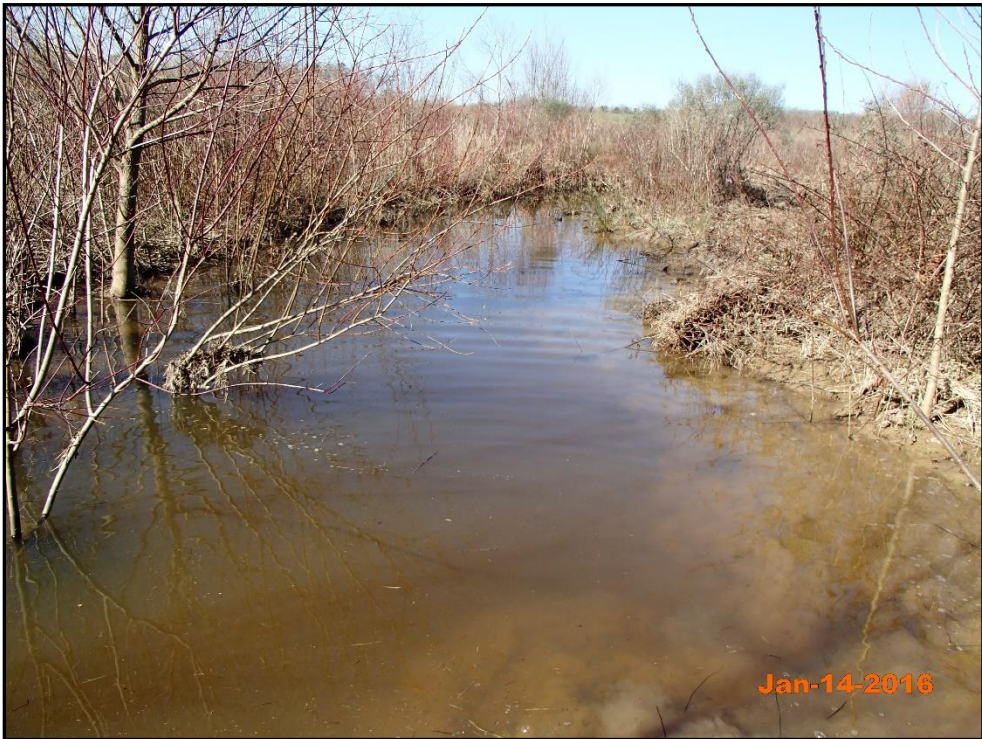
Project Reach 2 – Beaver Dam (removed) 11+00 Looking Upstream

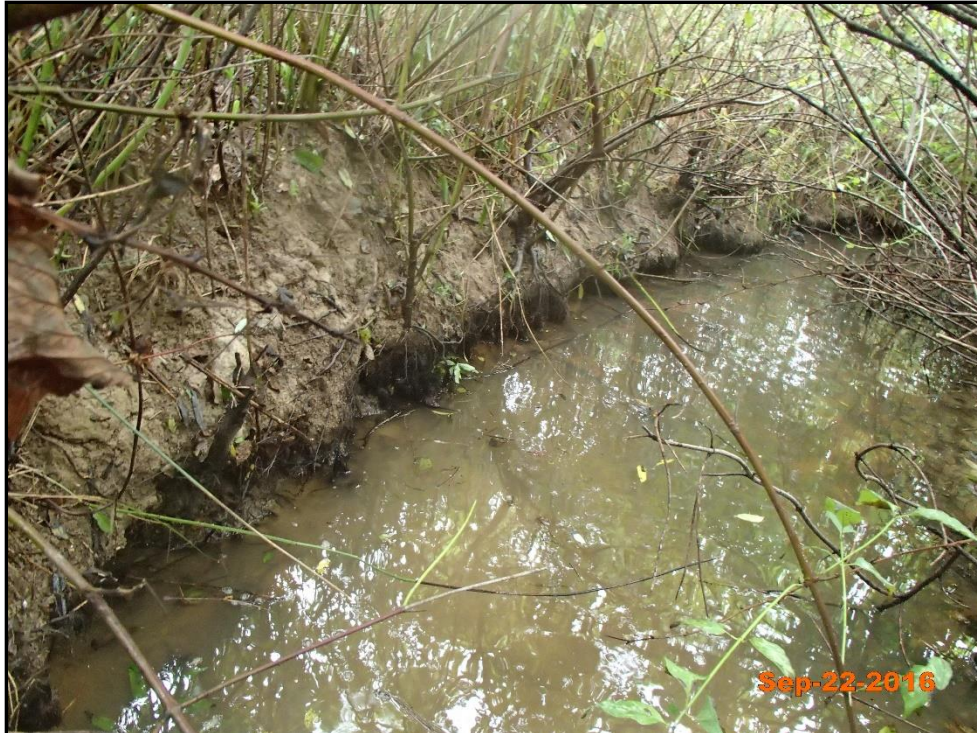
Project Reach 2 – Bank Erosion 11+25 Left Descending Bank

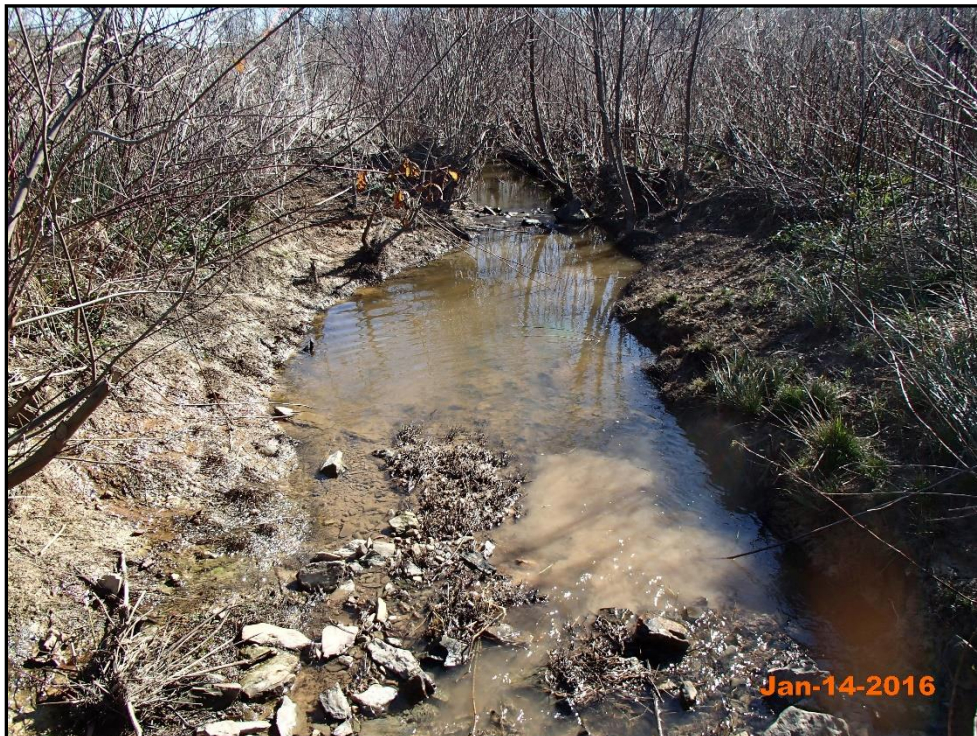
Project Reach 2 – Degradation 13+75 Right Descending Bank

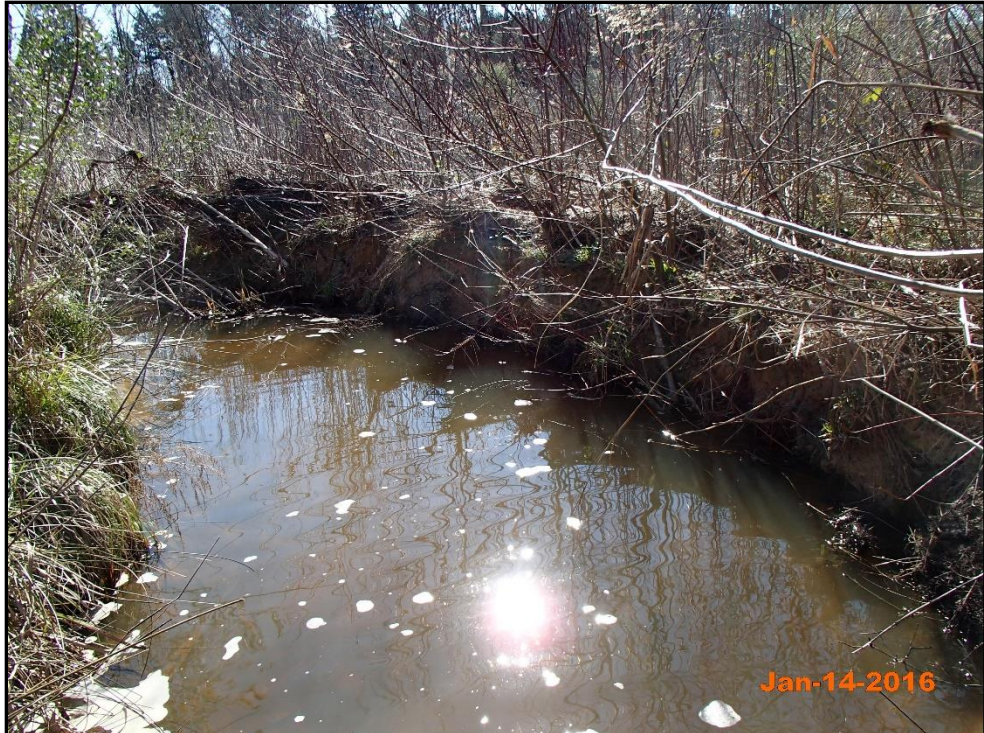
Project Reach 2 – Bank Erosion 19+50 Right Descending Bank

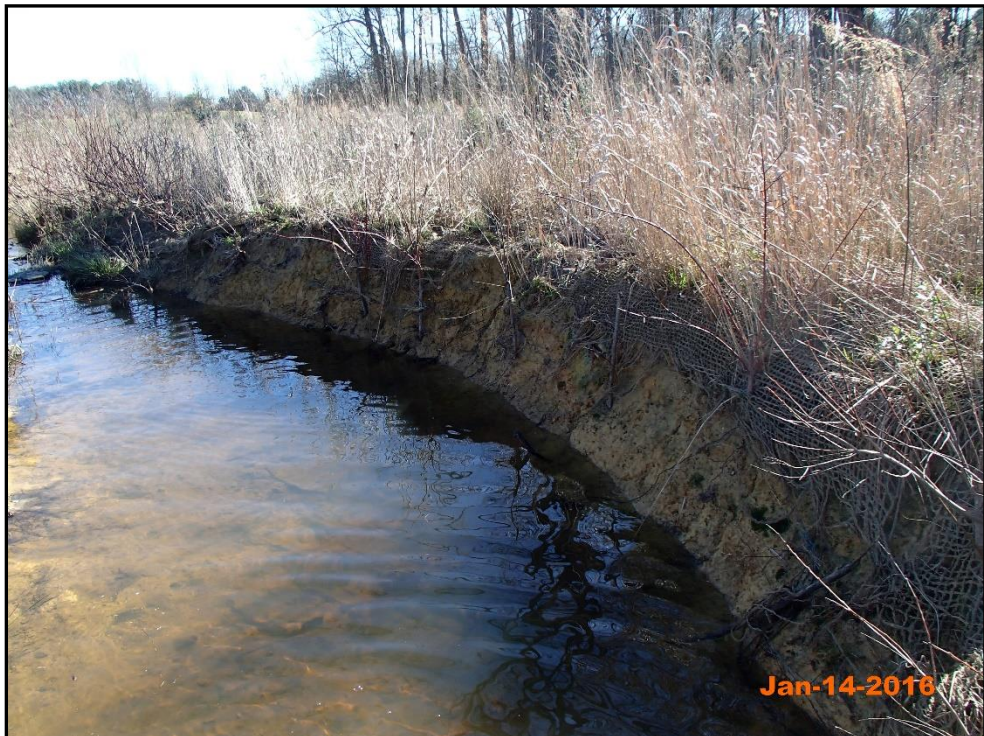
Project Reach 2 – Bank Erosion 22+50 Right Descending Bank

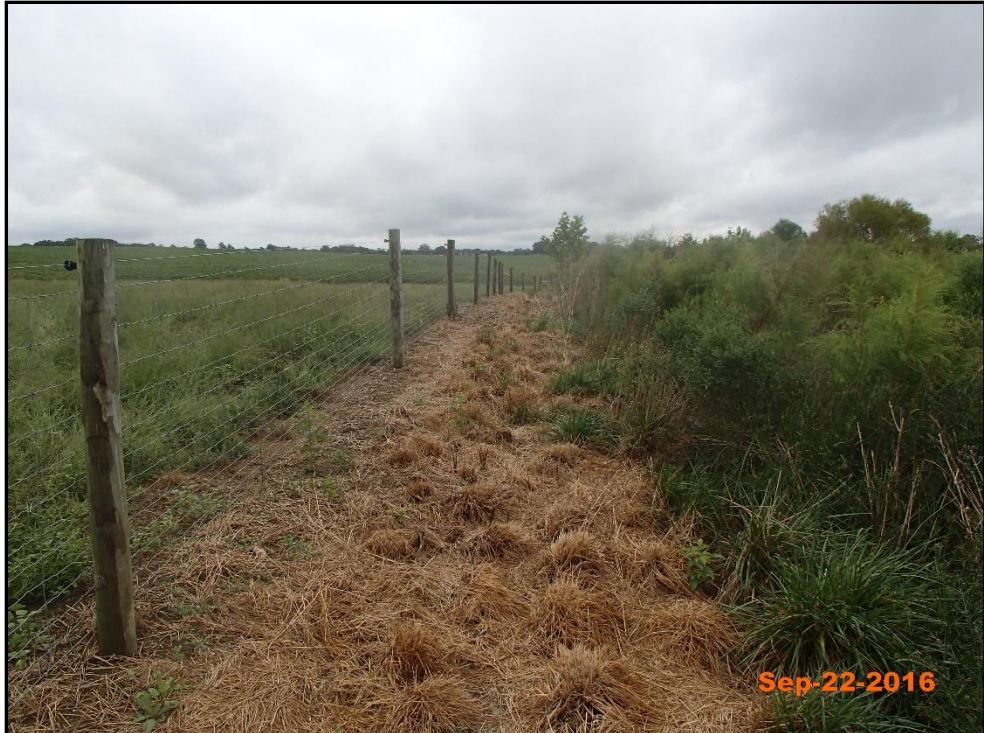
Project Reach 4 – Encroachment 0+00 Left Descending Bank

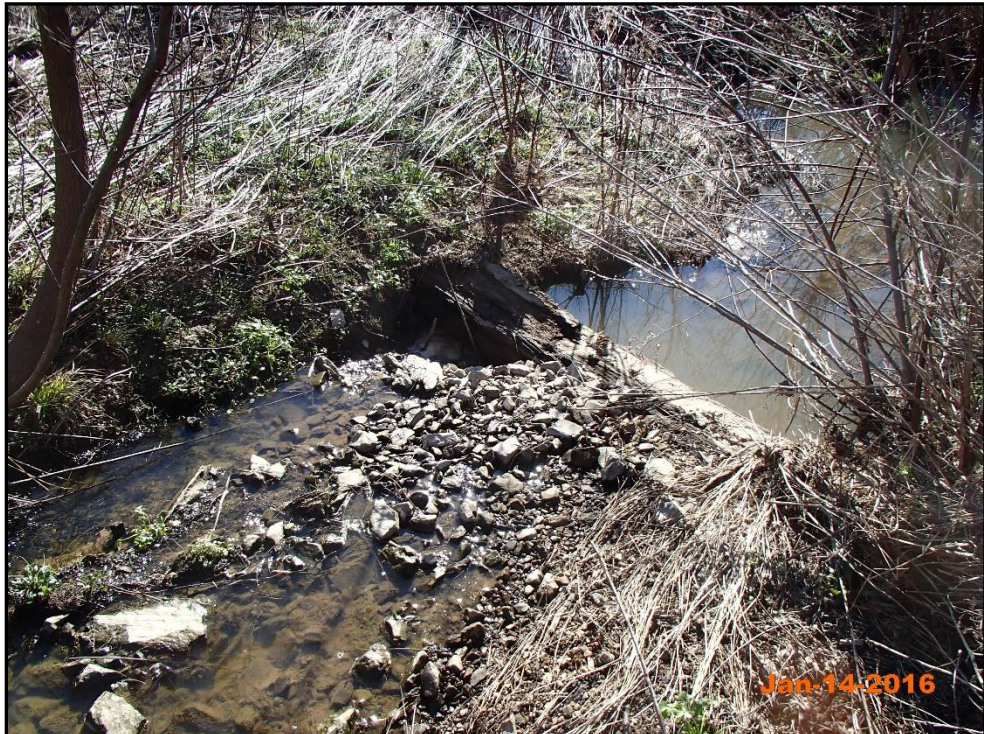
Project Reach 5 – Stressed Structure 13+25 Looking Downstream

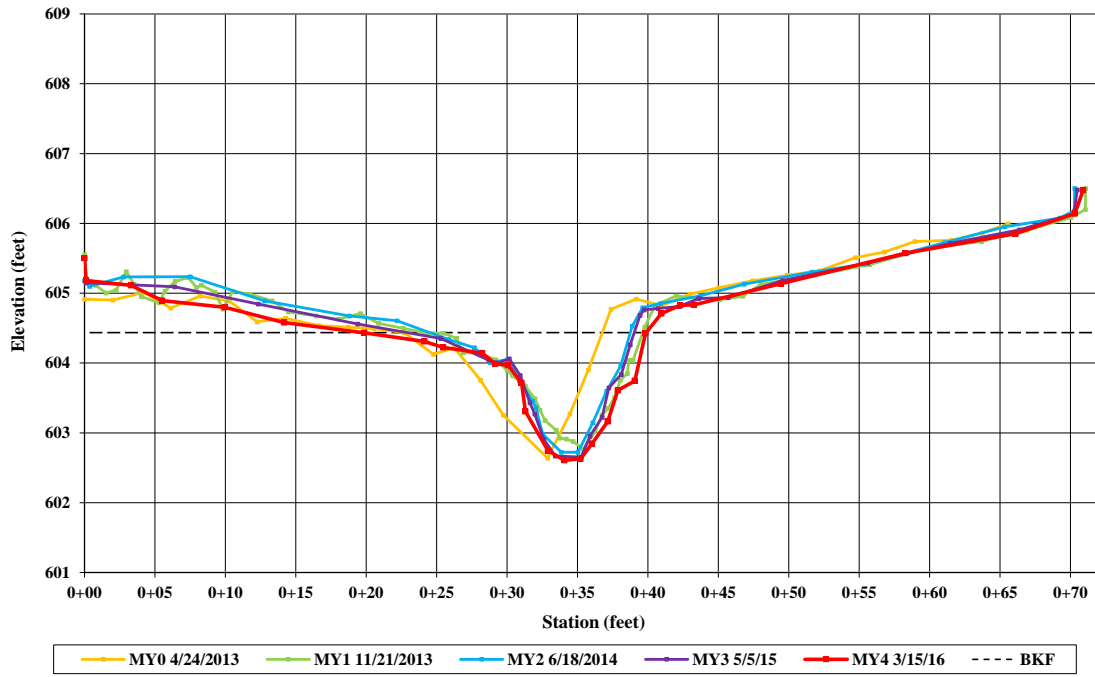
601 North II
Cross Section 5-Pool
Station 2+70

channel were identified. MY4 cross-section data showed little change between MY3 and MY4 (Appendix D), with the exception of cross-sections 5 and 6 in Reach 1 and Reach 2 respectively. Scour along both banks led to an increased bankfull width at cross-section 5, while scour along the right descending bank led to an increased bankfull width at cross-section 6.
