# 601 North Stream Restoration Project Annual Monitoring Report

Monitoring Year: 2010

Monitoring Year: 3

NCEEP Project Number: D 06054-A

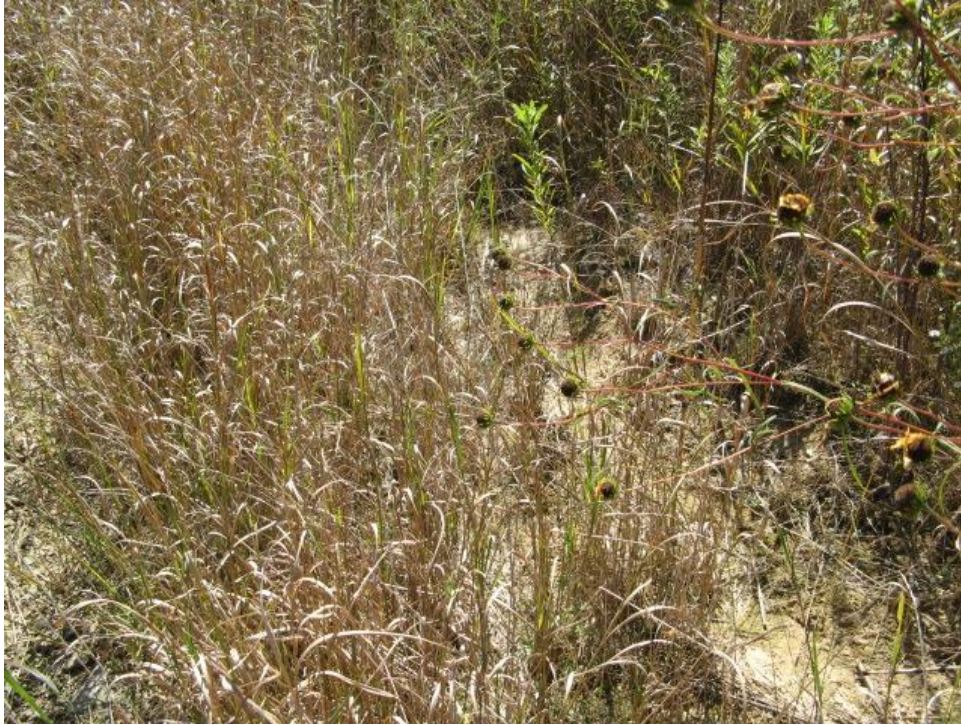
**Problem Area Photo 1**

<b>ID</b>	<b>Year Identified</b>	<b>Station</b>	<b>Description/ recommendation</b>	<b>Photo Number<sup>1</sup></b>
PA1	MY2	130+42 – 130+62	Corrected	Problem Area Photo 1
PA2	MY2	130+00 – 130+75	Replant	Problem Area Photo 2
PA3	MY2	129+49 – 129+76	Replant	Problem Area Photo 3
PA4	MY2	128+72 – 129+39	Corrected	Problem Area Photo 4
PA5	MY2	128+12 – 128+65	Corrected	Problem Area Photo 5
PA6	MY2	127+50 – 127+94	Replant	Problem Area Photo 6
PA7	MY2	126+70 – 127+24	Corrected	Problem Area Photo 7
PA8	MY2	125+20 – 125+58	Replant	Problem Area Photo 8
PA9	MY2	121+50 – 122+11	Replant	Problem Area Photo 9
PA10	MY3	119+24 – 119+61	Bank Erosion	Problem Area Photo 10

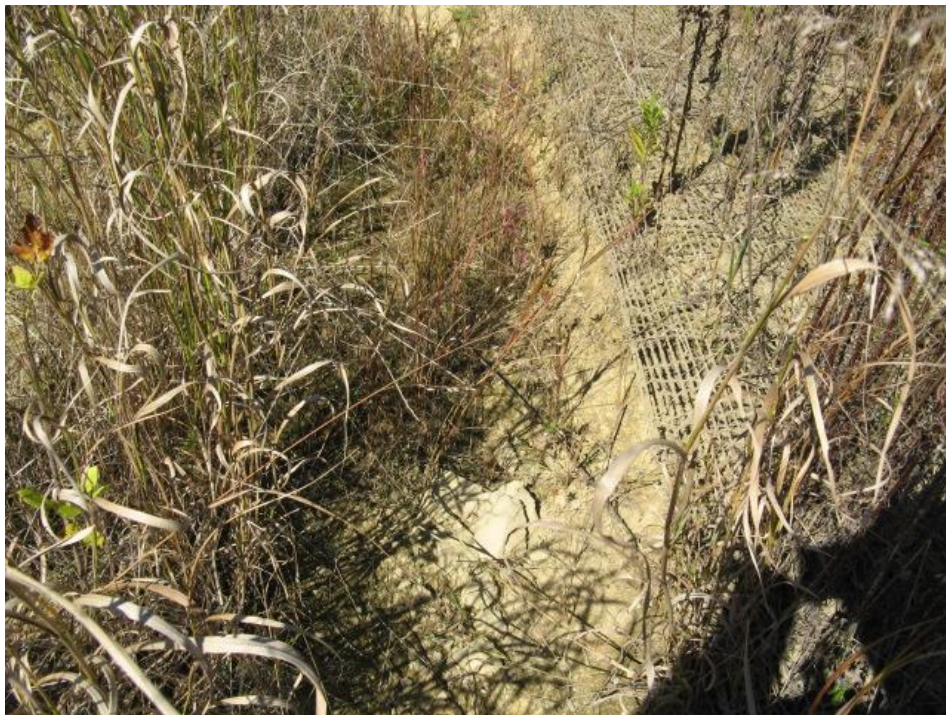
**Problem Area Photo 10**

There were nine problem areas identified from MY (2009) in the priority II section. These problem areas were all minor bank erosion issues. Four of these identified areas are resolving themselves with the resumption of normal rainfall which has improved the vegetative cover. The remaining five areas are stable but vegetative recovery is slower due to soil conditions. Vegetative assessment with possible supplemental seeding will be undertaken in 2011. This should allow the areas to repair themselves during the next growing season. A new tenth problem area (PA10) was located at station 119+24 where the top of bank is eroding outside the

coir matting. Additional matting and vegetative replanting is recommended here as well. No bank re-grading is required at present.
