601 West Stream Restoration Project Annual Monitoring Report

Monitoring Year: 2011

Monitoring Year: 4

NCEEP Project Number: D 06054-E

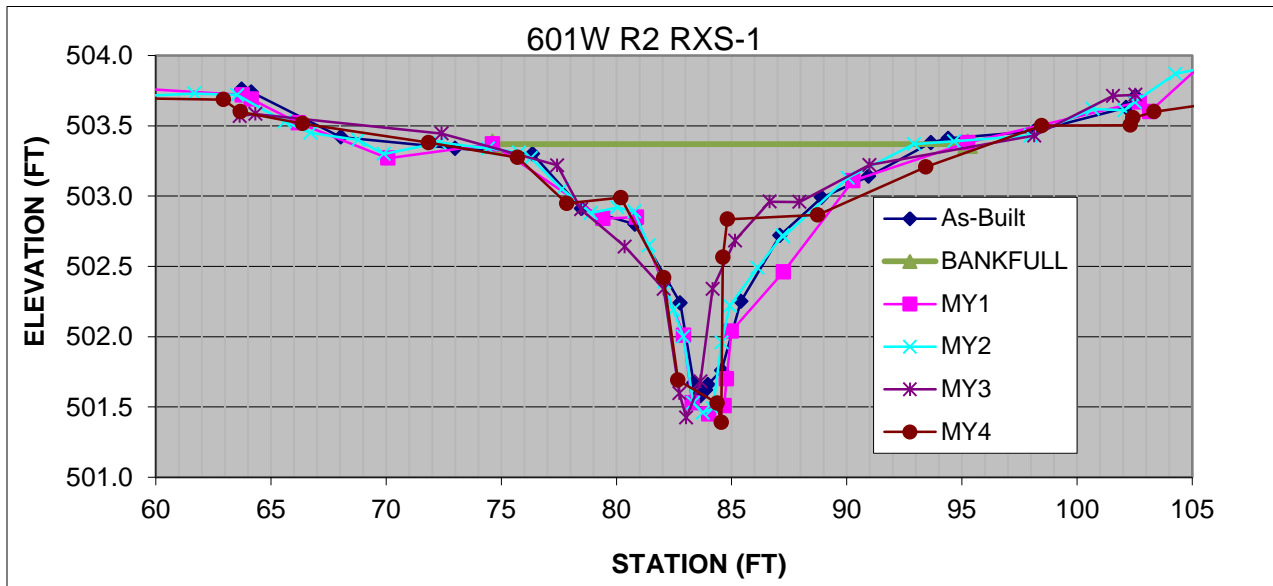
Figure C 3 - R2 RXS-1 Cross Section Plot

The survey data was collected in September 2011, and the results are presented in Appendix C. Cross sections appear to be stable. Reach 2 Riffle Cross Section 1 seems to have degraded along the right bank but the photos show it has not. One explanation might be that in clearing a lane in the vegetation to allow surveying, the bank was trampled down. The cross sectional area and width did not change significantly. The 2012 monitoring will resolve this question.

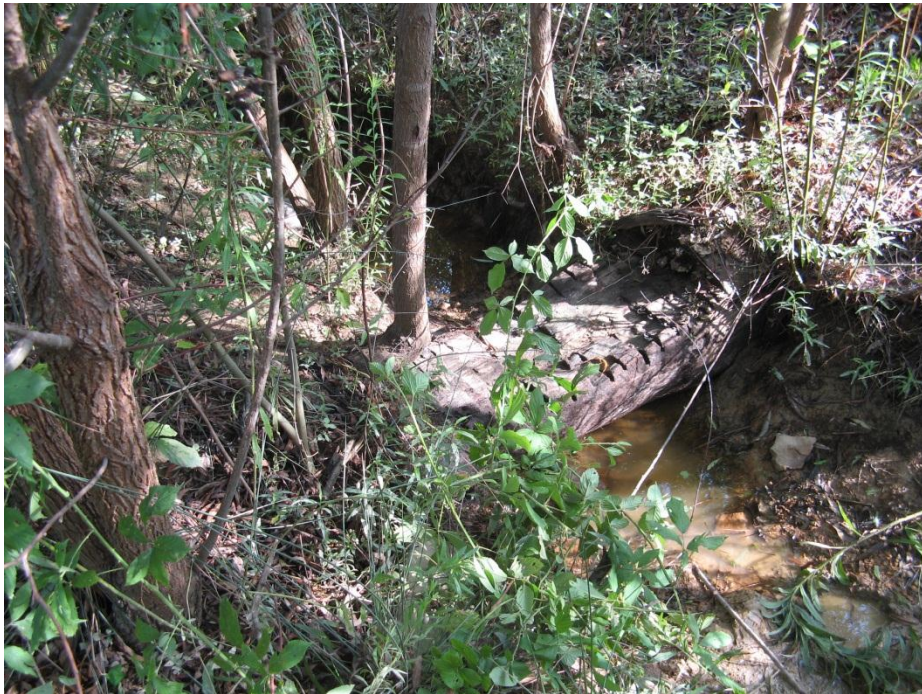
Photo Point 4 (Washed out sill log)

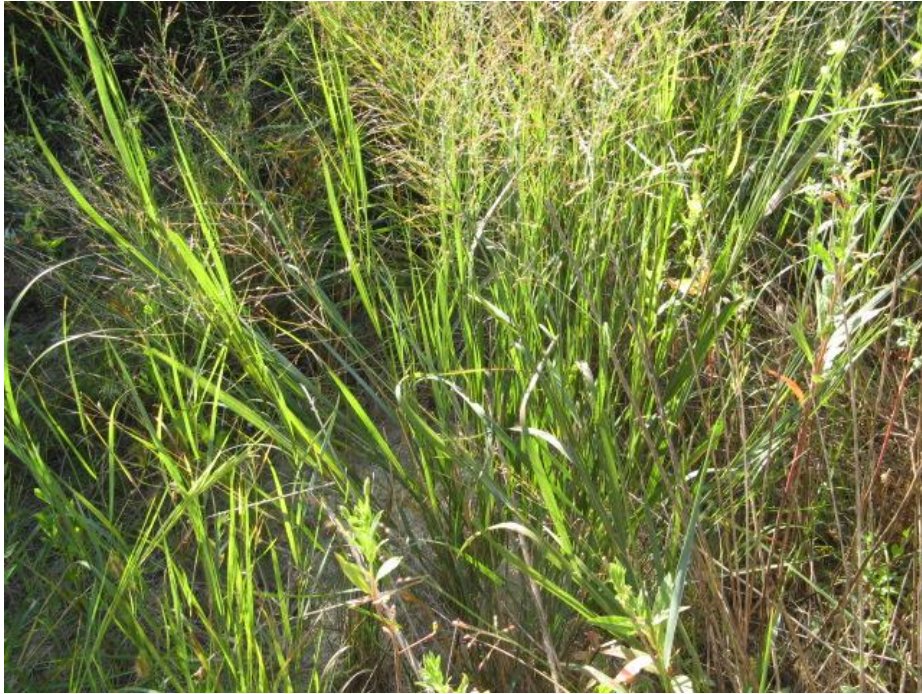
Problem Area 1 Photo Corrected

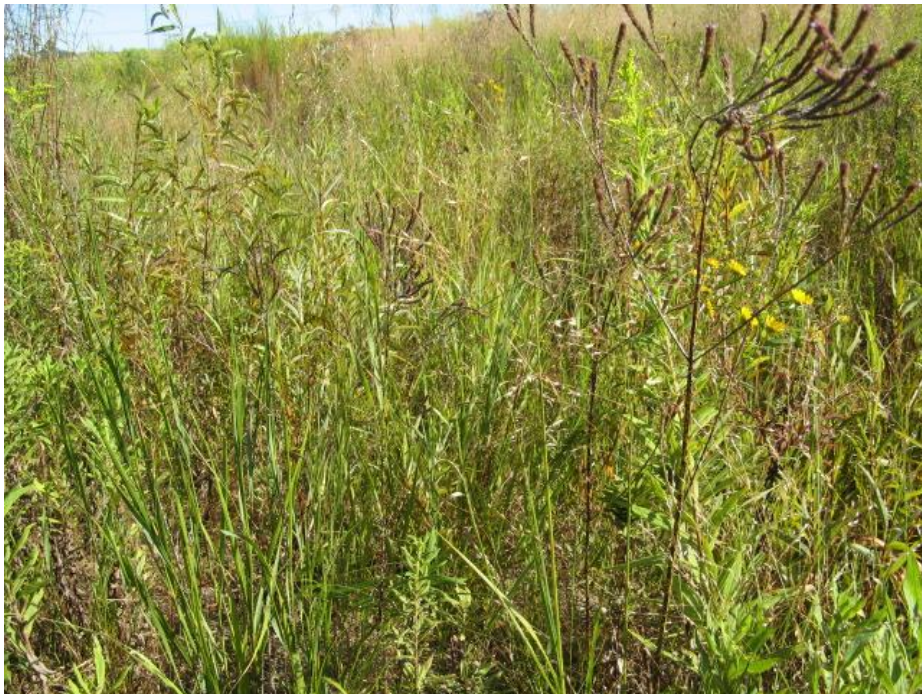
Problem Area 2 Photo Corrected

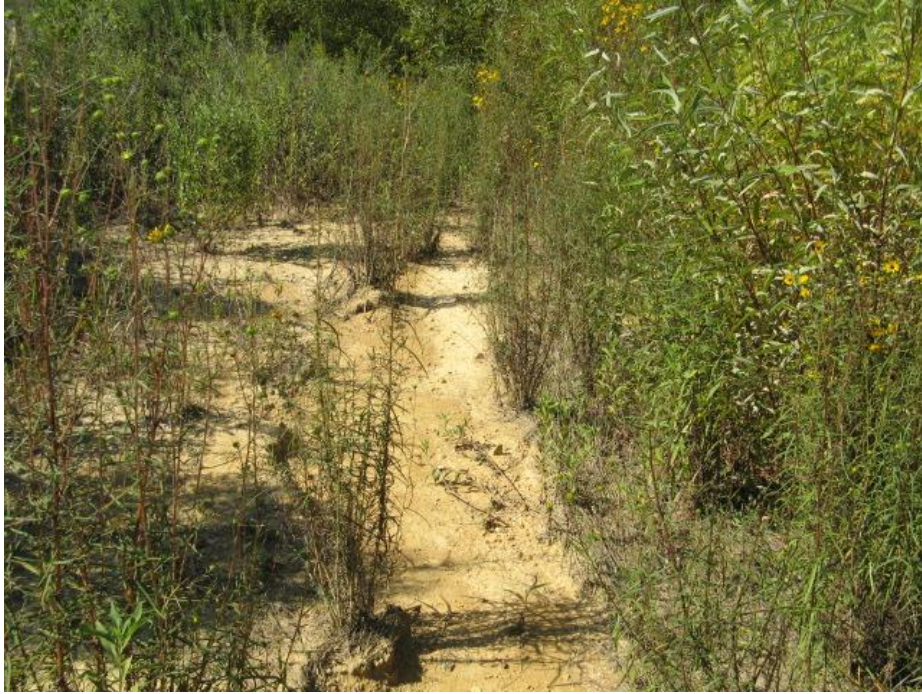
Problem Area 3 Photo

There were five problem areas previously identified at the 601 West site. Three were located in Reach 1 and were related to lack of vegetation. Two of these problem areas (PA1 and PA2) have repaired themselves with improved vegetative cover growth. PA3 has not recovered well enough and supplemental planting will be undertaken in 2011.

One of the five vegetative monitoring sites had dropped below the final vegetative success criteria and supplemental planting with four year old stems will be completed in early 2012.

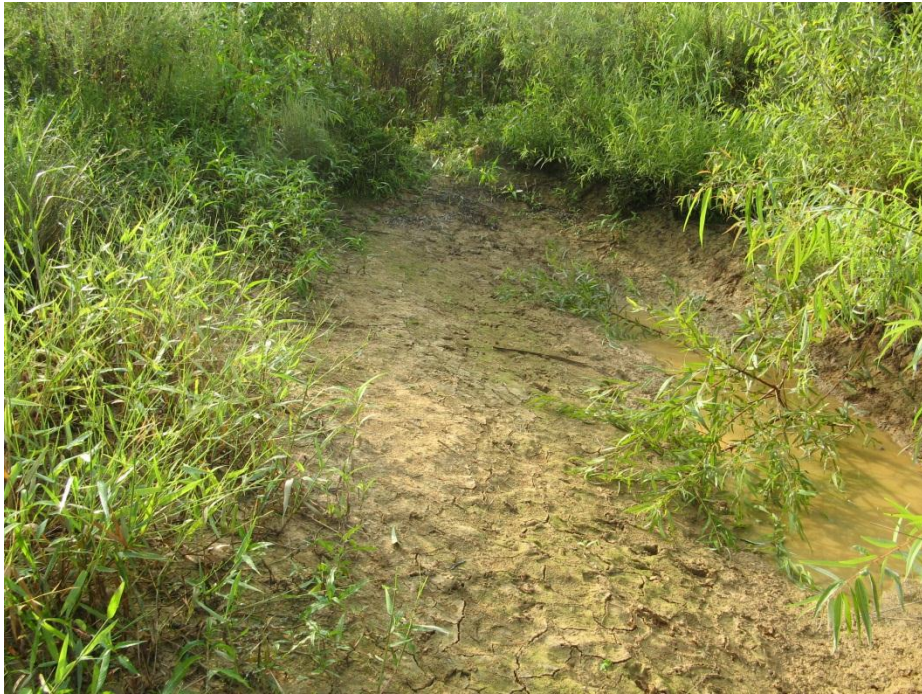
Problem Area 4 Photo

PA4 and PA5 are beaver dams that appeared in the Reach 2 section of channel during MY 2 (2009). The beavers were removed in 2010 but remnants of the dams were still in place at the time of the 2011 survey, causing backwater for approximately 200 feet upstream of the dams.

The beaver dams are scheduled to be fully removed in December 2011. Once the dams are removed replanting of the perimeter of the backwater areas may be needed.

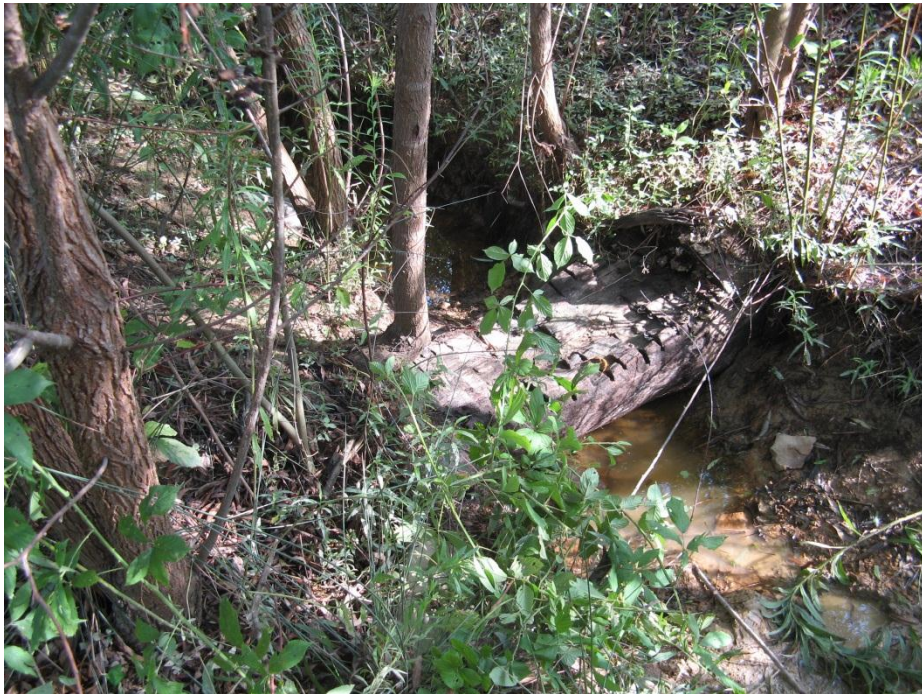
Problem Area 6 Photo

Eight additional problem areas were identified during the 2011 survey. All are minor and will be repaired or replanted in the winter of 2011/2012. The stream obstructions (PAs 9-13) are the result of the beaver impact, which left some areas of stream bed exposed to sunlight and allowed woody plants to establish within the bed. If left unchecked, the debris these trees collect will cause the channel to migrate away from the existing channel.
