1.0 Executive Summary

This Annual Monitoring Report documents the results of monitoring activities during the 2012 growing season on the 601 West Stream Restoration Project. Construction of the site, including planting of trees, was completed in March 2008. The 2012 data documents results from the fourth year of geomorphic and vegetation monitoring at the site.

*601 West Mitigation Site
Annual Monitoring Report for 2012
(Monitoring Year 5)*

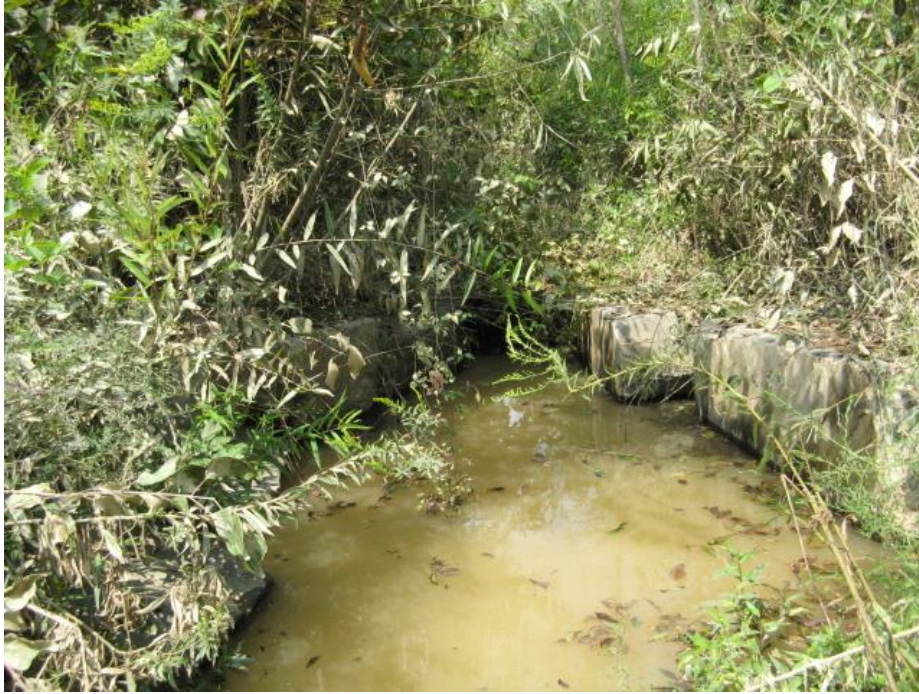
Photo Point 17 (repaired cross vane)

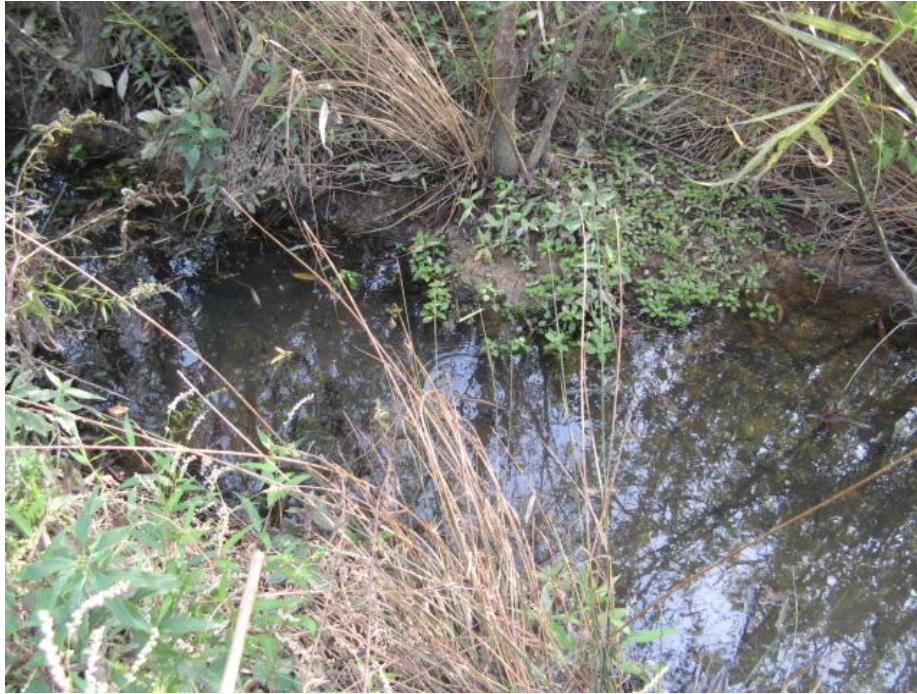
The remaining five problem areas are all in stream woody obstructions that will continue to create issues if not removed. If left unchecked, the debris these trees collect will cause further erosion by forcing the channel to migrate away from the existing channel.

MY4-PA9 - Stream Obstruction

Although the beaver were removed during MY3, the remnants of the beaver dams continue to degrade the bedform. In addition large woody vegetation has become established in the stream bed causing many debris dams and forcing channel migration which is impacting the developing flood plain vegetation. Repairs these issues are planned for winter 2013.

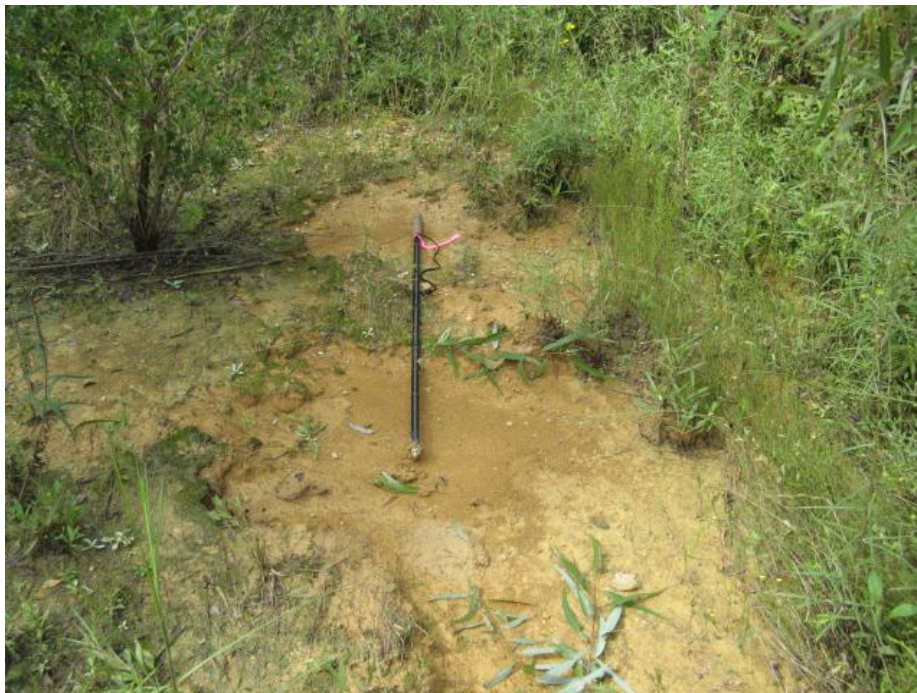
MY2-PA3, MY5-PA1 and MY5-PA2 are all existing or new eroding diversion channels on a flood plain from the previously mentioned obstructions.

MY2_PA3 - Diversion channel 45 feet of left bank from channel blockage

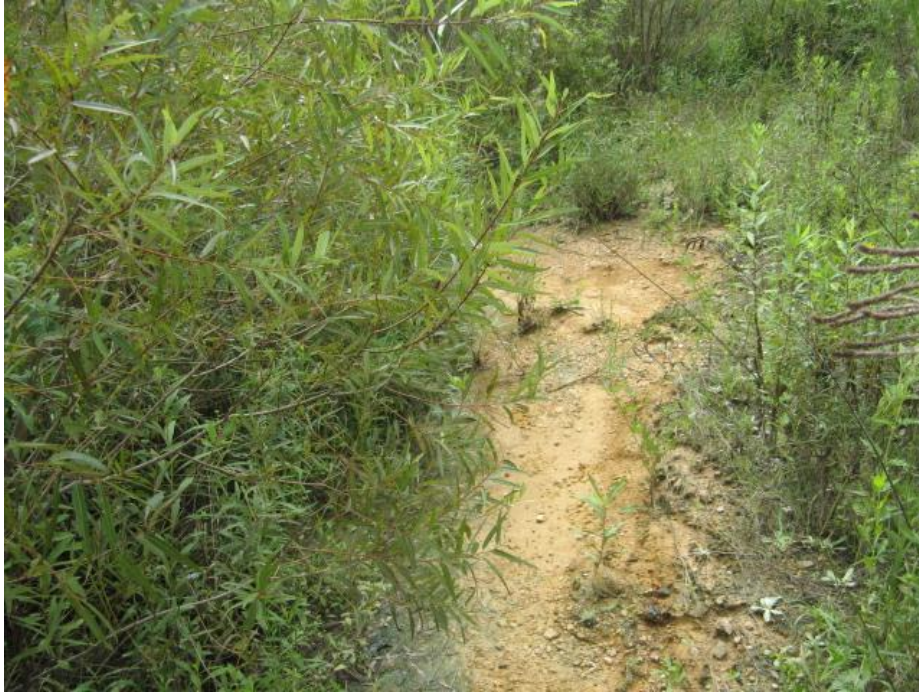
MY5-PA1 - Diversion channel cutting 30 feet of left bank from channel blockage

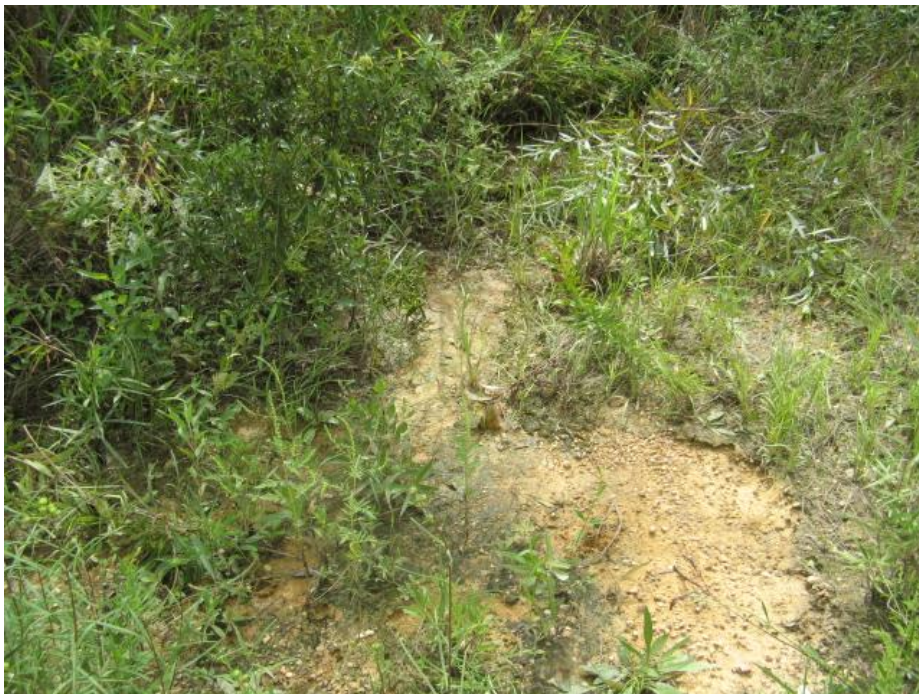
MY5-PA2 - Diversion channel cutting 40 feet of right bank from channel blockage

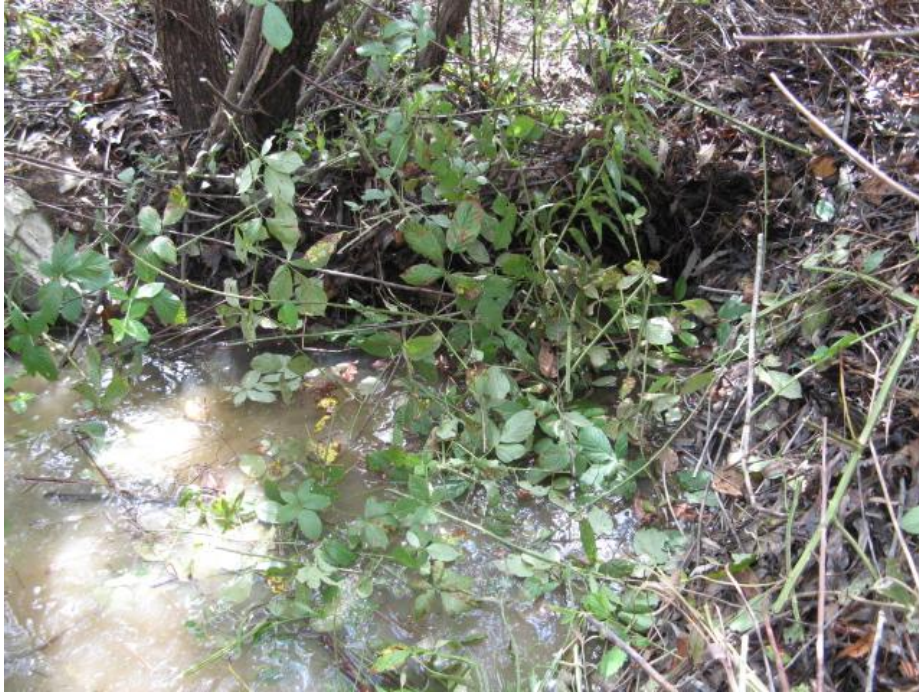
MY4-PA10 – channel obstruction

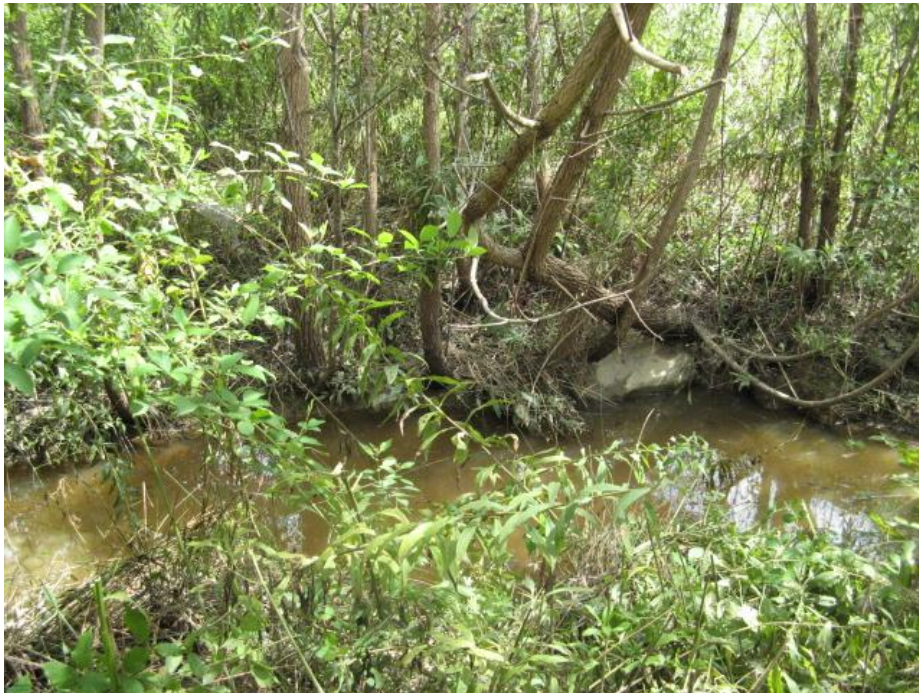
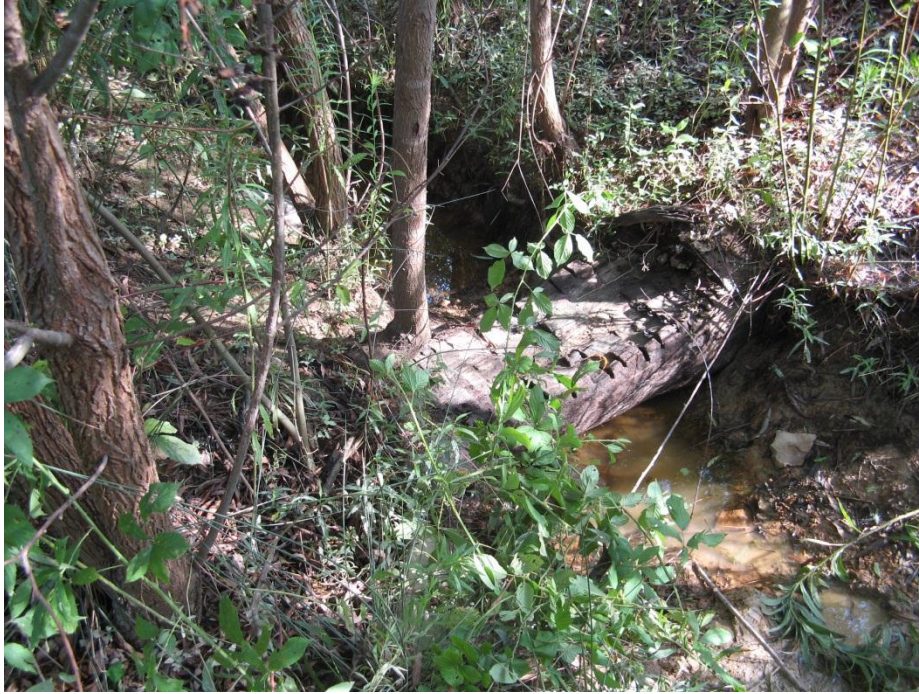
MY4-PA6 is a sill log that the stream has cut under. While the structure was under water due to the normal rainfall and backwater in the stream the structure is still in a failed condition.

MY4-PA6 – failed sill log (flooded in photo from 9/2012)

MY4-PA6 – failed sill log (photo from MY4 2011)

The channel was wet but not flowing during data collection preventing full assessment of structure function; however fourteen of the fifteen stream structures are stable. Repairs to the one problem structure (a sill log) is planned for winter 2012/2013. Overall, the site has achieved the stream stability and vegetative success criteria specified in the Restoration Plan

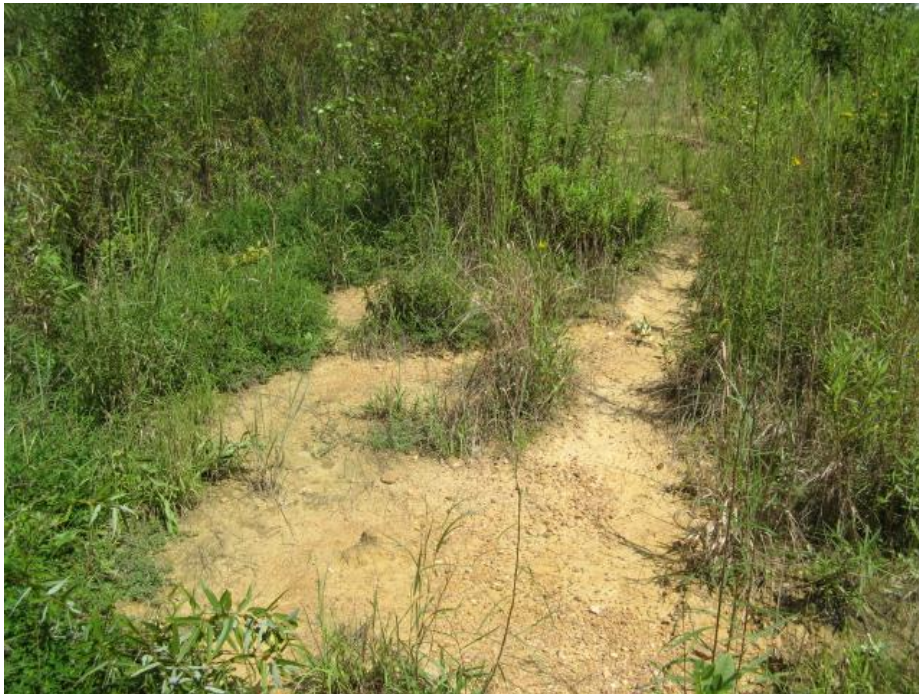
MY4-PA8 is approximately 140 feet of both banks that lack woody vegetation. Both banks are eroding to develop flood plain diversion channels due to the many stream flow obstructions throughout the restoration.

MY4-PA8 Diversion channels cutting 140 feet of both banks, no woody vegetation

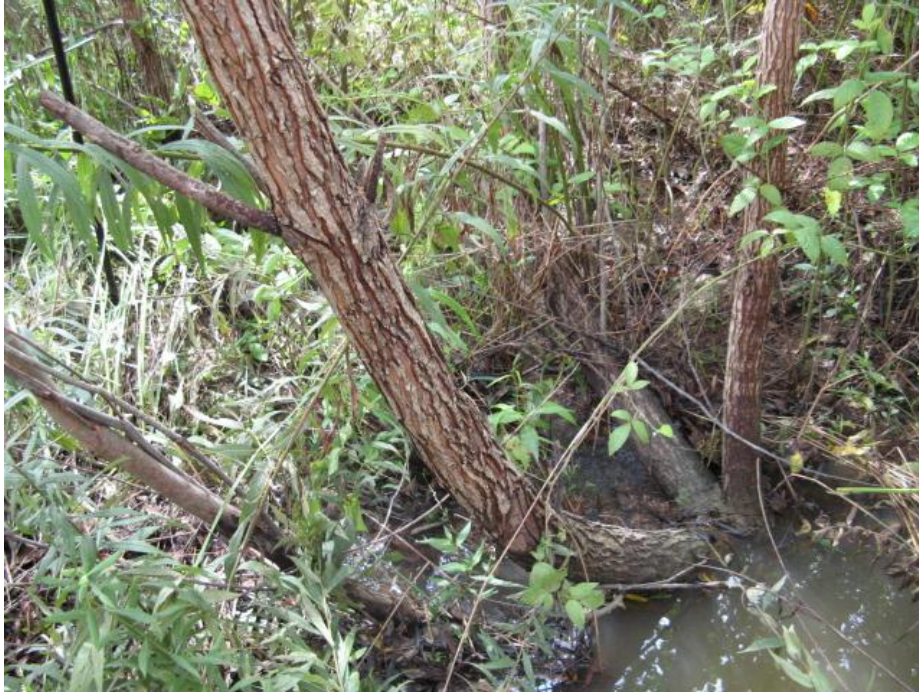
MY4-PA11 Channel obstruction

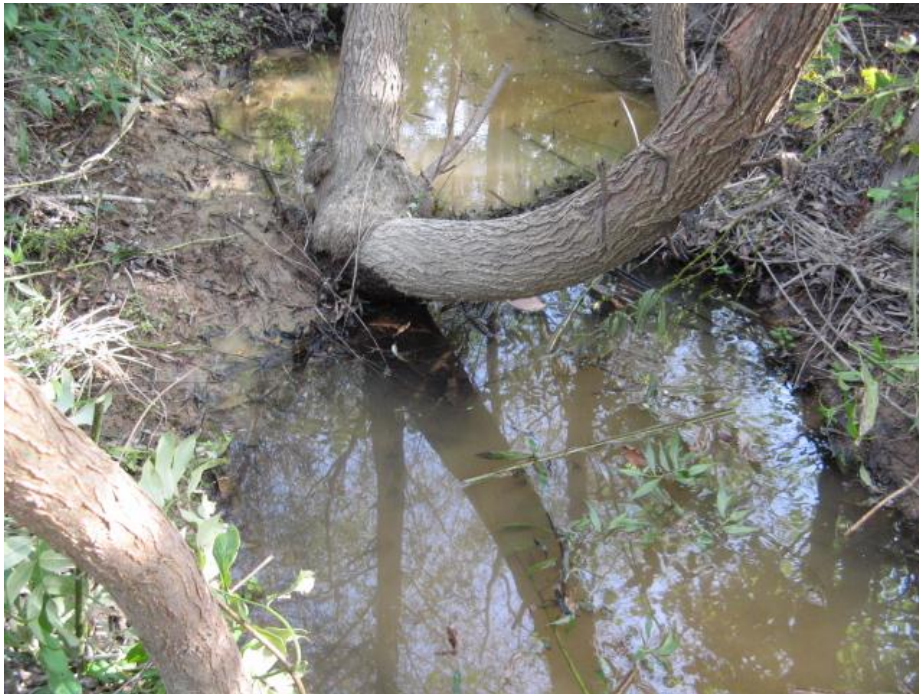
MY4-PA12 Channel obstruction

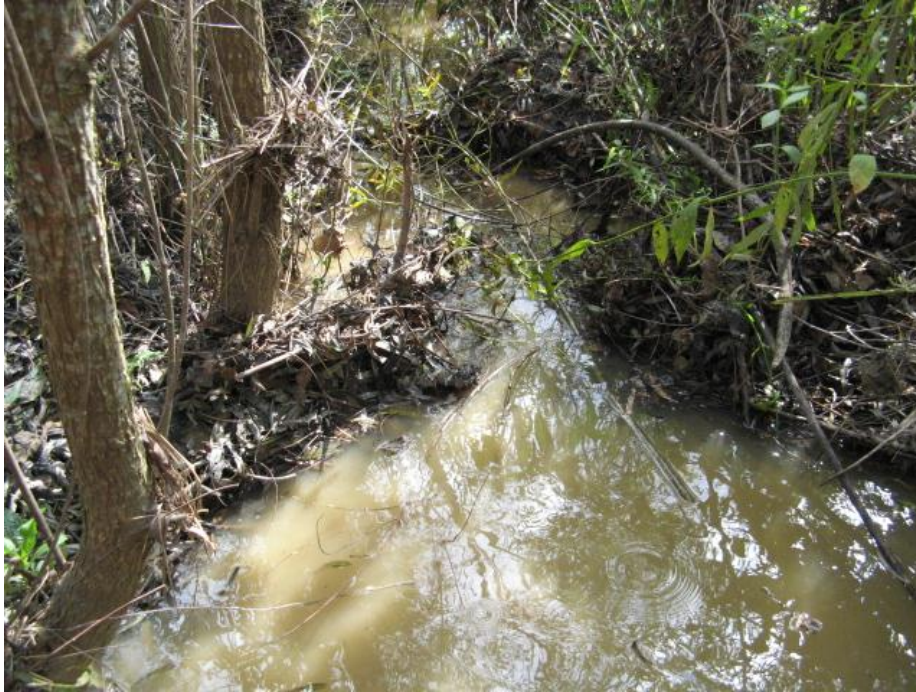
MY4-PA13 Channel obstruction (breached by monitoring team)

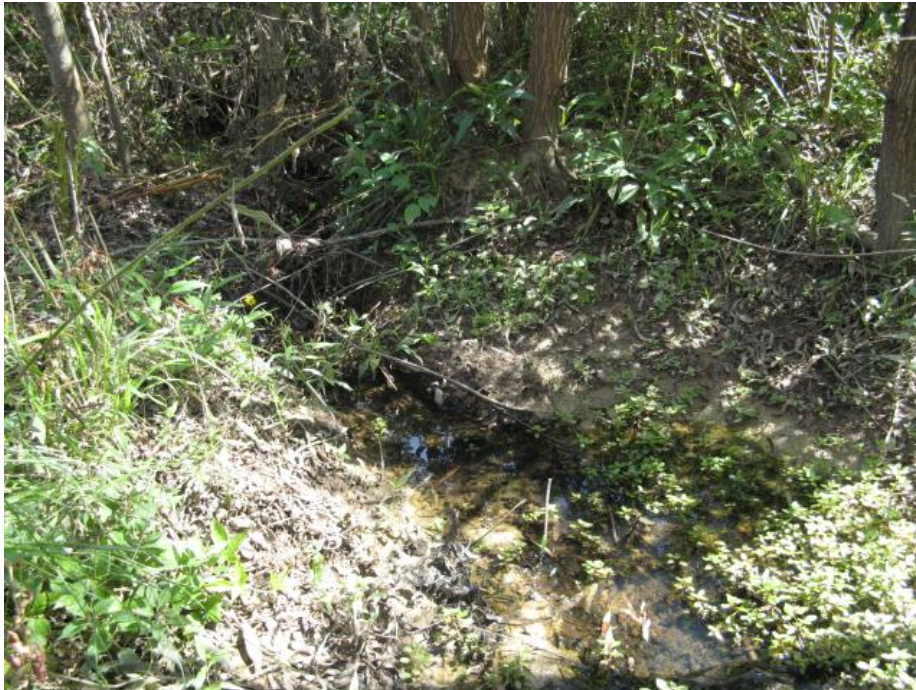
MY3-PA4 and MY3-PA5 are beaver dams that appeared in the Reach 2 section of channel during MY 2 (2009). The beavers were removed in 2010 but remnants of the dams were still in place at the time of the 2012 survey, causing backwater for approximately 200 feet upstream of the dams, flooding the stream banks and vanes and eliminating stream function.

MY3-PA4 Beaver dam (breached by monitoring team)

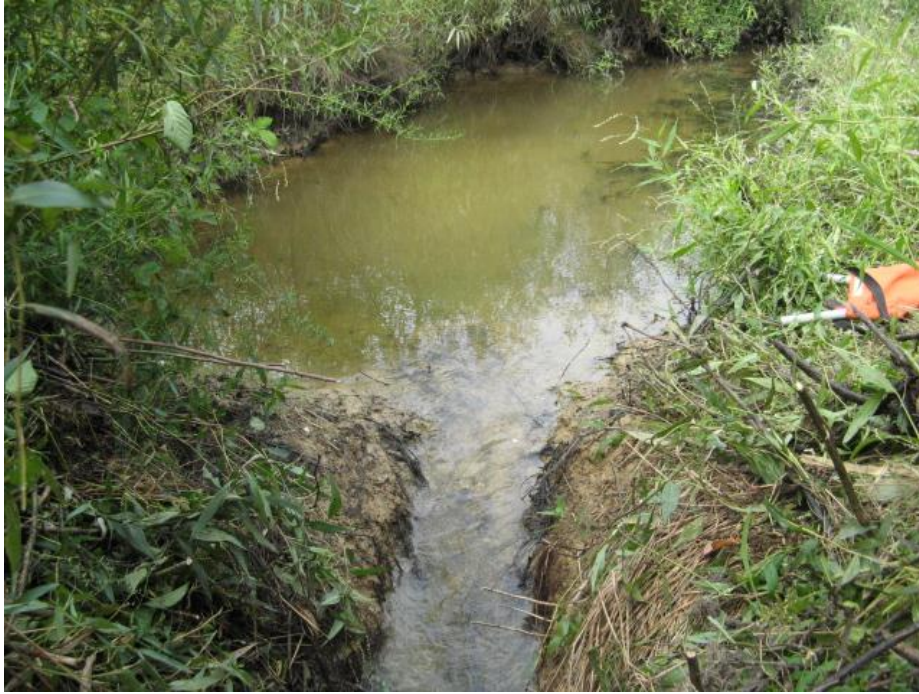
MY3-PA5 Beaver dam (breached by monitoring team)
