YEAR 3 (2017) MONITORING REPORT
ABBEY LAMM
STREAM AND WETLAND MITIGATION SITE
ALAMANCE COUNTY, NORTH CAROLINA
FULL DELIVERY CONTRACT NO. 5790

CAPE FEAR RIVER BASIN
CATALOGING UNIT 03030002

Data Collection – March-October 2017

January 2018

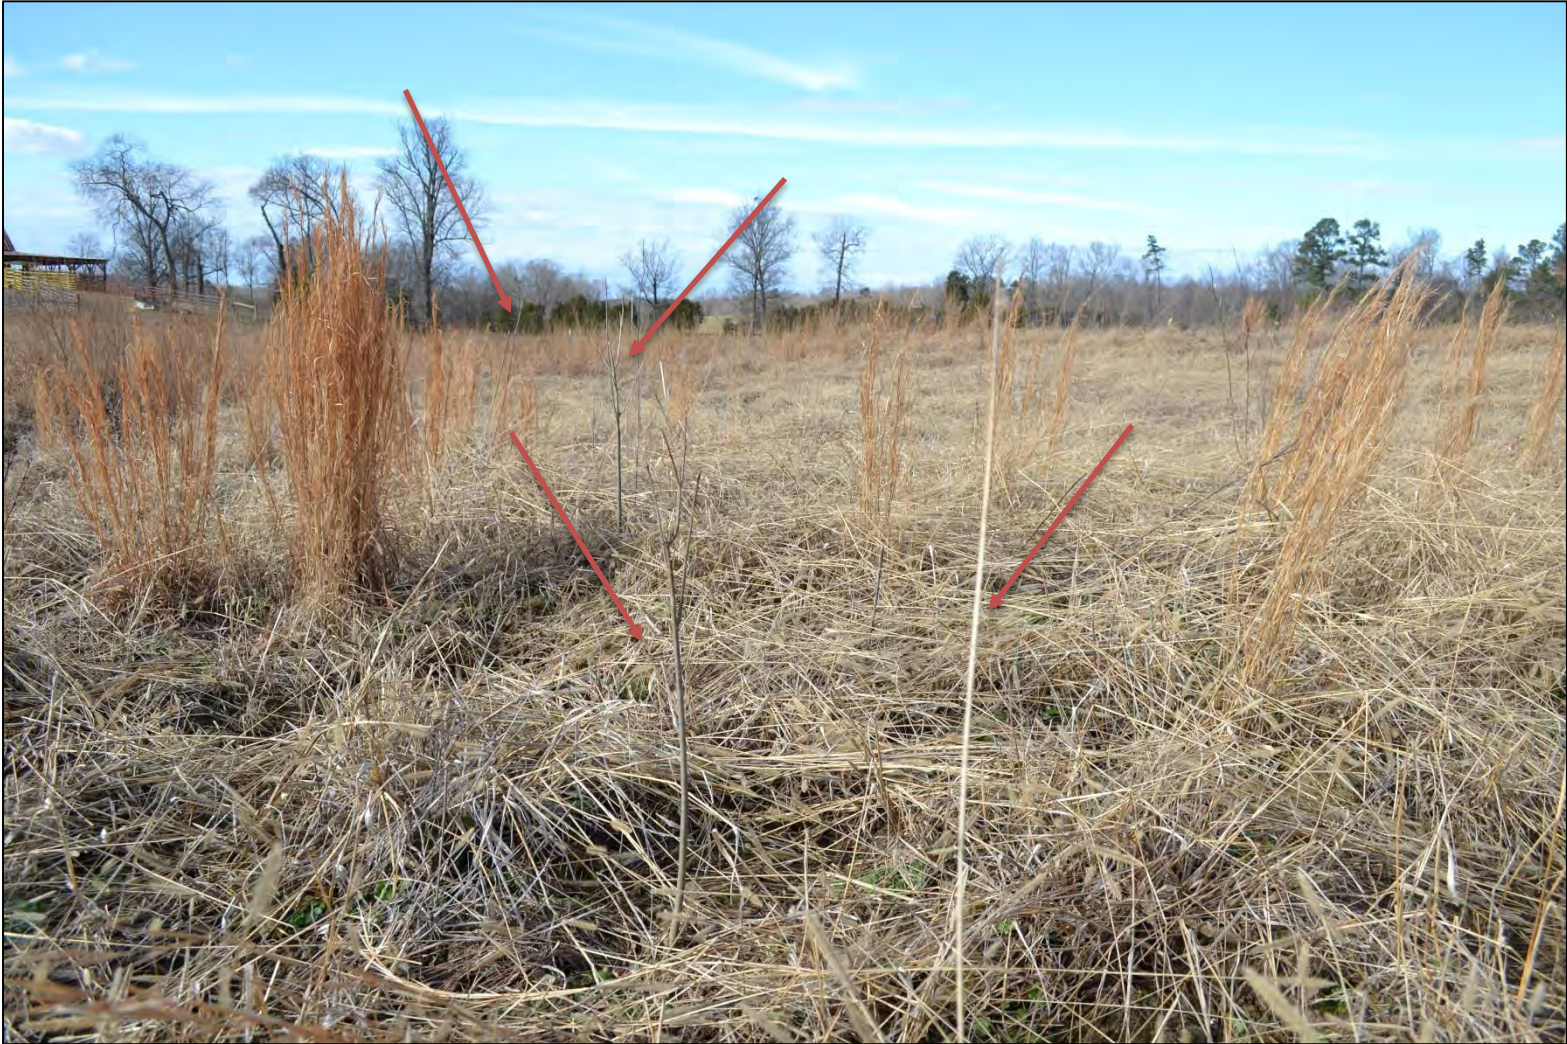
Photo 9: Surviving bear roots outside of replant area

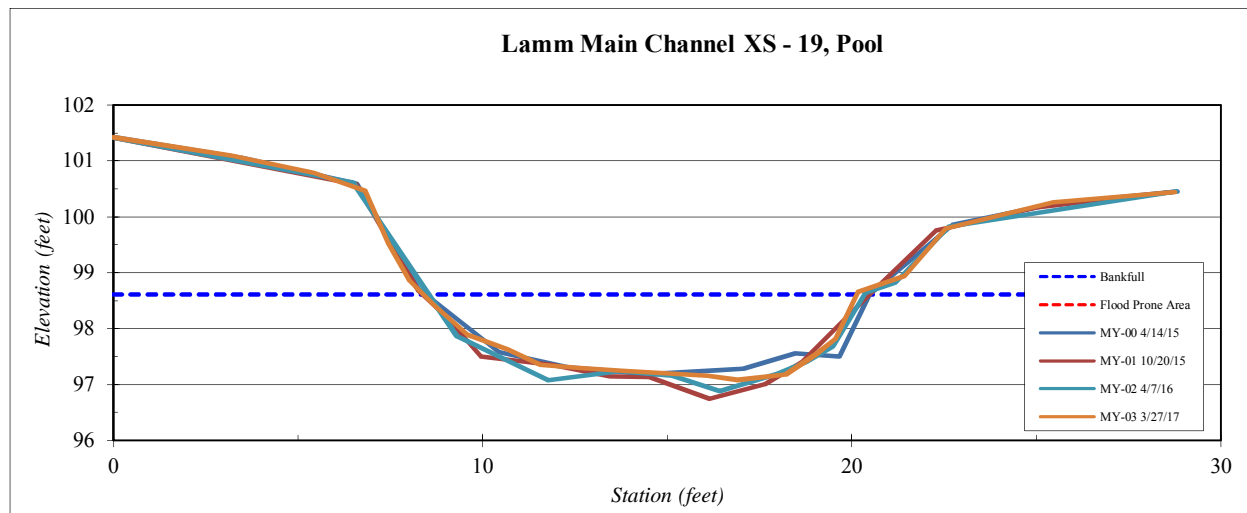
Enhancement Level II Reach. BHR varies through this reach; however, the reach is stable.

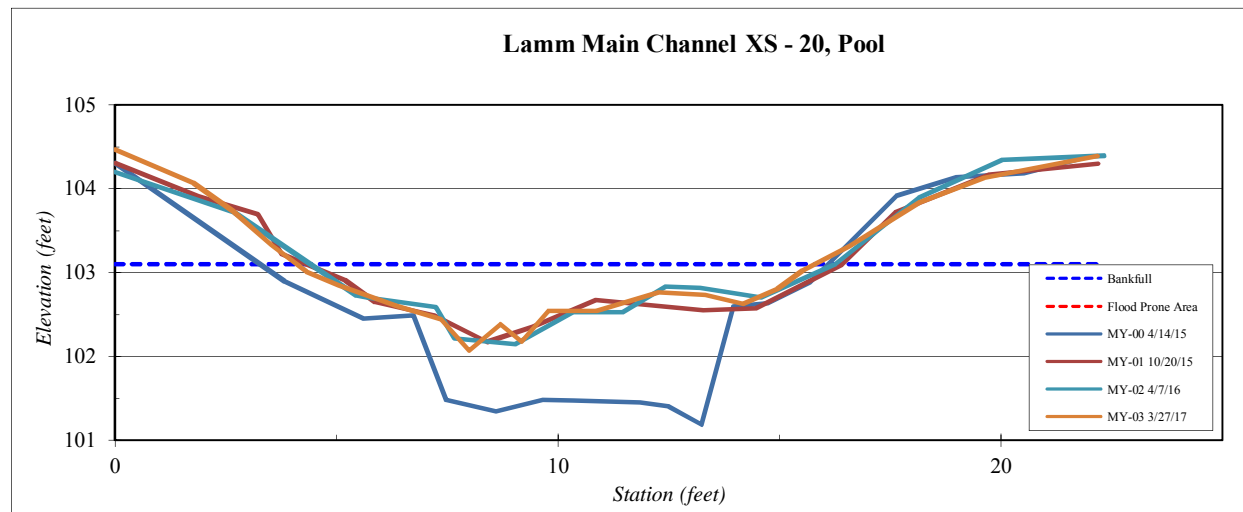
Sediment has aggraded behind a bedrock sill. Sediment has been stable MY-01 through MY-03.

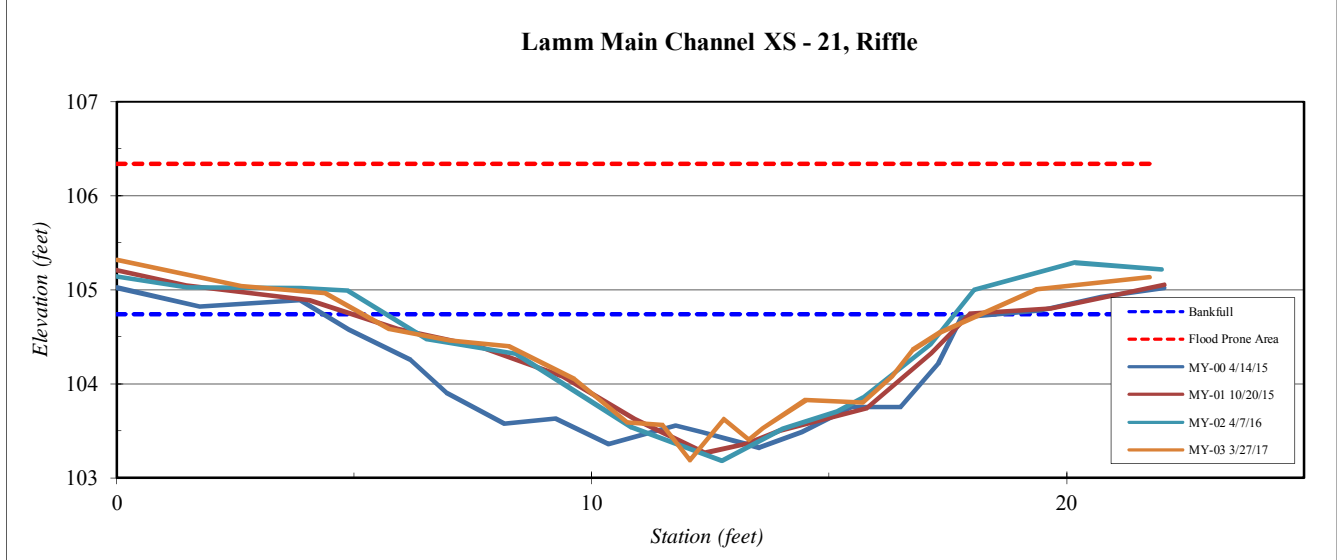
No problems have been noted in this reach. Elevated BHR results from shallow channel depth.

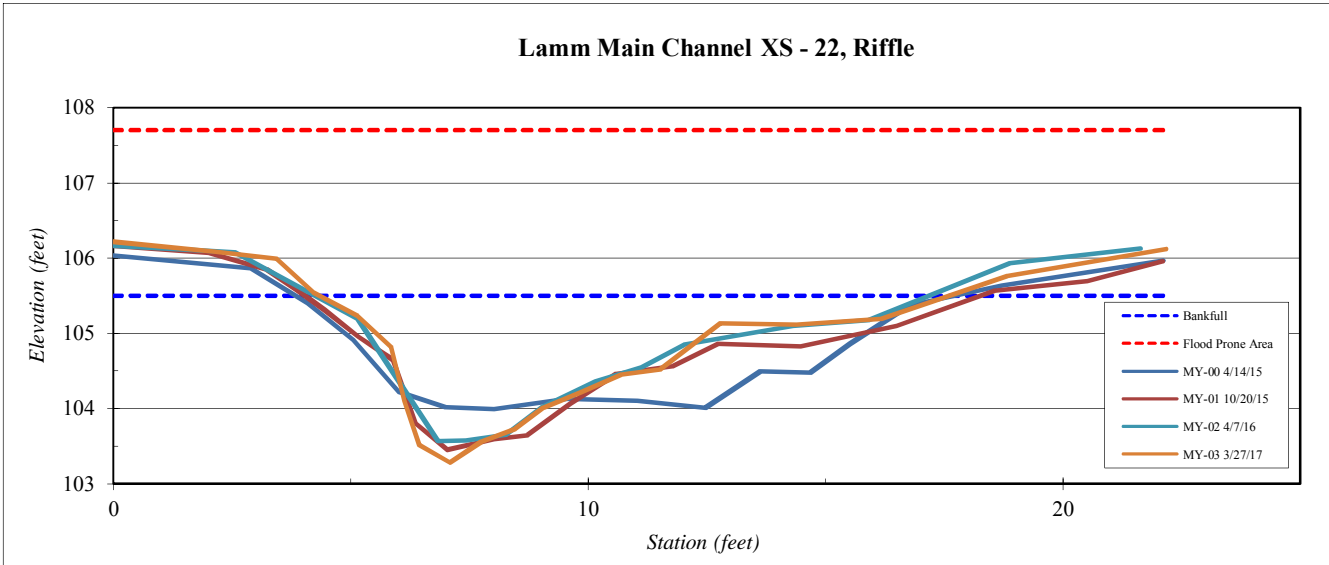
Overall channel area has decreased. Sediment mobilization has resulted in minor downcutting, which has stabilized over the past 3 years. No problems are visible in this reach.

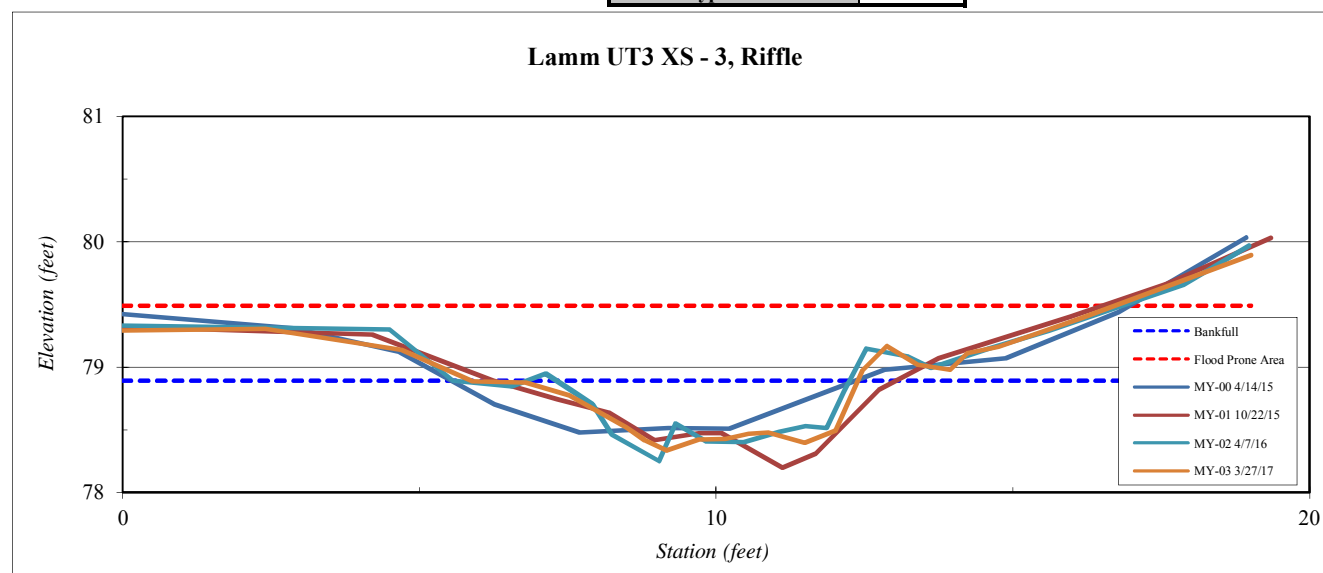
UT 3 has slight resorting of fill material in the channel; however, area has primarily remained constant and no significant erosion is apparent.
