YEAR 4 (2018) MONITORING REPORT
ABBEY LAMM
STREAM AND WETLAND MITIGATION SITE
ALAMANCE COUNTY, NORTH CAROLINA
FULL DELIVERY CONTRACT NO. 5790
DMS PROJECT NUMBER 96311

CAPE FEAR RIVER BASIN
CATALOGING UNIT 03030002

Data Collection – March-October 2018

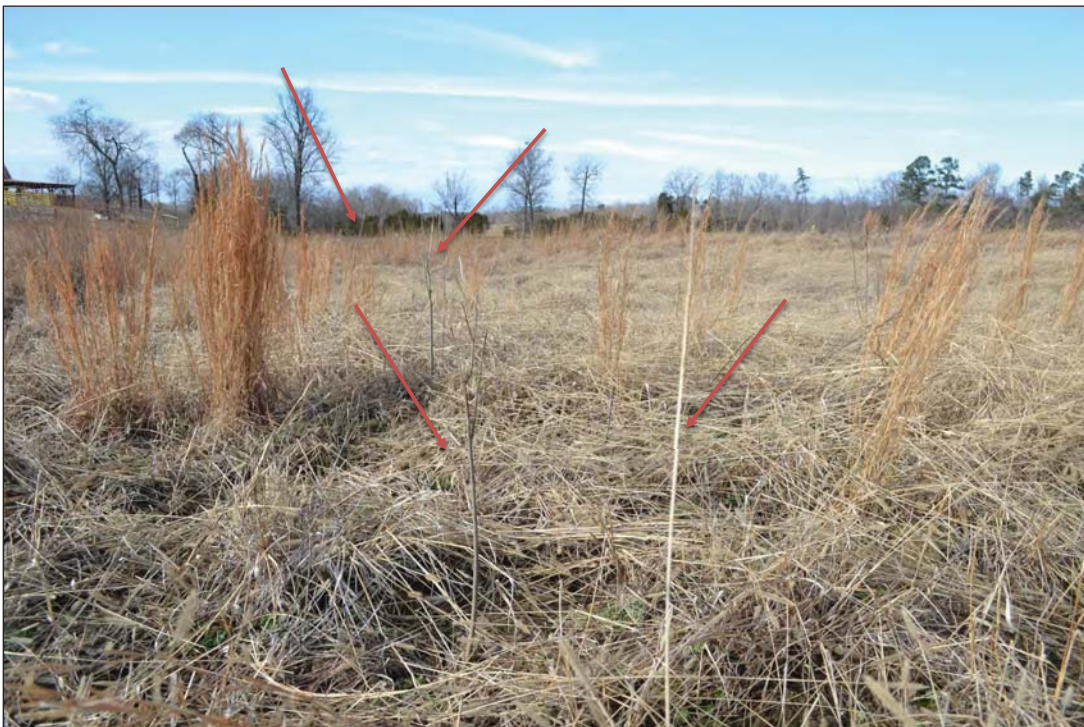
Photo 9: Surviving bear roots outside of replant area

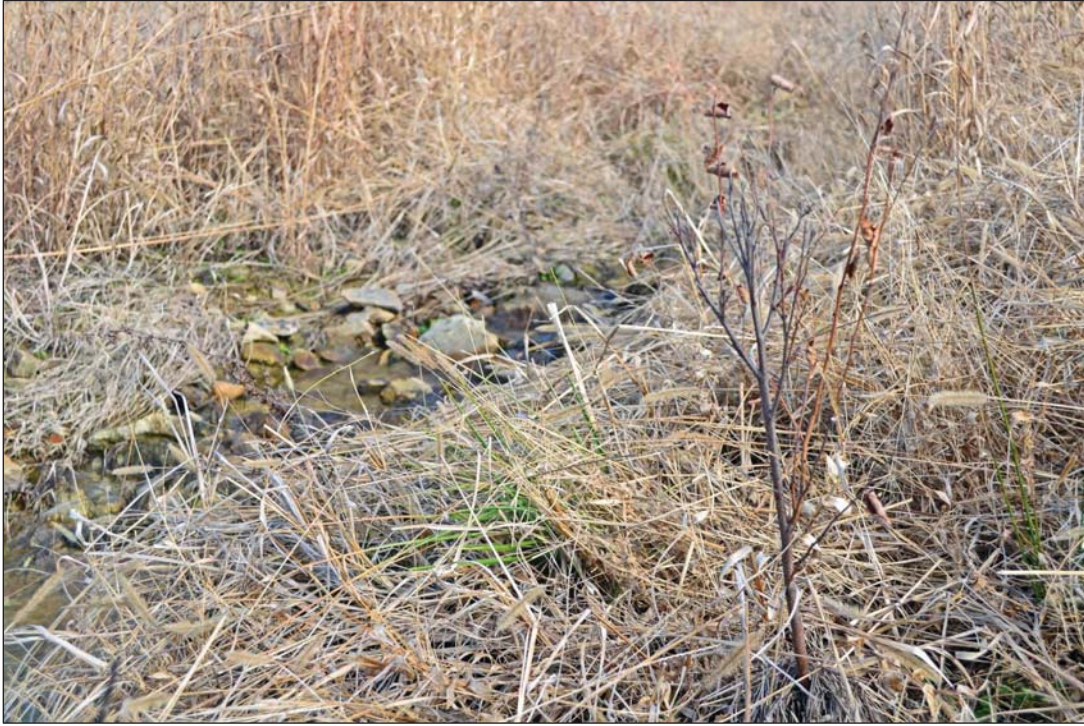
Photo 10: Surviving bear root outside of replant area

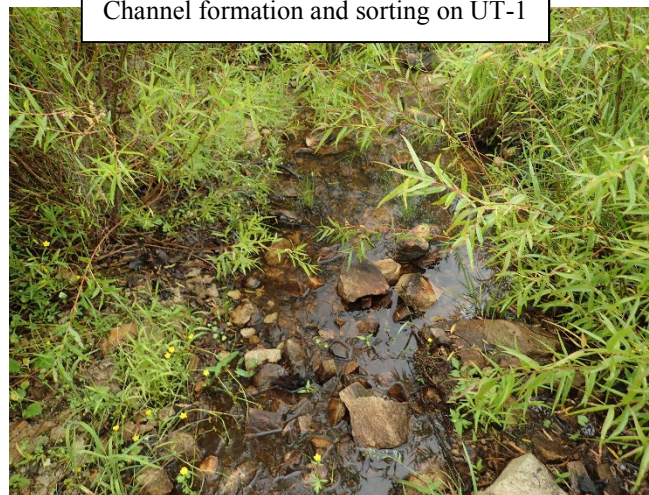
Channel formation and sorting on UT-1

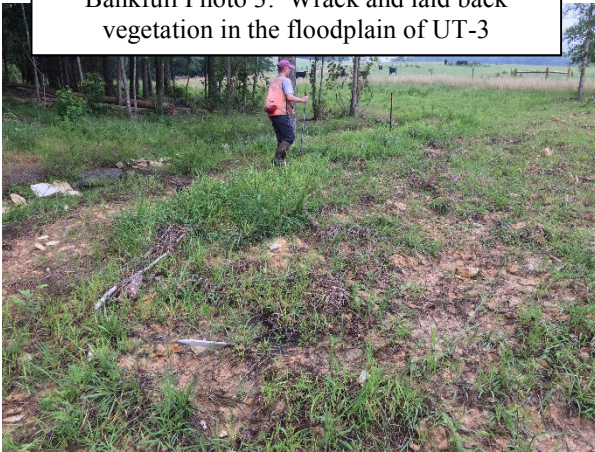
Bankfull Photo 3: Wrack and laid back vegetation in the floodplain of UT-3

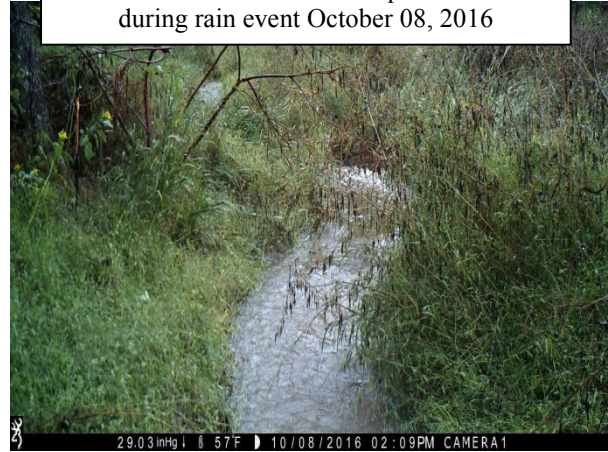
Bankfull Photo 4: Trail Cam photo of UT-3 during rain event October 08, 2016

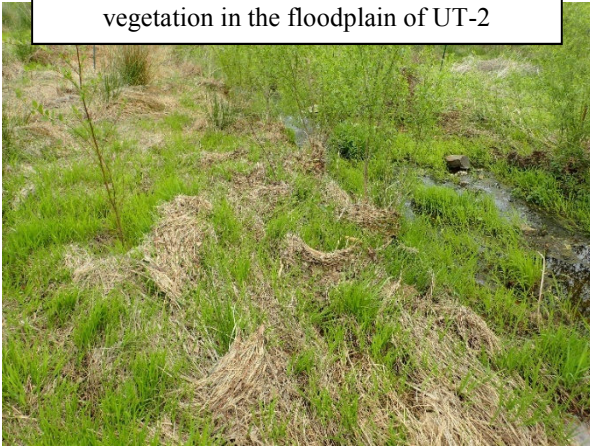
Bankfull Photo 5: Wrack and laid back vegetation in the floodplain of UT-2

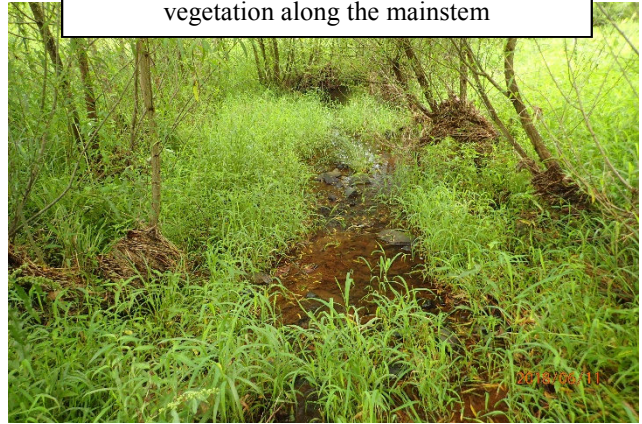
Bankfull Photo 6: Wrack in streamside vegetation along the mainstem

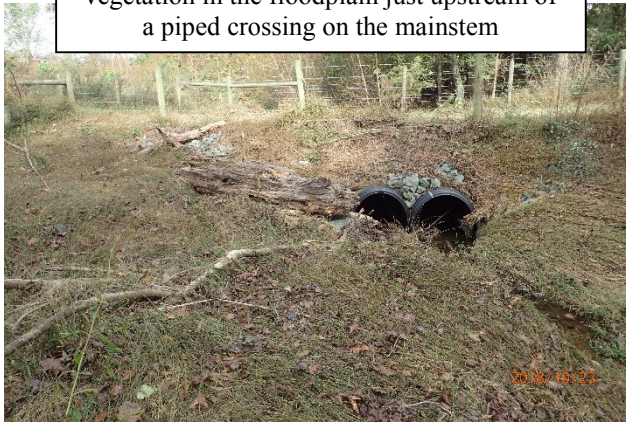
Bankfull Photo 7: Large wrack and laid back vegetation in the floodplain just upstream of a piped crossing on the mainstem

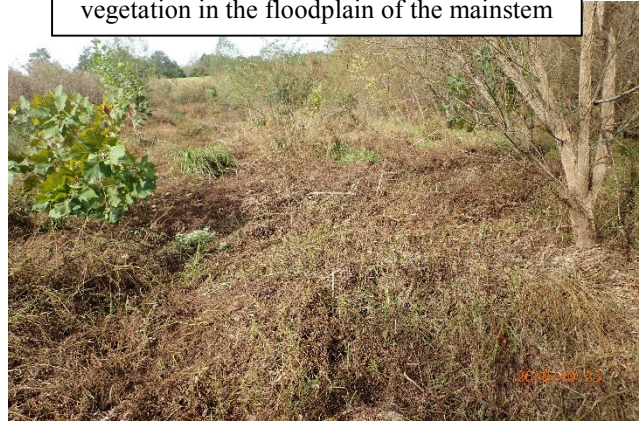
Bankfull Photo 8: Wrack and laid back vegetation in the floodplain of the mainstem
