YEAR 5 (2019) MONITORING REPORT
ABBEY LAMM
STREAM AND WETLAND MITIGATION SITE
ALAMANCE COUNTY, NORTH CAROLINA
FULL DELIVERY CONTRACT No. 5790
DMS PROJECT No. 96311
NCDWR PROJECT No. 20140336
USACE ACTION ID No. SAW-2014-01710

CAPE FEAR RIVER BASIN
CATALOGING UNIT 03030002

Data Collection – March-November 2019

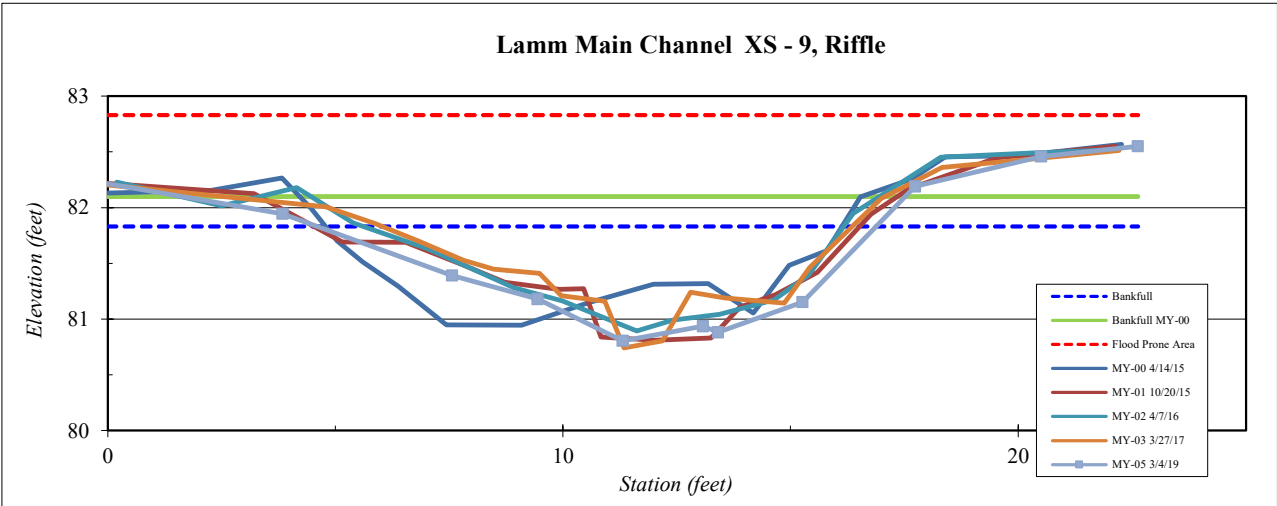
**MY0-3 BHR were calculated using DMS method of "Dmax year x / Dmax year 0". MY5-7 were calculated using DMS method of area best fit.
 No problems have been noted in this reach. Minor alterations in shallow channels may result in large discrepancies including elevated BHR.

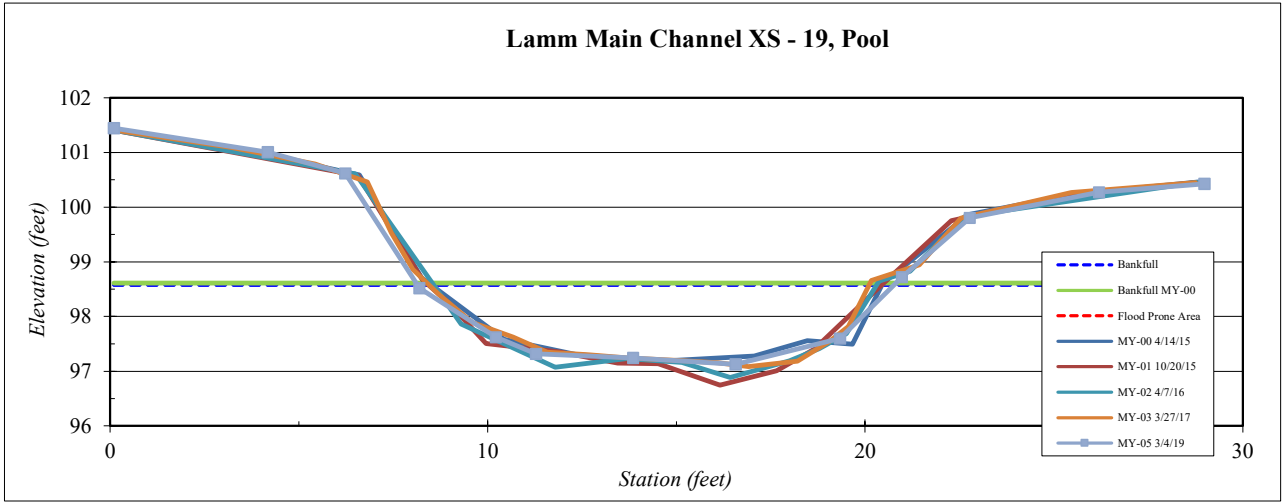
Enhancement Level II Reach. No problems have been noted in this reach.
Minor alterations in shallow channels may result in large discrepancies including elevated BHR.

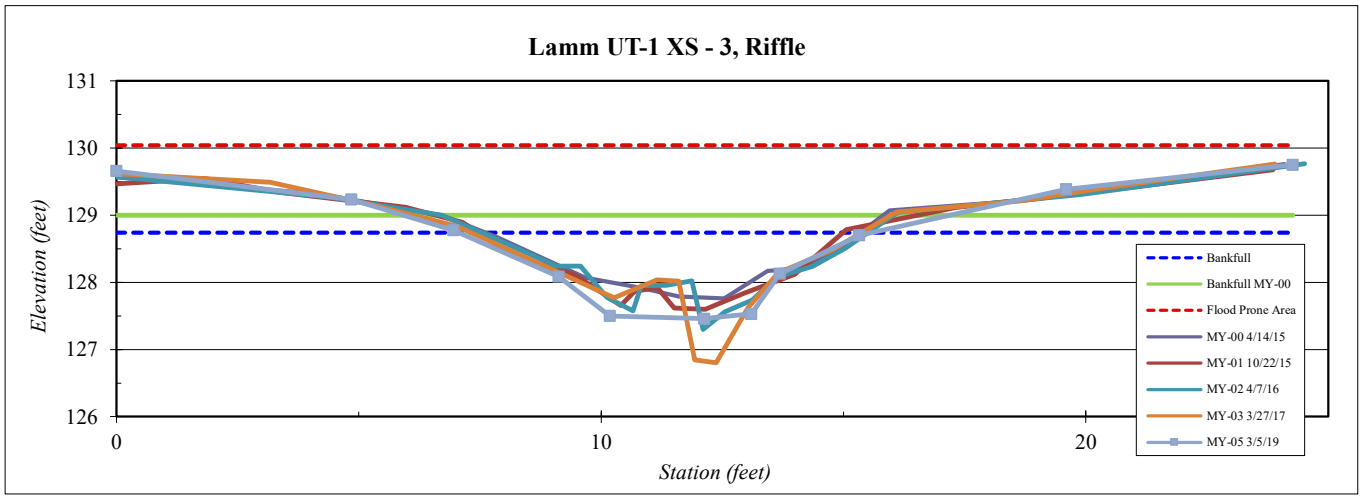
**MY0-3 BHR were calculated using DMS method of "Dmax year x /Dmax year 0". MY5-7 were calculated using DMS method of area best fit.
Elevated BHR results from shallow channel depth. UT 1 appears stable throughout.

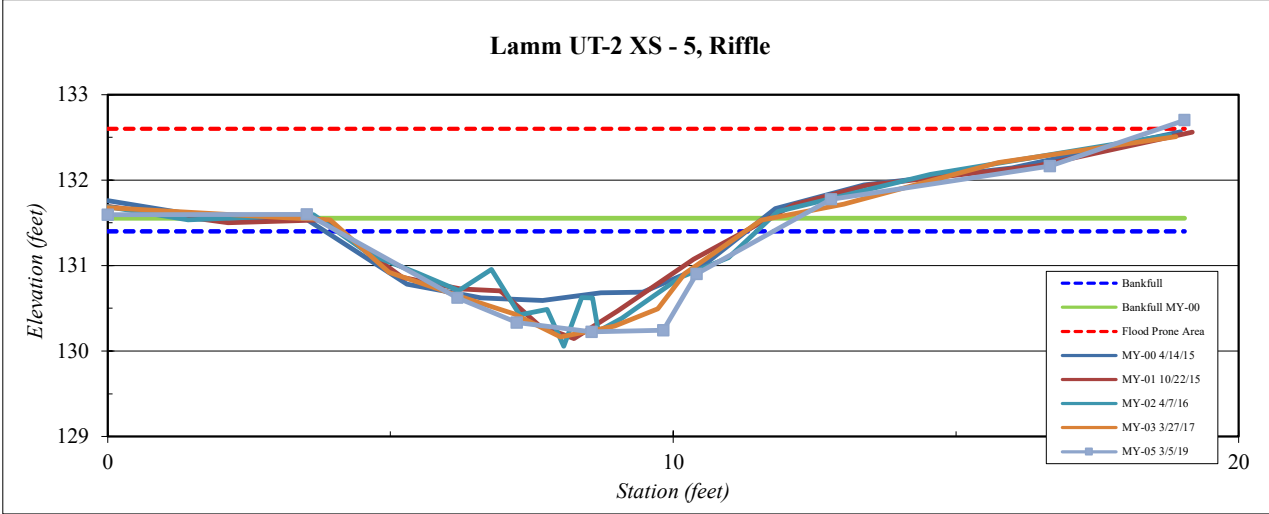
**MY0-3 BHR were calculated using DMS method of "Dmax year x /Dmax year 0". MY5-7 were calculated using DMS method of area best fit.
Overall channel area has remained constant. Sediment mobilization has resulted in minor downcutting, which has stabilized over the past 5 years. No problems are visible in this reach.

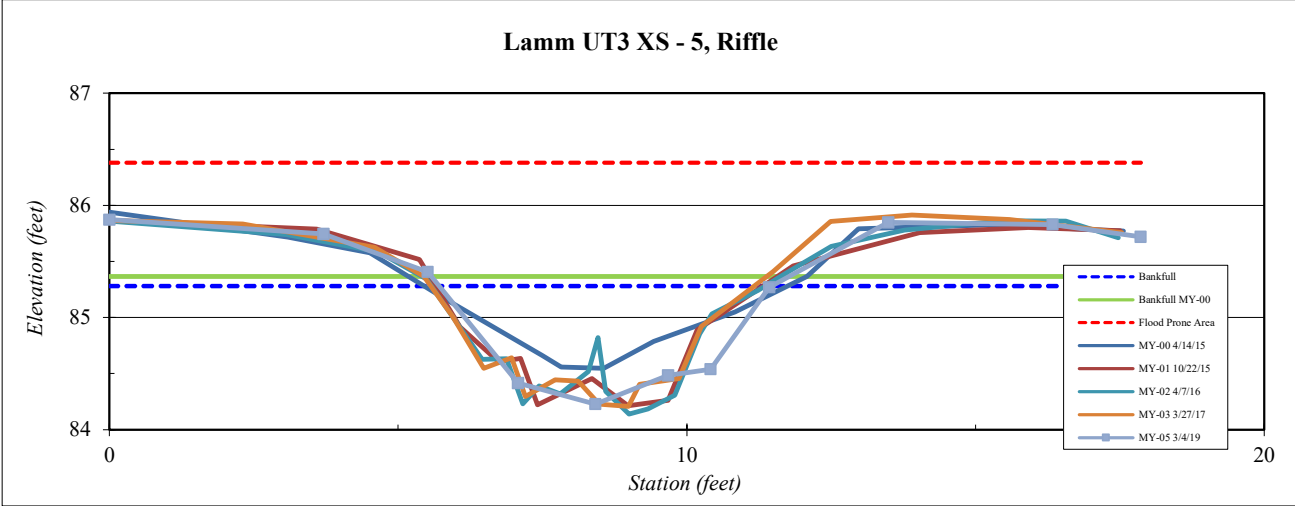
****MY0-3 BHR were calculated using DMS method of "Dmax year x /Dmax year 0". MY5-7 were calculated using DMS method of area best fit. Sediment mobilization has resulted in minor downcutting, which has stabilized over the past 5 years. No problems are visible in this reach.**

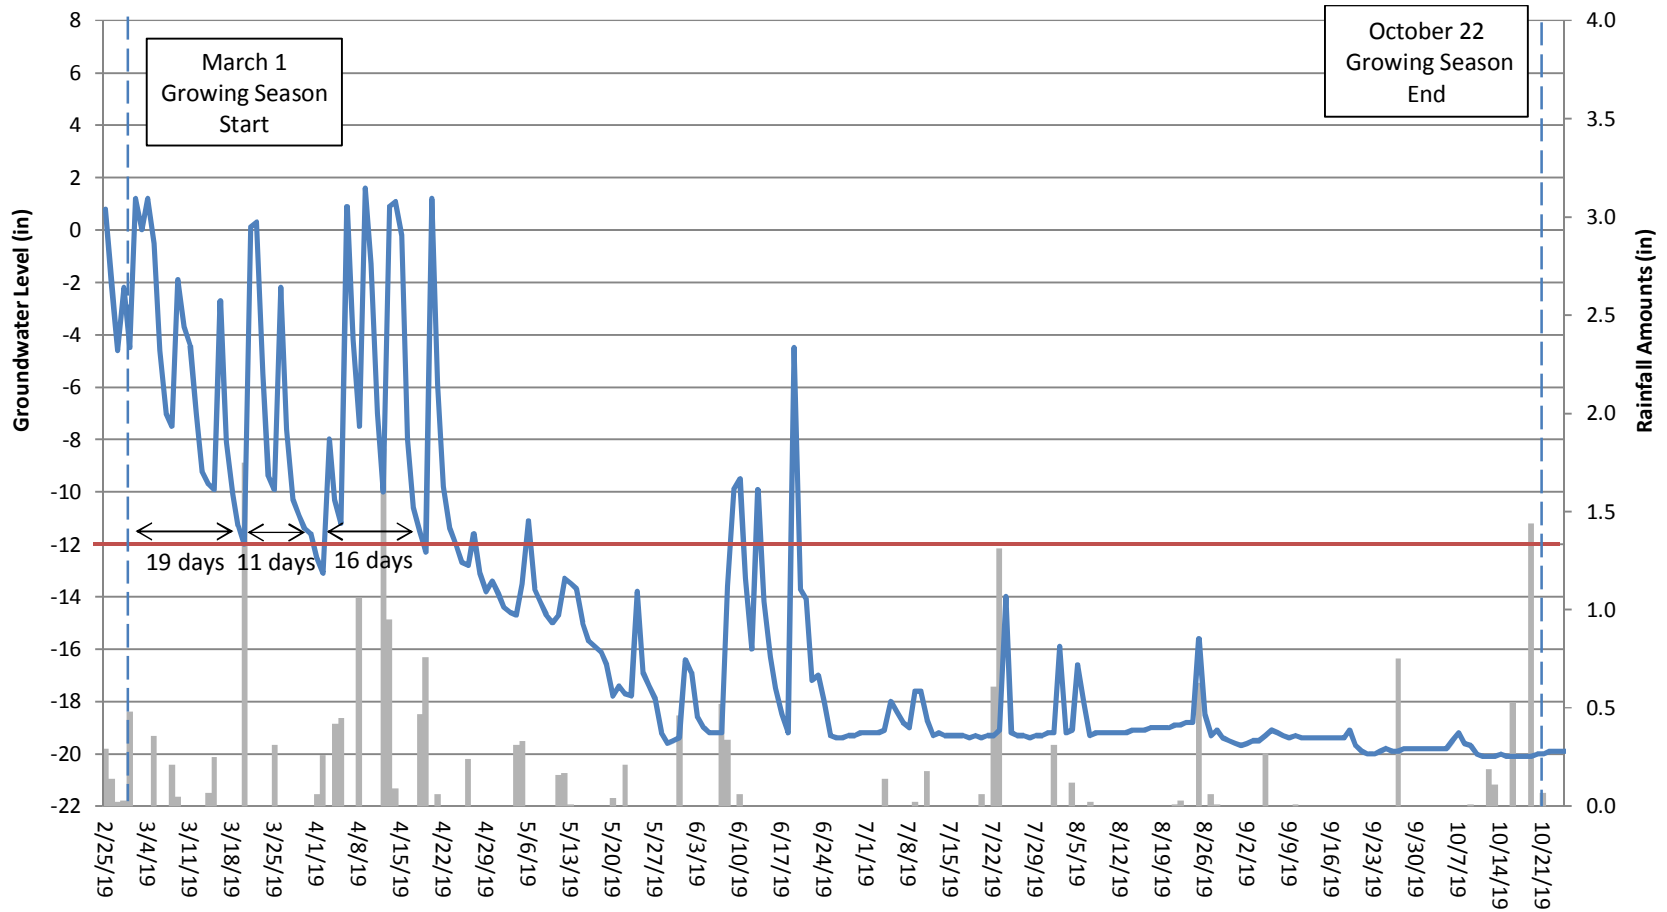
Lamm Groundwater Gauge 6 Year 5 (2019 Data)

[#] These gauges did not meet success criteria due to a data shuttle failure that resulted in the loss of data from March 20 to May 3. Based on rainfall and hydrology data that was not lost, these gauges would have likely met success criteria had the loss of data not occurred.

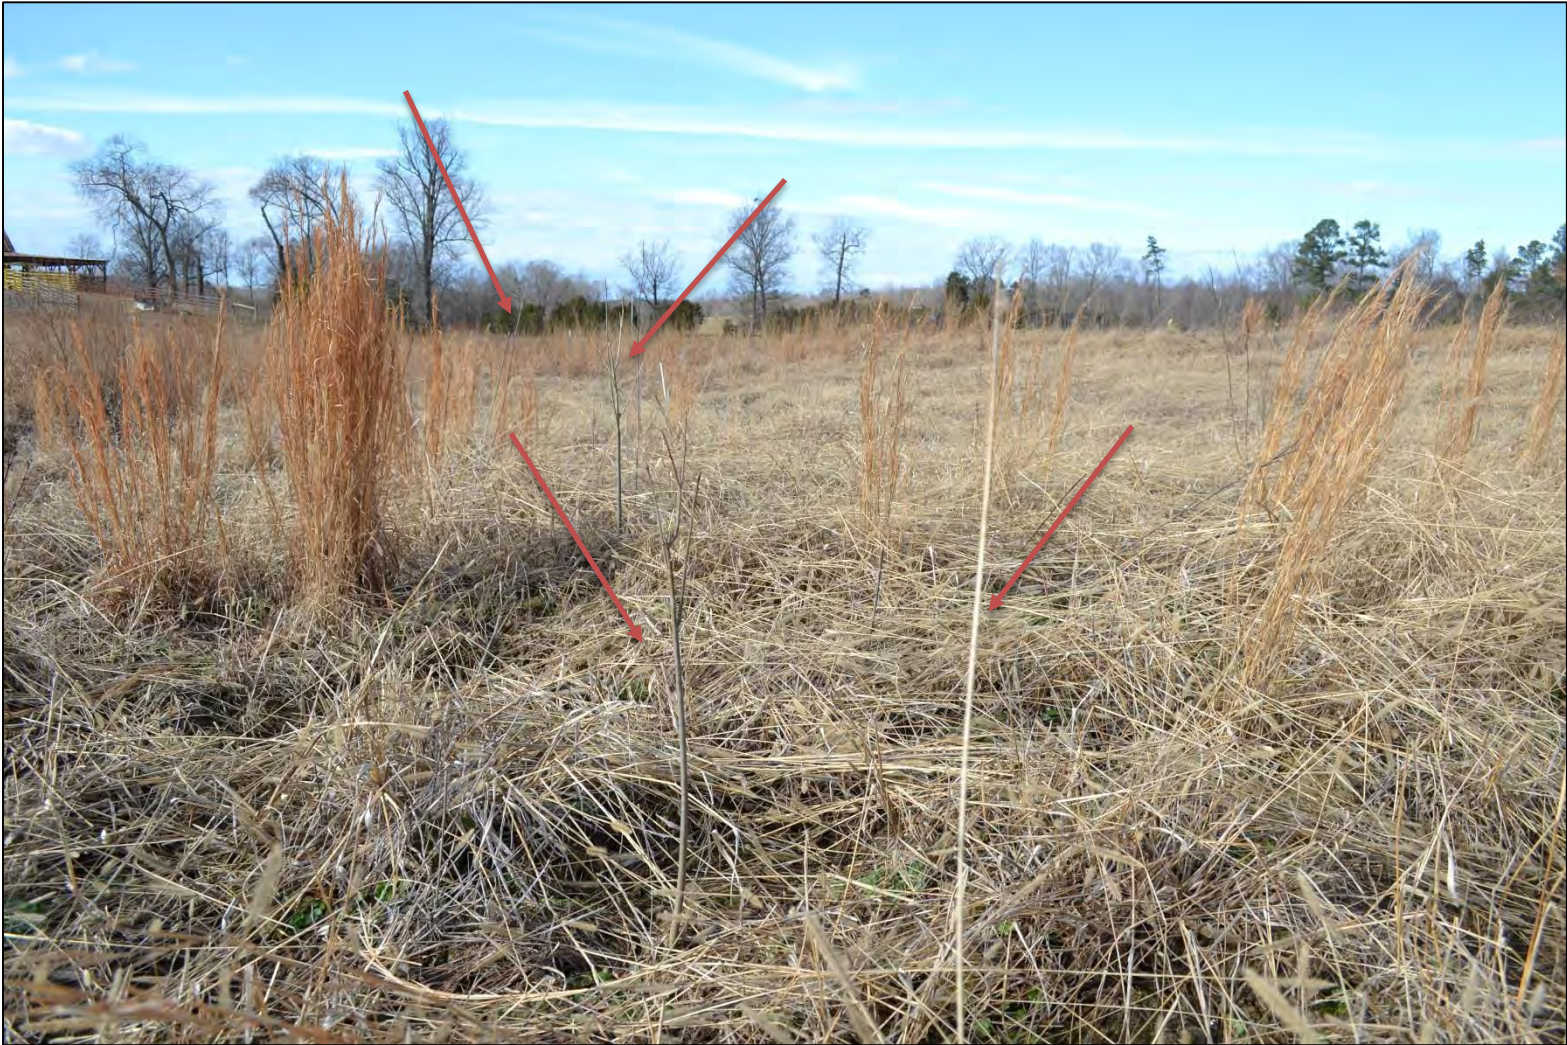
Photo 9: Surviving bear roots outside of replant area

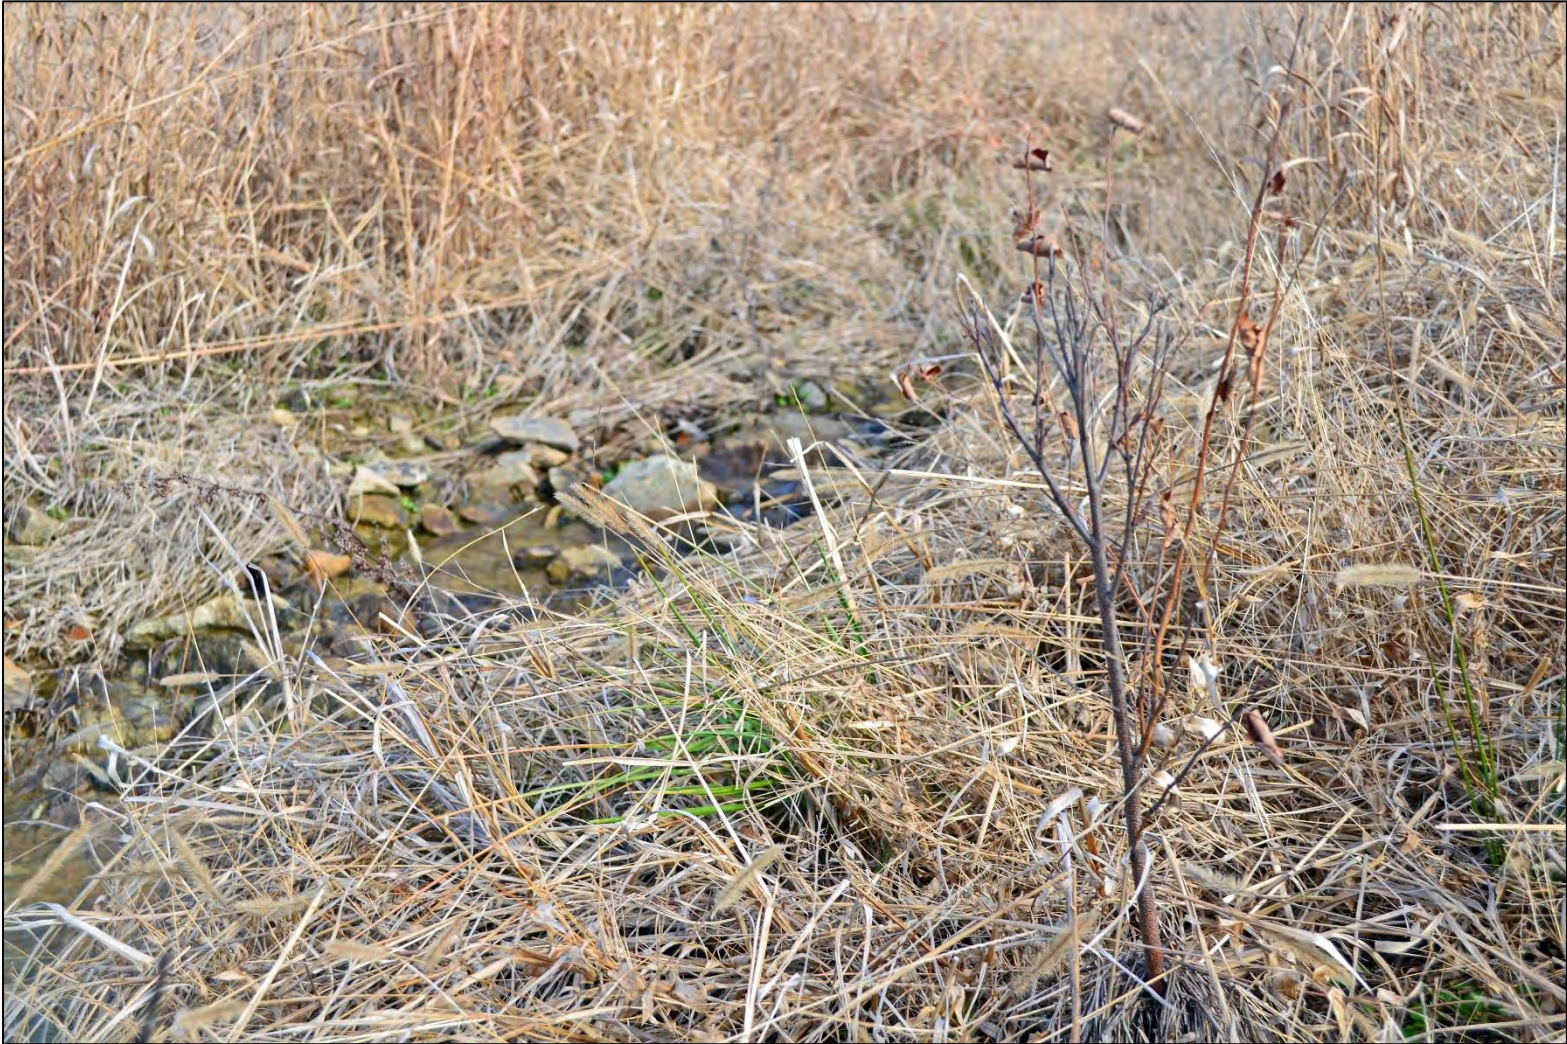
Photo 10: Surviving bear root outside of replant area
