YEAR 6 (2020) MONITORING REPORT
ABBEY LAMM
STREAM AND WETLAND MITIGATION SITE
ALAMANCE COUNTY, NORTH CAROLINA
FULL DELIVERY CONTRACT No. 5790
DMS PROJECT No. 96311
NCDWR PROJECT No. 20140336
USACE ACTION ID No. SAW-2014-01710

Abbey Lamm Year 6, 2020 Monitoring Summary

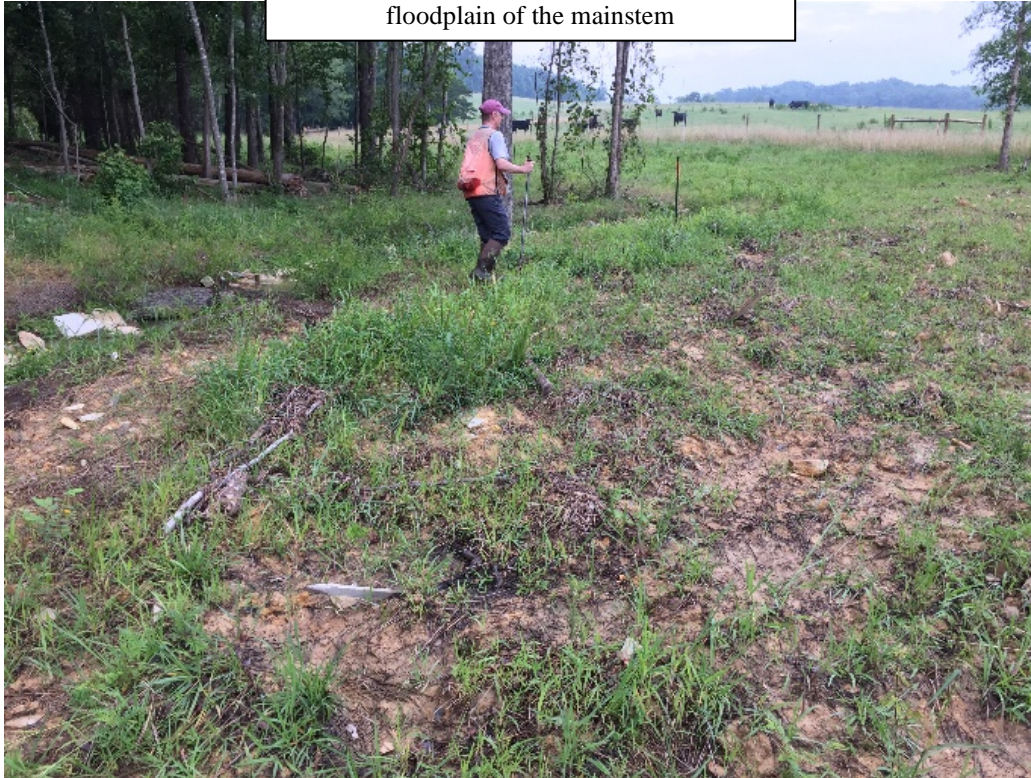
Bankfull Photo 1: Wrack and sediment in the floodplain of the mainstem

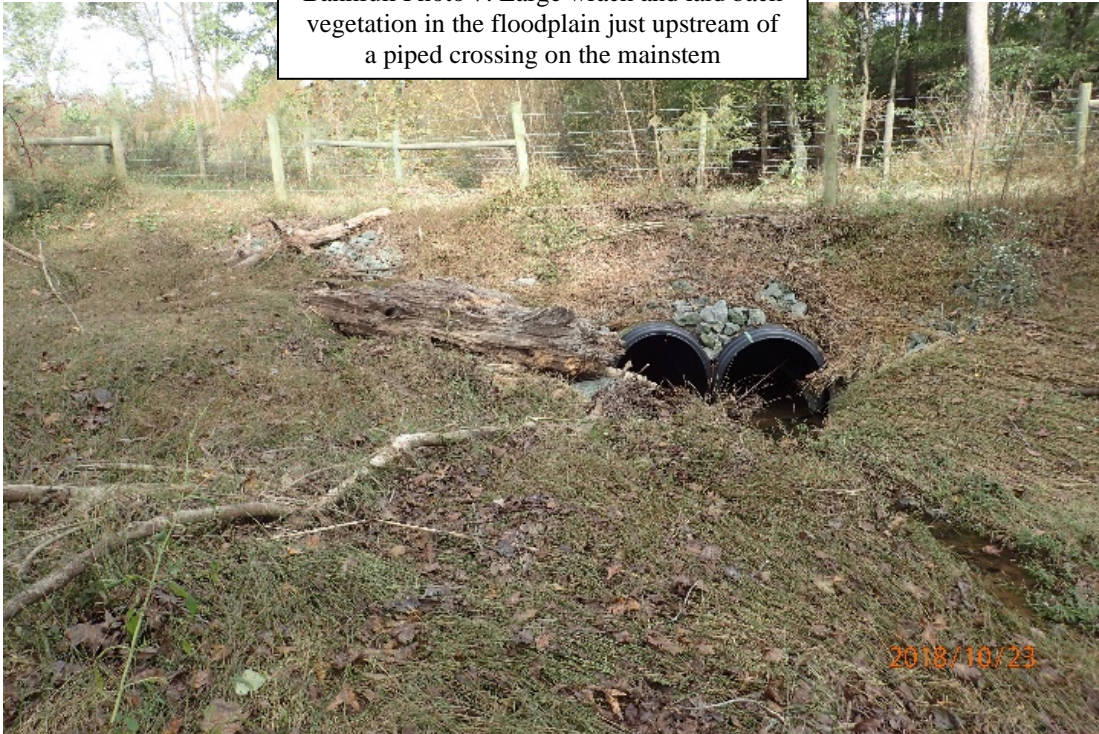
Bankfull Photo 7: Large wrack and laid back vegetation in the floodplain just upstream of a piped crossing on the mainstem

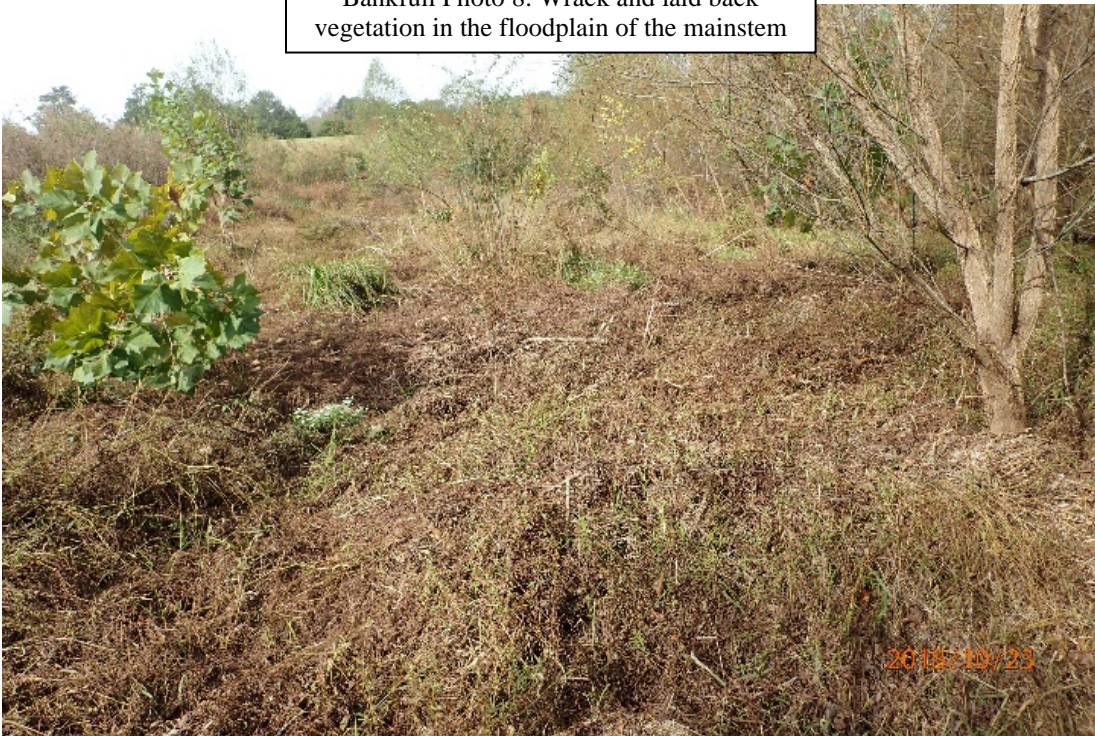
Bankfull Photo 8: Wrack and laid back vegetation in the floodplain of the mainstem

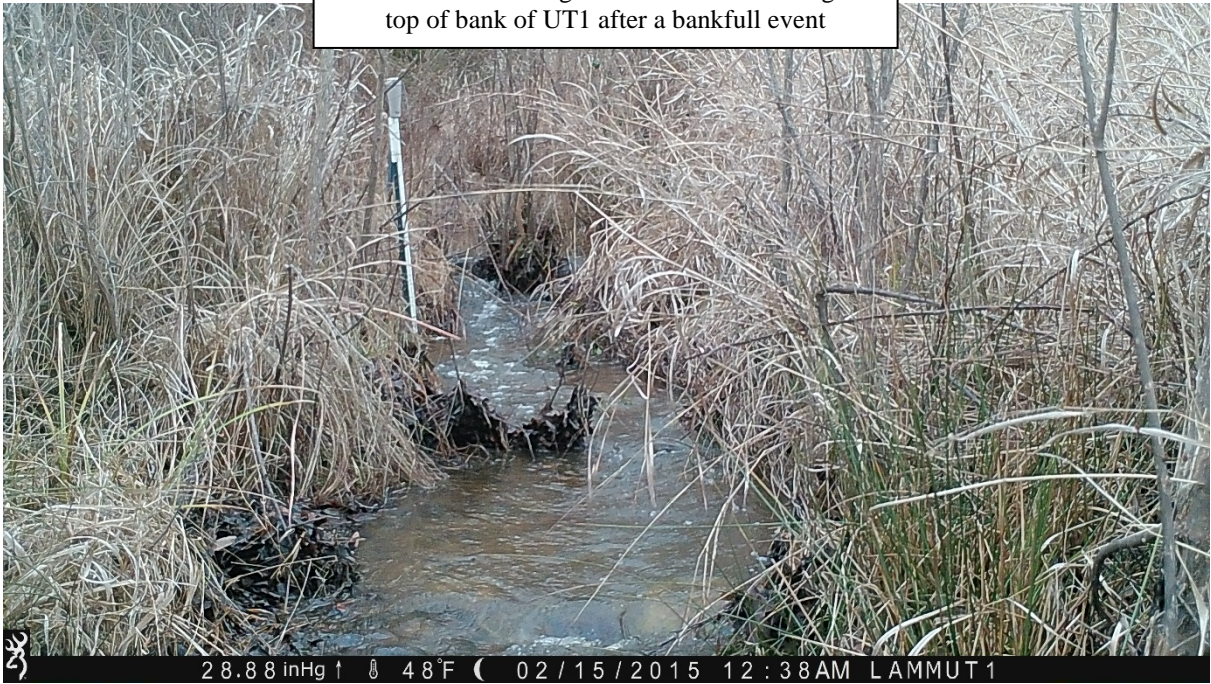
Bankfull Photo 9: High water and wrack along the top of bank of UT1 after a bankfull event

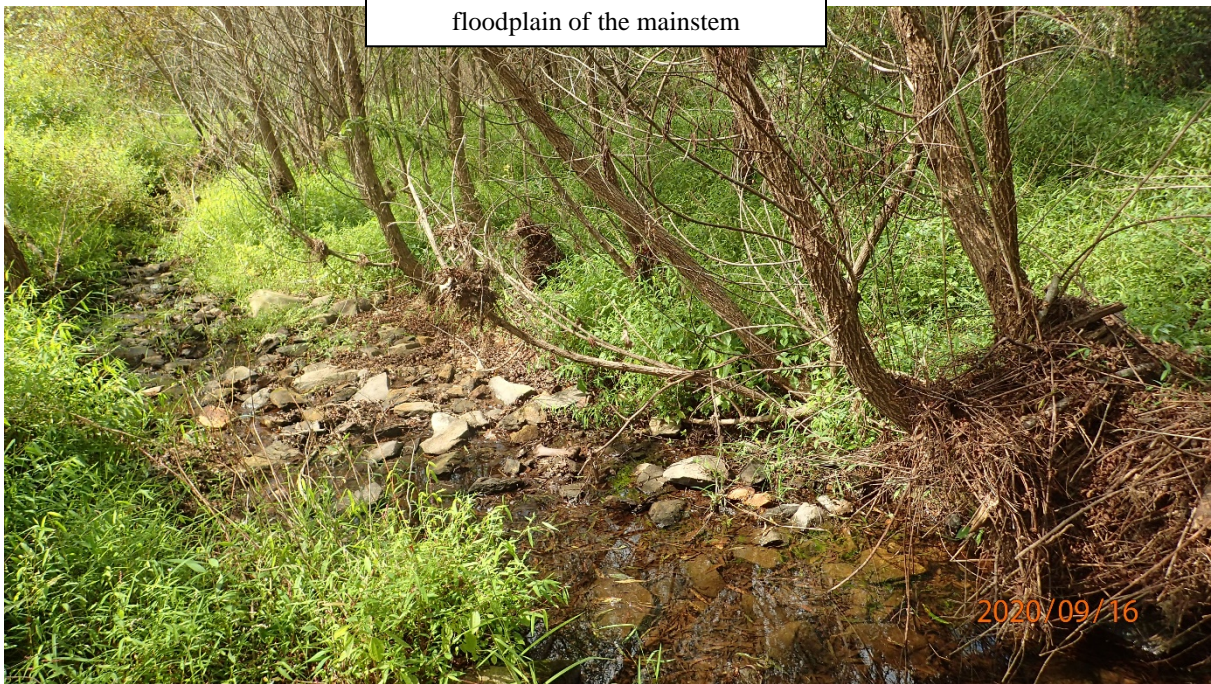
July 21st, 2020 (Photo: September 16th, 2020)	June 11th, 2020	Wrack in trees in the floodplain indicate a bankfull event occurred after 4.23 inches of rain was documented on June 11th, 2020 at an on-site rain gauge.	10

Bankfull Photo 10: Wrack in the floodplain of the mainstem

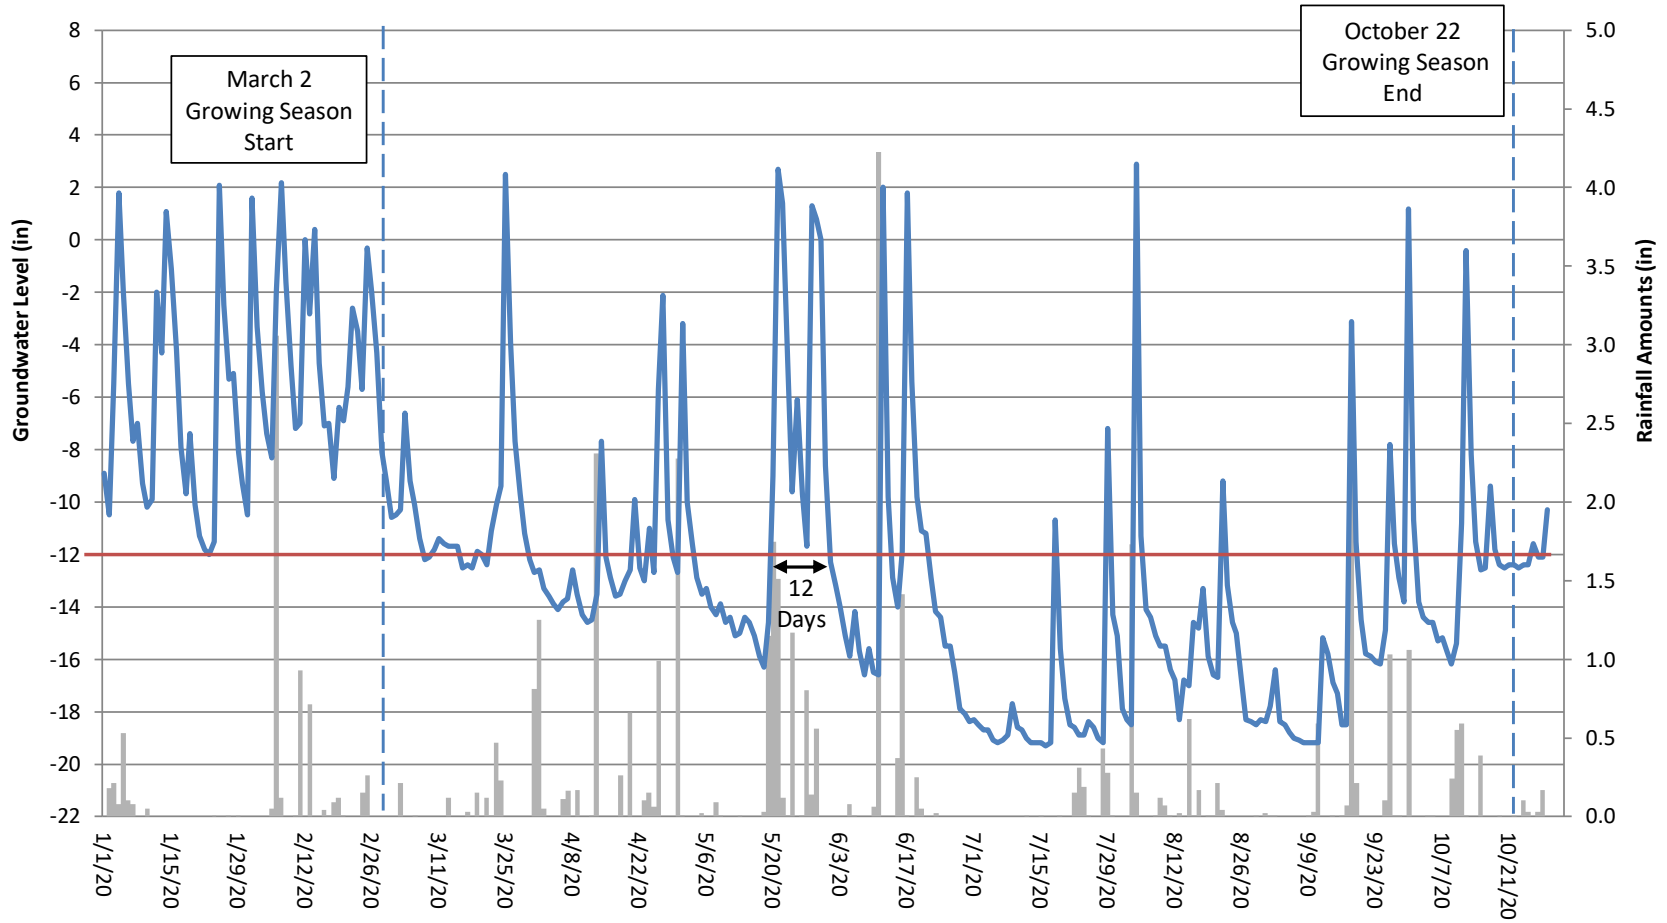
Lamm Groundwater Gauge 6 Year 6 (2020 Data)

3. Wetland credit around gauges 6 and 6B are at-risk due to each gauge only meeting success once, both in 2018. To date 85% of the total project wetland credits have been released. DMS will hold payment for the wetland component until credit release. Please discuss size of area at risk, factors contributing to falling short of success criteria, and potential, if any, for this wetland area's credit to be realized.
Understood. To evaluate the wetland restoration credit around gauge 6 and 6B, Raymond Holz and Alex Baldwin (PWS 2221) of Restoration Systems (RS) visited the Site on 12/8/2020 to review the subject area. Site work indicates 0.080 acres around gauge 6 and 6B is not meeting the Site's 10% hydroperiod period success metric.

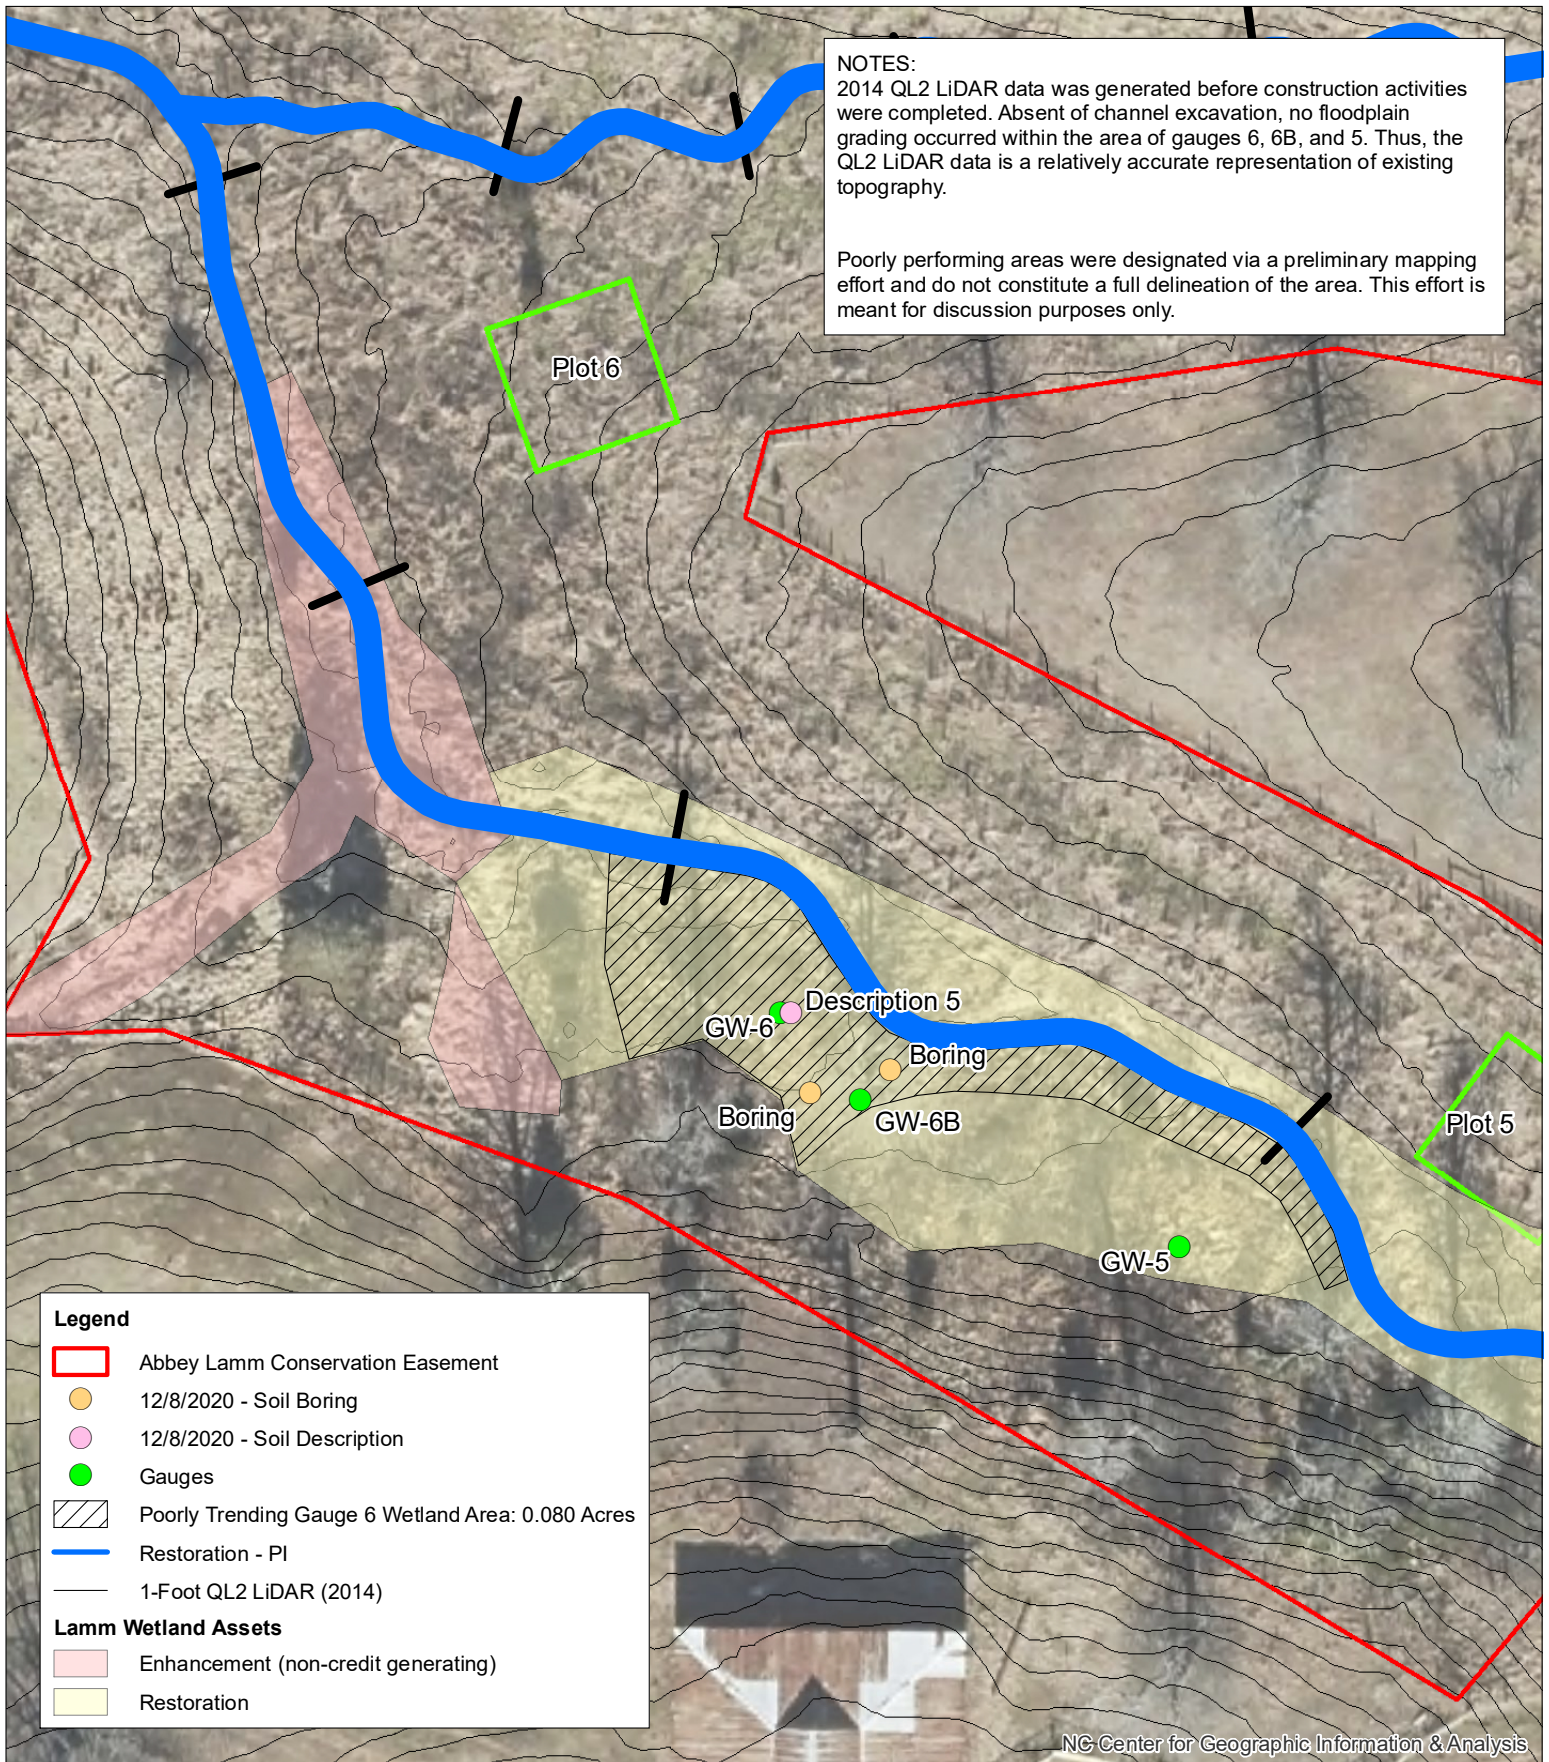
NOTES:
 2014 QL2 LiDAR data was generated before construction activities were completed. Absent of channel excavation, no floodplain grading occurred within the area of gauges 6, 6B, and 5. Thus, the QL2 LiDAR data is a relatively accurate representation of existing topography.

Poorly performing areas were designated via a preliminary mapping effort and do not constitute a full delineation of the area. This effort is meant for discussion purposes only.

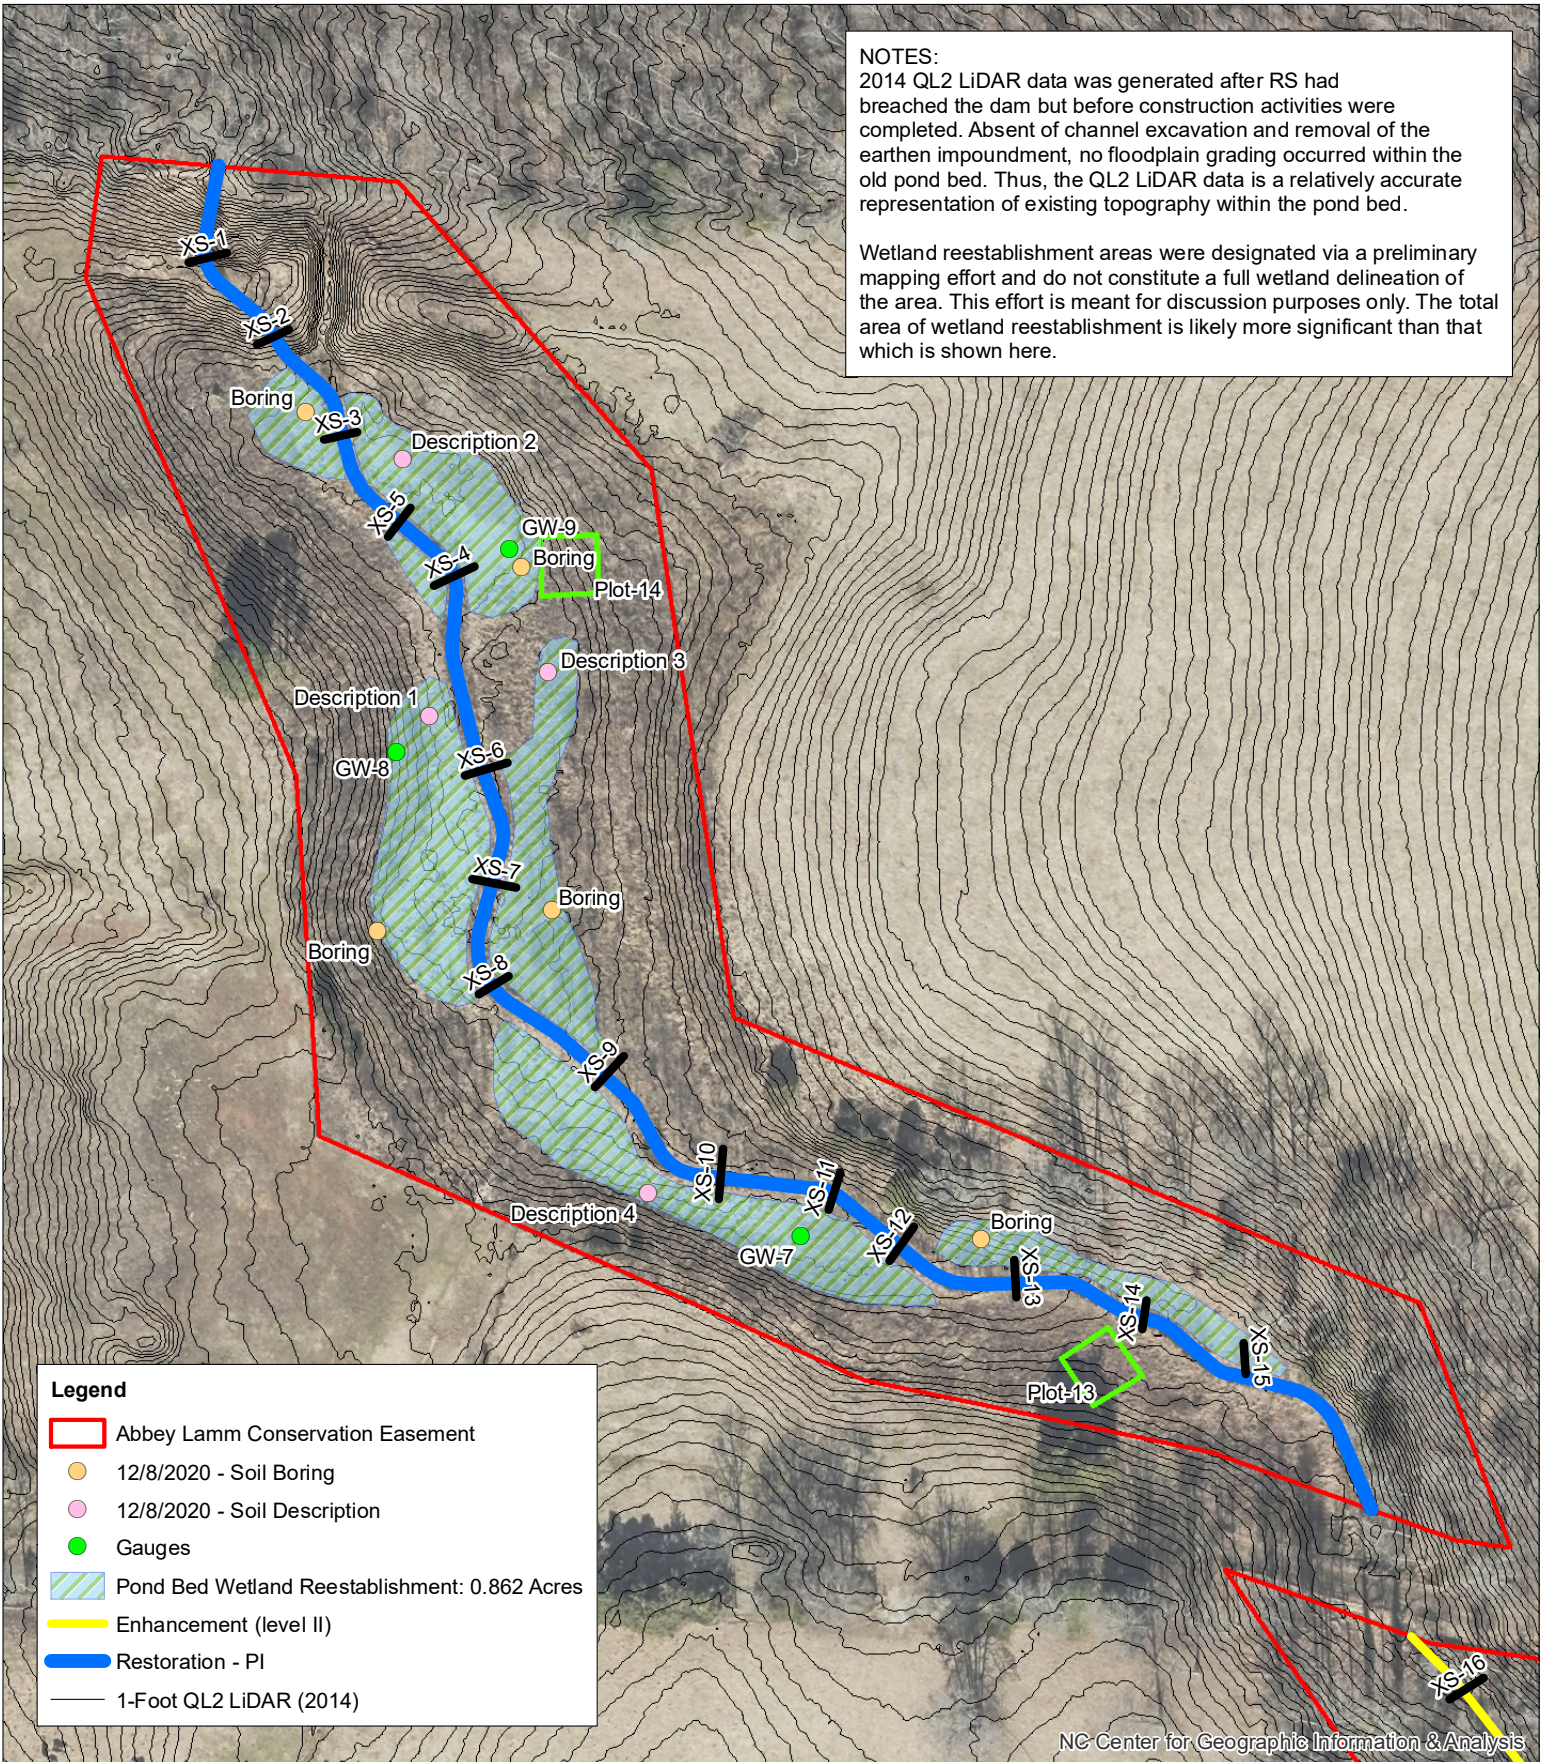
NOTES:
 2014 QL2 LiDAR data was generated after RS had breached the dam but before construction activities were completed. Absent of channel excavation and removal of the earthen impoundment, no floodplain grading occurred within the old pond bed. Thus, the QL2 LiDAR data is a relatively accurate representation of existing topography within the pond bed.

Wetland reestablishment areas were designated via a preliminary mapping effort and do not constitute a full wetland delineation of the area. This effort is meant for discussion purposes only. The total area of wetland reestablishment is likely more significant than that which is shown here.
