YEAR 1 MONITORING REPORT

ADKIN BRANCH STREAM RESTORATION PROJECT PHASE 1 – WASHINGTON AVE. TO LINCOLN ST.

Lenoir County, North Carolina

Project ID No. 050656101

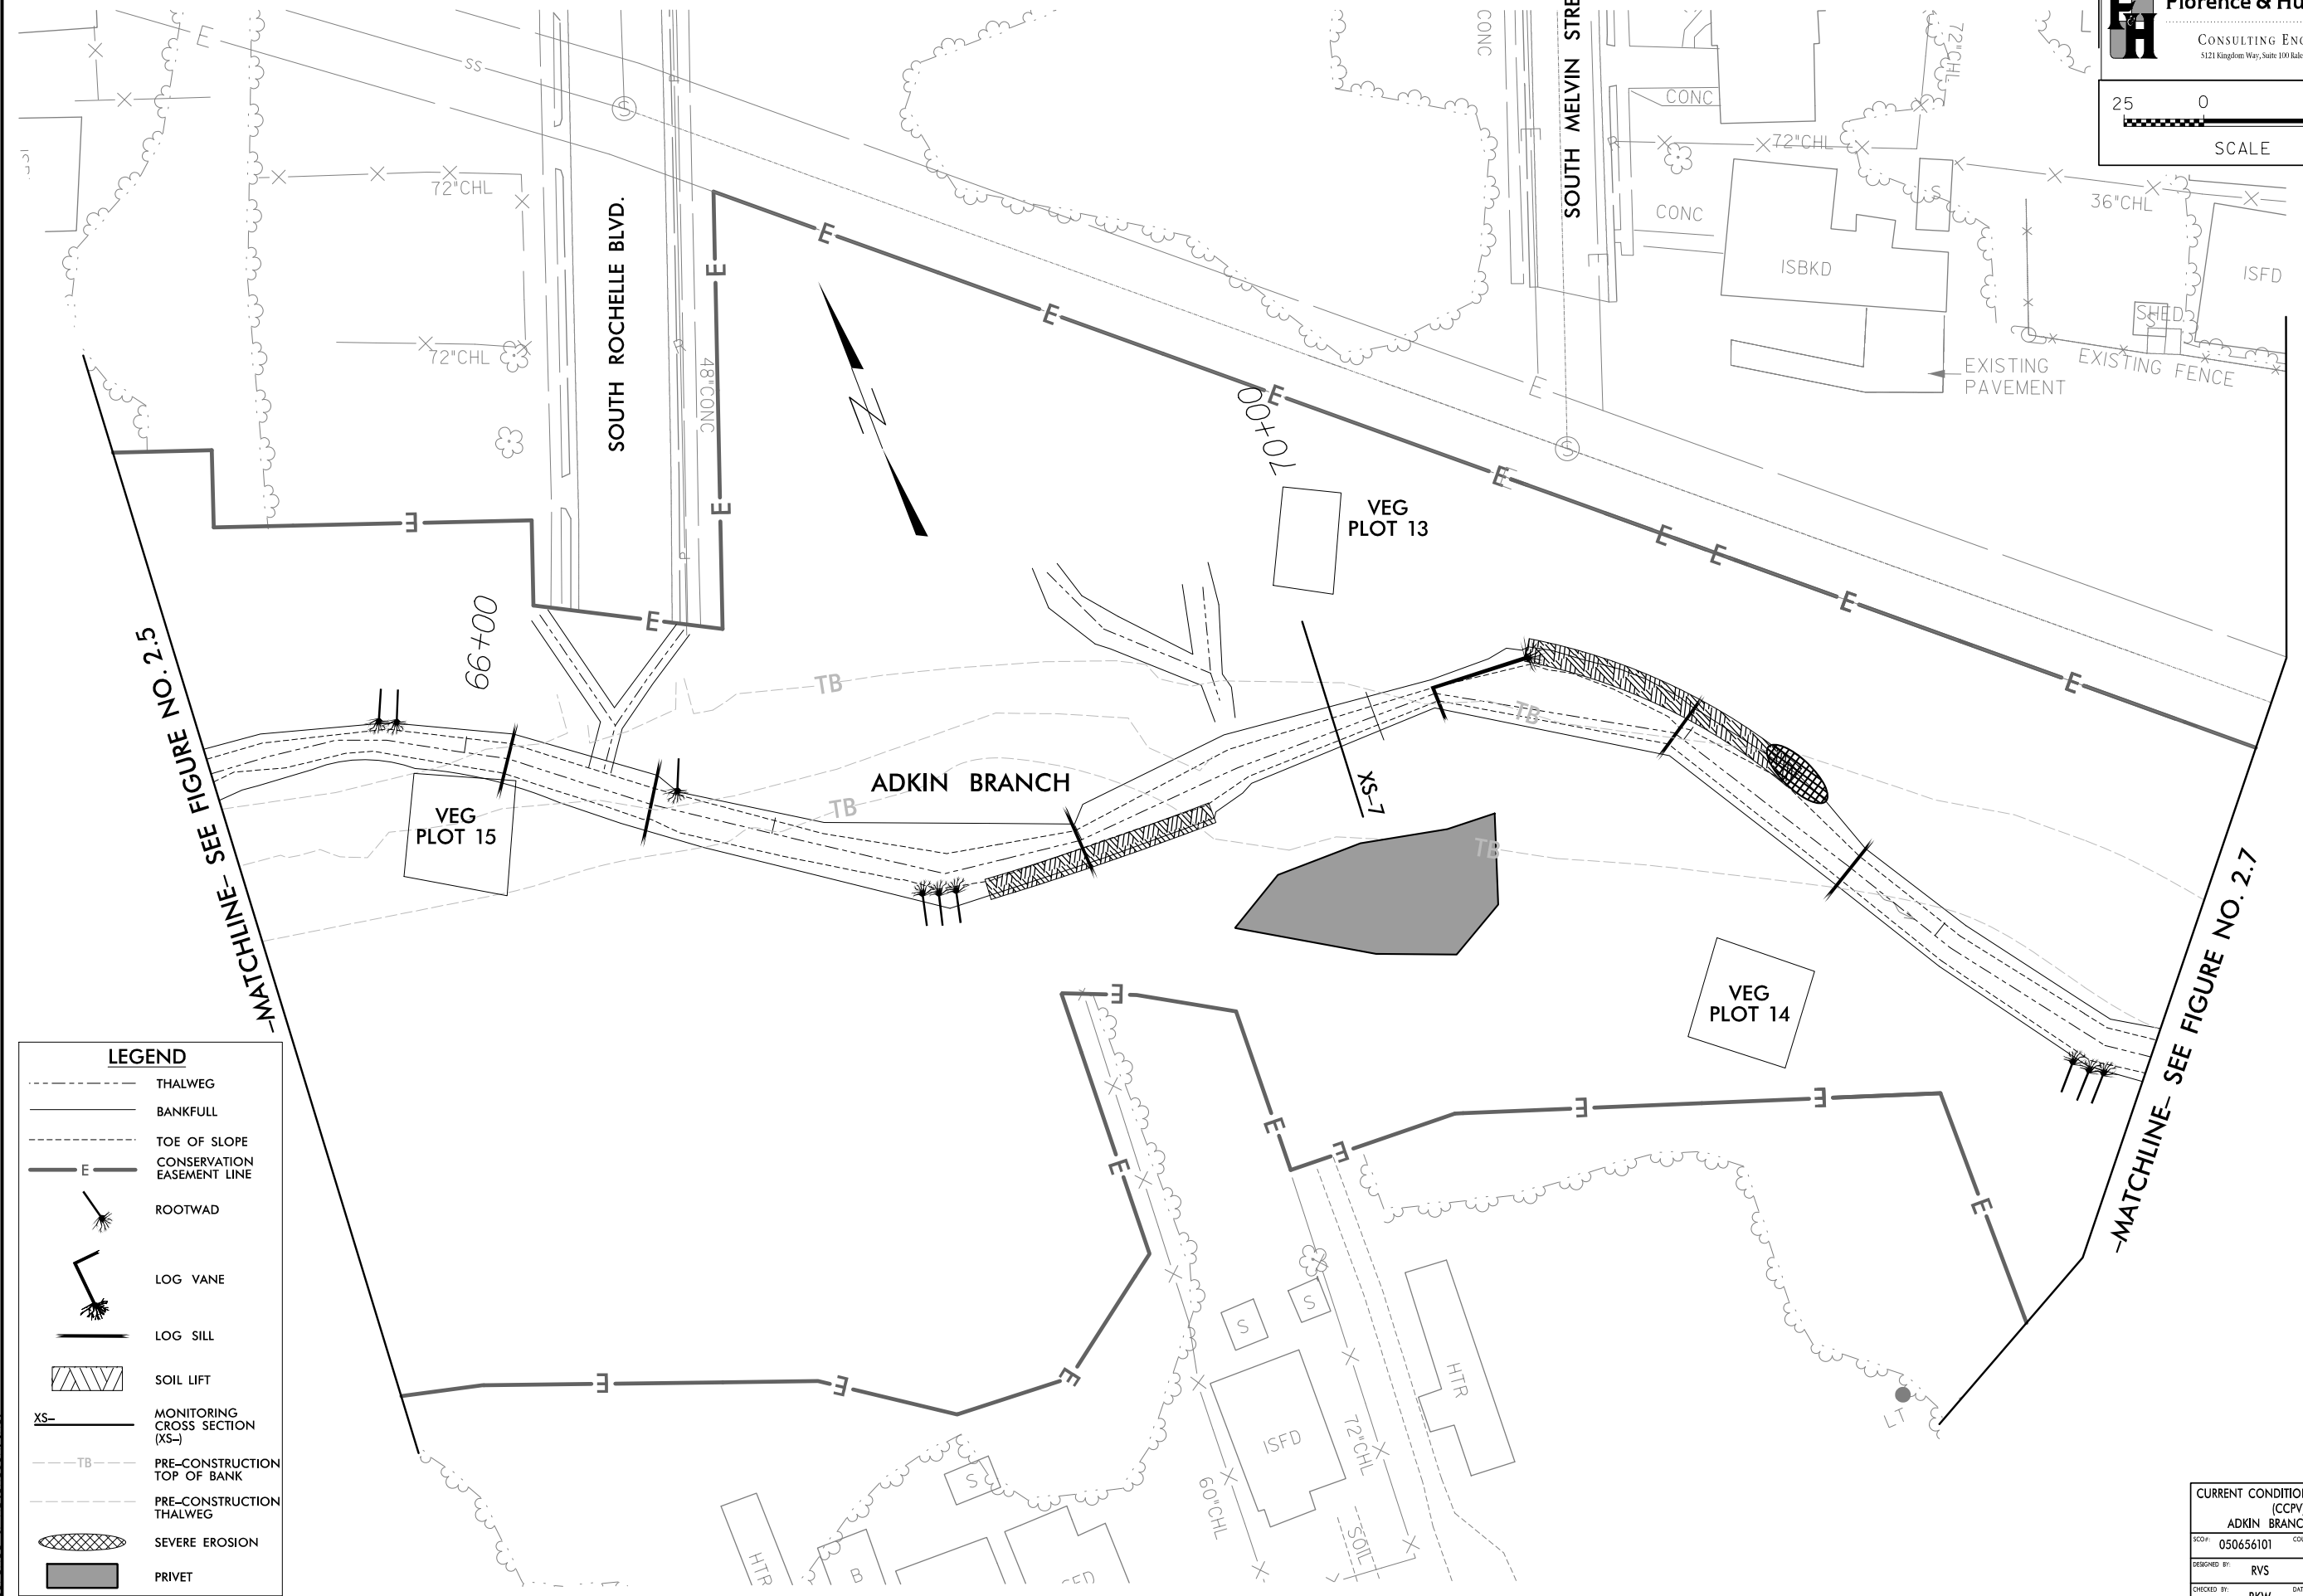
Chinese privet (*Ligustrum sinense*) was sparsely scattered throughout the Site. One dense cluster of privet was observed between monitoring plots 14 and 15 as depicted on the Current Condition Plan View (CCPV) map (Figure 2.6). Invasive/exotic vegetation is not currently compromising the vegetative success of the Site. Vegetation ground coverage within the stormwater wetland was 100 percent.

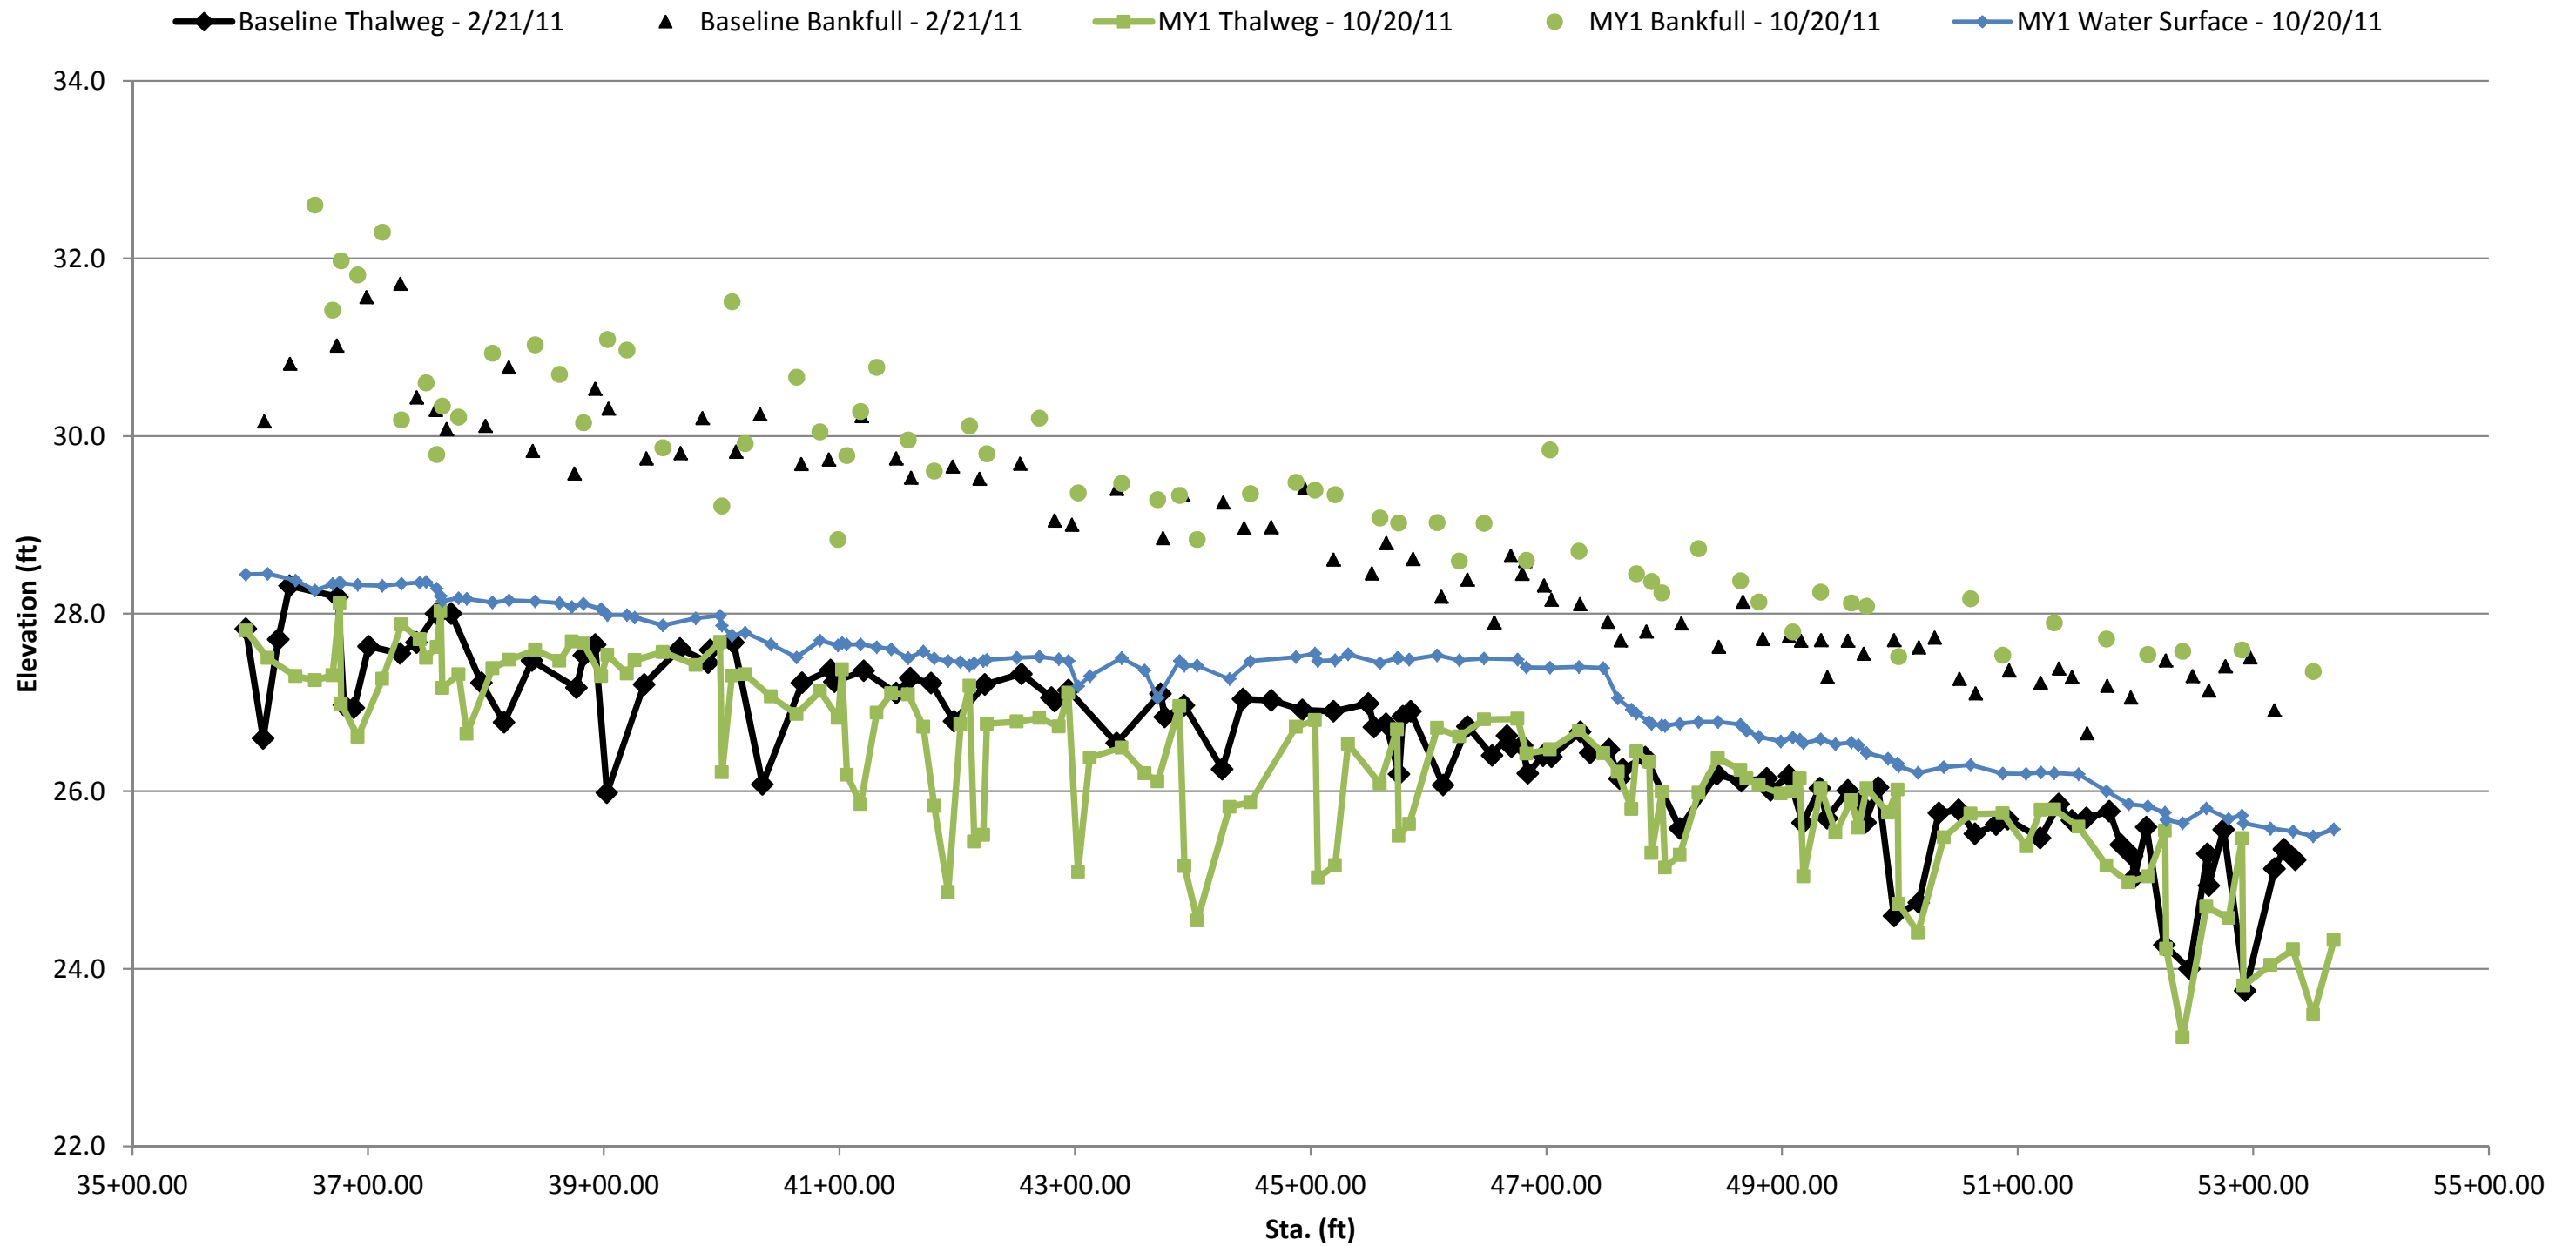
Figure 5.1 Reach 1 (Washington Ave. to Gordon St.) - Longitudinal Profile

Year 1 monitoring surveys along Adkin Branch and its UT occurred in October, 2011. Significant stream bed scour was observed in the following locations (Figures 5.1-5.2):

This scour likely occurred during the storm events associated with Hurricane Irene in late August, 2011. Several of the existing pools in Reach 1 and 2 deepened and/or lengthened as a result of the storm events, but the log structures maintained grade control and the overall stability of the channel was not compromised. These pools are expected to adjust over time, but will be monitored closely in Year 2 to make sure that the log structures are not undermined. Only minor shifting of pools and riffles was observed throughout the remainder of the profile, which is expected in a sand bed system. The majority of stream banks and structures throughout the project are stable and functioning as intended. There is no evidence of trends toward significant change in channel pattern. Cross-sectional data indicates that the channel width to depth ratio is lowering as the channel matures (Figures 4.1-4.17). This change is expected as detailed in the proposed success criteria from the Baseline Monitoring Document (NCDENR, 2011).

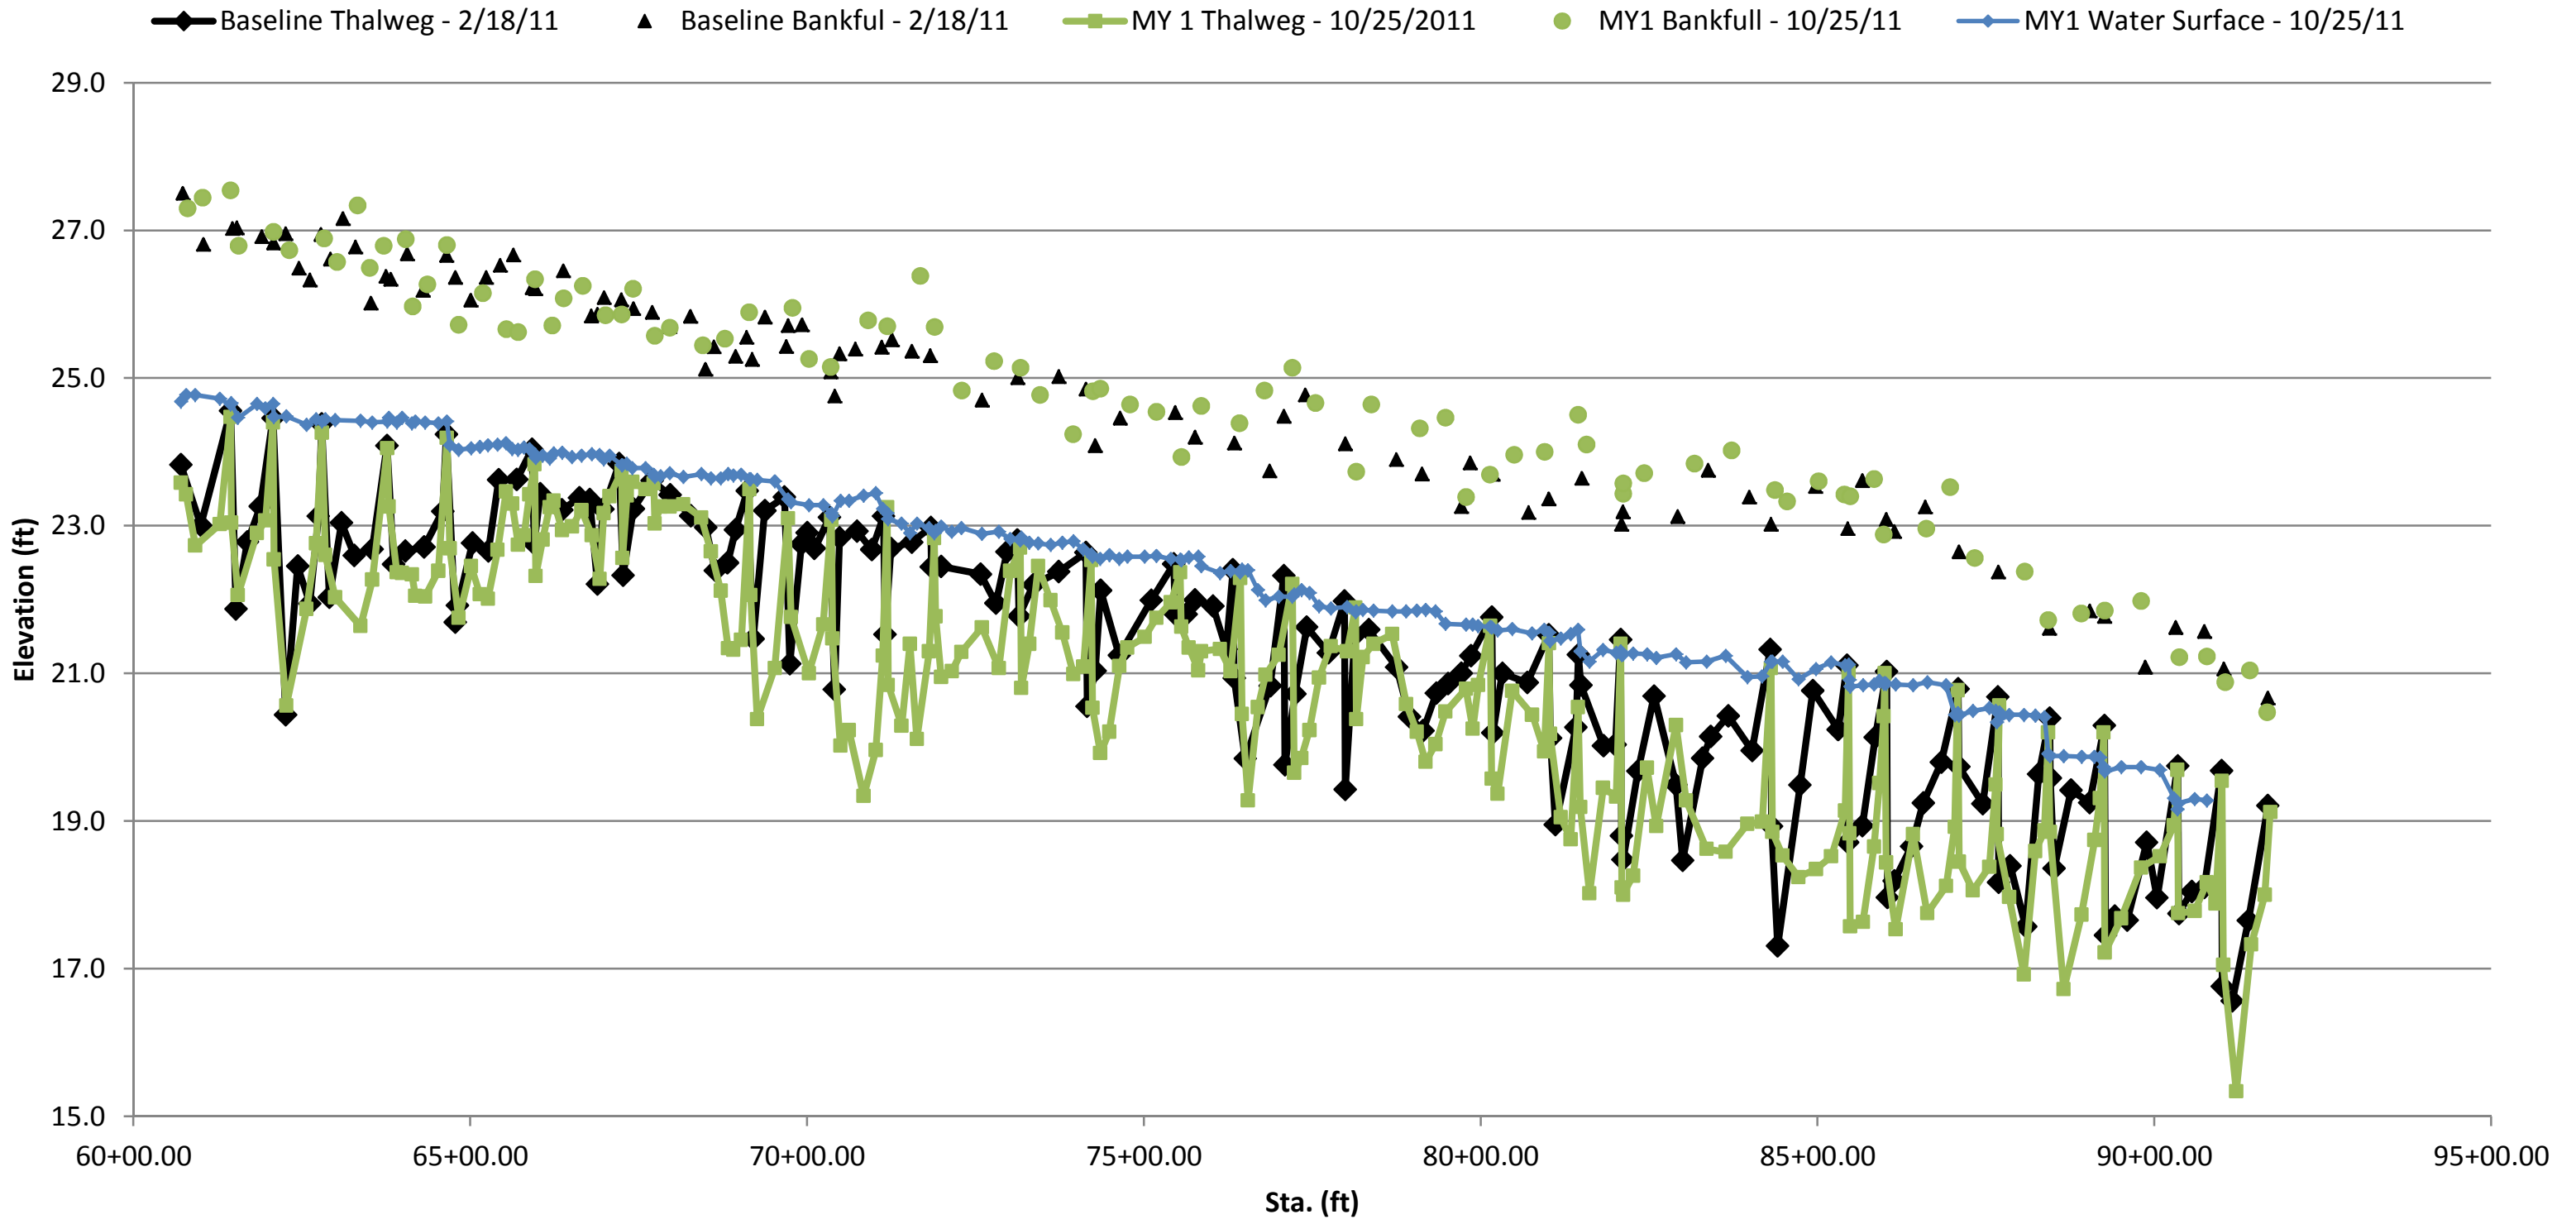
Figure "Reach 2 (Gordon St. to Lincoln St.) - Longitudinal Profile

Based on an overall visual assessment of the channel, Reach 2 appears to contain the majority of the problem areas on the Site. Twelve riffle segments were noted as unstable in Reach 2 as a result of the scour from large storm events, most notably, events associated with Hurricane Irene. Twelve bank segments were noted as eroding in Reach 2, due to a lack of vegetation along the stream banks. One log cross vane has been compromised in Reach 2 as a result of stream bank erosion around the vane arm (Figure 3.29). Six log structures are experiencing erosion on greater than 15 percent of the streambanks within their extent of influence and three log structures exhibit minor erosion around the vane arms. A Repair Plan has been developed to correct these problem areas, which includes the use of soil lifts, bank grading, and erosion control matting. The repair plan is expected to be implemented in 2012. Problem areas are depicted on the CCPV and photos are presented in Appendix B.

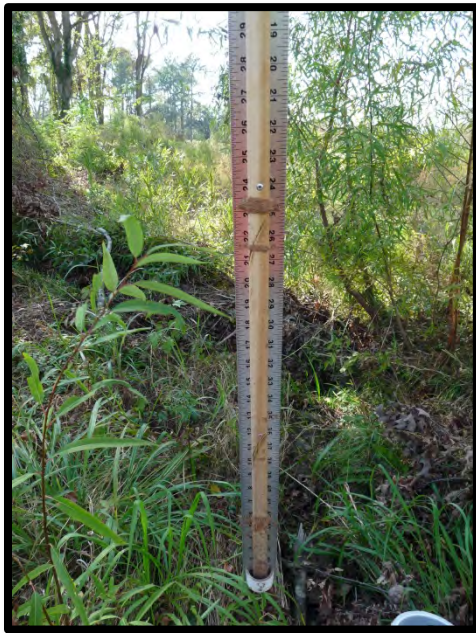
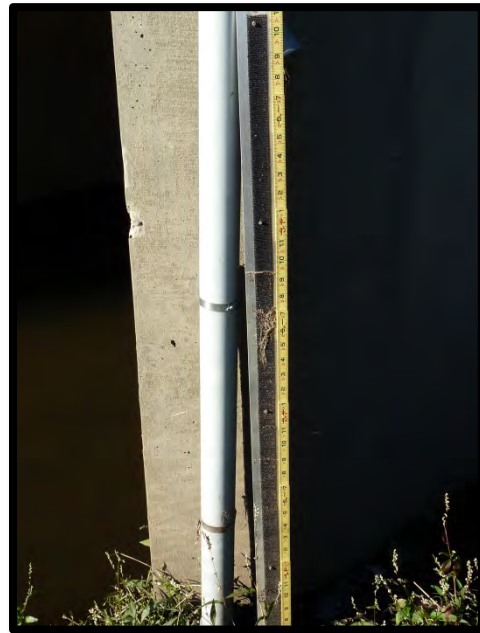
Figures 6.1 & 6.2 Crest Gauge Photos

Crest gauges installed on-site were inspected on 26 October, 2011. Crest Gauge 2 near station 75+25 was damaged during Hurricane Irene. The remaining crest gauges revealed that a bankfull event occurred at least once during 2011 (Table 13). Additional overbank evidence includes debris lines, and vegetation bent in the downstream direction. Evidence of bankfull events can be found in Appendix E.
