# ***YEAR 2 MONITORING REPORT***

## **ADKIN BRANCH STREAM RESTORATION PROJECT PHASE 1 – WASHINGTON AVE. TO LINCOLN ST.**

Lenoir County, North Carolina  
EEP IMS No. 7

Construction Completed: April 2011  
Morphology Data Collected: October/November 2012  
Vegetation Data Collected: August 2012  
Submitted: January 2013

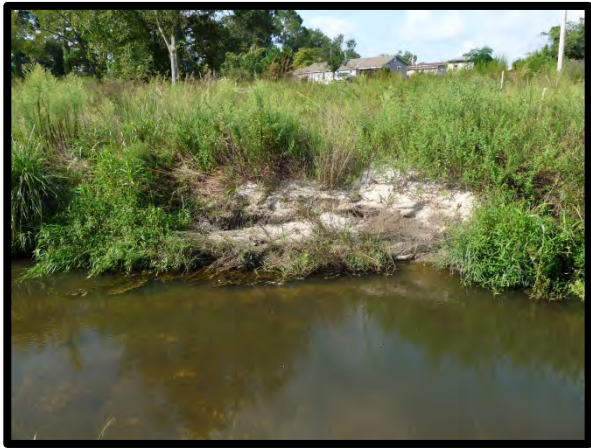
**3.21 Severe bank erosion near 65+35**

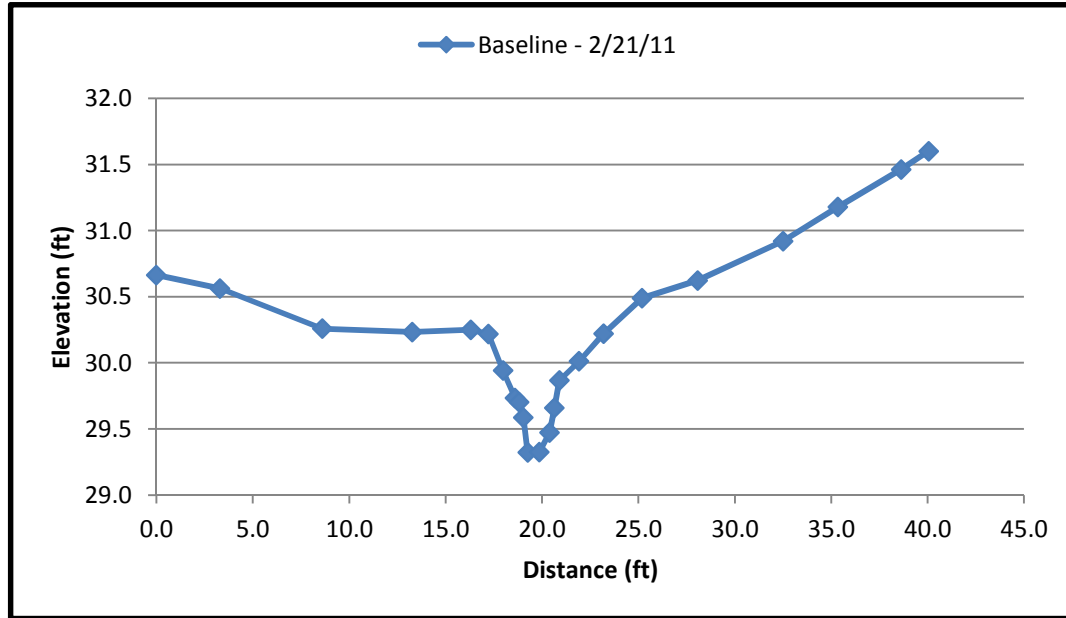
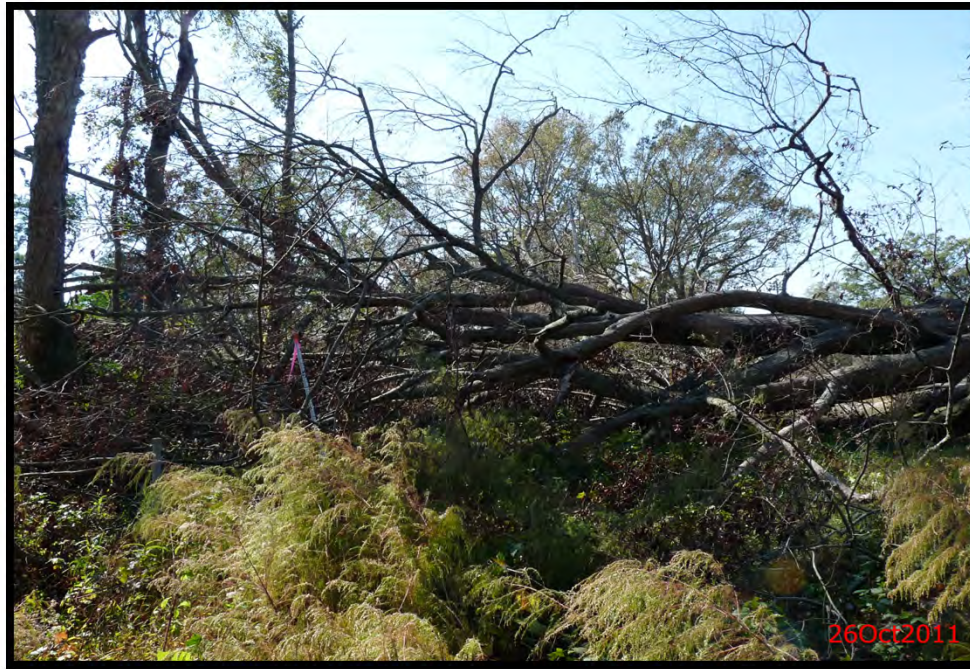
No Data - Fallen Tree over Channel

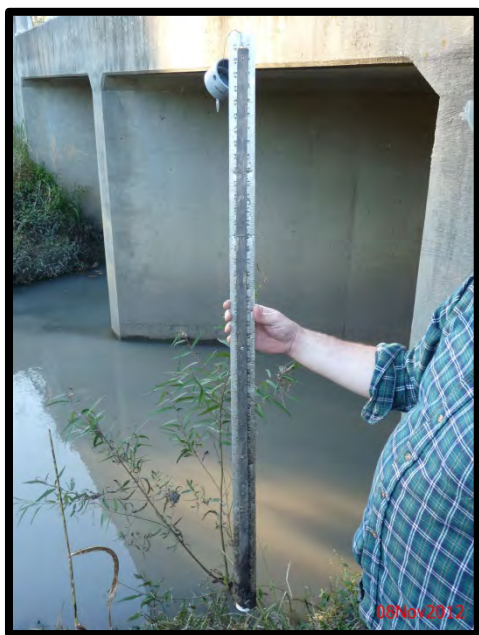
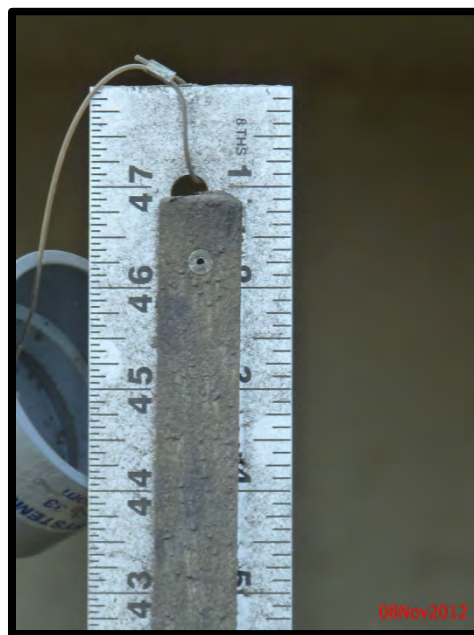
**Figures 6.1 & 6.2 Crest Gauge Photos**

Date	Crest Gauge Info		Gauge Reading (ft)	Gauge Elevation (ft)	Crest Elevation (ft)	Bankfull Elevation (ft)	Height above Bankfull (ft)	Photo
	Site	Sta.						
11/8/2012	1	54+00	4.0	25.27	29.27	27.03	2.24	6.1 & 6.2
