# ***YEAR 4 MONITORING REPORT***

## **ADKIN BRANCH STREAM RESTORATION PROJECT PHASE 1 – WASHINGTON AVE. TO LINCOLN ST.**

Lenoir County, North Carolina  
EEP IMS No. 7

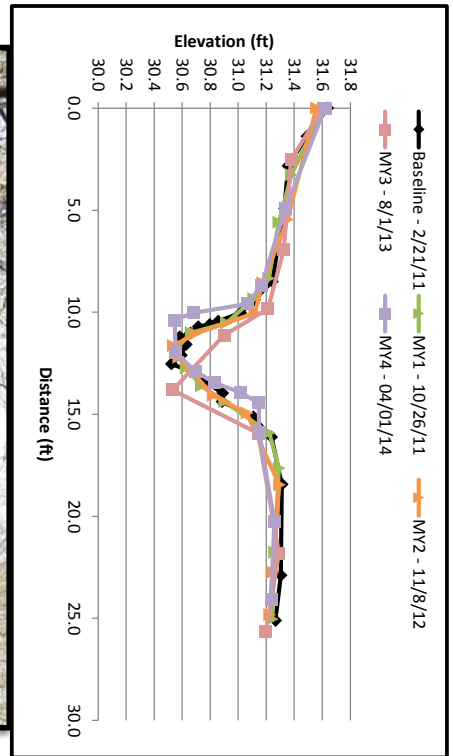
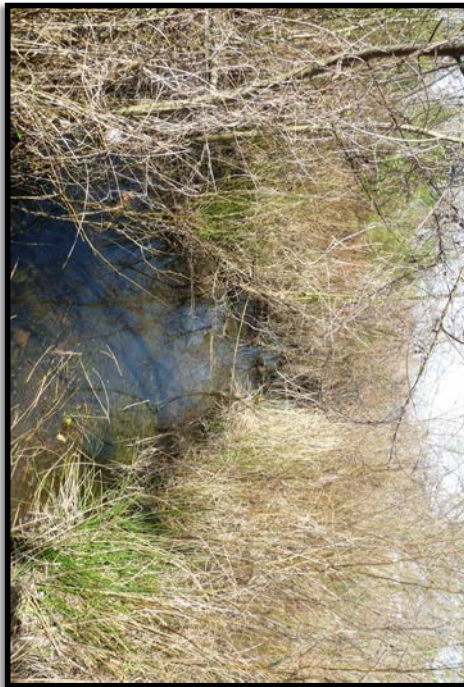
Figure 4.15 XS-15 Riffle, Sta. 19+28

Baseline		MY1		MY2		MY3		MY4	
Sta.	Elev.	Sta.	Elev.	Sta.	Elev.	Sta.	Elev.	Sta.	Elev.
0.00	30.666	No Data - Fallen Tree over Channel							
3.30	30.56								
8.61	30.26								
13.27	30.23								
16.31	30.25								
17.22	30.22								
17.98	29.94								
18.60	29.73								
18.81	29.70								
19.03	29.59								
19.26	29.32								
19.86	29.33								
20.39	29.47								
20.64	29.66								
20.90	29.87								
21.92	30.01								
23.19	30.22								
25.19	30.49								
28.07	30.62								
32.50	30.92								
35.34	31.18								
38.62	31.46								
40.05	31.60

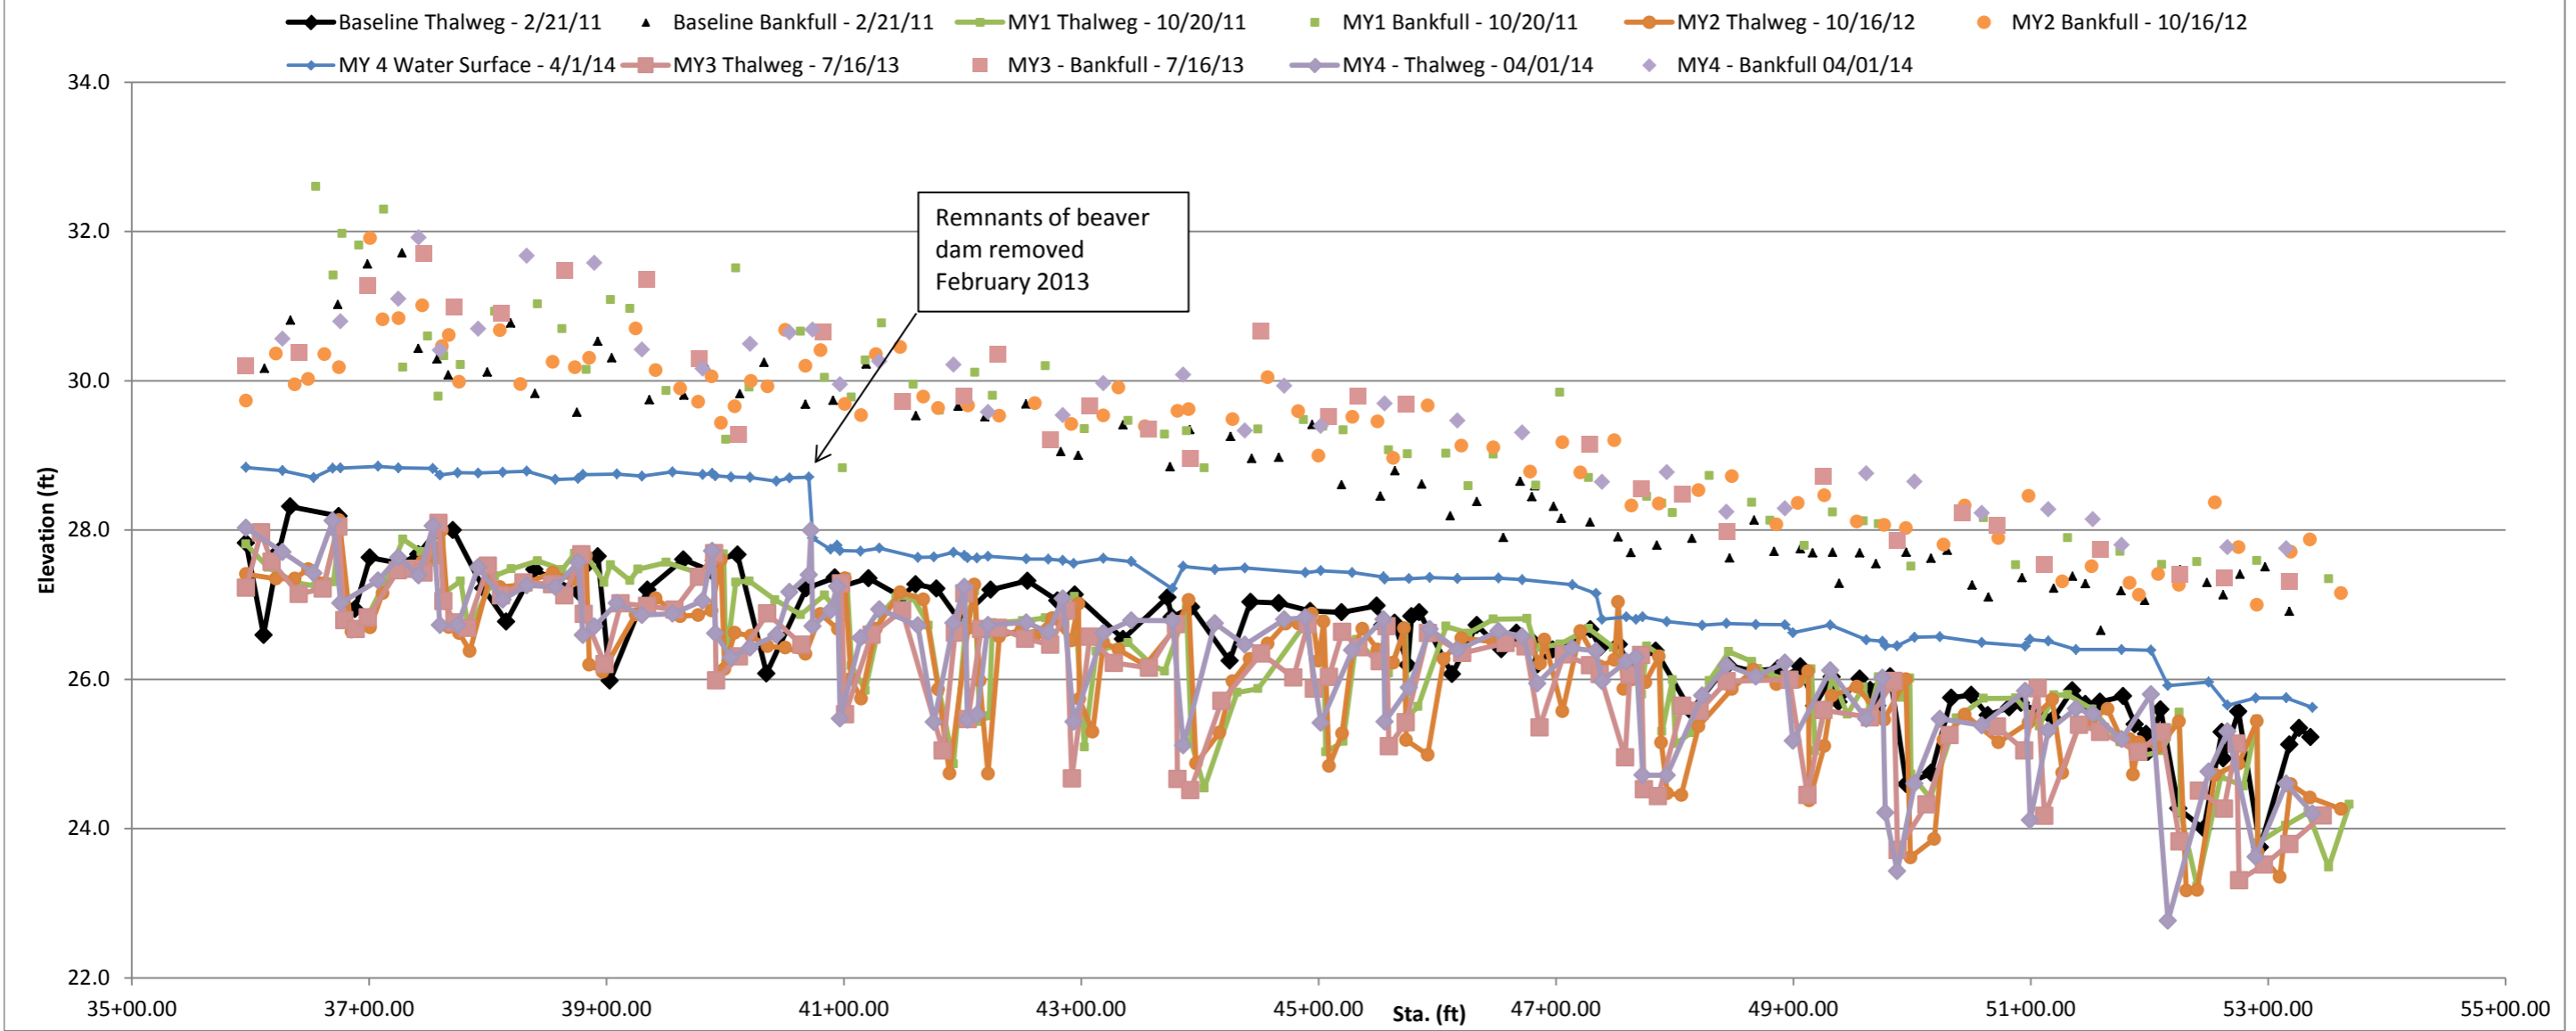
**Figure 5.1 Reach 1 (Washington Ave. to Gordon St.) - Longitudinal Profile**

Reach 1: Reach 1 profile experienced minor scouring near station 52+00, however this change in profile depth is expected in a sand bed system. All structures appear to be maintaining grade control. An area around station 53+00 is experiencing major erosion along the right bank and may require repairs if erosion continues. Moderate bank erosion is also occurring in three areas downstream of station 58+00. Four areas between stations 42+00 and 47+00 are experiencing minor erosion along the banks (Figure 3.21). Bank widening is also occurring between station 55+50 and 58+00 (Figure 3.27). Areas of minor bank erosion and bank widening should be watched closely in future monitoring years.

A beaver dam was observed near Station 40+80 on April 4, 2014. EEP contacted APHIS and the dam was removed by chainsaw on April 14, 2014. The area where the dam was removed should be watched for signs of stream instability. Photos of the beaver dam can be seen in Figures 3.25 and 3.26.

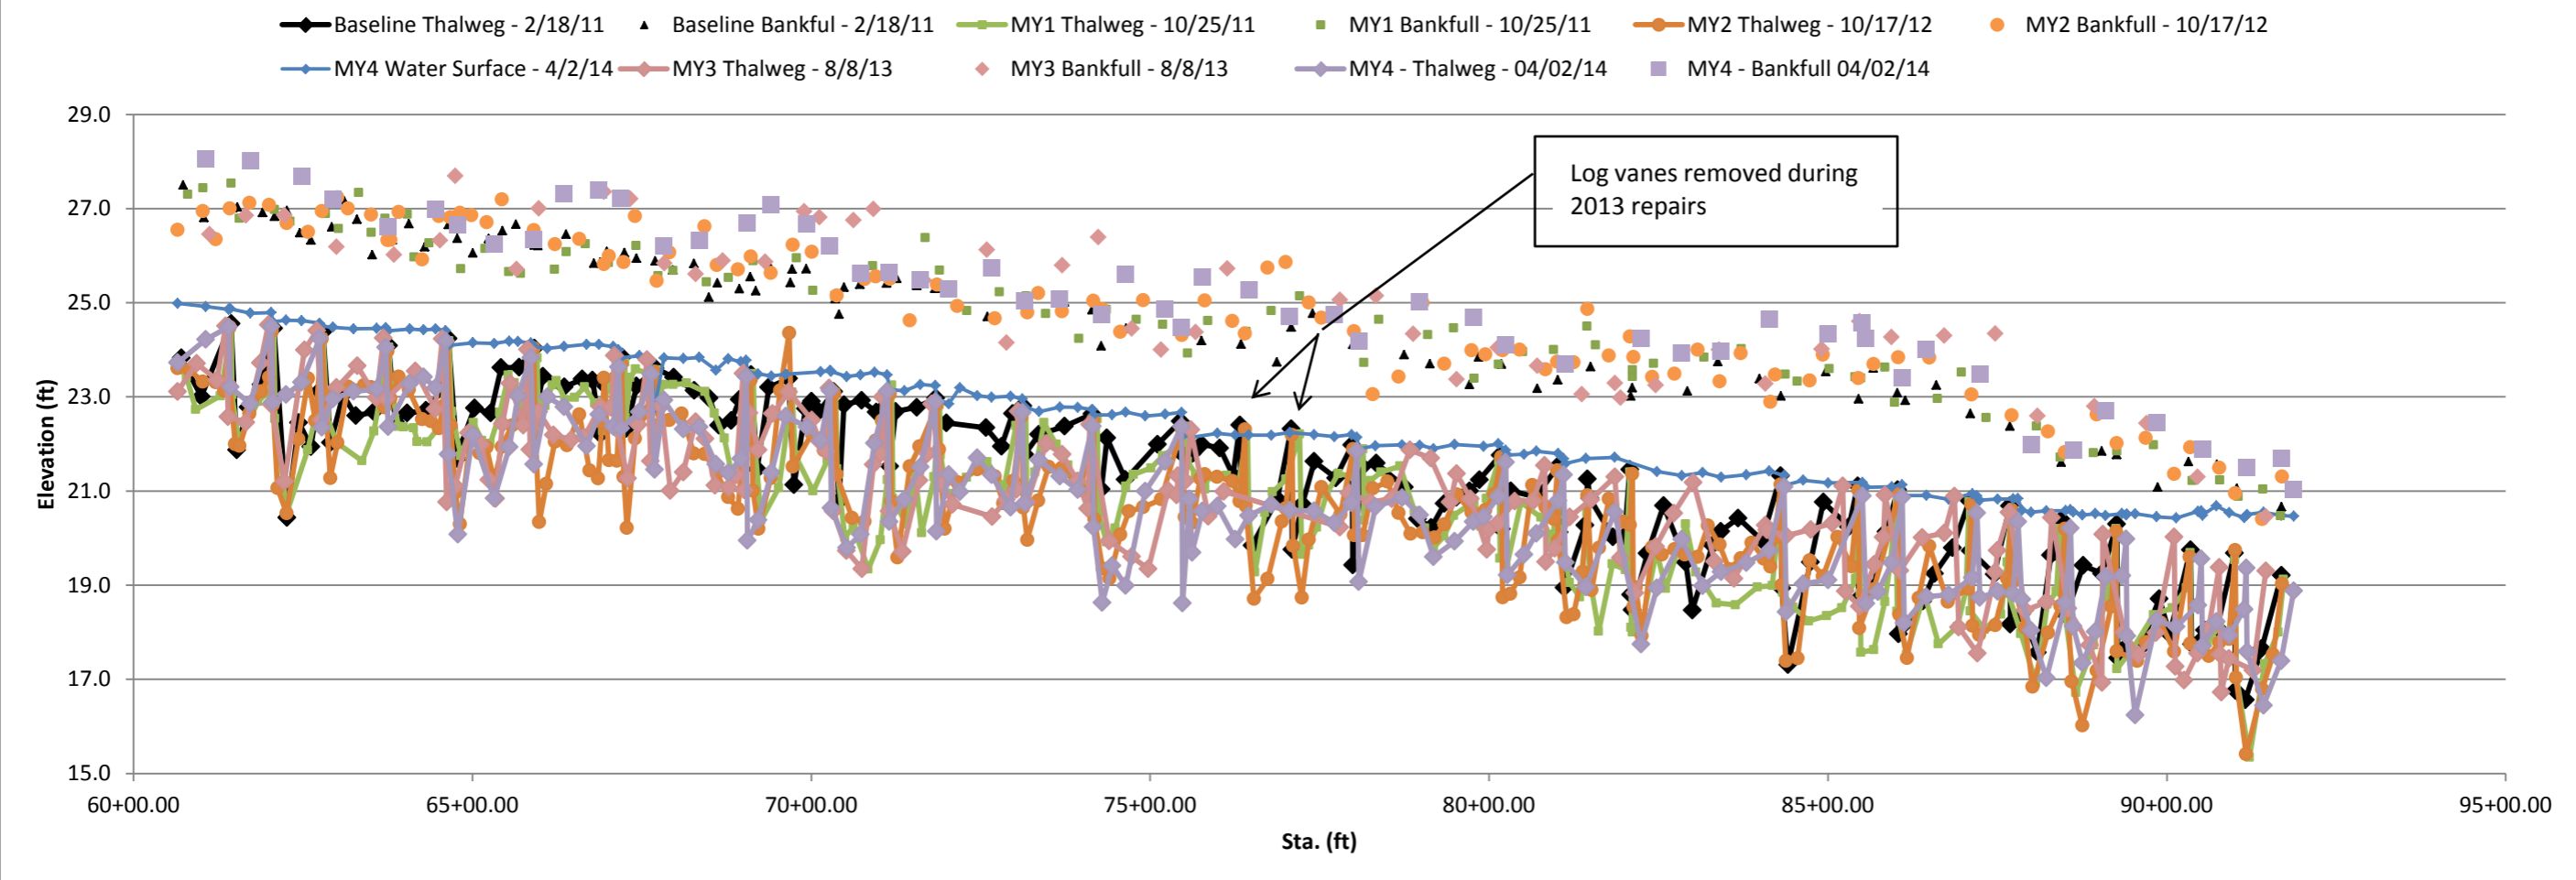
**Figure 5.2 Reach 2 (Gordon St. to Lincoln St.) - Longitudinal Profile**

Reach 2: The profile along Reach 2 provides evidence of the fluctuating nature of a sand bed system. Some pools became deeper and longer while others filled in and shortened. In general, the unstable sections of Reach 2 that were documented in the Year 2 Monitoring Report were repaired as part of construction activities completed in September of 2013. The majority of the plans consisted of installed soil lifts along eroded banks, which are now shown in the CCPV. Fluctuation in channel bed features is expected to continue throughout the monitoring period, but the overall stream reach should stabilize once woody vegetation establishes along the stream banks.

The Year 2 monitoring report discussed various bank reaches that exhibited different levels of erosion. The majority of the eroded banks were repaired during the Hurricane Irene repairs that were completed in September of 2013. The eroding banks have been stabilized through bank grading with matting or with the installation of soil lifts. All repaired sections were planted with live stakes and should remain stable as long as the newly planted vegetation continues to thrive. Some moderate scour has developed behind the vane arm of the log cross vane at station 64+80 which can be seen in the cross section 6 data. However, multiple black willow trees are continuing to grow and stabilize the bank around the scour which should aid in the long term stability of the right bank. It is recommended that observation of this section continues throughout the upcoming monitoring periods to determine whether the condition necessitates repair in the future. Cross section 7 displayed changes in geometry due to the installation of soil lifts as part of the Hurricane Irene repair plan. The repaired banks have been restored to the geometry recorded in the baseline report.

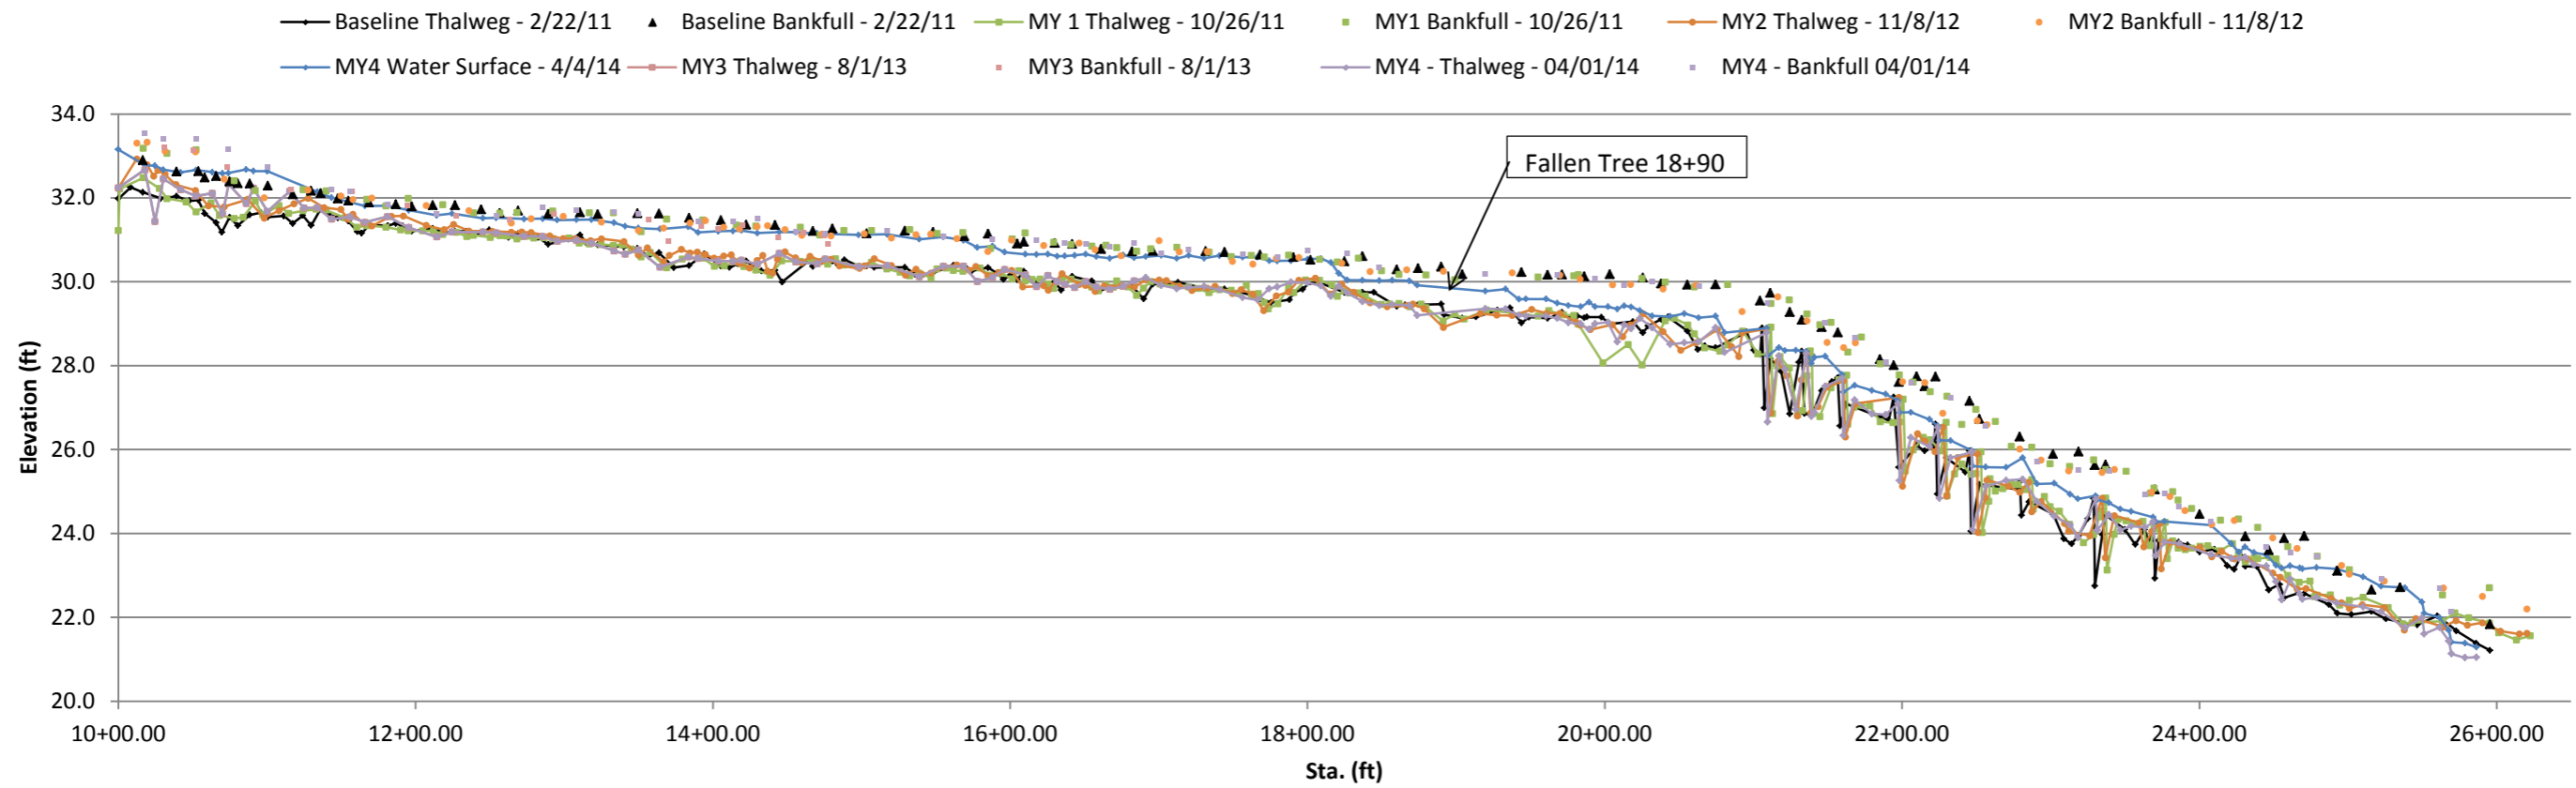
**Figure 5.3 Reach 3 (UT to Adkin Branch) - Longitudinal Profile**

Reach 3: Reach 3 experienced some minor scouring and filling of the stream bed at the upstream end of the reach. Most of the changes occur between section 10+00 and 11+75, as observed at Cross Section 13. The channel profile shows no significant changes through the majority of the reach (Station 11+75 through 21+00. Cross Sections 14, 16, and 17 do not show signs of serious erosion and have retained similar geometry to the previous monitoring year. Cross Section 15 was not surveyed due to a fallen tree over the channel.
