YEAR 5 MONITORING REPORT

ADKIN BRANCH STREAM RESTORATION PROJECT PHASE 1 – WASHINGTON AVE. TO LINCOLN ST.

Lenoir County, North Carolina
DMS IMS No. 7

Submitted: December 2015

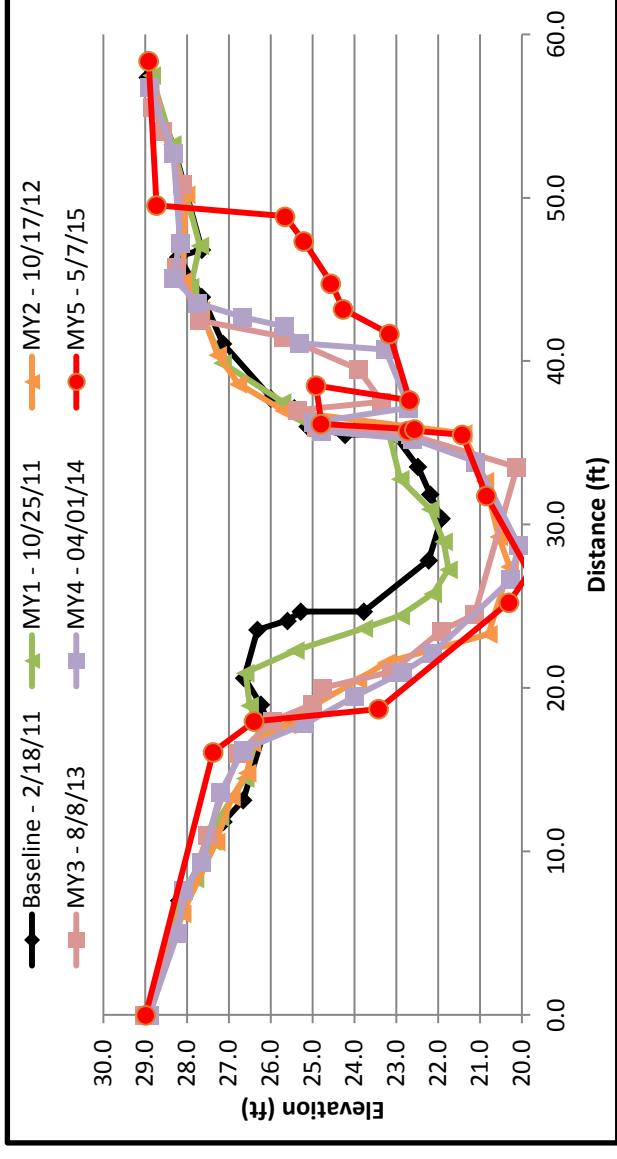
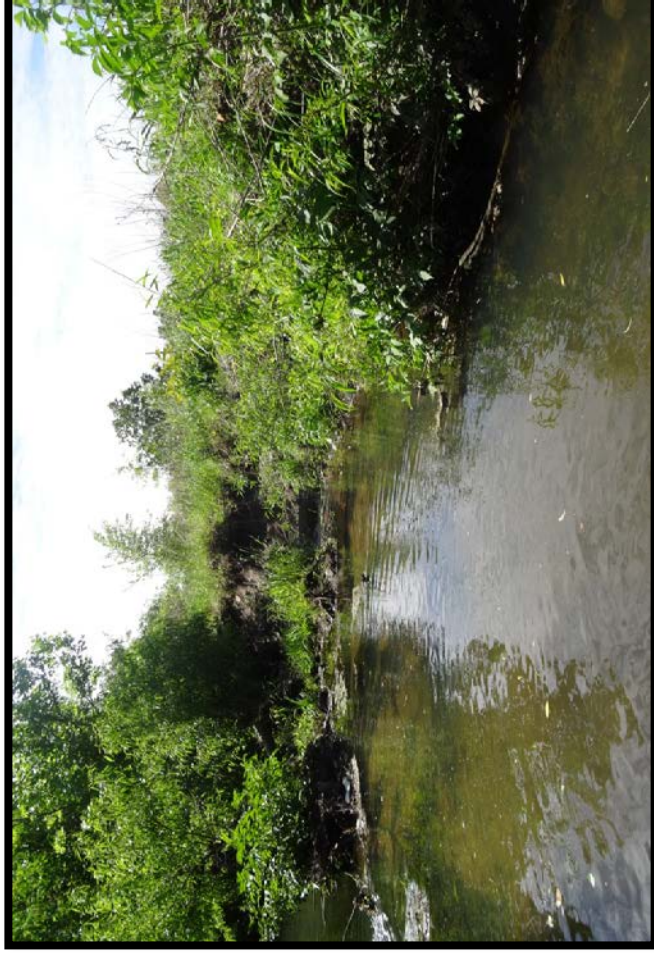
Figure 4.7 XS-7 Riffle, Sta. 70+00

The Year 2 monitoring report discussed various bank reaches that exhibited different levels of erosion. The majority of the eroded banks were repaired during the Hurricane Irene repairs that were completed in September of 2013. The eroding banks have been stabilized through bank grading with matting or with the installation of soil lifts. All repaired sections were planted with live stakes and should remain stable as long as the newly planted vegetation continues to thrive. Some moderate scour has developed behind the vane arm of the log cross vane at station 64+80 which can be seen in the Cross Section 6 data. However, multiple black willow trees are continuing to grow and stabilize the bank around the scour which should aid in the long term stability of the right bank. It is recommended that observation of this section continues throughout the upcoming monitoring periods to determine whether the condition necessitates repair in the future. Cross Section 7 displayed changes in geometry due to the installation of soil

lifts as part of the Hurricane Irene repair plan. The repaired banks have been restored to the geometry recorded in the baseline report.

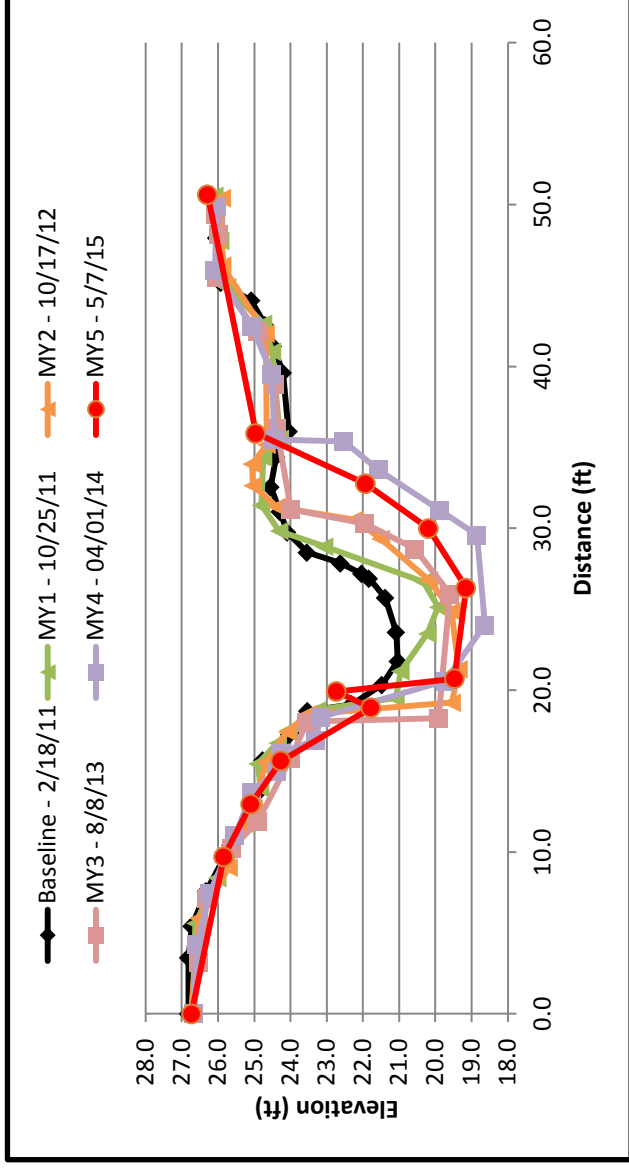
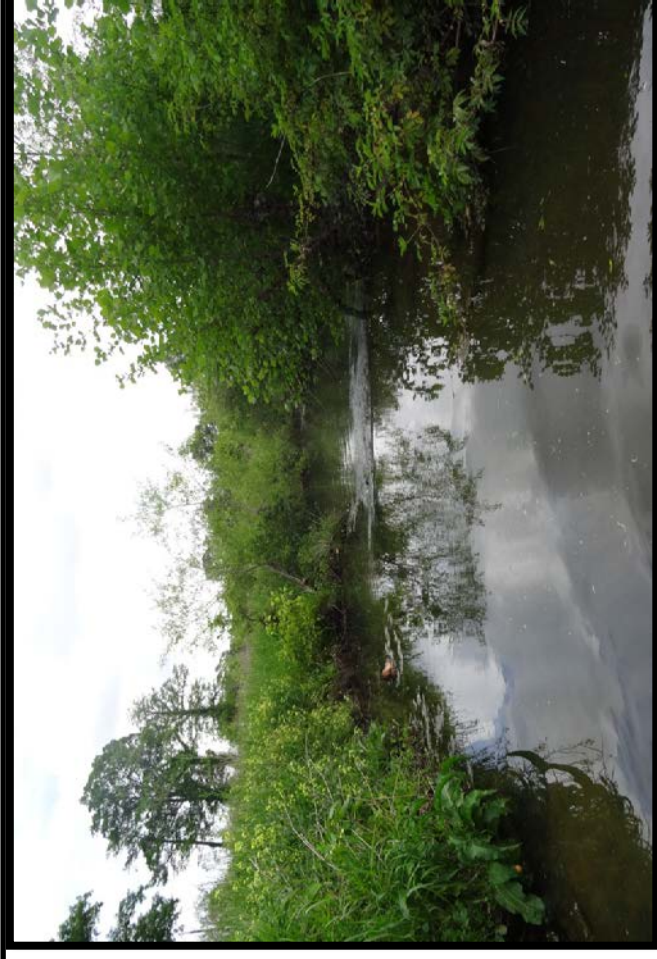
Figure 4.9 XS-9 Riffle, Sta. 75+78

Reach 2: Overall willow establishment and maturity is much weaker on Reach 2 compared to other reaches of Adkin Branch. Specifically, erosion is increasing along the right bank at approximately station 64+90 due to a lack of vegetative cover. Cross Section 6 (Station 64+81) is exhibiting increased scour along the right bank which has caused the bankfull area to increase by 38% over the previous monitoring year. Vegetation has failed to establish to the right of the log vane arm, leaving the bank prone to erosion over the monitoring period. Increases in erosion due to lack of vegetative establishment are common throughout the reach, including station 71+75 and 74+10. These areas will continue to actively erode until stabilizing vegetation established along the banks. Overall, average bankfull cross sectional area drastically increased between monitoring years three and five. The increase in bankfull area after year three is a result of the Hurricane Irene repairs that were constructed in September of 2013. These repairs changed channel geometry for three of the cross sections in Reach 2. Currently, all repaired areas are stable except for the right bank of Cross Section 9 which is experiencing active erosion due to a lack of vegetative cover.

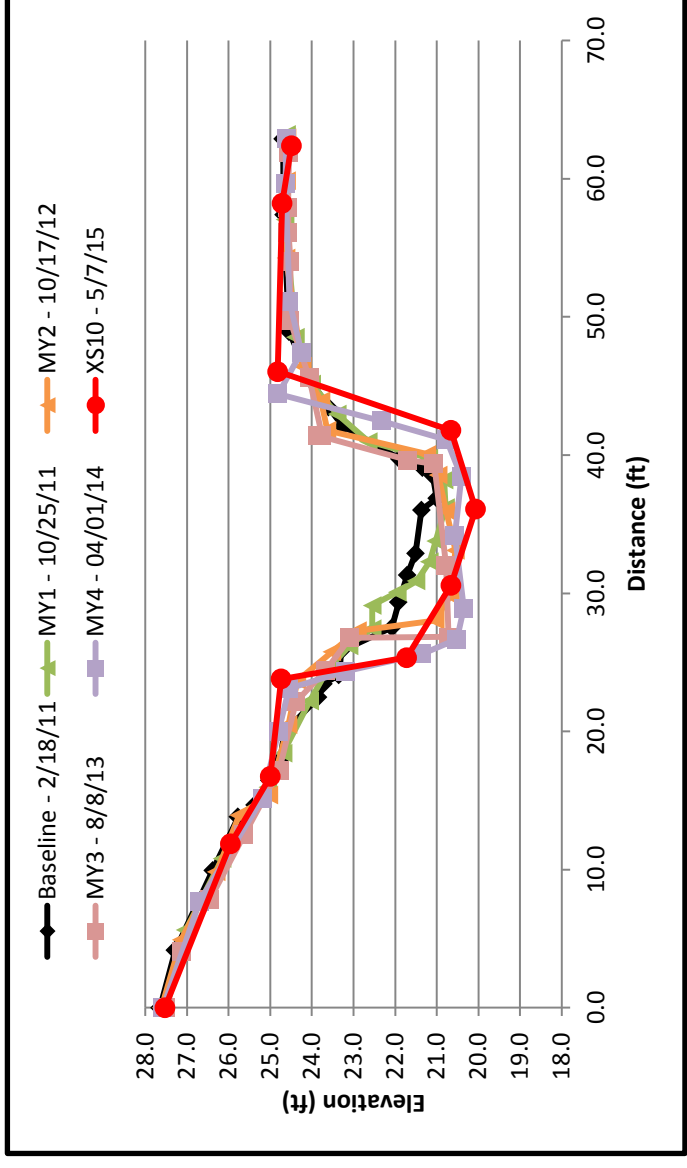
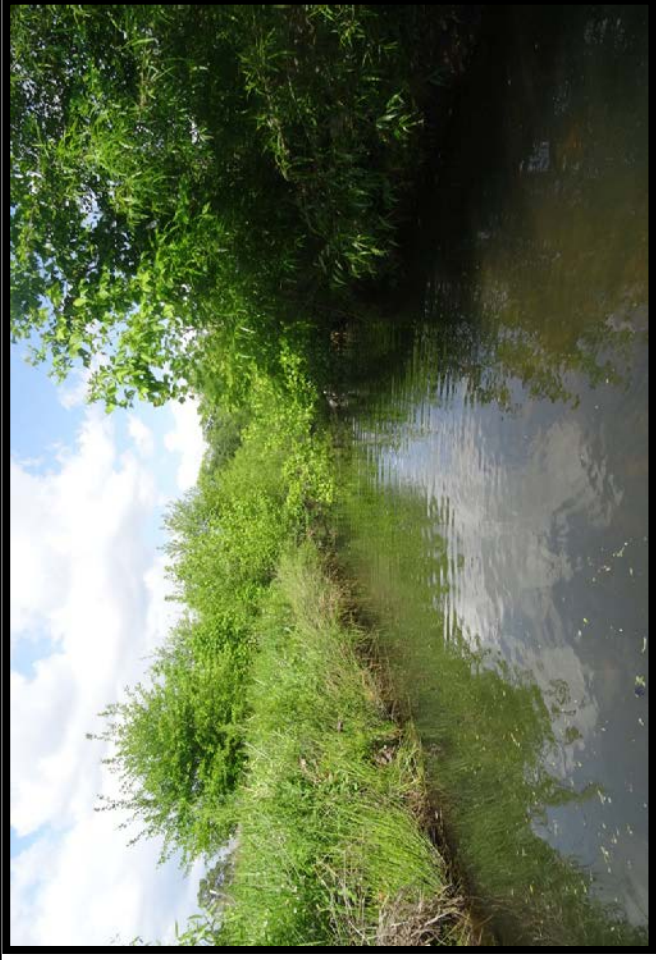
Figure 4.11 XS-11 Pool, Sta. 82+30

82+50. Cross section 11 geometry remains consistent with year 4, indicating that this portion of the channel is in stable condition.

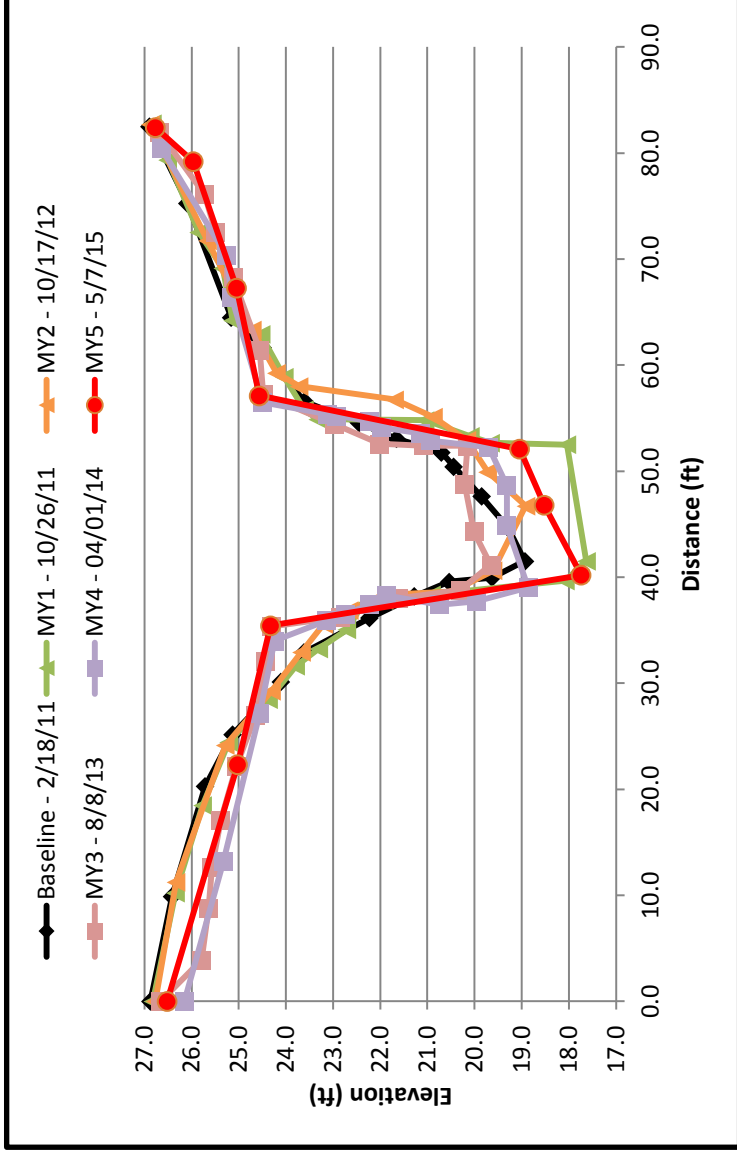
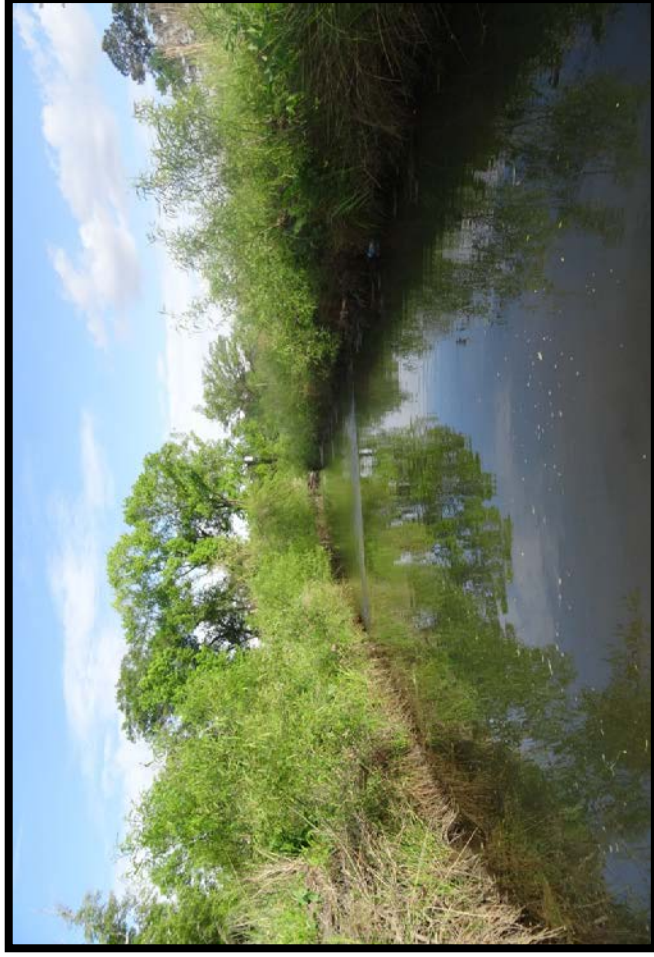
Figure 4.13 XS-13 Pool, Sta. 11+64

Reach 3: Reach 3 experienced some minor scouring and filling of the stream bed at the upstream end of the reach. Most of the changes occur between section 10+00 and 11+75, as observed at Cross Section 13. The channel profile shows no significant changes through the majority of the reach (Station 11+75 through 21+00). Cross Sections 14, 16, and 17 do not show signs of serious erosion and have retained similar geometry to the previous monitoring year. Cross Section 15 was not surveyed due to a fallen tree over the channel.

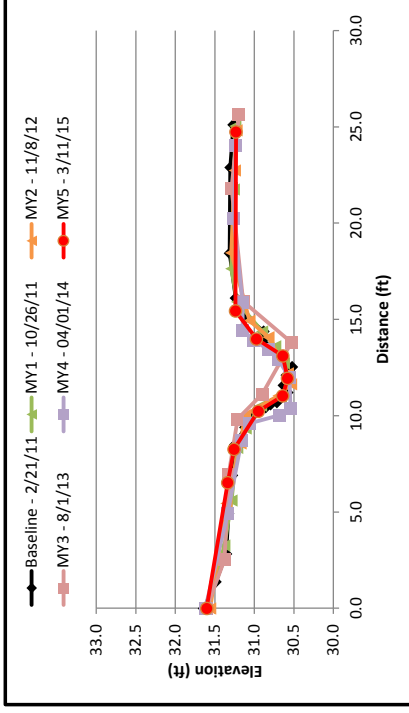
Figure 4.15 XS-15 Riffle, Sta. 19+28

Baseline	MY1		MY2		MY3		MY4		MY5	
	Sta.	Elev.	Sta.	Elev.	Sta.	Elev.	Sta.	Elev.	Sta.	Elev.
0.00	30.66	No Data - Fallen Tree over Channel								
3.30	30.56	No Data - Fallen Tree over Channel
