**MONITORING YEAR 1
ANNUAL REPORT**
Final

AGONY ACRES MITIGATION SITE

Guilford County, NC

NCDMS Project Number 95716

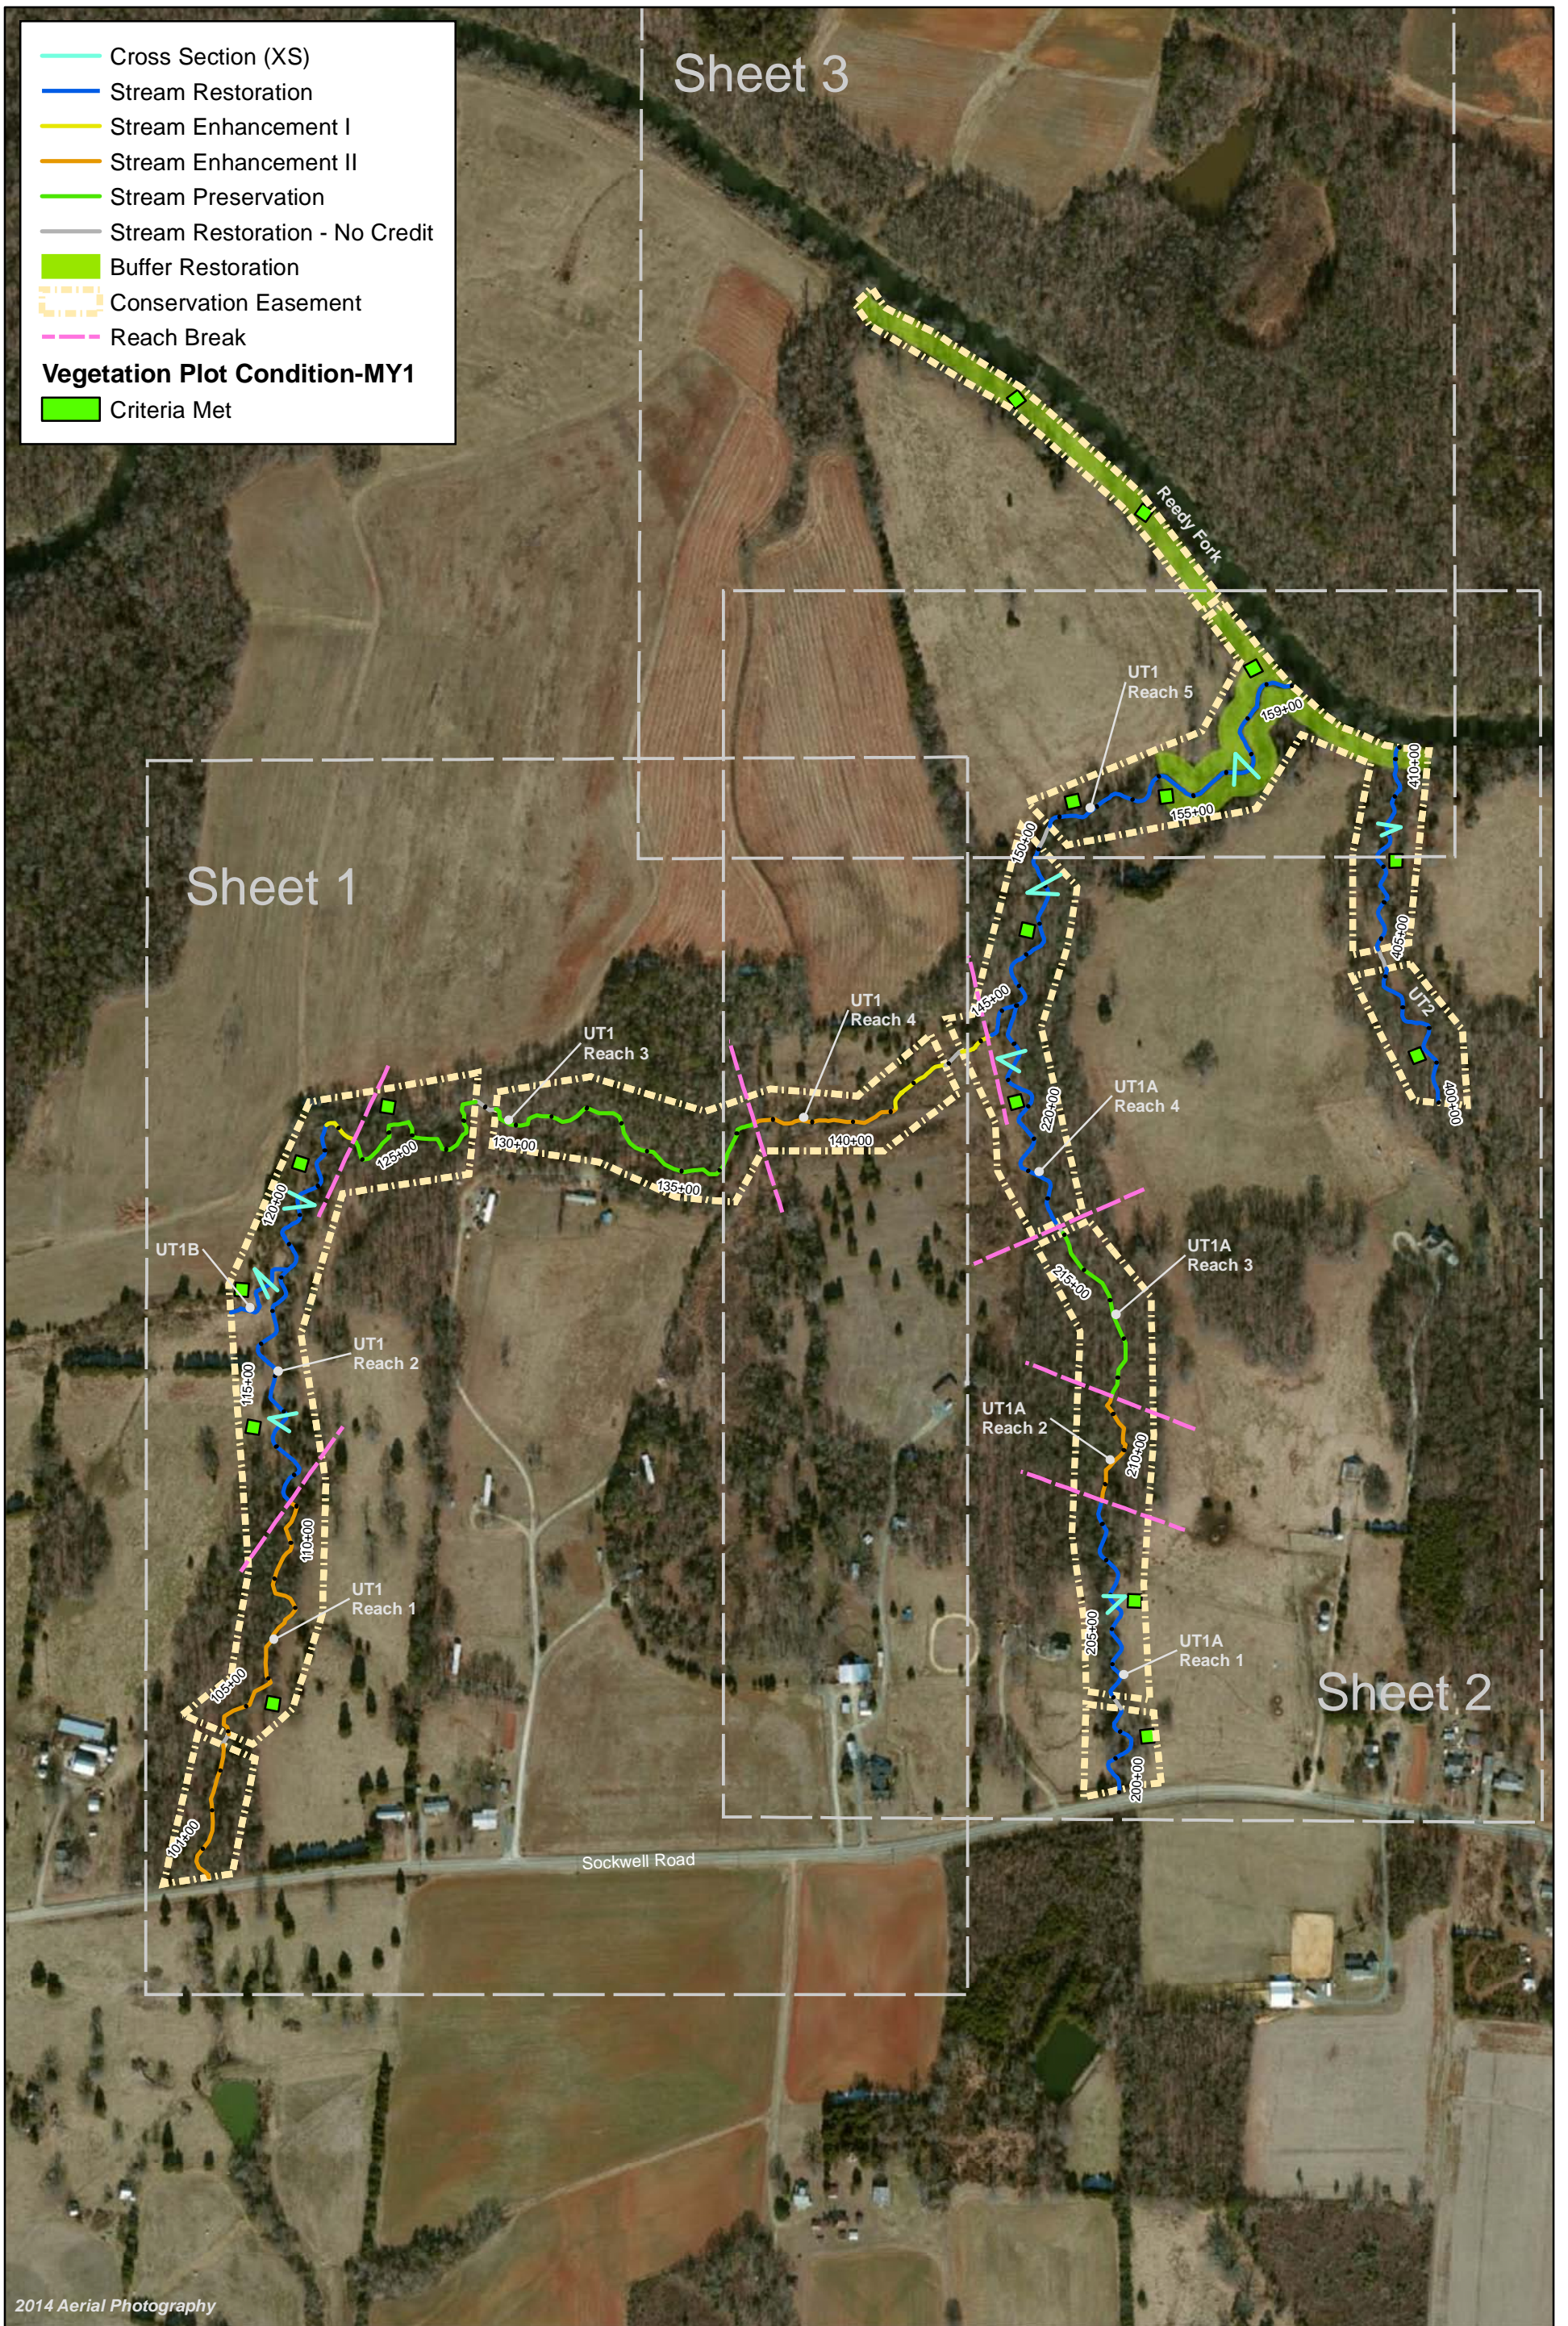
Figure 3.0 Integrated Current Condition Plan View (Key)

Morphological surveys for the MY1 were conducted in May 2015. All streams within the Site are stable with little to no erosion and have met the success criteria for MY1. Please refer to Appendix 2 for the visual assessment table, Integrated Current Condition Plan View, and reference photographs. Refer to Appendix 4 for the morphological data and plots.

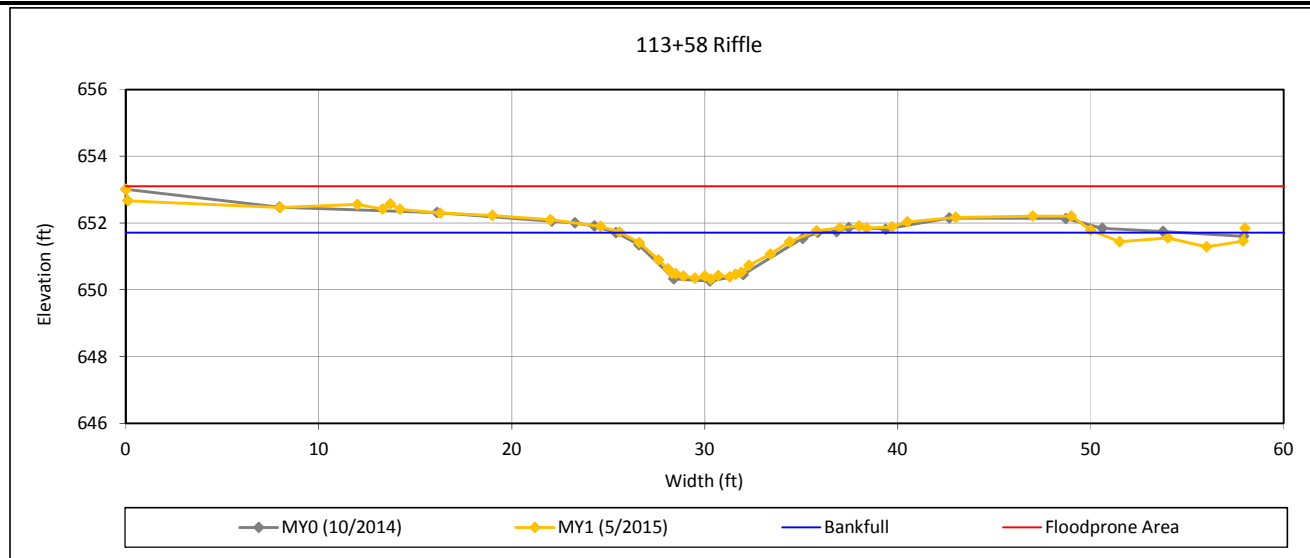
Cross Section 1-UT1 Reach 2

8.0	x-section area (ft.sq.)
9.9	width (ft)
0.8	mean depth (ft)
1.4	max depth (ft)
10.4	wetted parimeter (ft)
0.8	hyd radi (ft)
12.2	width-depth ratio
100.0	W flood prone area (ft)
10.1	entrenchment ratio
1.0	low bank height ratio

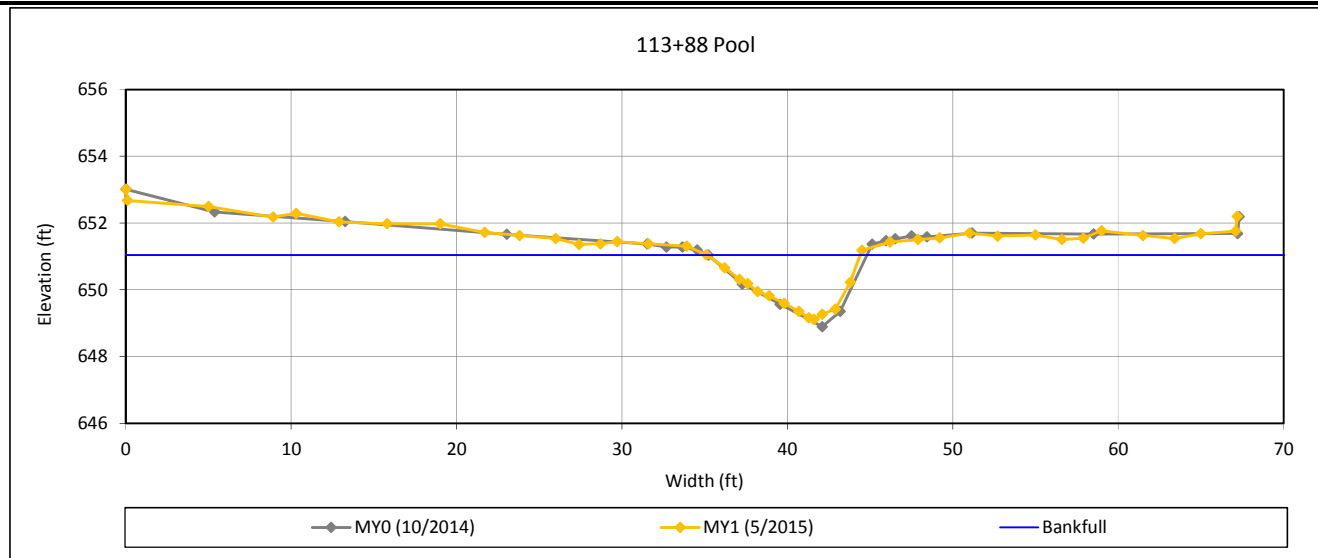
Cross Section 2-UT1 Reach 2

10.4	x-section area (ft.sq.)
9.3	width (ft)
1.1	mean depth (ft)
1.9	max depth (ft)
10.3	wetted parimeter (ft)
1.0	hyd radi (ft)
8.3	width-depth ratio

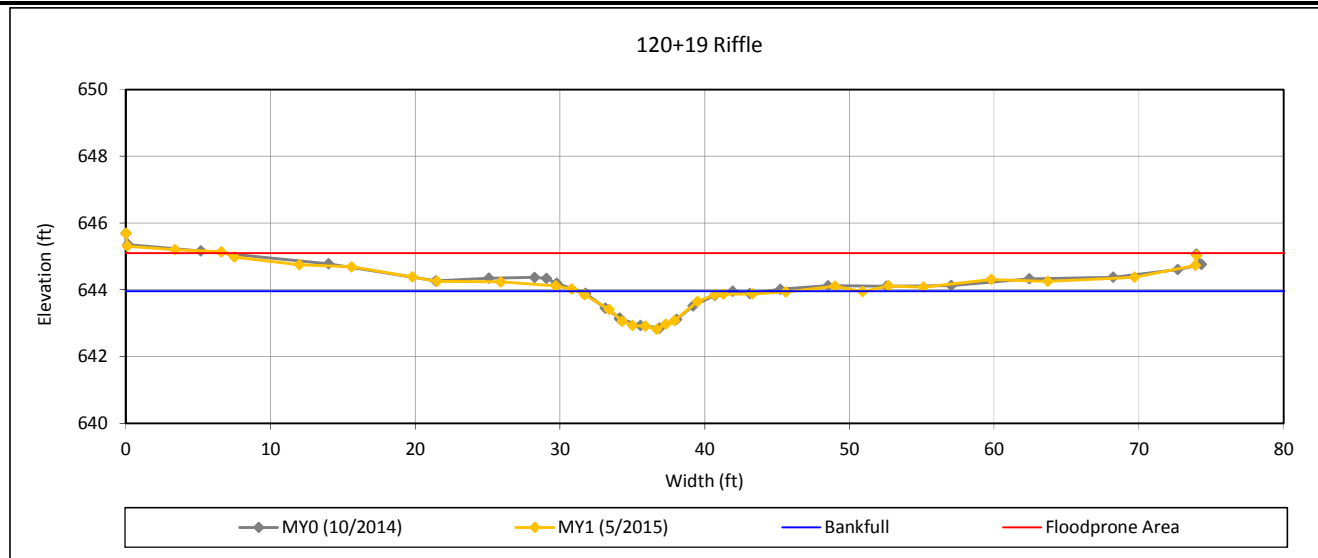
Cross Section 3-UT1 Reach 2

6.2	x-section area (ft.sq.)
10.2	width (ft)
0.6	mean depth (ft)
1.1	max depth (ft)
10.5	wetted parimeter (ft)
0.6	hyd radi (ft)
16.7	width-depth ratio
60.0	W flood prone area (ft)
5.9	entrenchment ratio
1.0	low bank height ratio

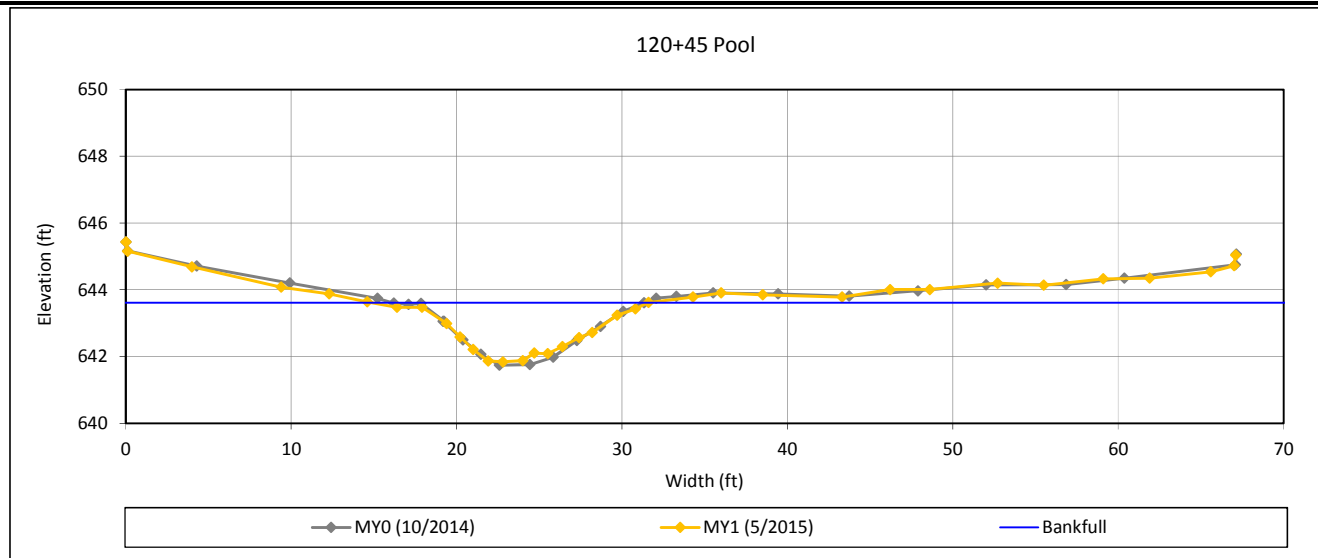
Cross Section 4-UT1 Reach 2

14.2	x-section area (ft.sq.)
13.7	width (ft)
1.0	mean depth (ft)
1.8	max depth (ft)
14.2	wetted parimeter (ft)
1.0	hyd radi (ft)
13.2	width-depth ratio

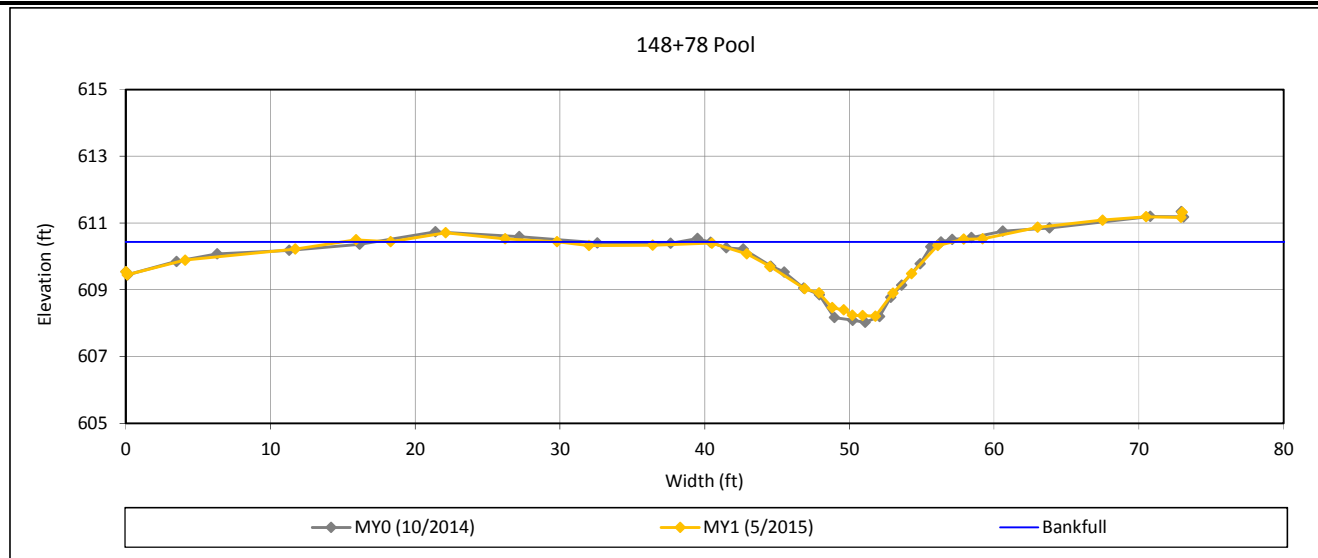
Cross Section 5-UT1 Reach 5

18.1	x-section area (ft.sq.)
16.5	width (ft)
1.1	mean depth (ft)
2.2	max depth (ft)
17.3	wetted parimeter (ft)
1.0	hyd radi (ft)
15.1	width-depth ratio

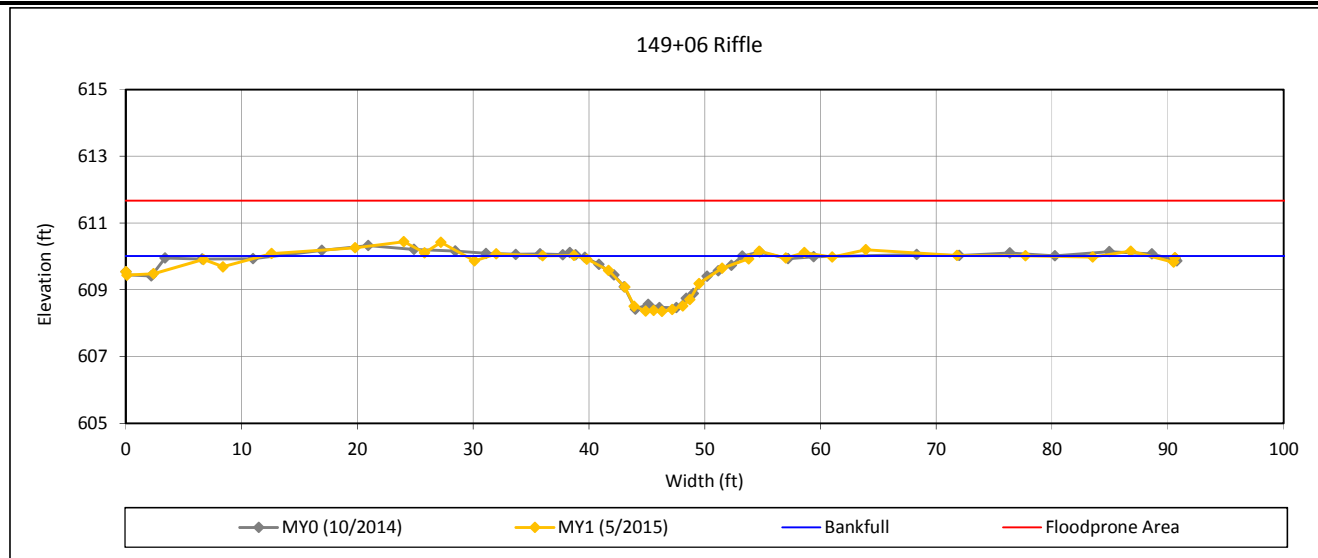
Cross Section 6-UT1 Reach 5

12.6	x-section area (ft.sq.)
15.2	width (ft)
0.8	mean depth (ft)
1.7	max depth (ft)
15.8	wetted parimeter (ft)
0.8	hyd radi (ft)
18.4	width-depth ratio
200.0	W flood prone area (ft)
13.1	entrenchment ratio
1.0	low bank height ratio

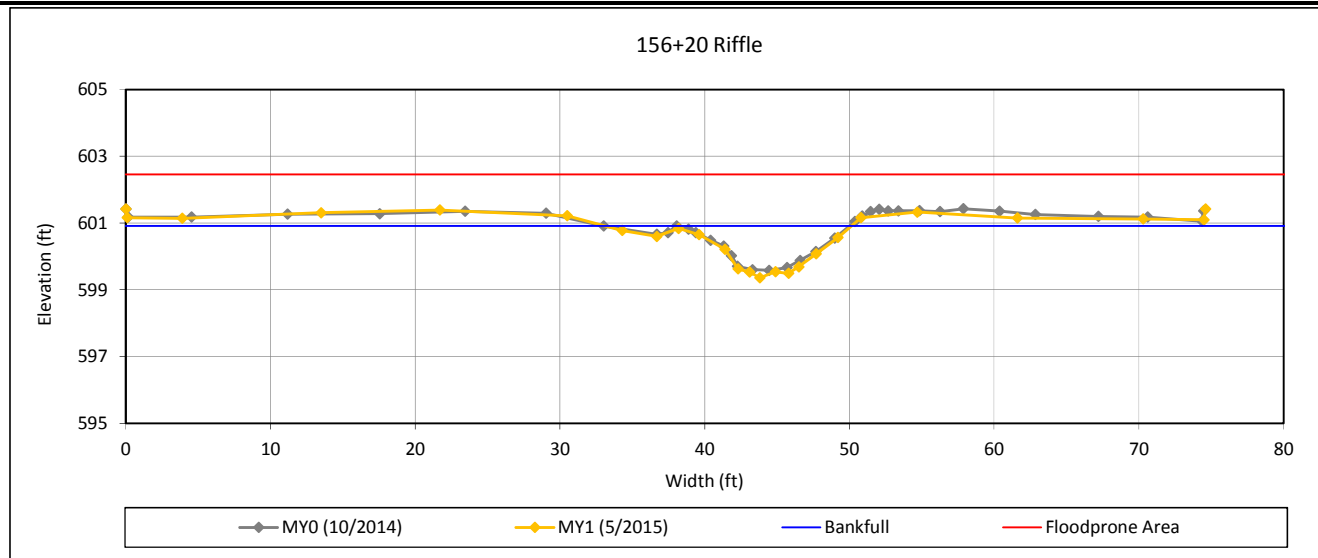
Cross Section 7-UT1 Reach 5

10.1	x-section area (ft.sq.)
11.9	width (ft)
0.8	mean depth (ft)
1.5	max depth (ft)
12.4	wetted perimeter (ft)
0.8	hyd radi (ft)
14.0	width-depth ratio
200.0	W flood prone area (ft)
16.8	entrenchment ratio
1.0	low bank height ratio

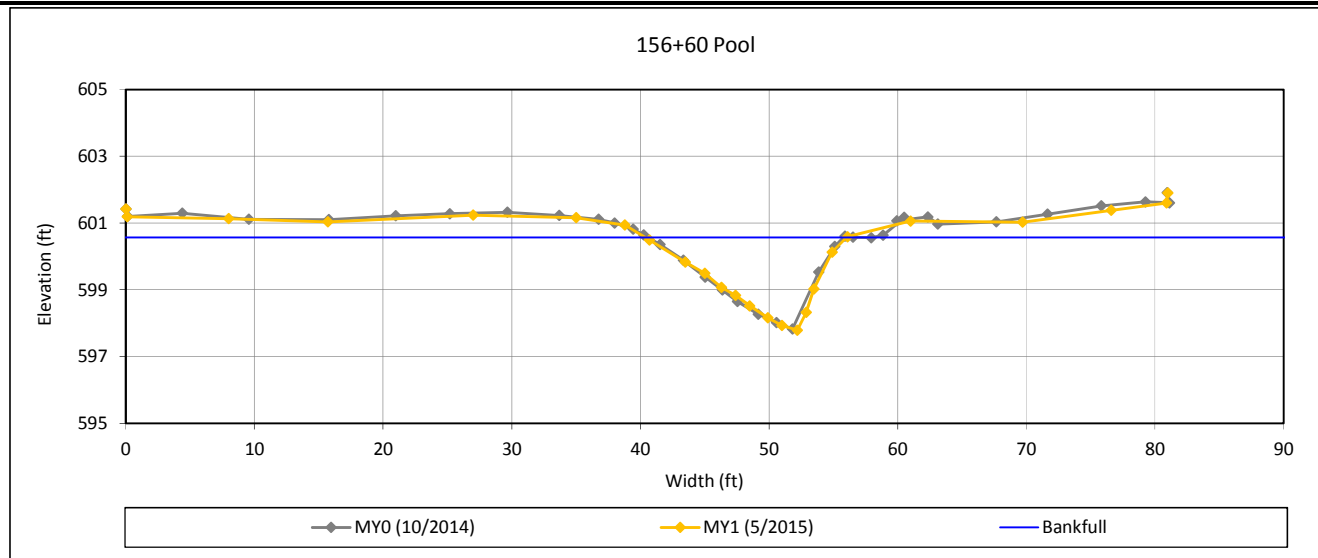
Cross Section 8-UT1 Reach 5

21.8	x-section area (ft.sq.)
15.7	width (ft)
1.4	mean depth (ft)
2.8	max depth (ft)
17.0	wetted perimeter (ft)
1.3	hyd radi (ft)
11.3	width-depth ratio

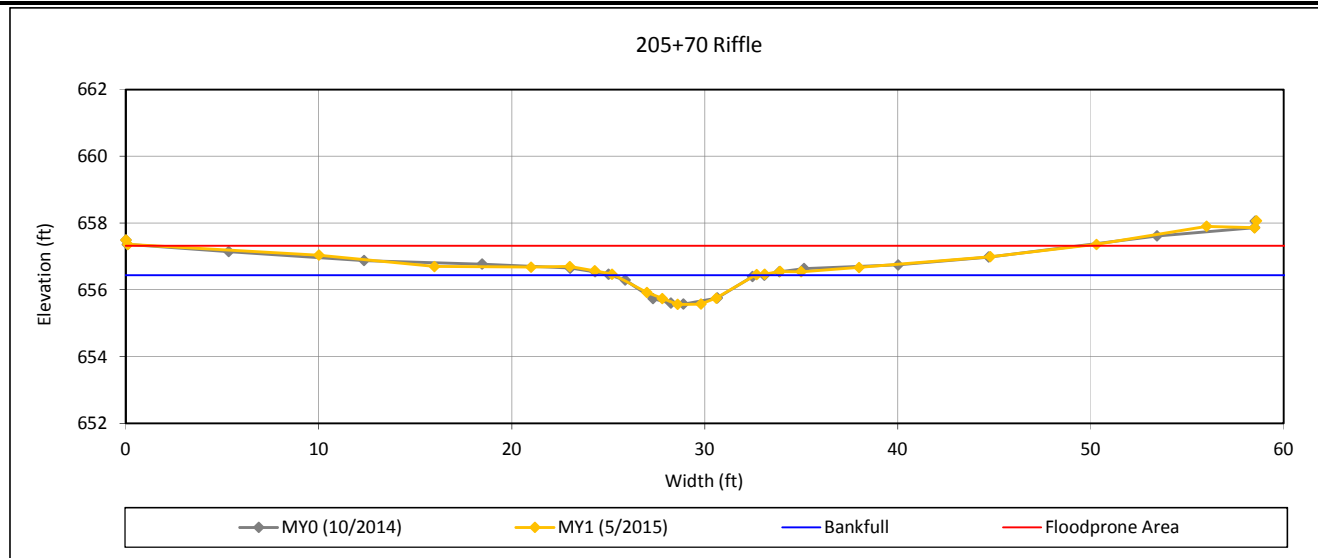
Cross Section 9-UT1A Reach 1

3.9	x-section area (ft.sq.)
7.3	width (ft)
0.5	mean depth (ft)
0.9	max depth (ft)
7.6	wetted parimeter (ft)
0.5	hyd radi (ft)
13.7	width-depth ratio
50.0	W flood prone area (ft)
6.8	entrenchment ratio
1.0	low bank height ratio

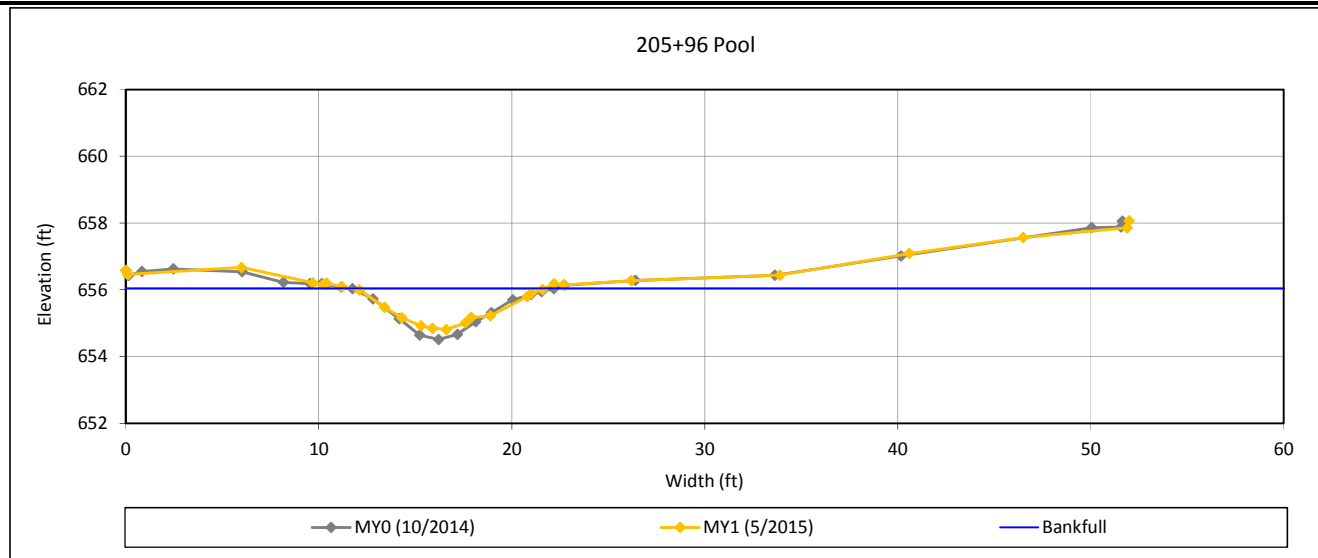
Cross Section 10-UT1A Reach 1

7.0	x-section area (ft.sq.)
10.0	width (ft)
0.7	mean depth (ft)
1.2	max depth (ft)
10.4	wetted parimeter (ft)
0.7	hyd radi (ft)
14.4	width-depth ratio

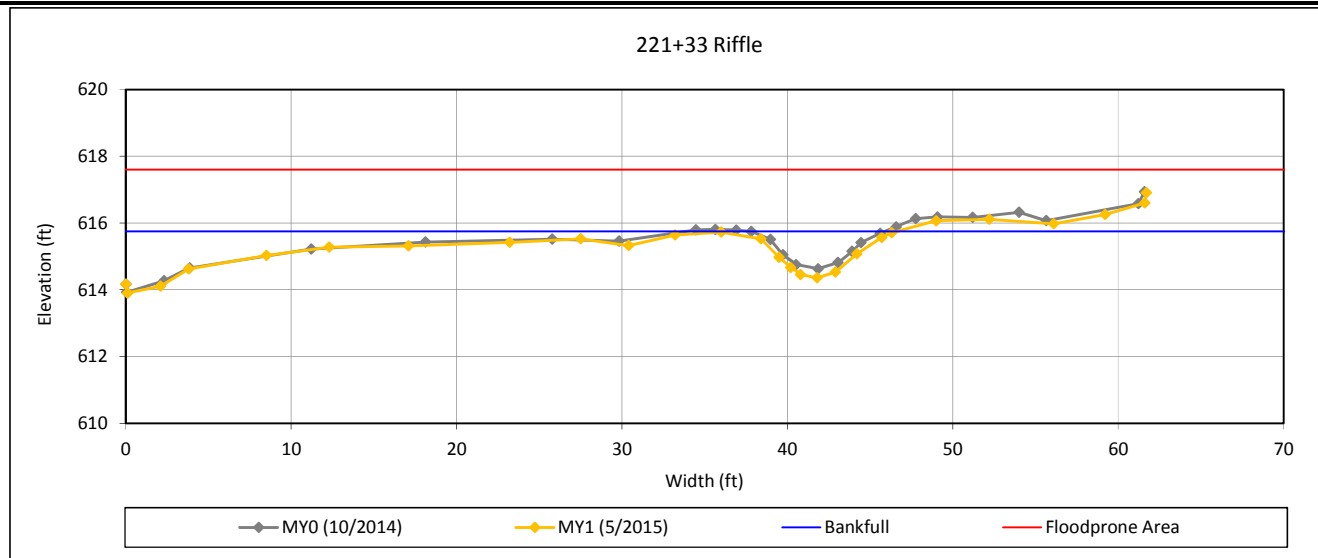
Cross Section 11-UT1A Reach 4

6.6	x-section area (ft.sq.)
8.2	width (ft)
0.8	mean depth (ft)
1.9	max depth (ft)
8.7	wetted parimeter (ft)
0.8	hyd radi (ft)
10.1	width-depth ratio
200.0	W flood prone area (ft)
24.4	entrenchment ratio
1.0	low bank height ratio

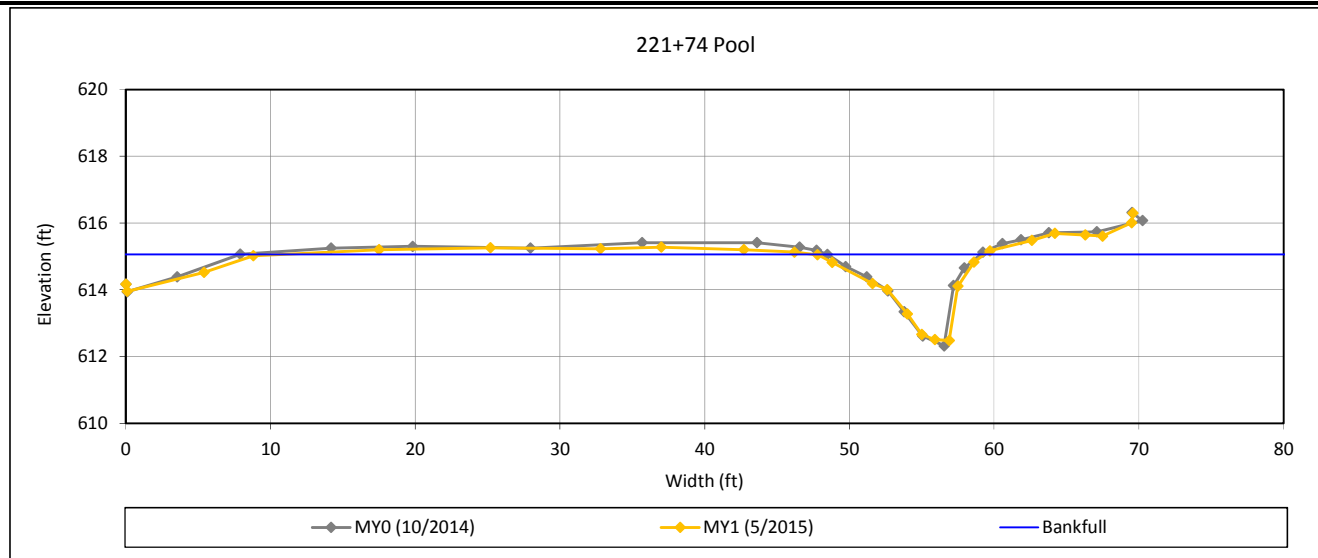
Cross Section 12-UT1A Reach 4

13.2	x-section area (ft.sq.)
10.5	width (ft)
1.2	mean depth (ft)
2.6	max depth (ft)
12.4	wetted parimeter (ft)
1.1	hyd radi (ft)
8.4	width-depth ratio

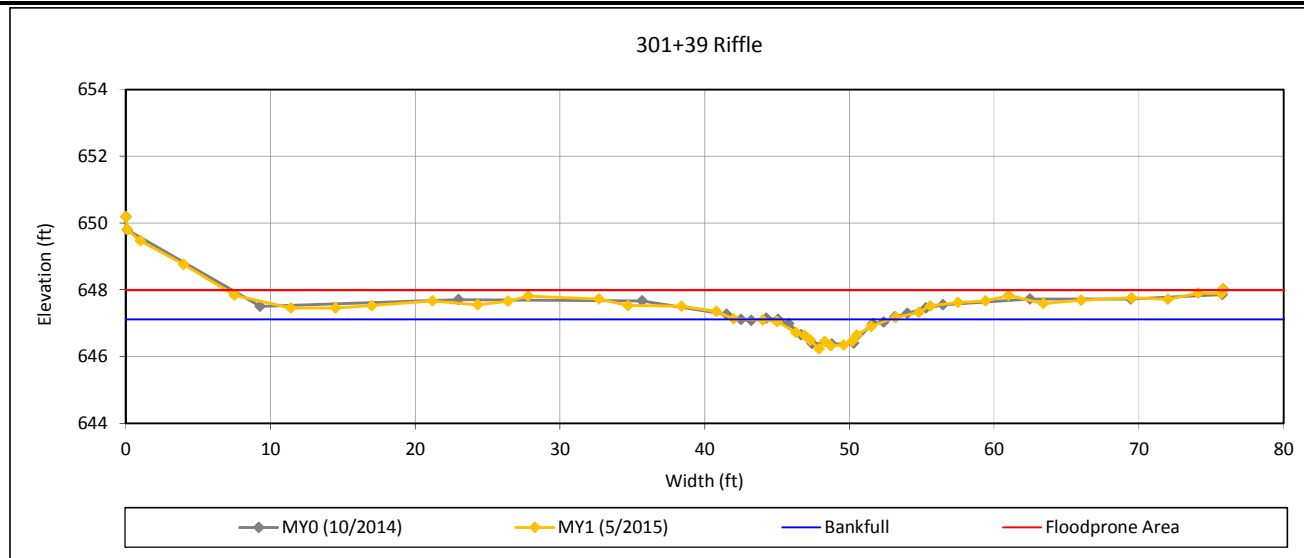
Cross Section 13-UT1B

3.6	x-section area (ft.sq.)
7.8	width (ft)
0.5	mean depth (ft)
0.9	max depth (ft)
8.1	wetted parimeter (ft)
0.4	hyd radi (ft)
16.9	width-depth ratio
70.0	W flood prone area (ft)
9.0	entrenchment ratio
1.0	low bank height ratio

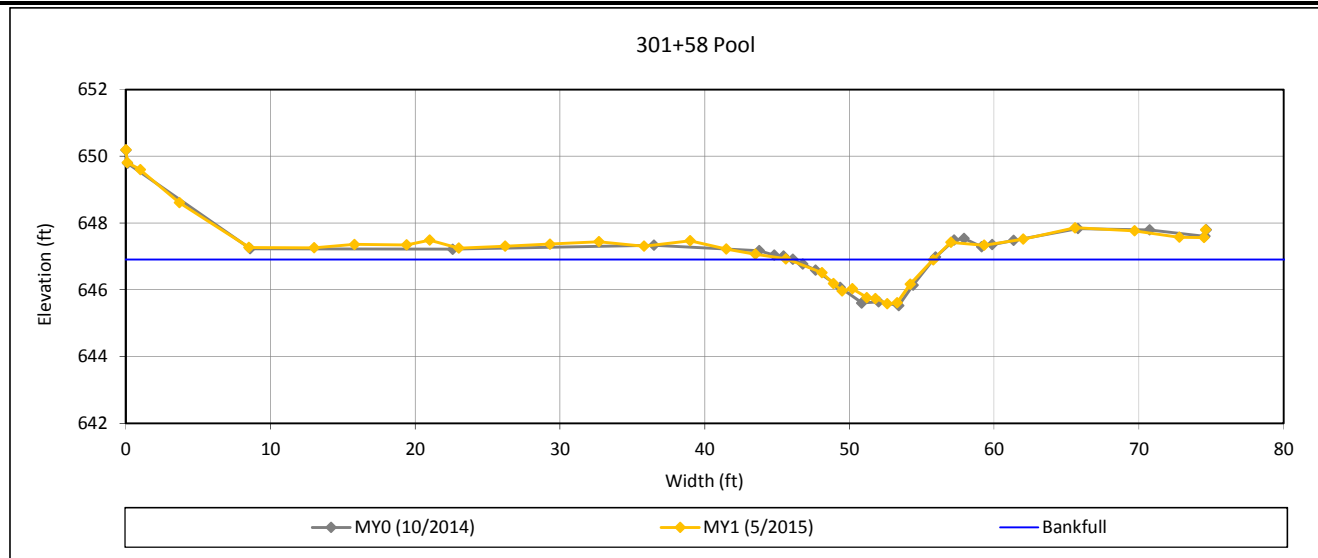
Cross Section 14-UT1B

7.2	x-section area (ft.sq.)
10.1	width (ft)
0.7	mean depth (ft)
1.3	max depth (ft)
10.6	wetted parimeter (ft)
0.7	hyd radi (ft)
14.2	width-depth ratio

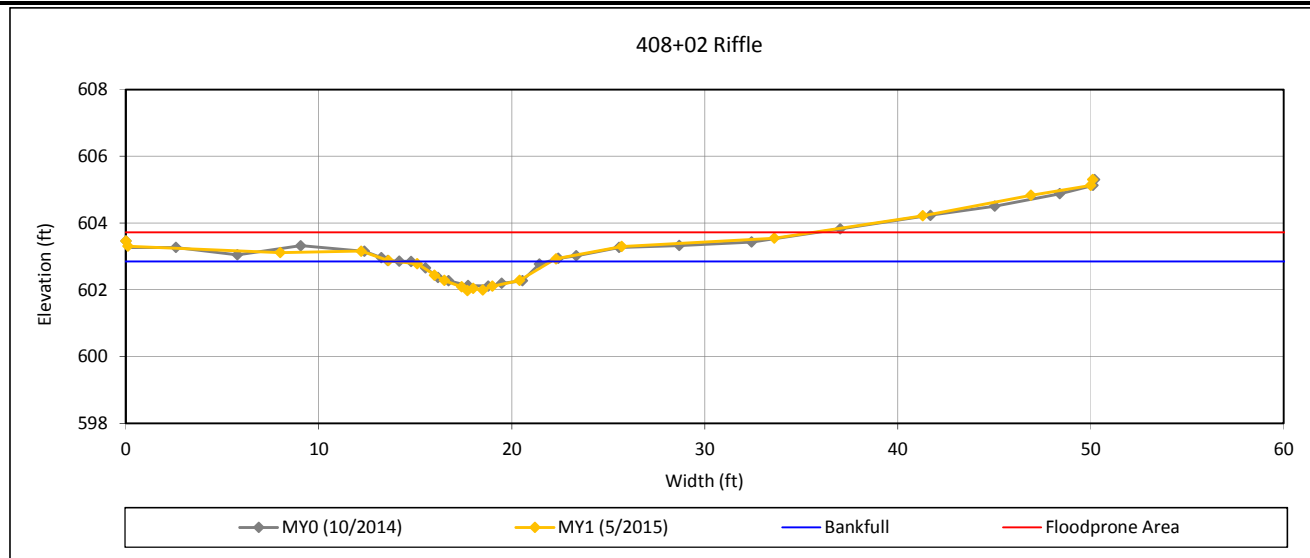
Cross Section 15-UT2

3.8	x-section area (ft.sq.)
7.0	width (ft)
0.5	mean depth (ft)
0.9	max depth (ft)
7.2	wetted parimeter (ft)
0.5	hyd radi (ft)
12.9	width-depth ratio
50.0	W flood prone area (ft)
7.2	entrenchment ratio
1.0	low bank height ratio

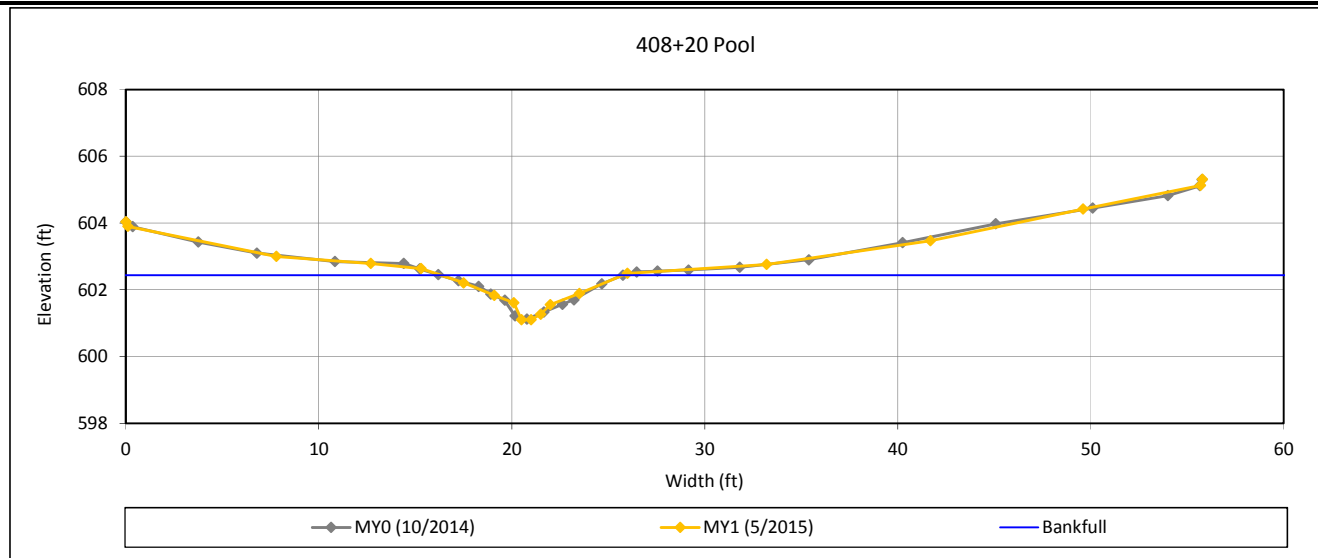
Cross Section 16-UT2

5.5	x-section area (ft.sq.)
9.5	width (ft)
0.6	mean depth (ft)
1.3	max depth (ft)
10.0	wetted parimeter (ft)
0.5	hyd radi (ft)
16.3	width-depth ratio
