MONITORING YEAR 2 ANNUAL REPORT

AGONY ACRES MITIGATION SITE

Guilford County, NC
NCDEQ Contract 004949
DMS Project Number 95716

Data Collection Period: January 2016 – August 2016
Draft Submission Date: September 26, 2016
Final Submission Date: October 19, 2016

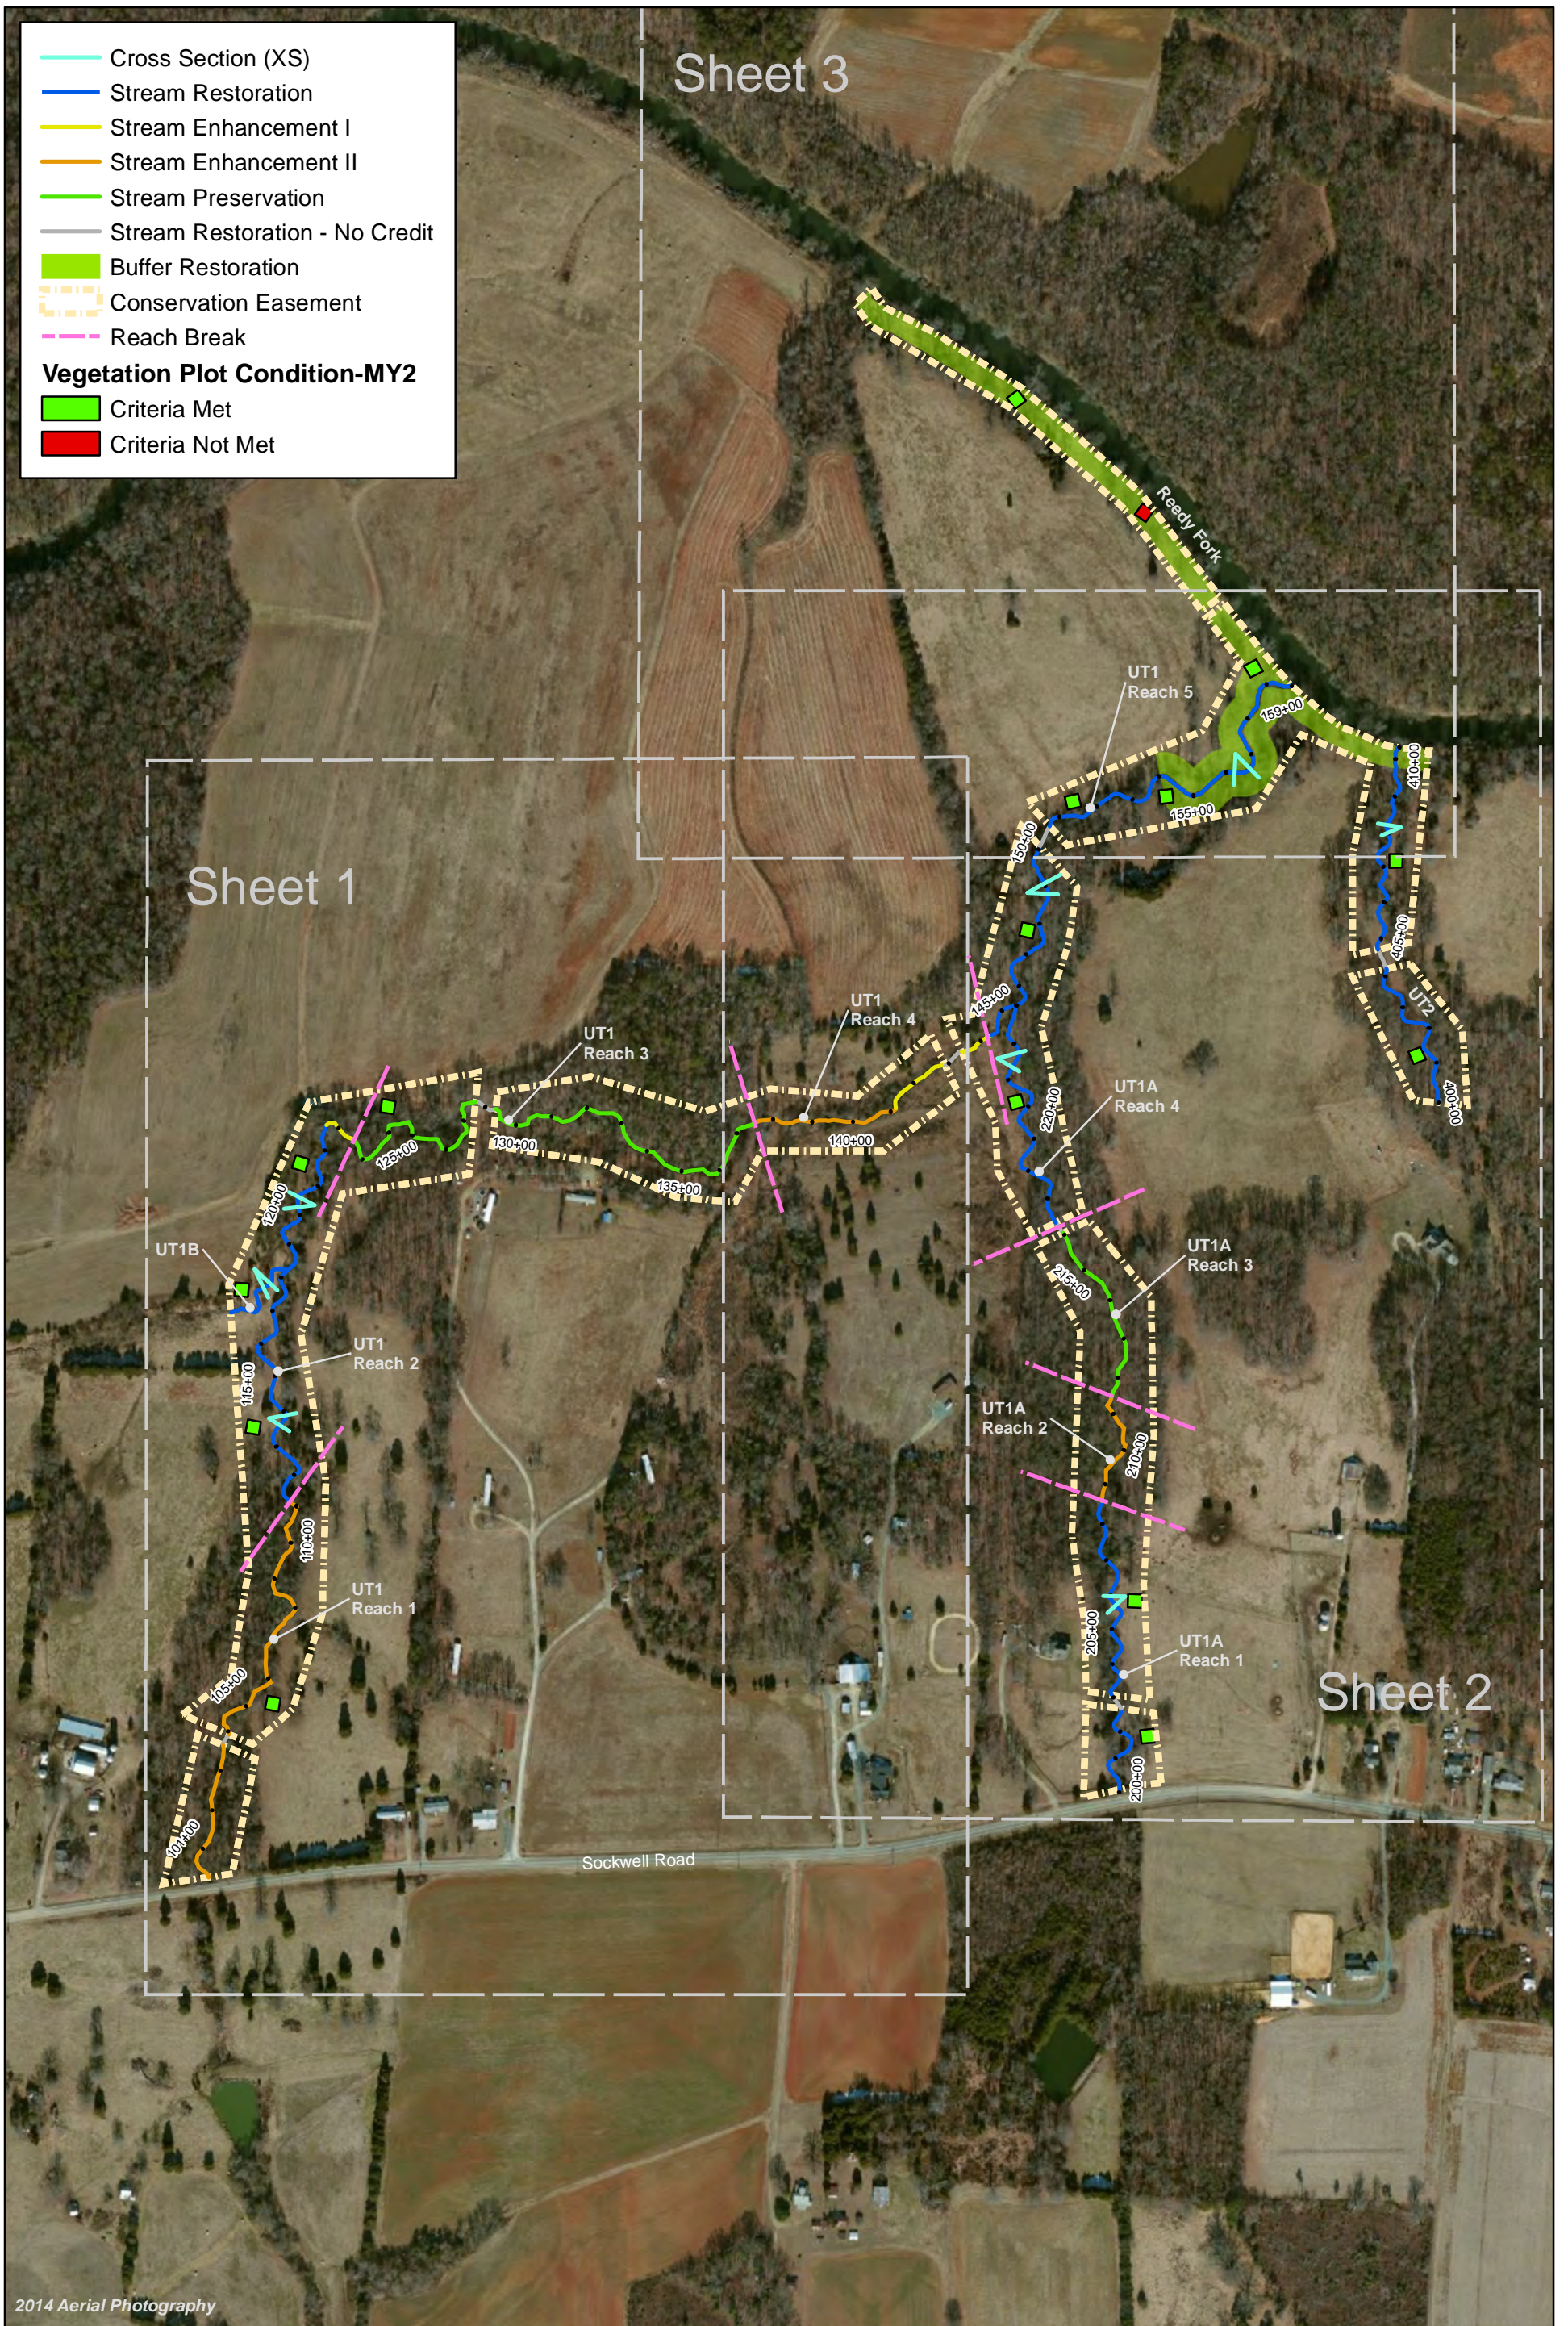
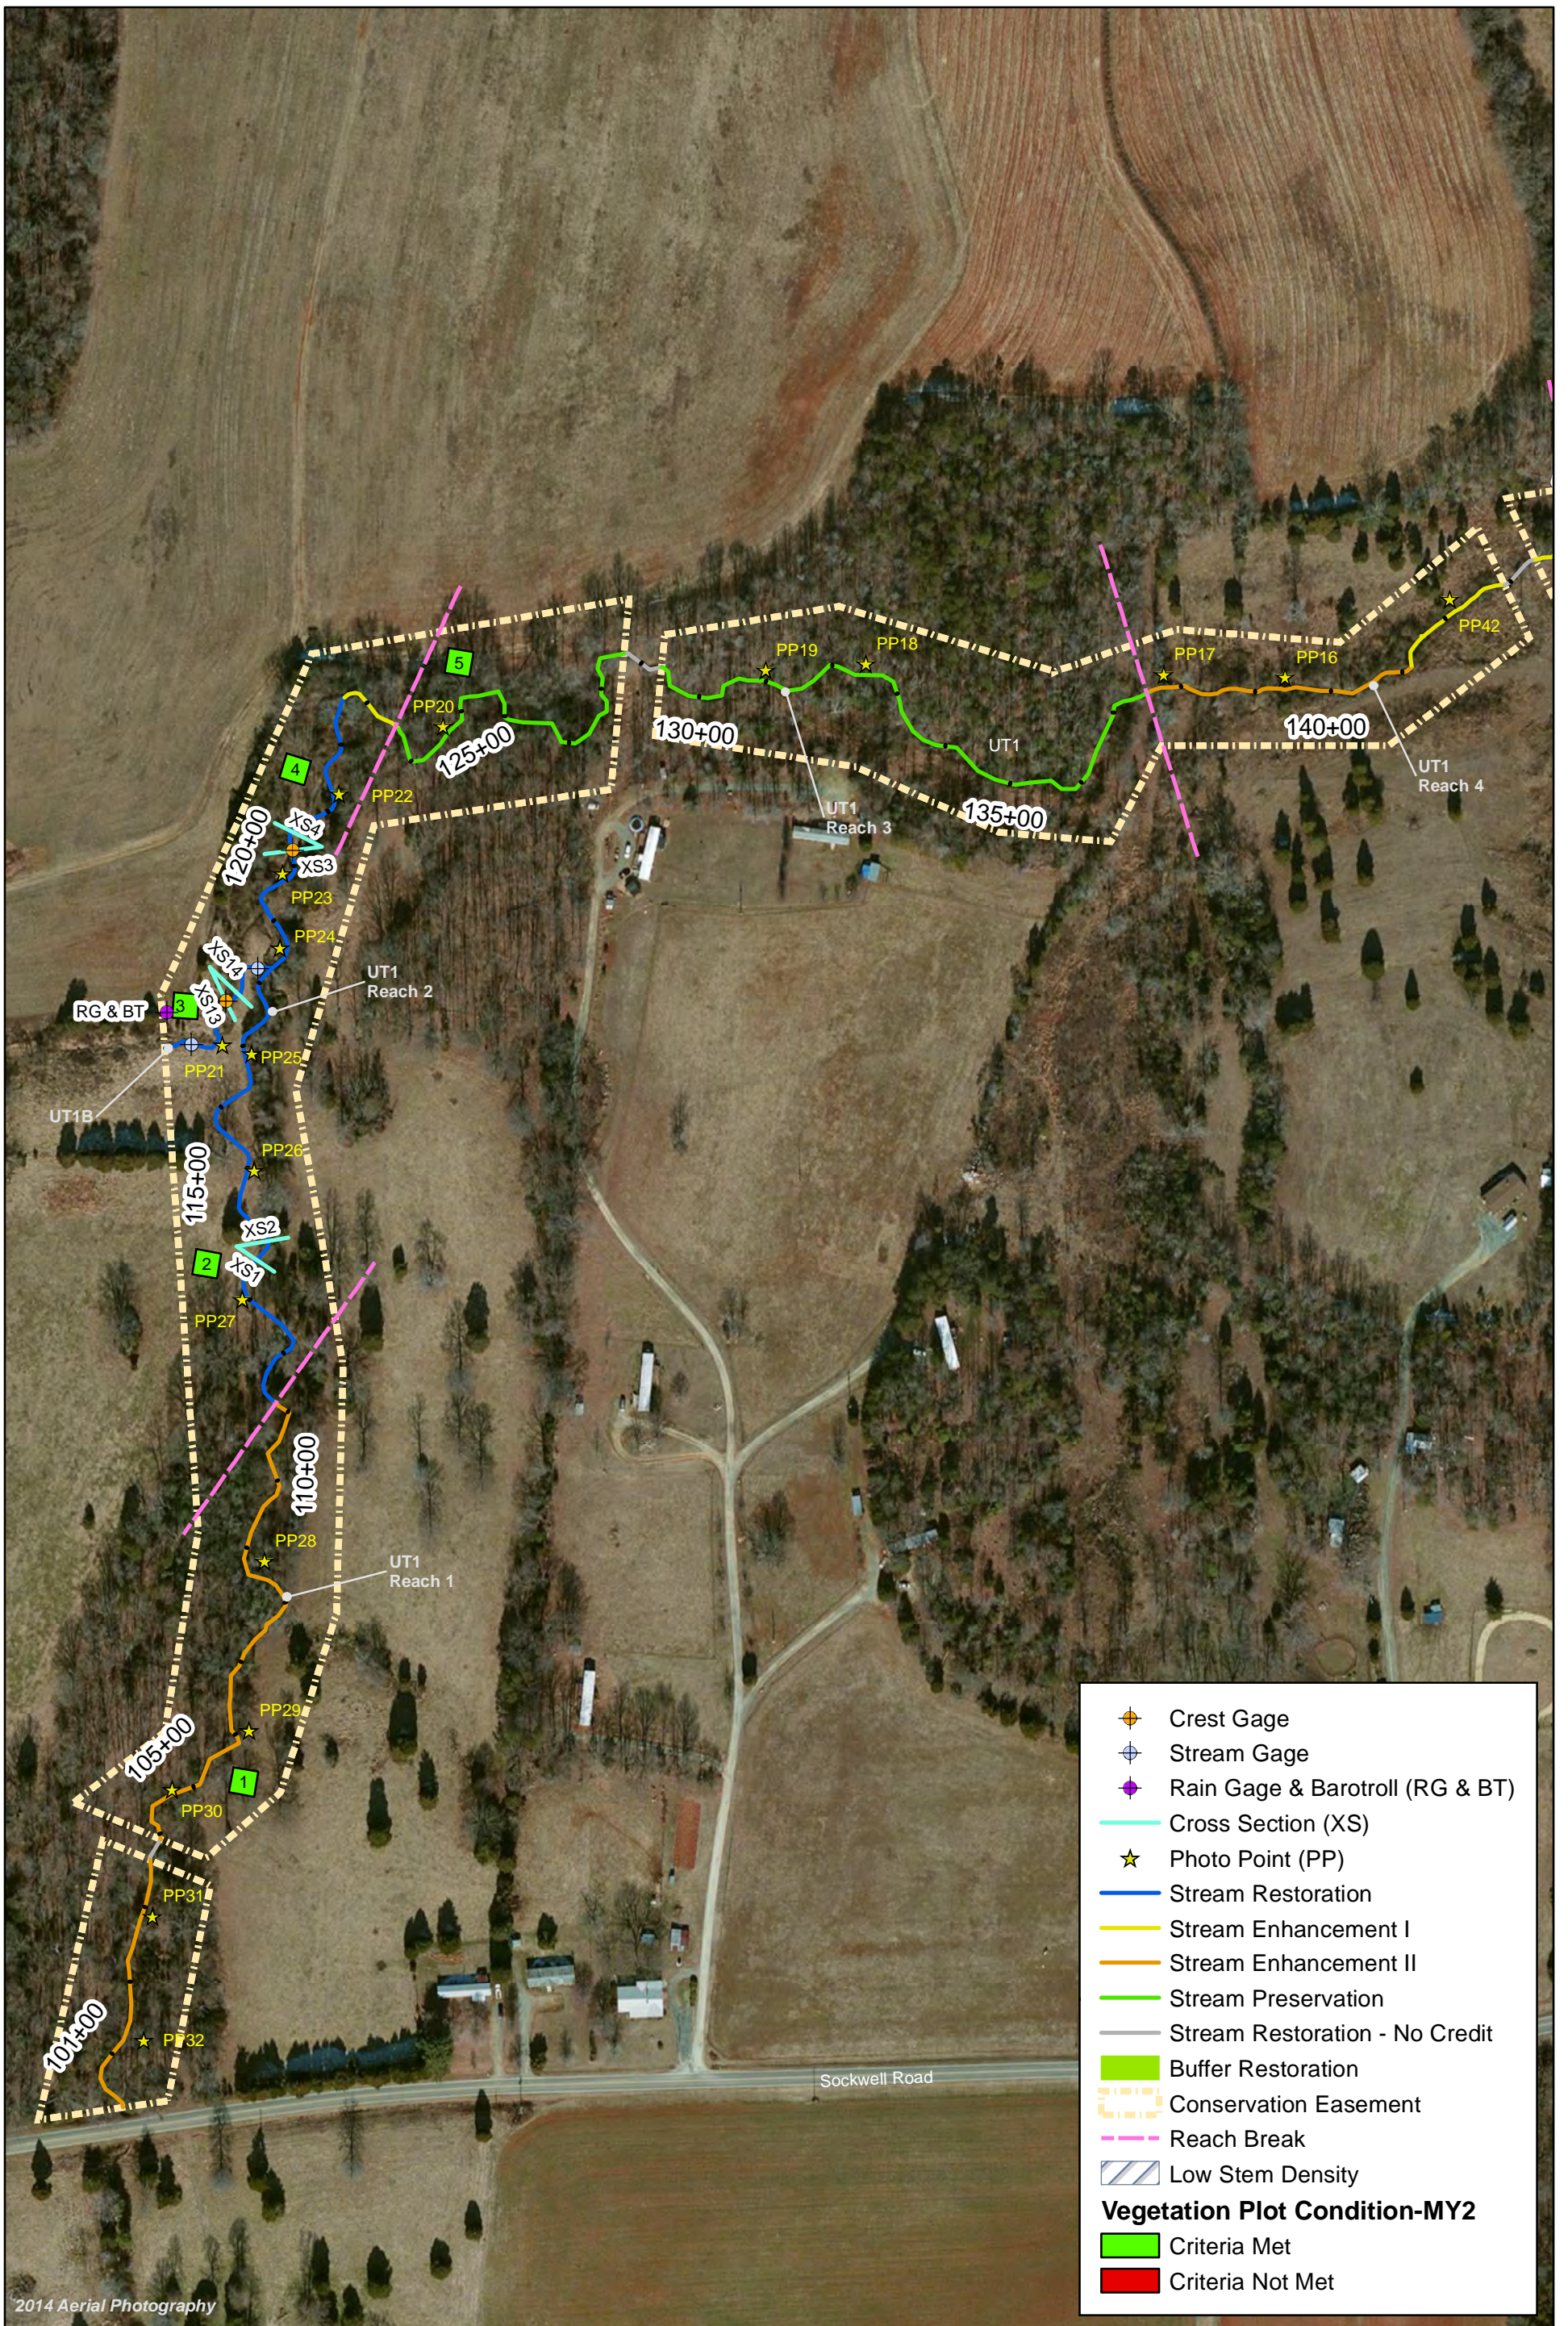
Figure 3.1 Integrated Current Condition Plan View
 (Sheet 1 of 3)
 Agony Acres Mitigation Site
 DMS Project No.95716
 Monitoring Year 2 - 2016
 Guilford County, NC

An area less than one acre in size along Reedy Fork; near vegetation plot 10, has a low planted stem density. Supplemental planting will be performed in this area during the fall/winter of 2016. Native trees from the original plant list will be used to supplement this area. Refer to the Integrated Current Condition Plan View Map (CCPV) in Appendix 2 for this area of low stem density.
