MONITORING YEAR 3 ANNUAL REPORT

AGONY ACRES MITIGATION SITE

Guilford County, NC

DMS Project Number 95716

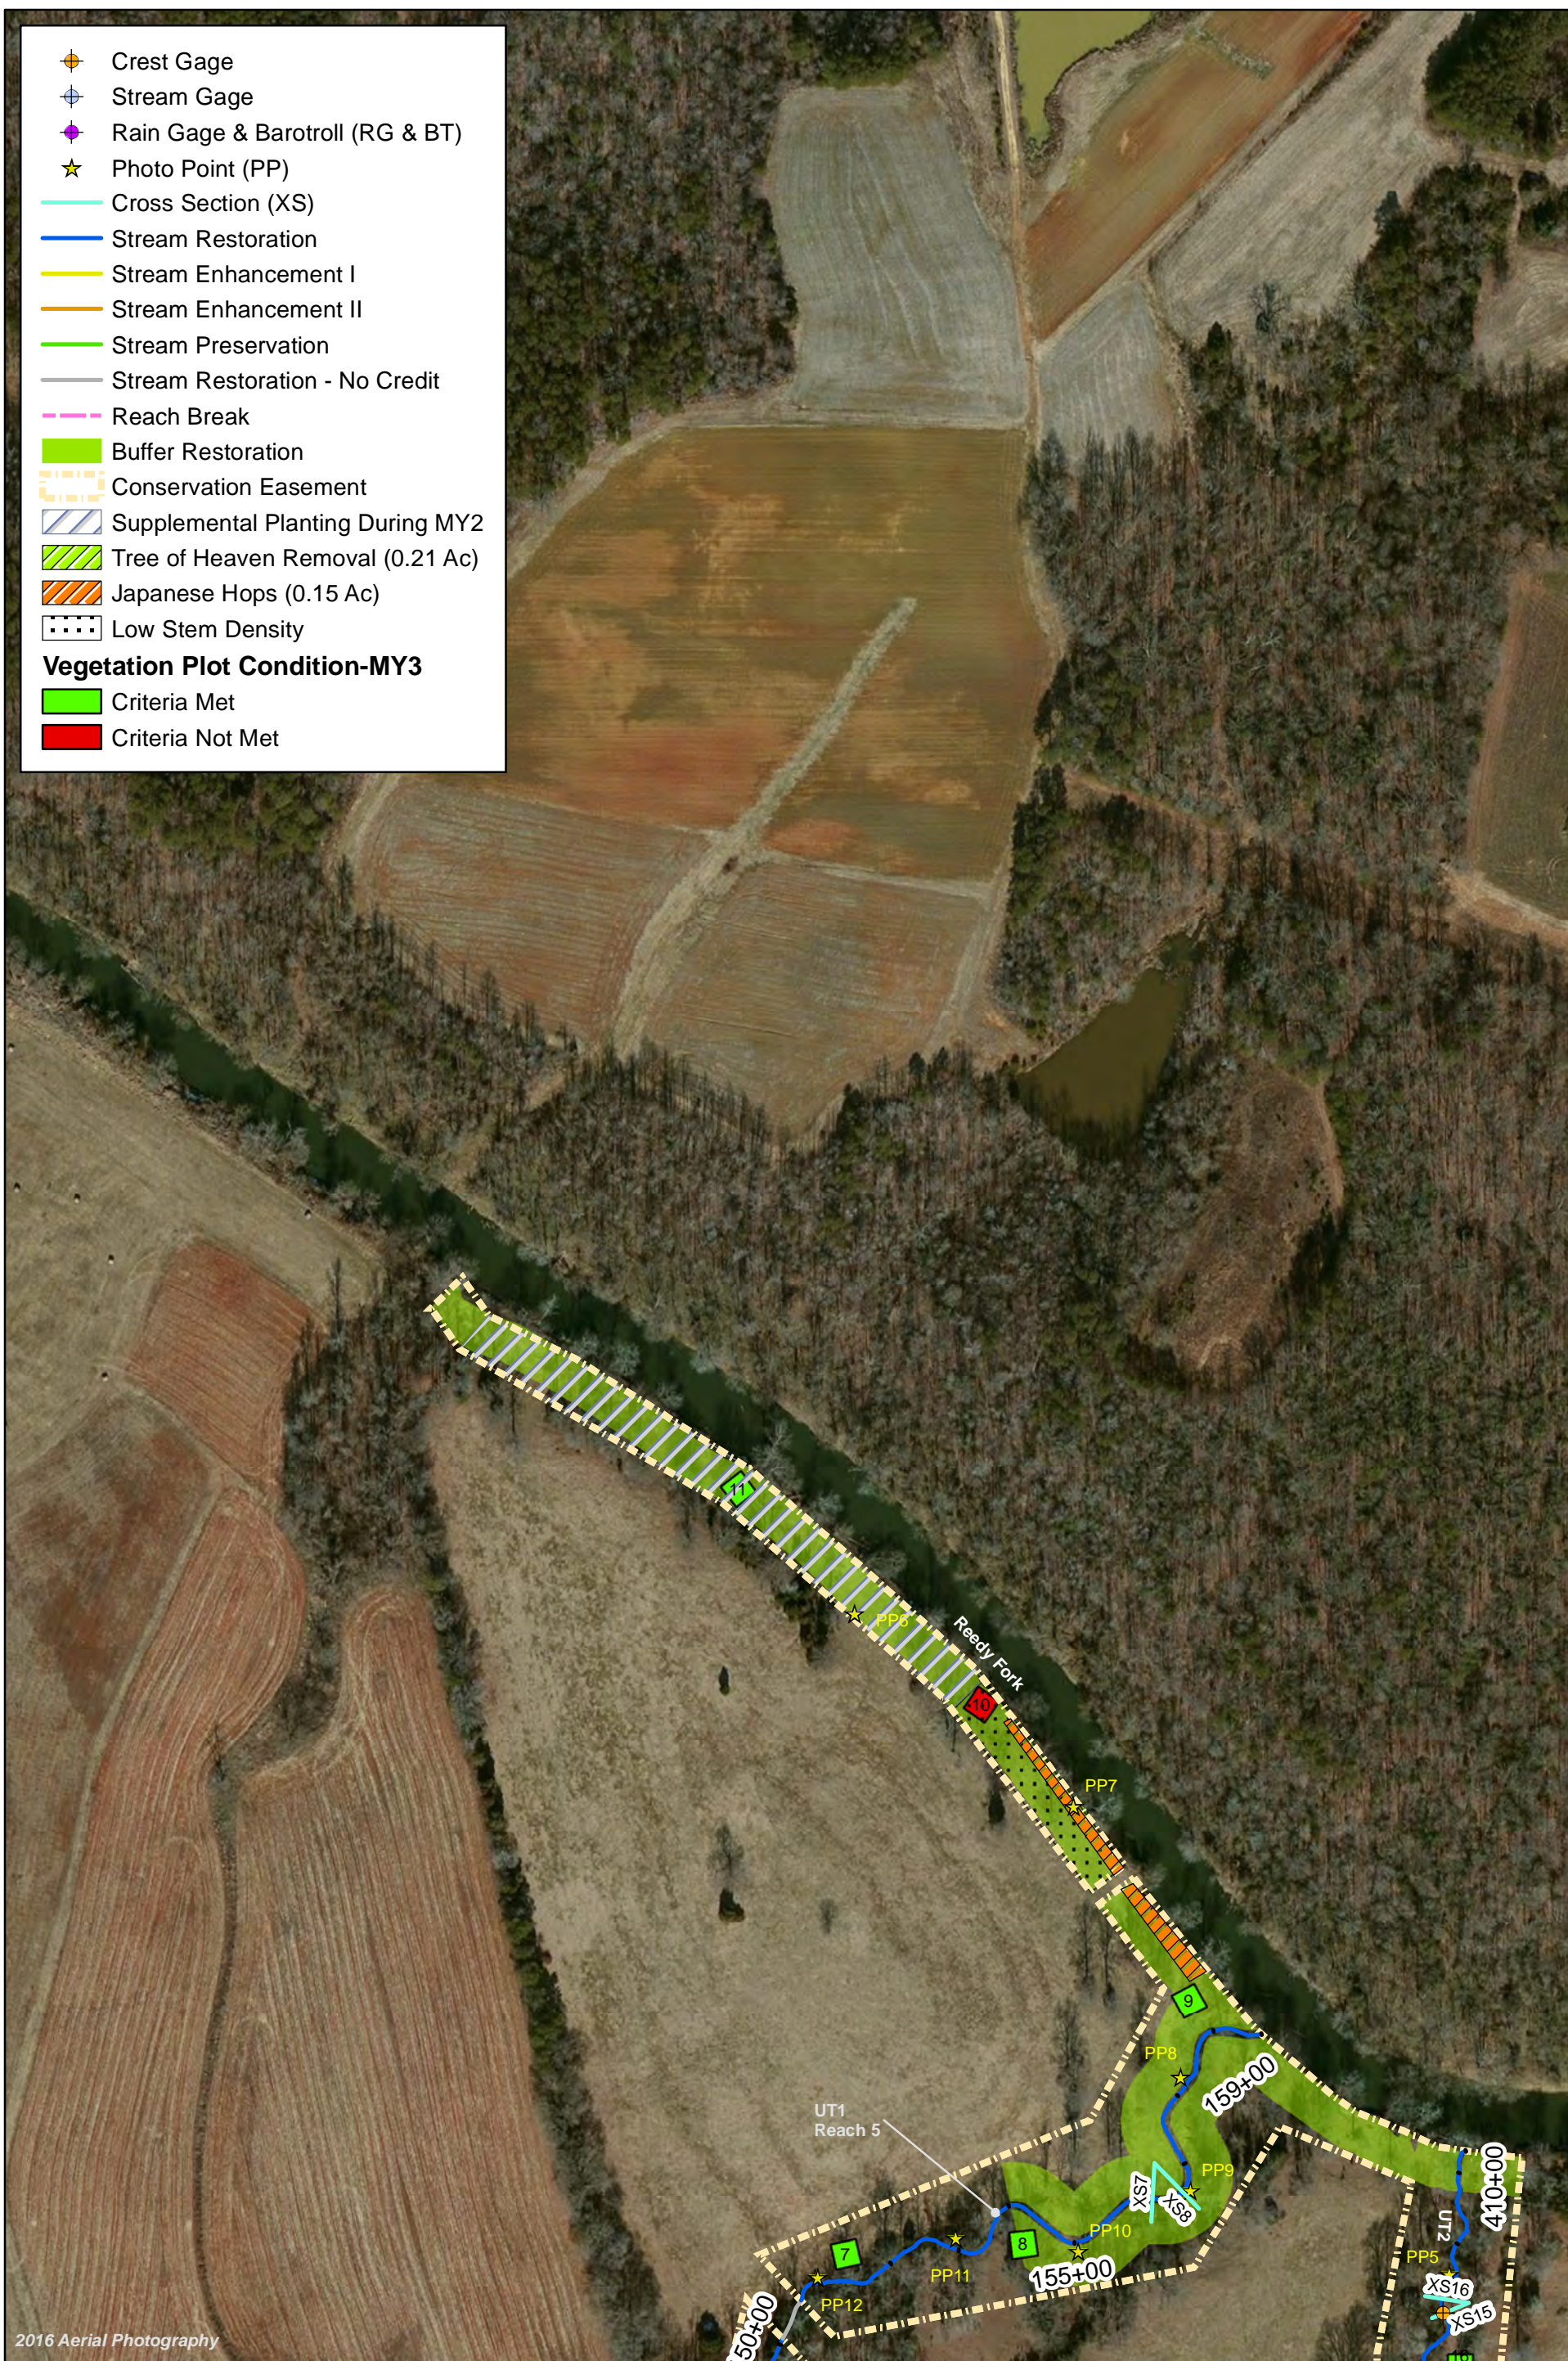
Figure 3.3 Integrated Current Condition Plan View
 (Sheet 3 of 3)
 Agony Acres Mitigation Site
 DMS Project No. 95716
 Monitoring Year 3 - 2017
 Guilford County, NC

Japanese hops (*Humulus japonicus*) was observed growing in a portion of the buffer restoration area along Reedy Fork (Figure 3.3, CCPV). A pre-emergent herbicide with the active ingredient sulfometuron methyl will be used in mid-March 2018 to control Japanese hops. This herbicide should cause minimal or no damage to surrounding vegetation while effectively controlling Japanese hops. This area will continue to be monitored for new growth and will be treated with the appropriate herbicide as needed.
