# **MONITORING YEAR 5 ANNUAL REPORT**

## **AGONY ACRES MITIGATION SITE**

Guilford County, NC

DMS Project Number 95716

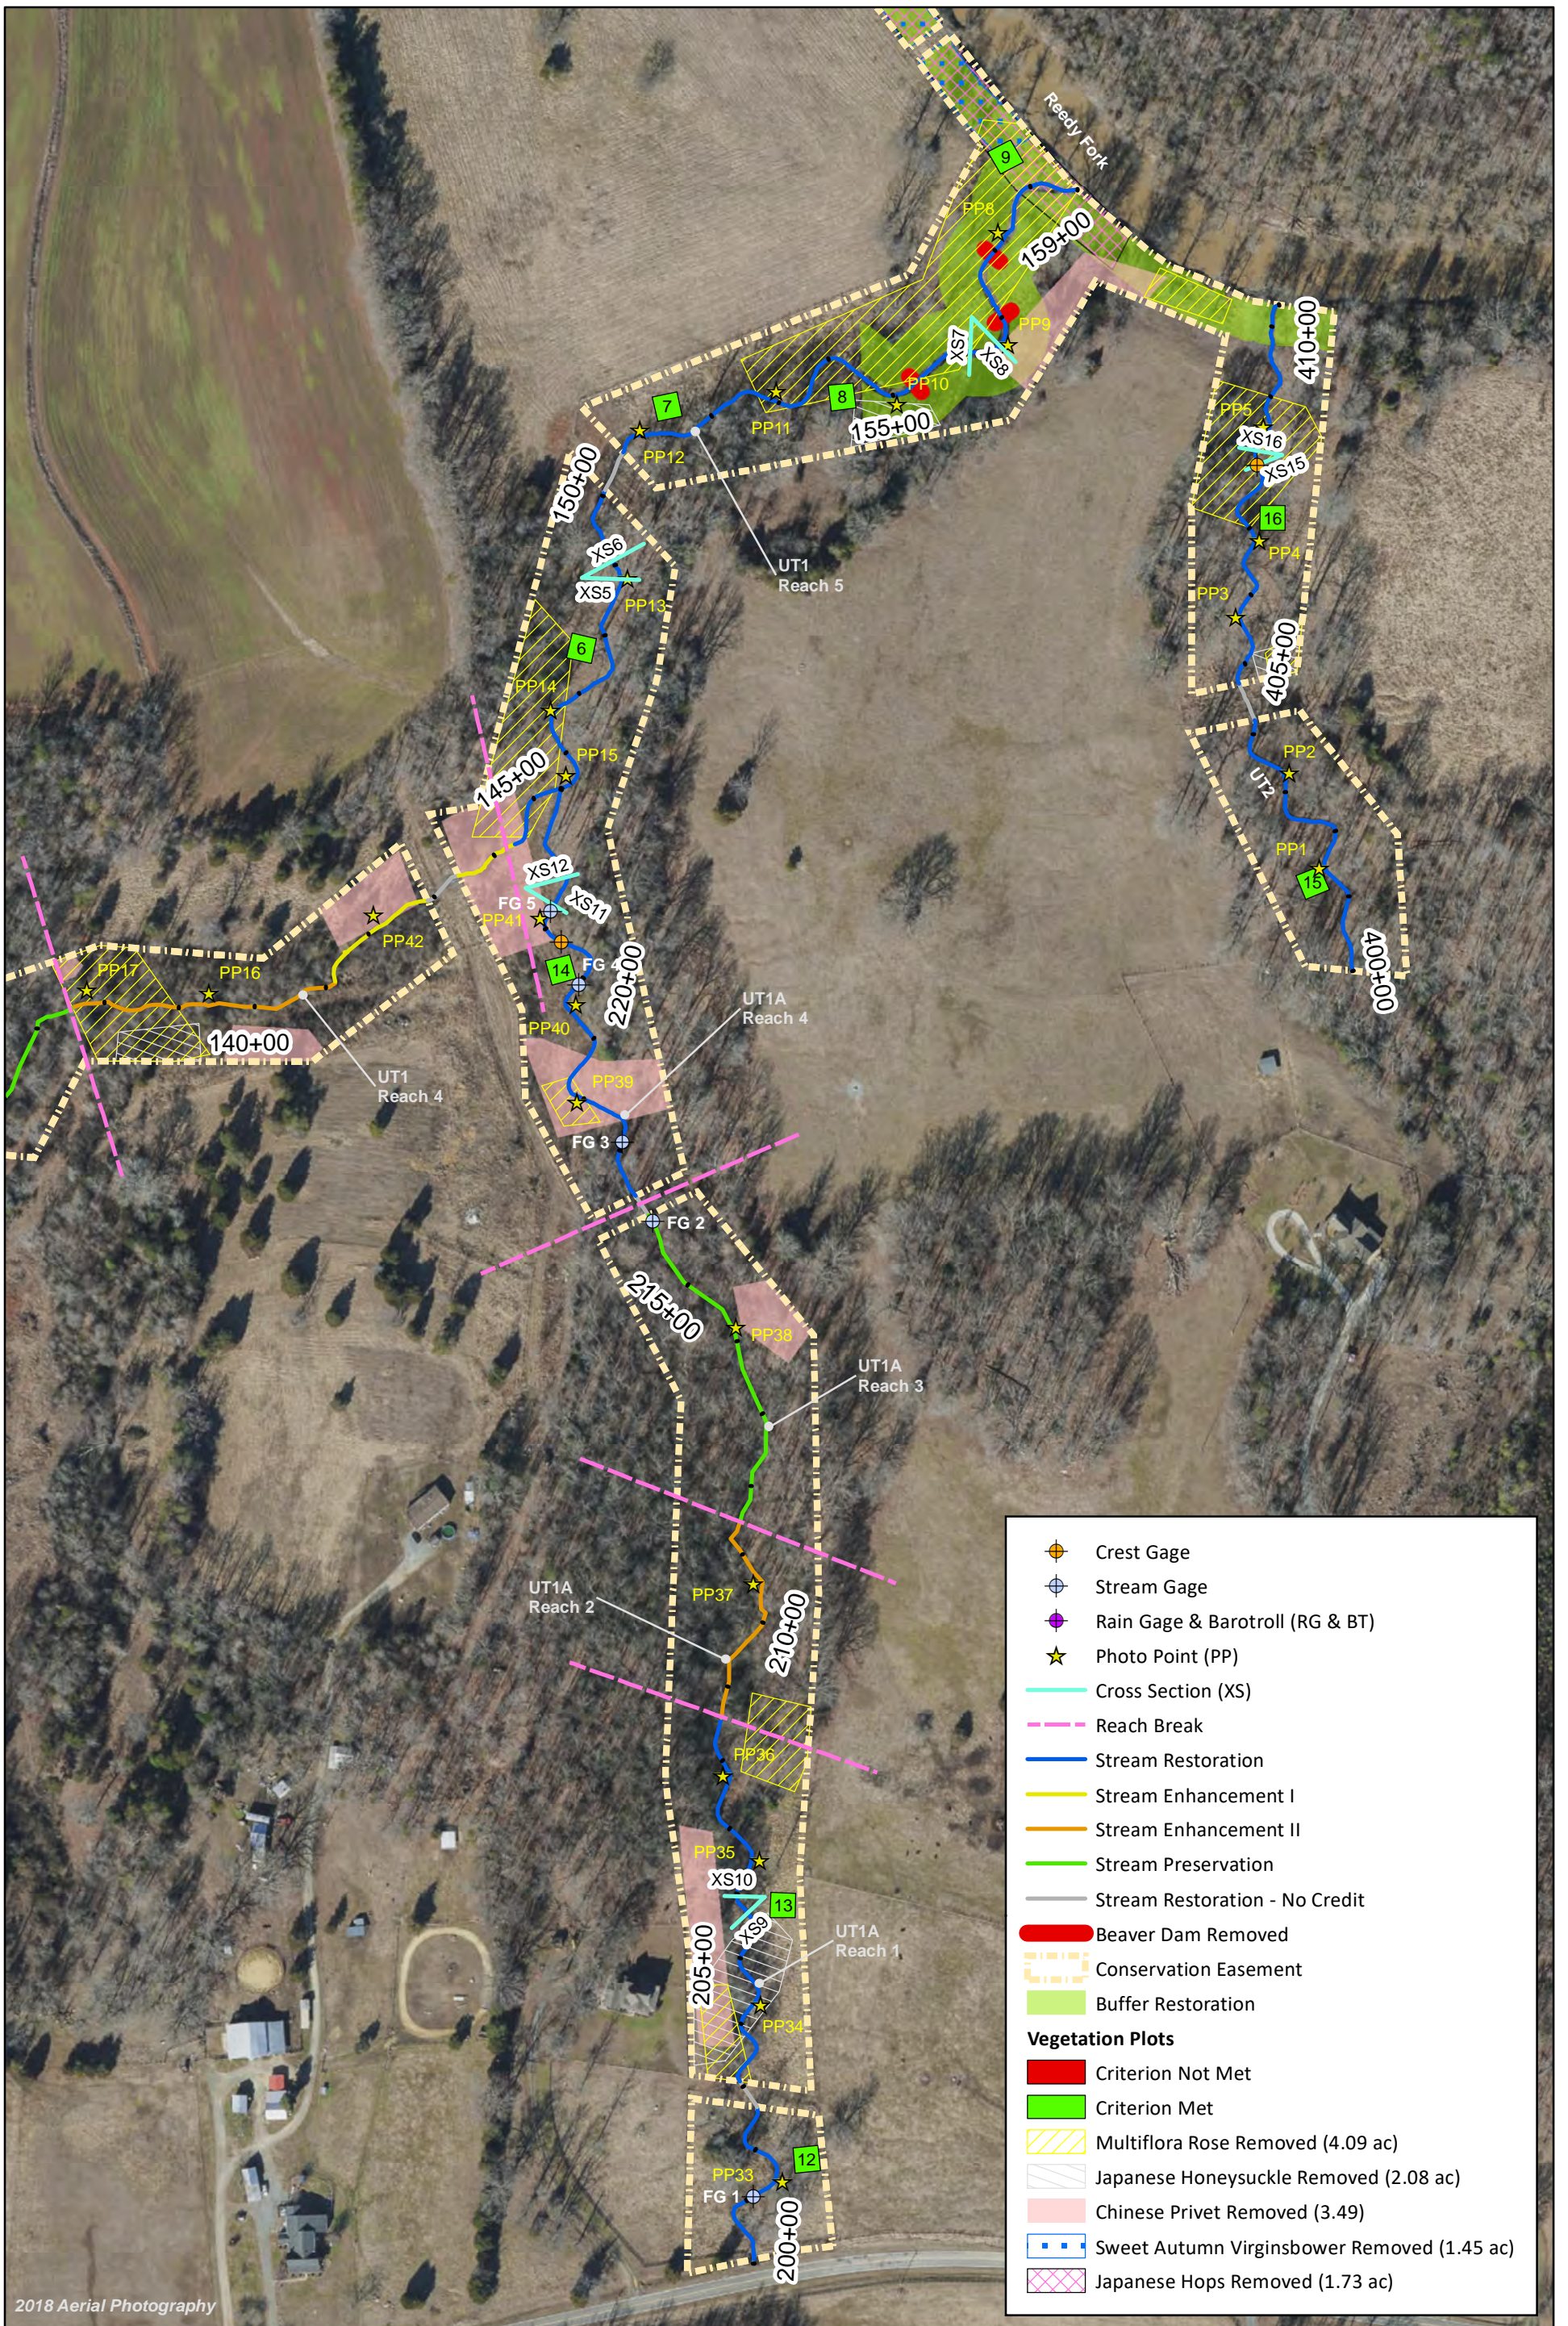
Figure 3.2. Integrated Current Condition Plan View  
 (Sheet 2 of 3)  
 Agony Acres Mitigation Site  
 DMS Project No. 95716  
 Monitoring Year 5 - 2019  
 Guilford County, NC

Beaver activity occurred on UT1 where it approaches the Reedy Fork floodplain (Figure 3.2). Beaver activity was identified in September and removal was completed in October. Minimal damage occurred to the stream channels and tree community.
